**Huyton Town Centre Regeneration**  
CCTV Condition Report

Project Ref: TS-2645 Huyton Town Centre Regeneration CCTV  
Report\_303\_Issue01

**Dominic White – Tower Surveys CCTV Ltd**  
**23/05/2025**

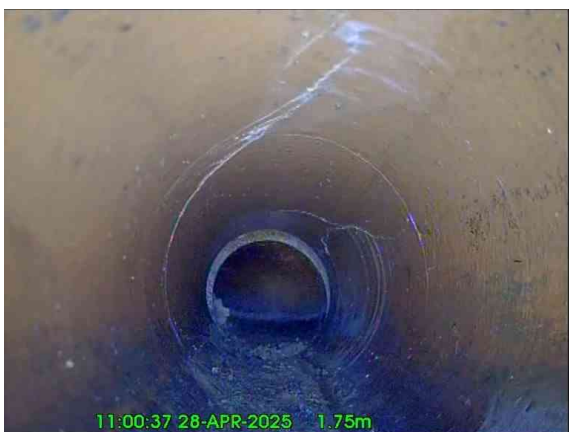
| Scale: | 1:50 | Position [m] | Code | Observation | MPEG | Photo | Grade |
|---|---|---|---|---|---|---|---|
| | 1.75 | CMJ | Cracks, multiple at joint from 8 o'clock to 4 o'clock | 00:00:30 | 3 | | 3 / 2 |

3, 00:00:30, 1.75 m  
Cracks, multiple at joint from 8 o'clock to 4 o'clock

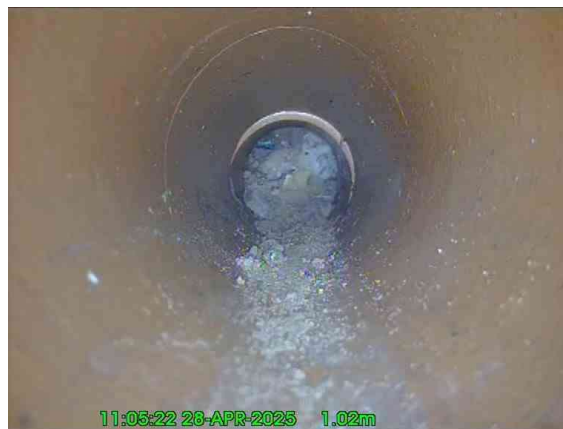
| Scale: | 1:50 | Position [m] | Code | Observation | MPEG | Photo | Grade |
|---|---|---|---|---|---|---|---|
| | | 1.02 | CC | Crack, circumferential from 8 o'clock to 3 o'clock | 00:00:14 | 2 | 2 / 2 |

2, 00:00:14, 1.02 m  
Crack, circumferential from 8 o'clock to 3 o'clock

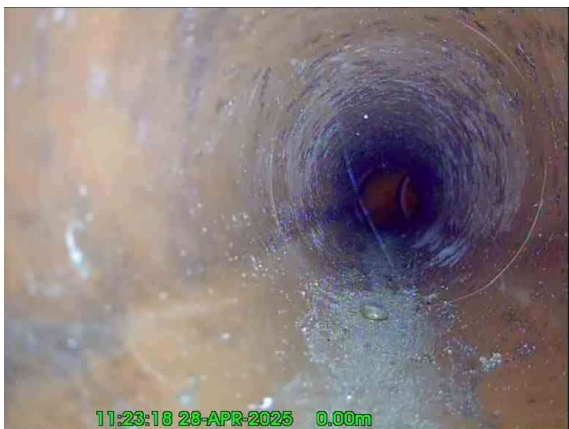
| Scale: | 1:50 | Position [m] | Code | Observation | MPEG | Photo | Grade |
|---|---|---|---|---|---|---|---|
| | | 0.00 | CC | Crack, circumferential from 1 o'clock to 5 o'clock | 00:00:01 | 1 | 2 / 2 |

1, 00:00:01, 0.00 m  
Crack, circumferential from 1 o'clock to 5 o'clock

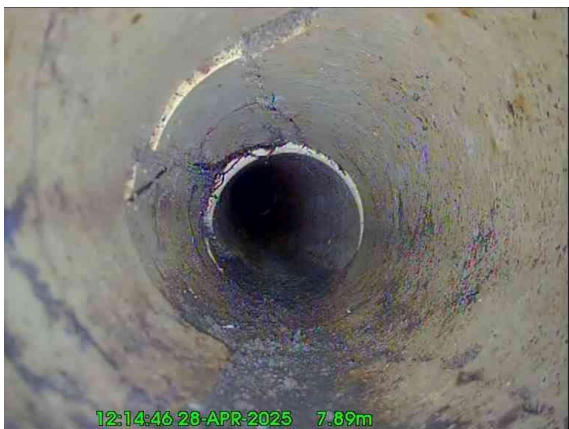
| Section | PLR | Grade | Description |
|---|---|---|---|
| 8 | MH2 UTL | 3 | Fracture, circumferential from 9 o'clock to 12 o'clock |

| Scale: | 1:133 | Position [m] | Code | Observation | MPEG | Photo | Grade |
|---|---|---|---|---|---|---|---|
| | FC | Fracture, circumferential from 9 o'clock to 12 o'clock | 00:01:01 | 9 | 3 / 2 | | |

9, 00:01:01, 7.89 m  
Fracture, circumferential from 9 o'clock to 12 o'clock

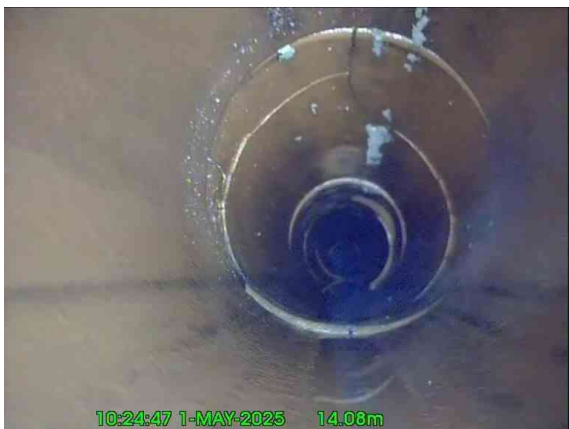
| Section | PLR | Grade | Description |
|---|---|---|---|
| 14 | MH10 X | 3 | Fracture, circumferential at joint from 8 o'clock to 4 o'clock |

<table><tr><th>Position [m]</th><th>Code</th><th>Observation</th><th>MPEG</th><th>Photo</th><th>Grade</th></tr><tr><td>14.08</td><td>FCJ</td><td>Fracture, circumferential at joint from 8 o'clock to 4 o'clock</td><td>00:00:53</td><td>5</td><td>3 / 2</td></tr></table>

Fracture, circumferential at joint from 8 o'clock to 4 o'clock

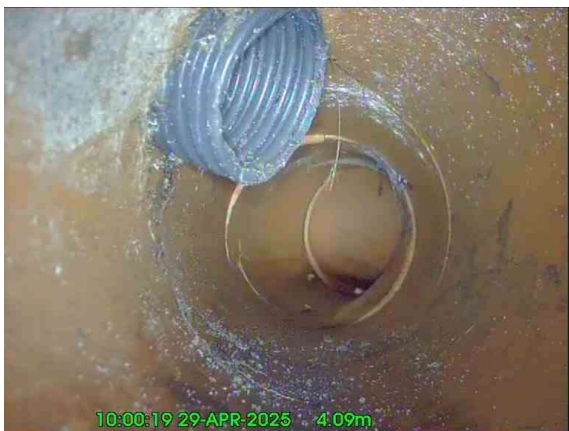
<table><tr><td>MH</td><td>0.00</td><td>Start node, manhole, reference: MH23 A: UU MH Ref: 2704</td><td>00:00:00</td><td></td><td></td><td></td></tr><tr><td>CXI</td><td>4.09</td><td>Connection defective, connecting pipe is intruding at 10 o'clock, 100mm dia, intrusion: 20%</td><td>00:00:36</td><td>3</td><td>4</td><td></td></tr></table>

3, 00:00:36, 4.09 m  
Connection defective, connecting pipe is intruding at 10 o'clock, 100mm dia, intrusion: 20%

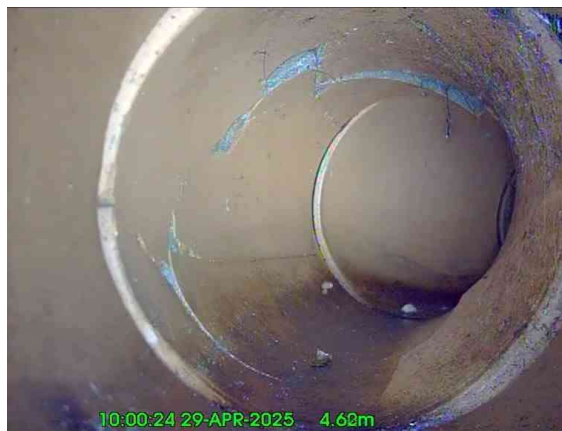
| Section | PLR | Grade | Description |
|---|---|---|---|
| 27 | Gully | 4 | Fractures, multiple at joint from 7 o'clock to 1 o'clock |

<table><tr><td>MH</td><td>0.00</td><td>Start node, manhole, reference: MH23 A: UU MH Ref: 2704</td><td>00:00:00</td><td></td><td></td><td></td></tr><tr><td>FMJ</td><td>4.62</td><td>Fractures, multiple at joint from 7 o'clock to 1 o'clock</td><td>00:00:41</td><td>4</td><td>4 / 2</td><td></td></tr></table>

4, 00:00:41, 4.62 m  
Fractures, multiple at joint from 7 o'clock to 1 o'clock

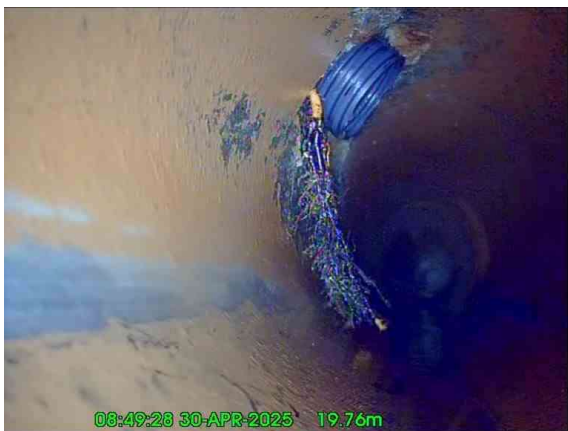
<table><tr><th>Position [m]</th><th>Code</th><th>Observation</th><th>MPEG</th><th>Photo</th><th>Grade</th></tr><tr><td>19.76</td><td>CXI</td><td>Connection defective, connecting pipe is intruding at 10 o'clock, 100mm dia, intrusion: 5%</td><td>00:01:24</td><td>3</td><td>3</td></tr></table>

3, 00:01:24, 19.76 m  
Connection defective, connecting pipe is intruding at 10 o'clock, 100mm dia, intrusion: 5%

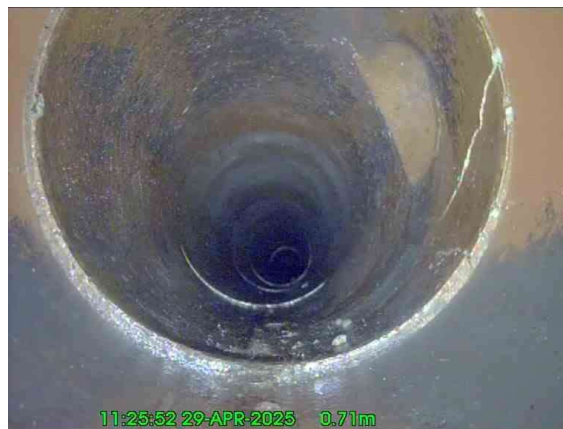
2, 00:00:09, 0.71 m  
Crack, circumferential at joint from 2 o'clock to 4 o'clock

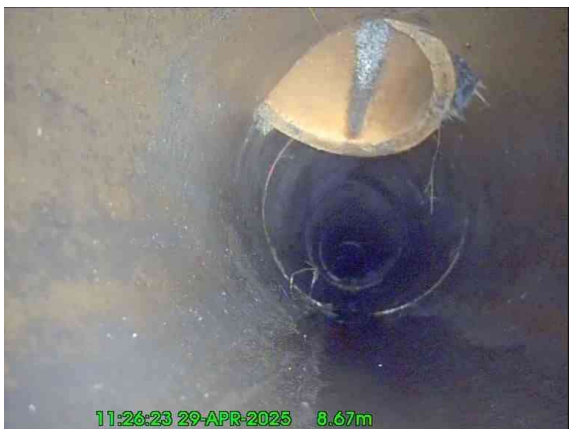
5, 00:00:41, 8.67 m  
Connection defective, connecting pipe is intruding at 12 o'clock, 100mm dia, intrusion: 20%

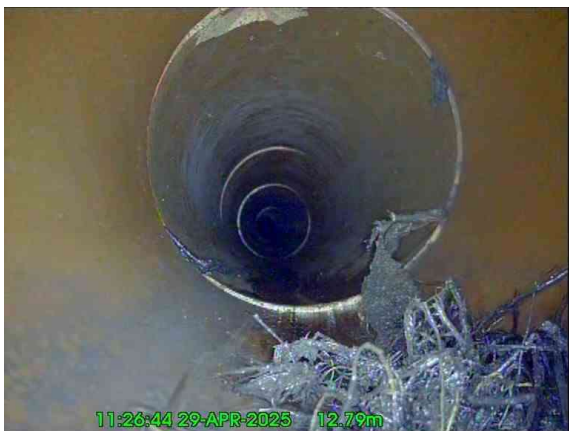
11, 00:01:01, 12.79 m  
Surface damage, increased roughness from 11 o'clock to 12 o'clock

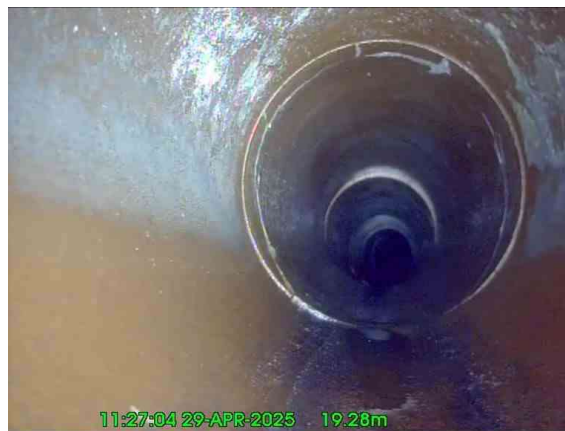
12, 00:01:21, 19.28 m  
Crack, circumferential at joint from 8 o'clock to 4 o'clock

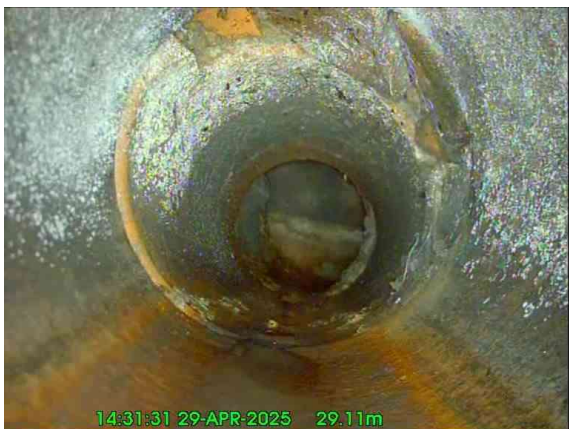
| Scale: 1:258 | Position [m] | Code | Observation | MPEG | Photo | Grade |
|---|---|---|---|---|---|---|
| | 29.11 | SW | Surface damage, increased roughness from 10 o'clock to 3 o'clock | 00:01:47 | 5 | 1 |

5, 00:01:47, 29.11 m  
Surface damage, increased roughness from 10 o'clock to 3 o'clock

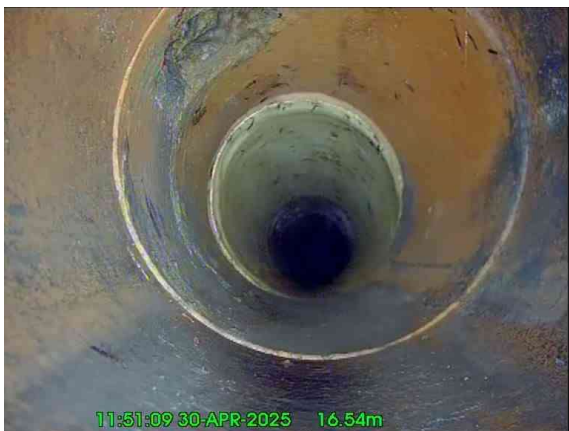
| Scale: 1:305 | Position [m] | Code | Observation | MPEG | Photo | Grade |
|---|---|---|---|---|---|---|
| | 16.54 | SW | Surface damage, increased roughness from 10 o'clock to 11 o'clock | 00:00:47 | 3 | 1 |

3, 00:00:47, 16.54 m  
Surface damage, increased roughness from 10 o'clock to 11 o'clock

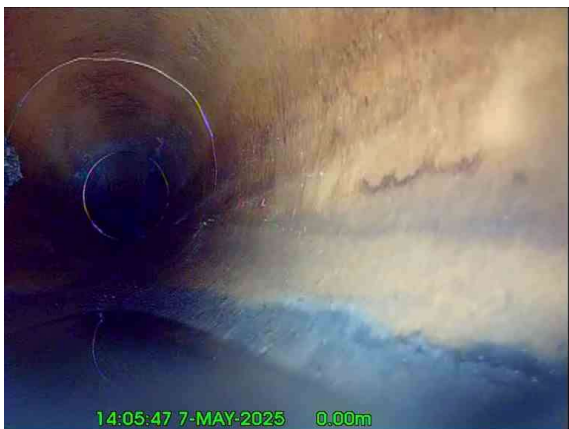
1, 00:00:02, 0.00 m  
Crack, circumferential from 10 o'clock to 2 o'clock

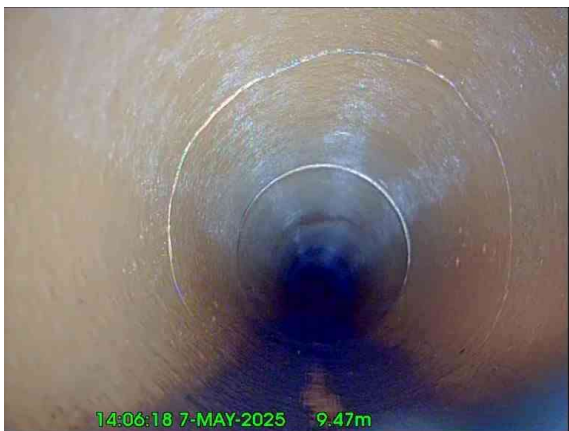
3, 00:00:34, 9.47 m  
Crack, circumferential from 8 o'clock to 4 o'clock
