Cockpit House, Prescott  
for Purcell

Roof Plan

Drawing No: X54/104    Rev: -    Scale: 1:100 @ A3    Date: October 2021

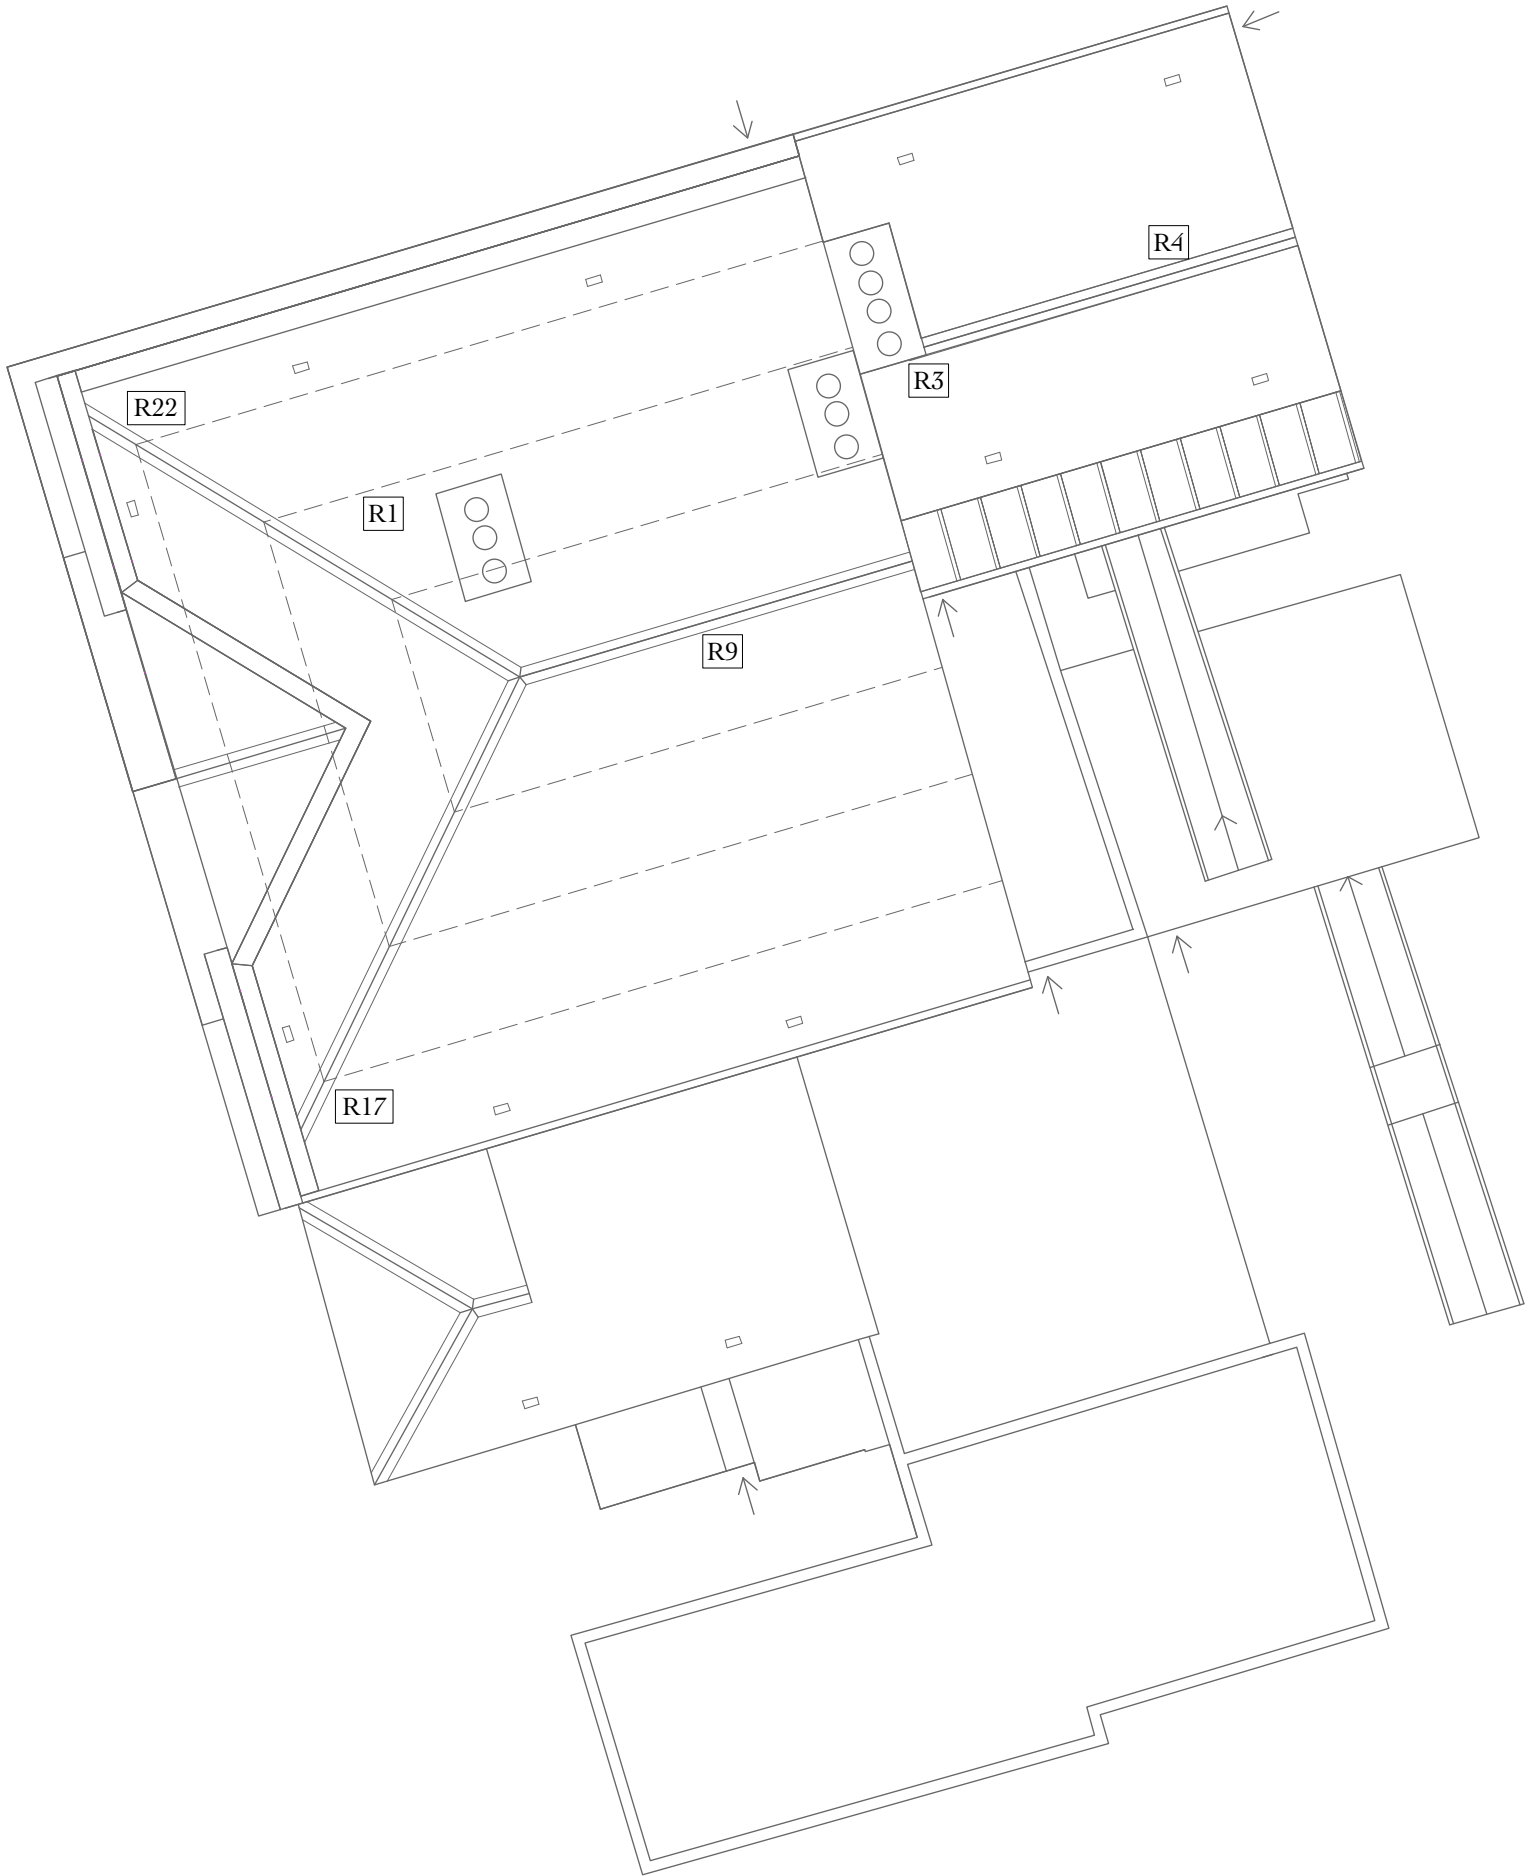
| Ref. | STRUCTURAL DEFECT |
|---|---|
| R1 | Common rafter slipped off notch in purlin |
| R3 | Daylight between roof & wall |
| R4 | Ridgeboard |
| R9 | Bending failure of ridge beam |
| R17 | Purlins slipping off the hip member |
| R22 | Purlins slipping off the hip member |

1. EXISTING ROOF FELT IS NOT BREATHABLE.
2. SPACING OF EXISTING RAFTERS IS TOO LARGE.
