Cockpit House, Prescot  
for Purcell

Basement Plan

Drawing No: X54/100    Rev: -    Scale: 1:100 @ A3    Date: October 2021

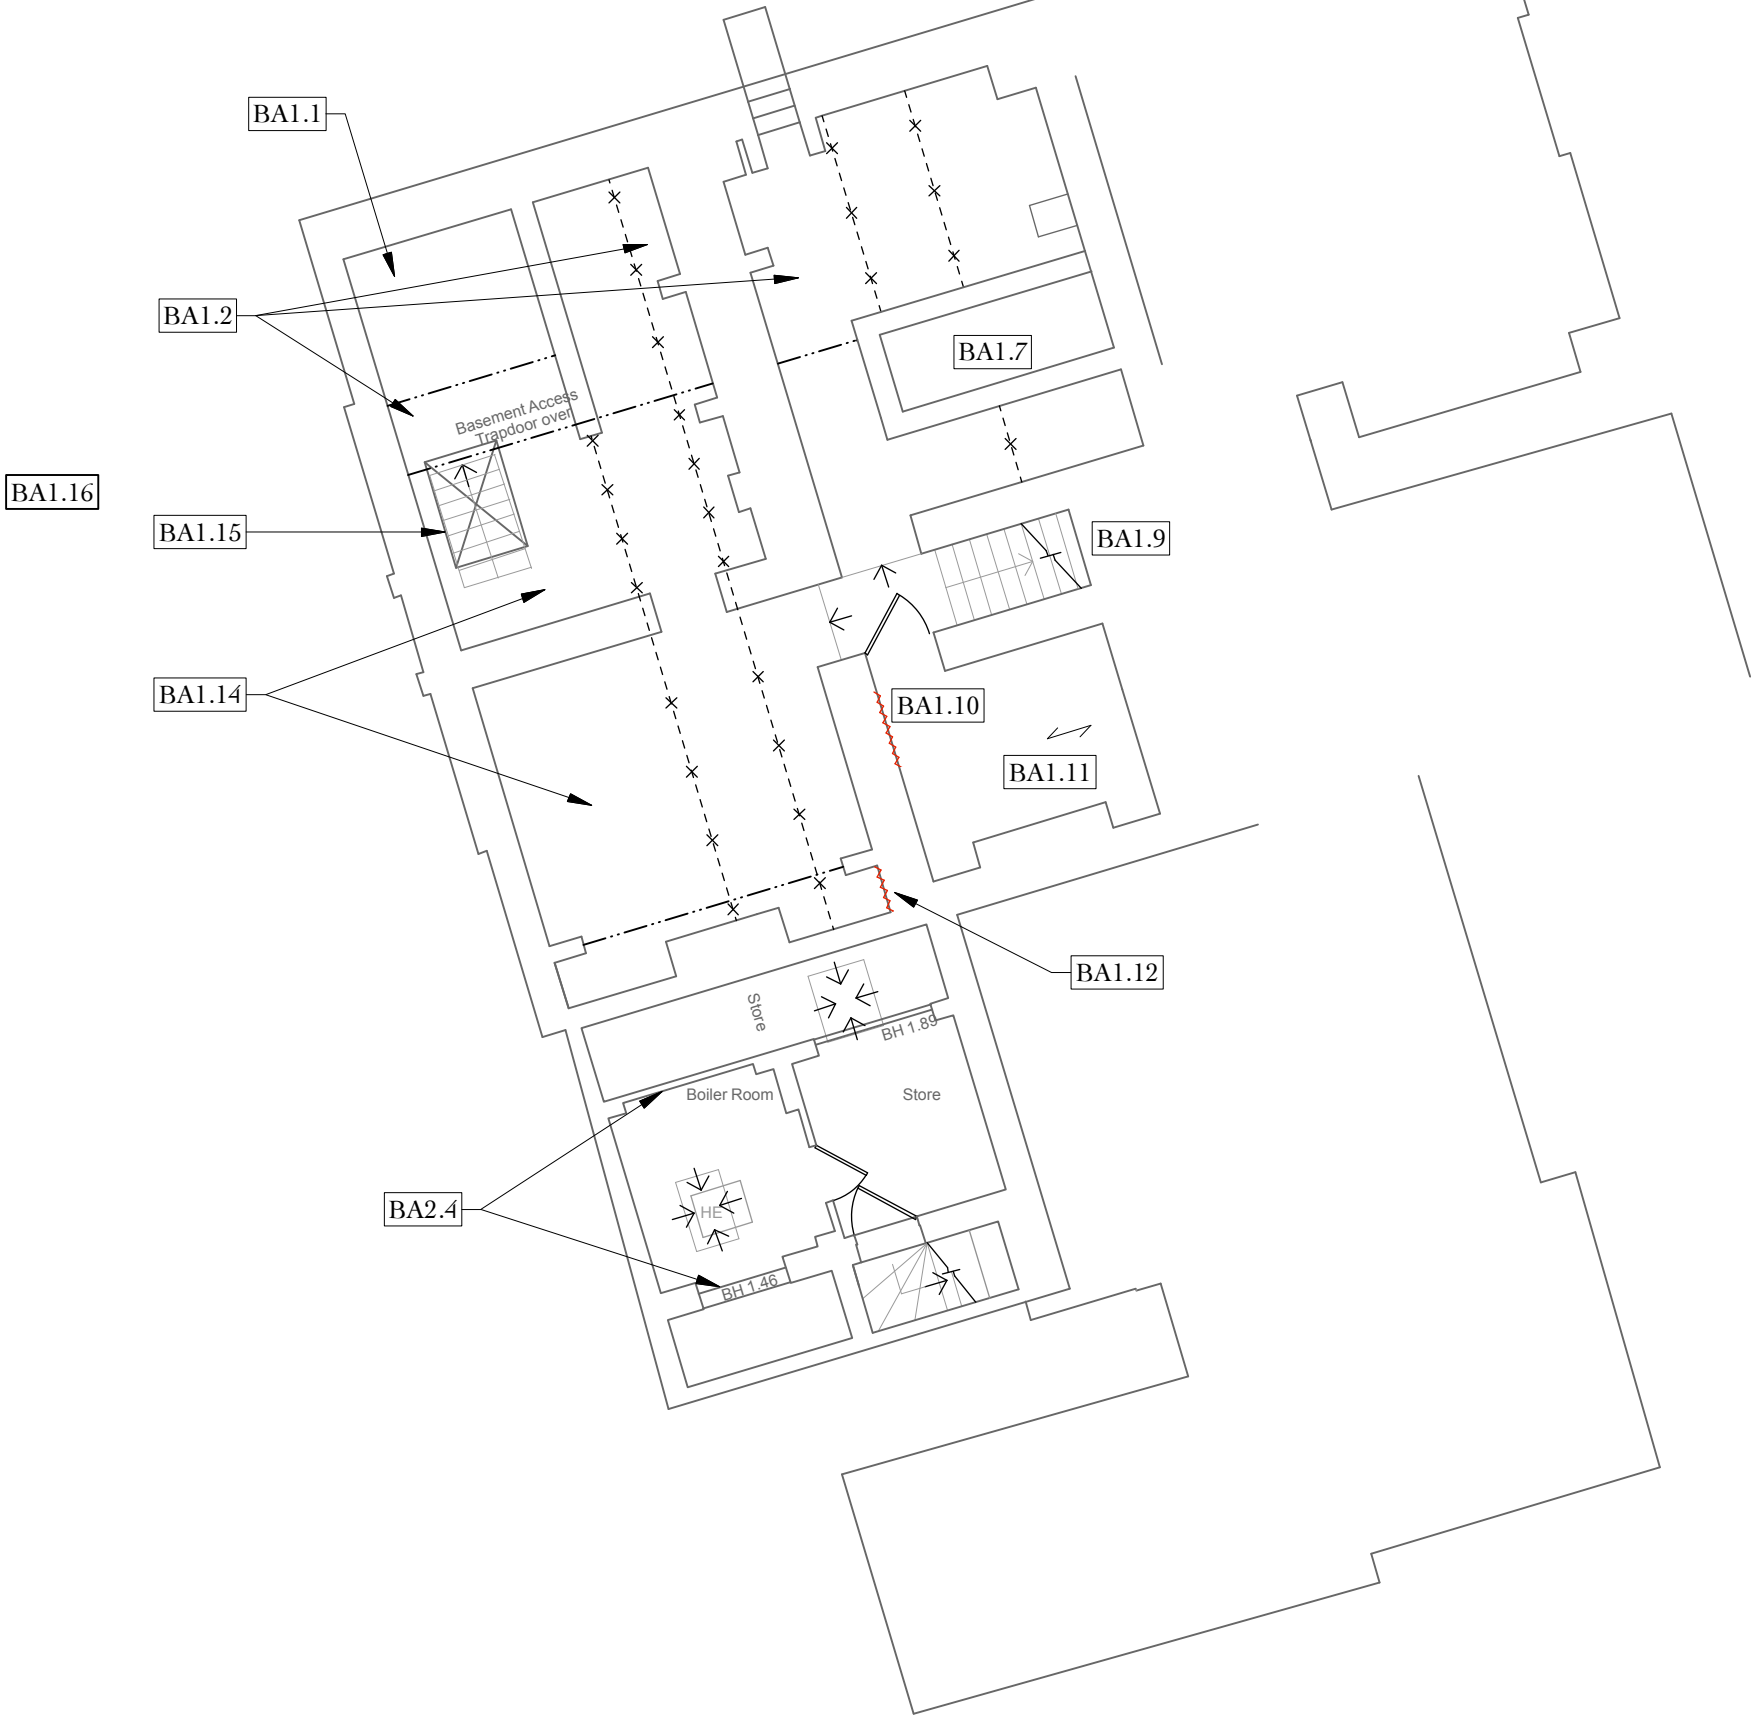
| Ref. | STRUCTURAL DEFECT |
|---|---|
| BA1.1 | Steel ' Beam & Block' – Old entrance replacement floor |
| BA1.2 | Shuttered concrete with big brick aggregates |
| BA1.10 | 5mm diagonal crack on face of wall |
| BA1.11 | Span direction of compact filler joist floor with the steel joists at 200mm c/c |
| BA1.12 | Hairline diagonal crack on this face |
| BA1.14 | Assume suspended floor on this section but not proven as covered by fire protection – possible asbestos. |
| BA1.16 | Acrow props with timber beams are an inappropriate permanent support for the floors above – a more permanent solution should be investigated. |
| BA2.4 | Decaying steel lintels |
