Cockpit House, Prescott  
for Purcell

First Floor Plan

Drawing No: X54/102    Rev: -    Scale: 1:100 @ A3    Date: October 2021

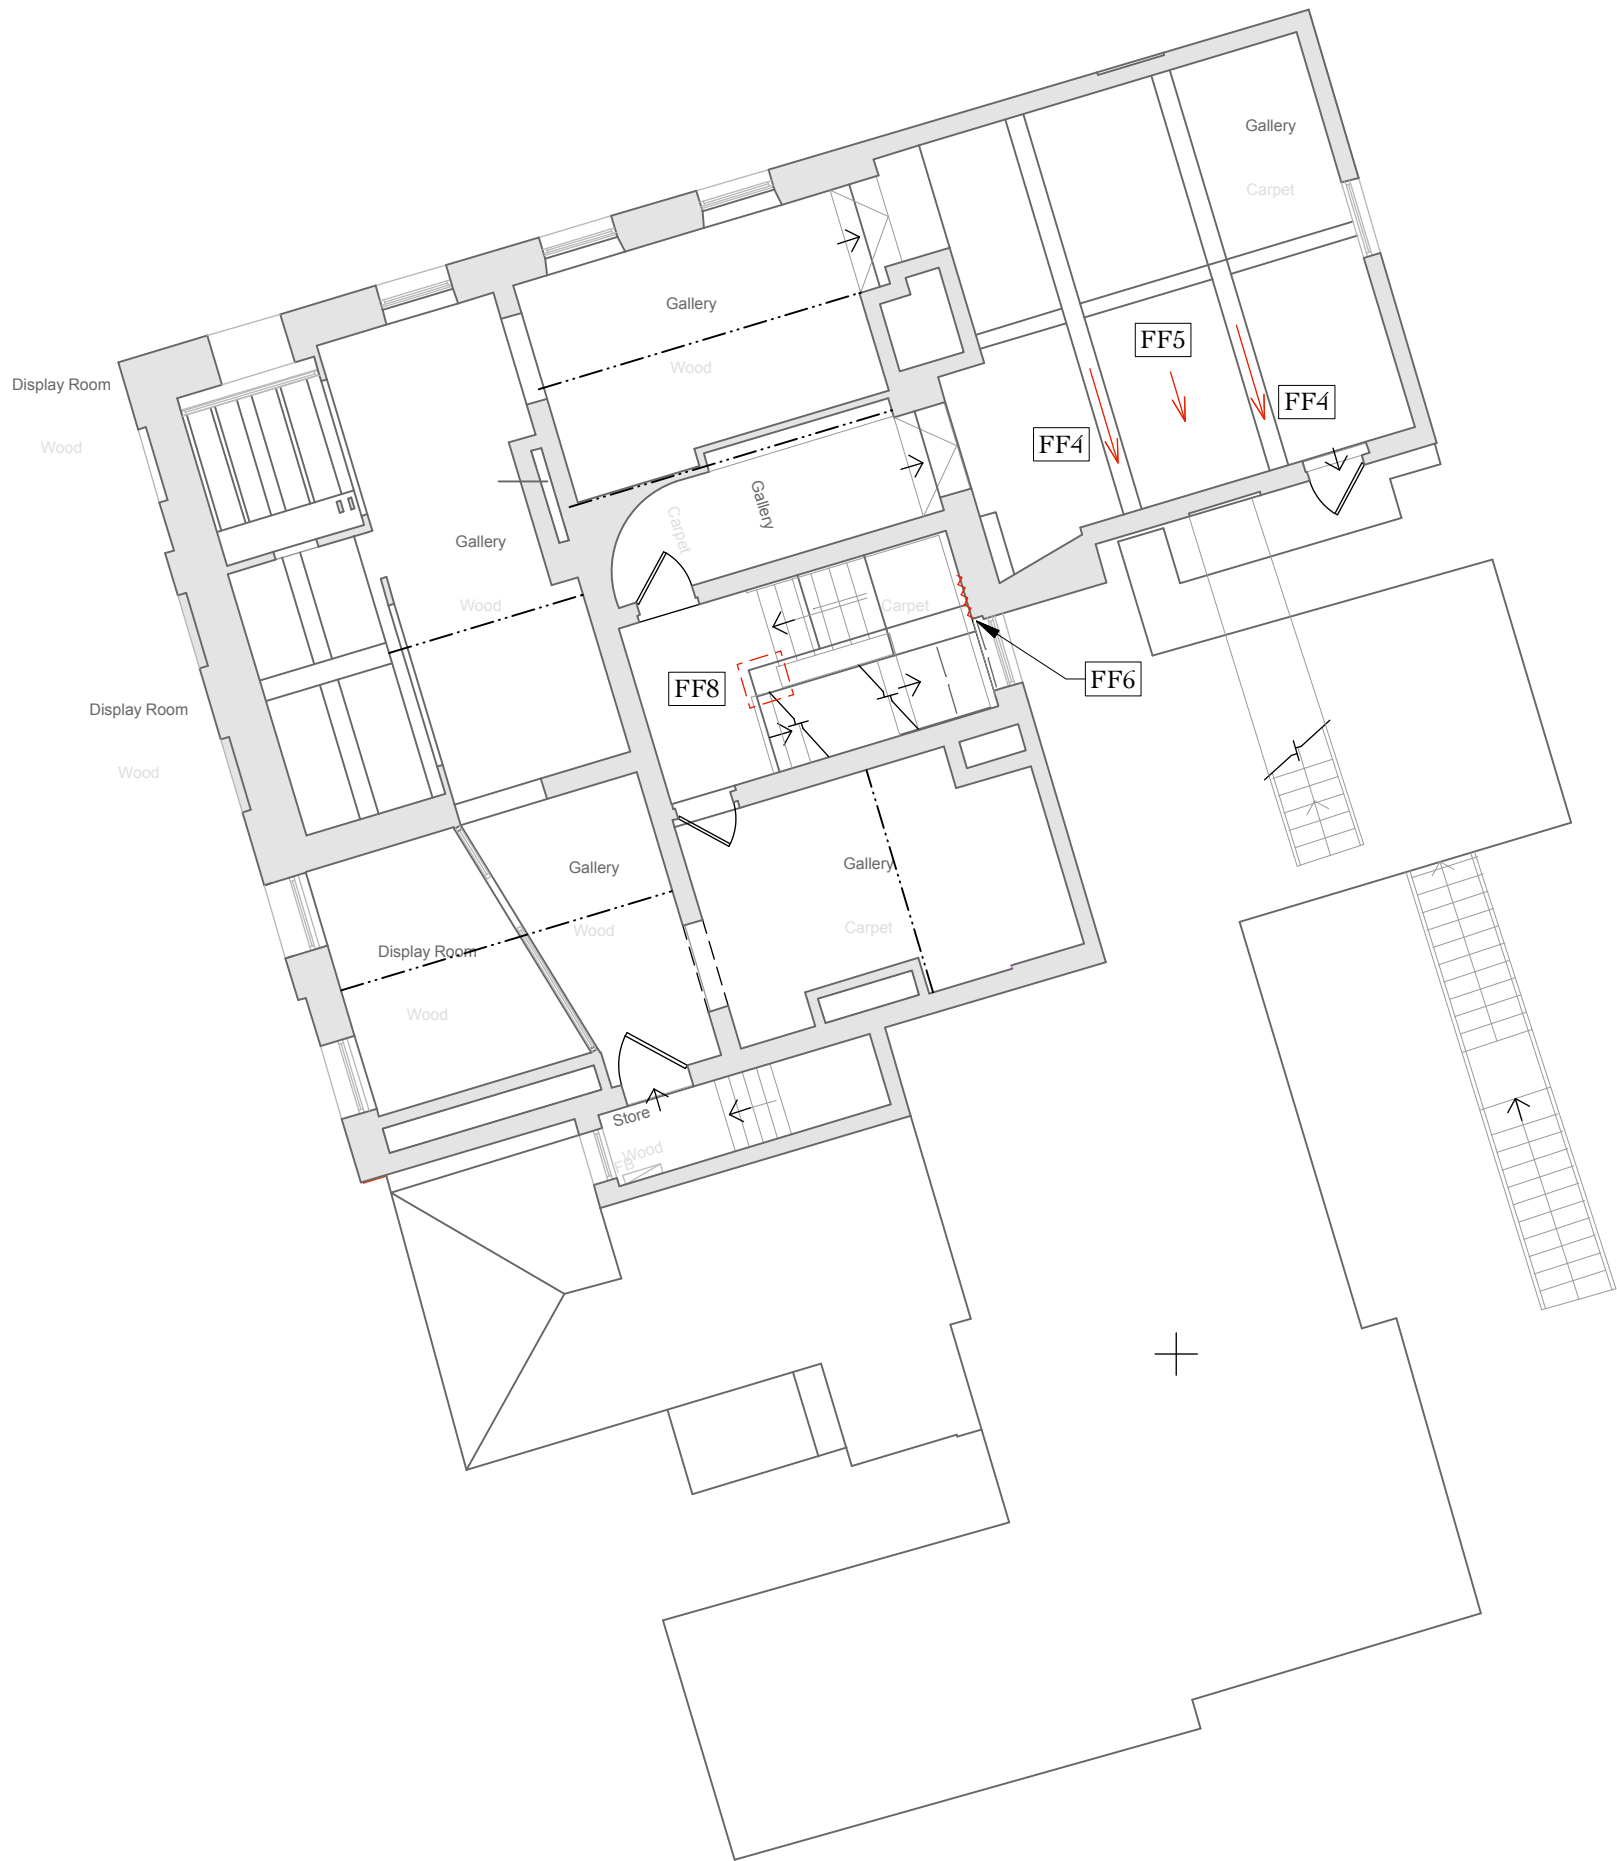
| Ref. | STRUCTURAL DEFECT |
|---|---|
| FF4 | Primary beams lean down towards this elevation from the midpoint |
| FF5 | Floor leans down towards this elevation from the midpoint |
| FF6 | Some cracking from ceiling to window |
| FF8 | Steps lean down – unsupported by post below |
