Cockpit House, Prescott  
for Purcell

Second Floor Plan

Drawing No: X54/103    Rev: -    Scale: 1:100 @ A3    Date: October 2021

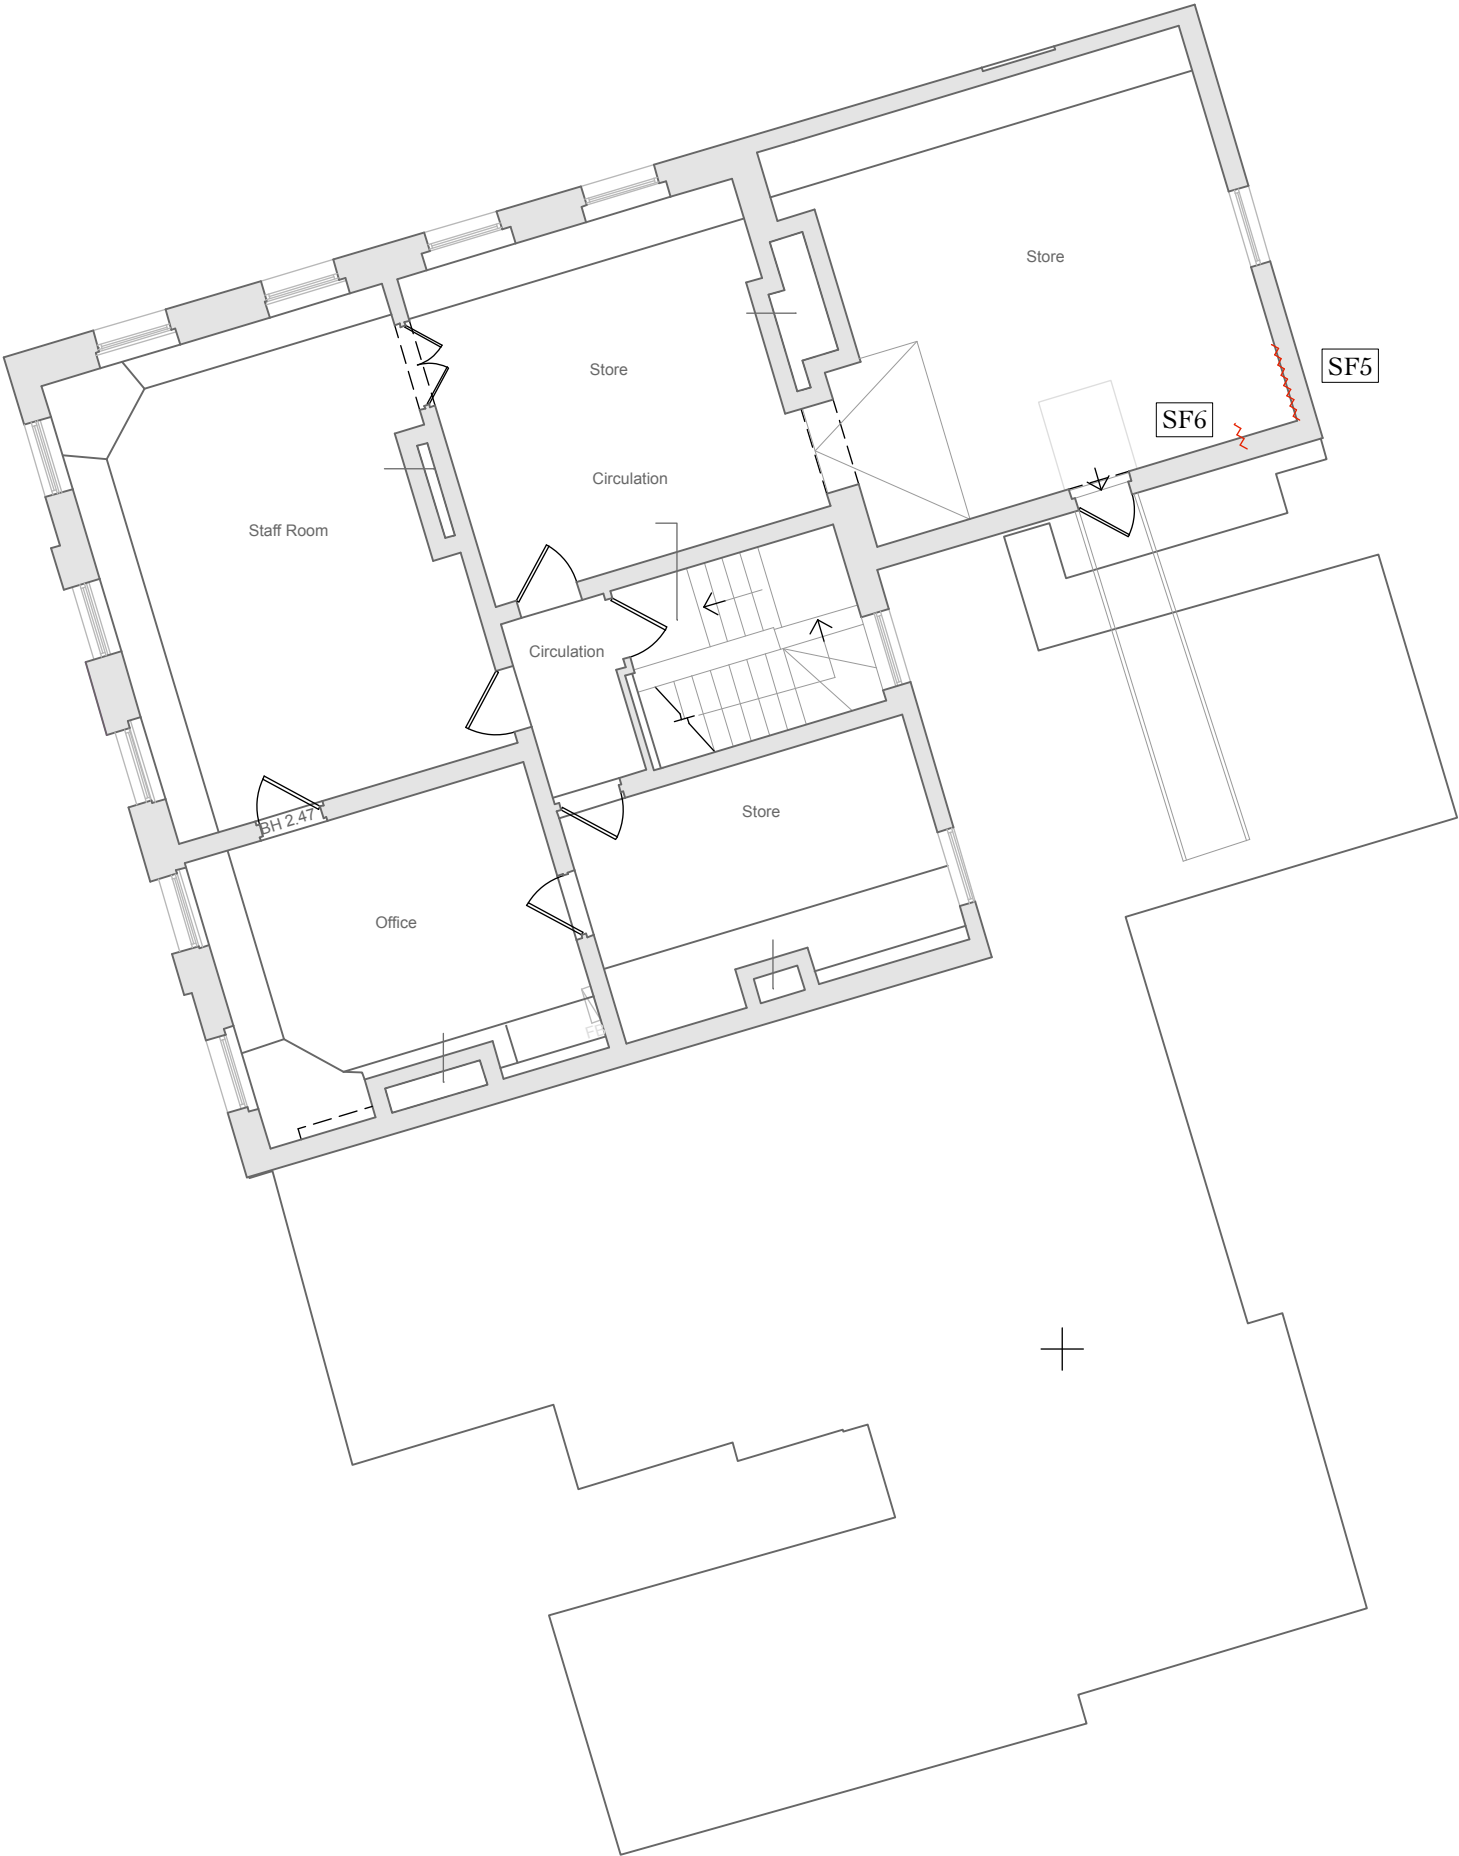
| Ref. | STRUCTURAL DEFECT |
|---|---|
| SF5 | Diagonal hairline crack in the top corner tracking down towards elevation D. |
| SF6 | Hairline cracks through finishes, wallpaper peeling off as a result of damp |
