**Cockpit House, Prescott**  
**for Purcell**

#### Elevation A

Drawing No: X54/105 Rev: - Scale: 1:100 @ A3 Date: October 2021

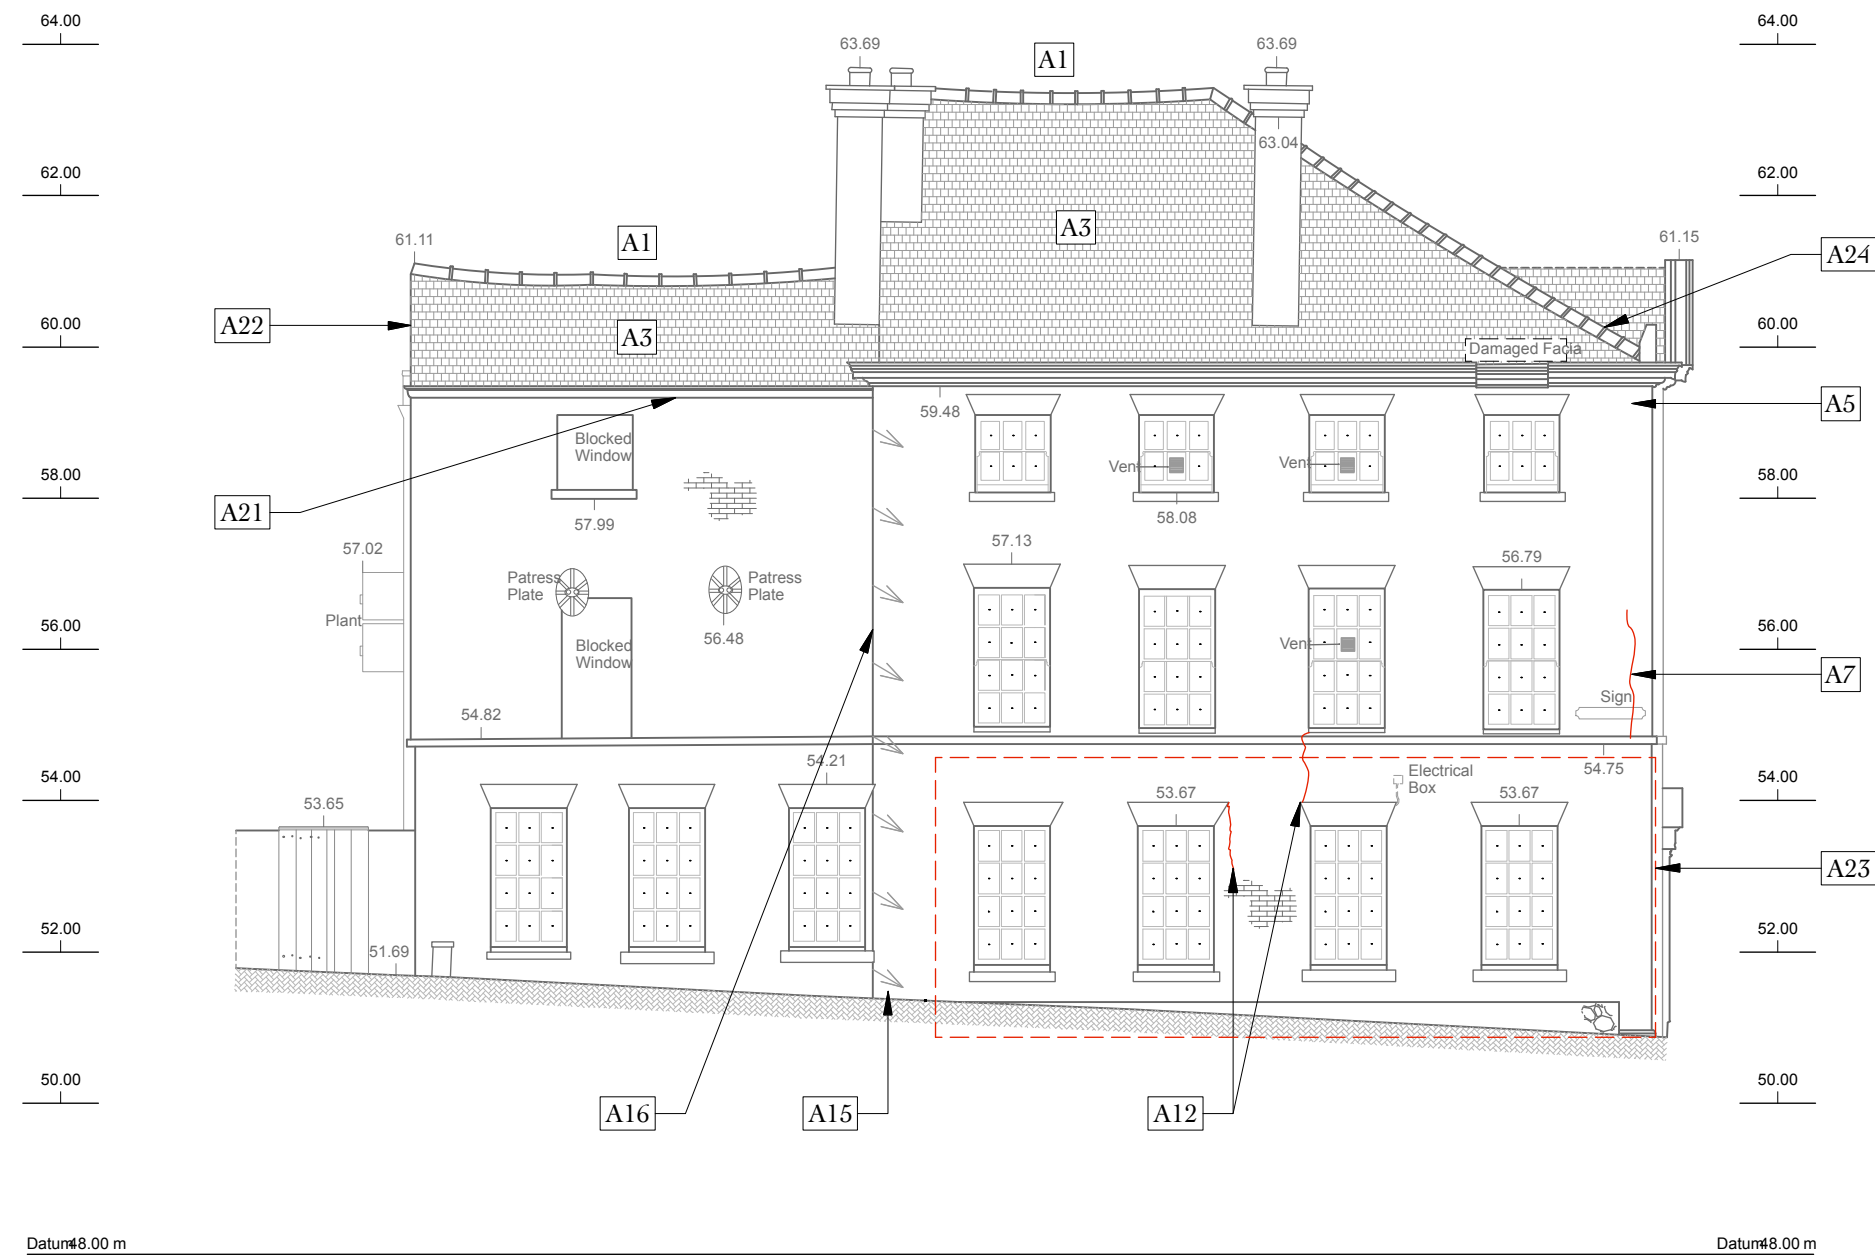
| Ref. | STRUCTURAL DEFECT |
|---|---|
| A1 | Sagging ridge line between supports on both roofs |
| A3 | Dished roof slopes according to sagging ridgeline |
| A5 | Downward movement of flat arches below particularly damaged coping stone |
| A7 | Hairline crack and split bricks tracking down past the street sign, across the string course and down towards the ground floor flat arch. |
| A12 | Vertical hairline cracks |
| A15 | Sloping bed joints along this interface |
| A16 | Butt joint at interface except at ground floor level where the jamb of this window has been well bonded into existing masonry. |
| A21 | Fascia damaged at midpoint and damp fabric below |
| A22 | Gable peak leans inwards slightly, ca. 20mm over its height. |
| A23 | This area of wall has been rebuilt when bank use stopped and corner remodeled to remove entrance and shop front. |
| A24 | The end of the hip dips suggesting a thrust has moved the corner brickwork outwards |
