EXISTING DUTCH & STONE BARNES & PIGGERY, FORMER COACH ROAD FARM, CUT LANE, KNOWSLEY, L33 3AQ

STRUCTURAL APPRAISAL OF EXISTING BARNES & PIGGERY FOR CONVERSION TO LIVING ACCOMMODATION

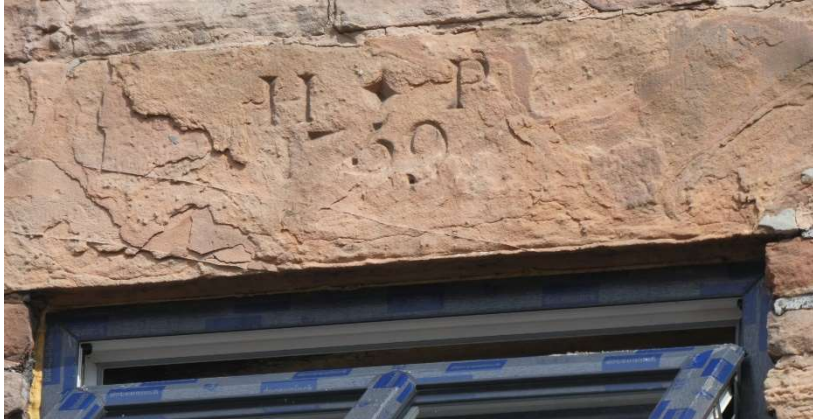
The original part of the stone barn was built in 1759 as can be seen from the date stone in the photograph below with the rendered brick annexe being constructed at a later date but prior to 1840 as shown in the Heritage Statement map review.

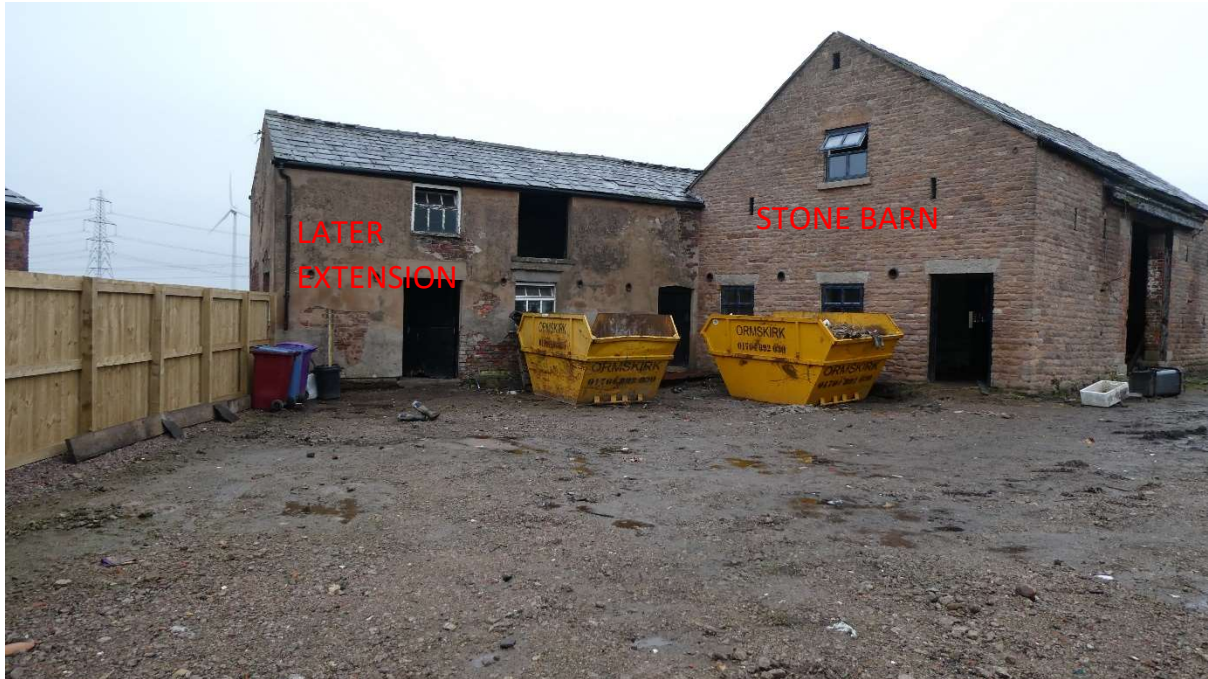
#### 2.1.1 Original Stone Barn

The barn has been standing since 1759 and overall there is little sign of any differential settlement or deflection'

The walls are constructed of stone ranging in thickness from 350mm to 400mm thick.

The foundations are of stone thickened out below ground level.

The roof is constructed entirely of exposed timber members with a slate roof.

The existing roof timbers will require further investigation as to the extent of any damage caused by wood worm attack, and any necessary repairs be carried out.

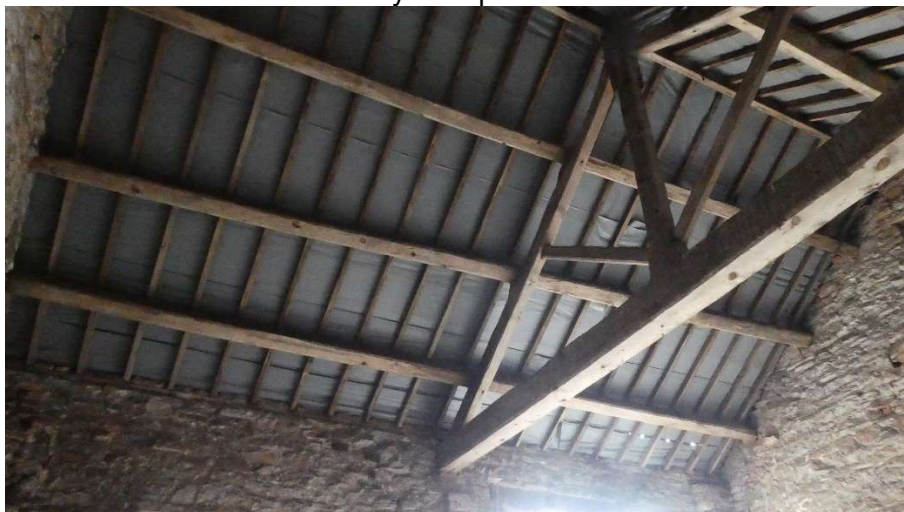
There is a King Post Truss Rafter in the centre of the main barn area.

The ground floors are of concrete which may overlay the original floors, with the upper floors being constructed of open timber flooring.

There are signs of woodwork attack to some of the timbers and further investigations and repairs would be required.

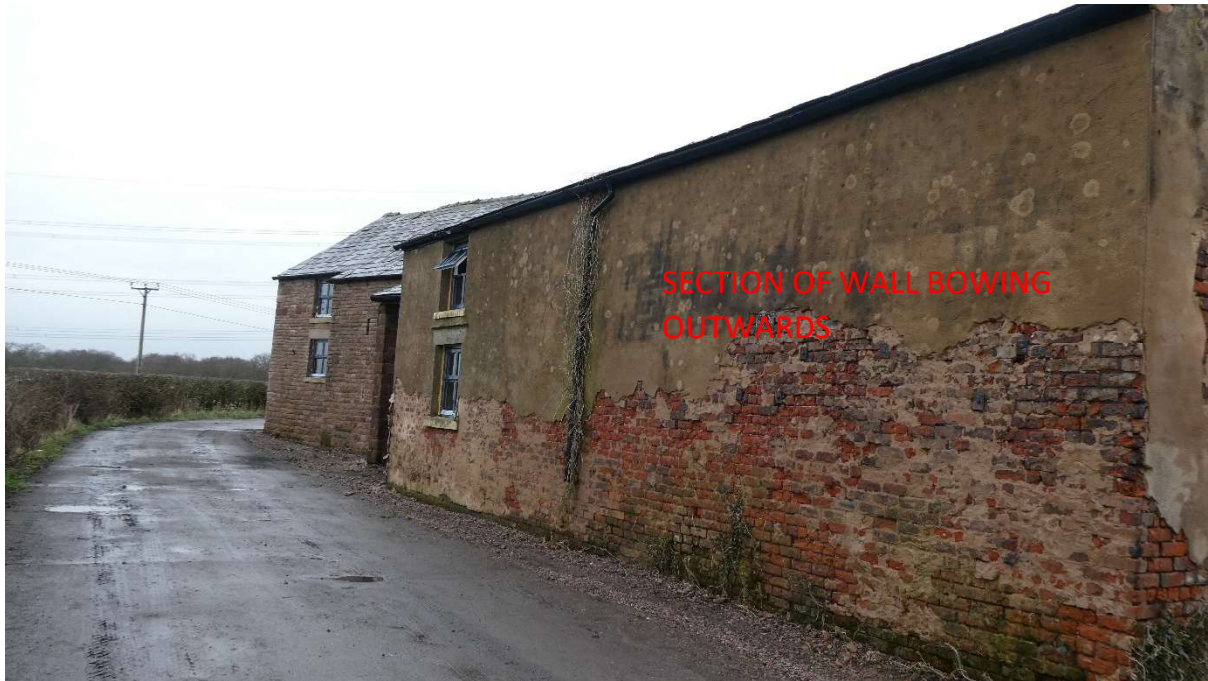
### 2.1.2 Later Extension to Stone Barn

Built later prior to 1840 the extension shows some signs of movement and settlement, in particular the side elevation to Cut Lane is bowing outwards and requires to be rebuilt

The walls are constructed of 350mm thick brickwork rendered on the outside with a sand/cement render.

The roof is constructed entirely of exposed timber members with a slate roof.

There is a King Post Trusse Rafter in the centre of the stable area.

The first floors where present are constructed from timber.

The ground floors are of concrete which may overlay the original floors, with the upper floors being constructed of open timber flooring.

There are signs of woodwork attack to some of the timbers and further investigations and repairs would be required.

Approximately 1/3<sup>rd</sup> of the existing side elevation wall to Cut Lane has bowed outward and needs to be taken down, the foundations investigated and repaired as necessary, then the wall rebuilt and tied into the remaining structure.

Again the existing roof timbers will require further investigation as to the extent of any damage caused by wood worm attack, and any necessary repairs be carried out.

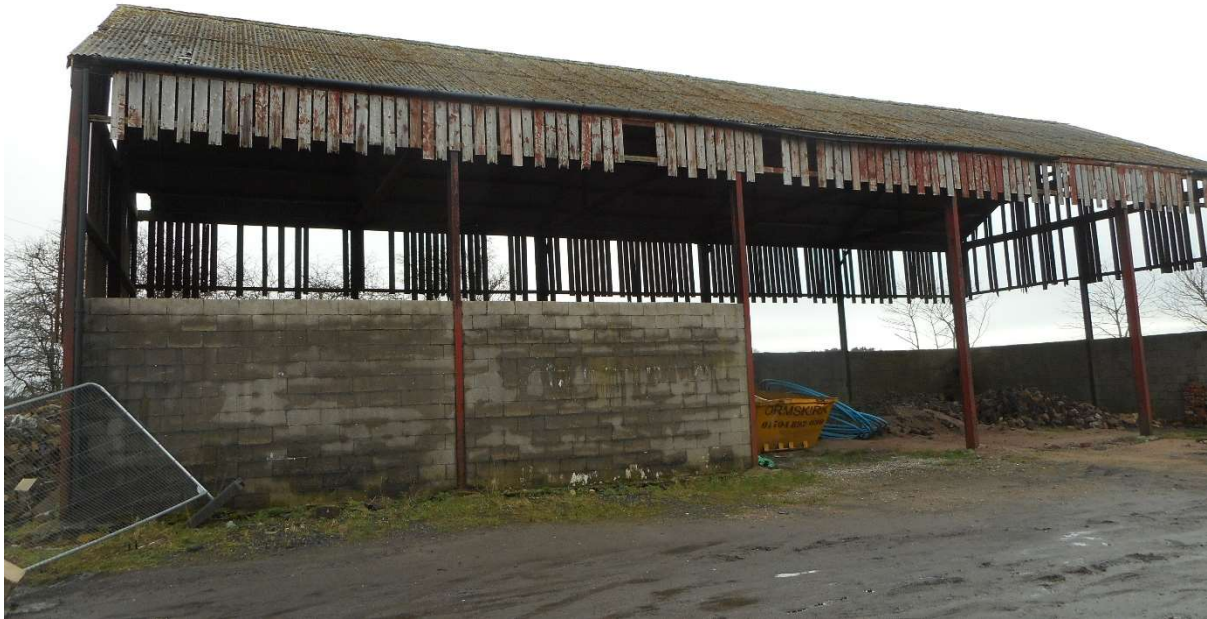
### 2.1.3 Dutch Barn

The building would appear to have been constructed within the mid-20th century and overall there are no signs of settlement or movement.

The sides of the building are constructed of blockwork at ground level and a slatted timber downstand from the roof at the upper level.

There is a concrete slab of unknown thickness covering approximately 2/5ths of the ground with the remainder being compacted ground.

The roof is supported off 14No. 178 x 102 x 19kg universal beams, as columns, set in concrete around the external at an average of 4.6m centres. The beams show signs of rust due to lack of maintenance and would need to be treated and repainted

The roof is constructed of timber trusses with timber purlins and corrugated cement sheeting over.

From the ground there are no visual signs of woodworm attack to the timber trusses.

The corrugated roof sheets would appear to be of asbestos/cement and would require removal in a controlled manner(e.g. wetting down and 'Double Bagging') and taken to an appropriate waste disposal site.

The existing structure to the Dutch Barn will be retained as the principal structure and is capable of carrying the loads placed upon the columns and roof timbers. The existing steel columns require treatment and repainting.

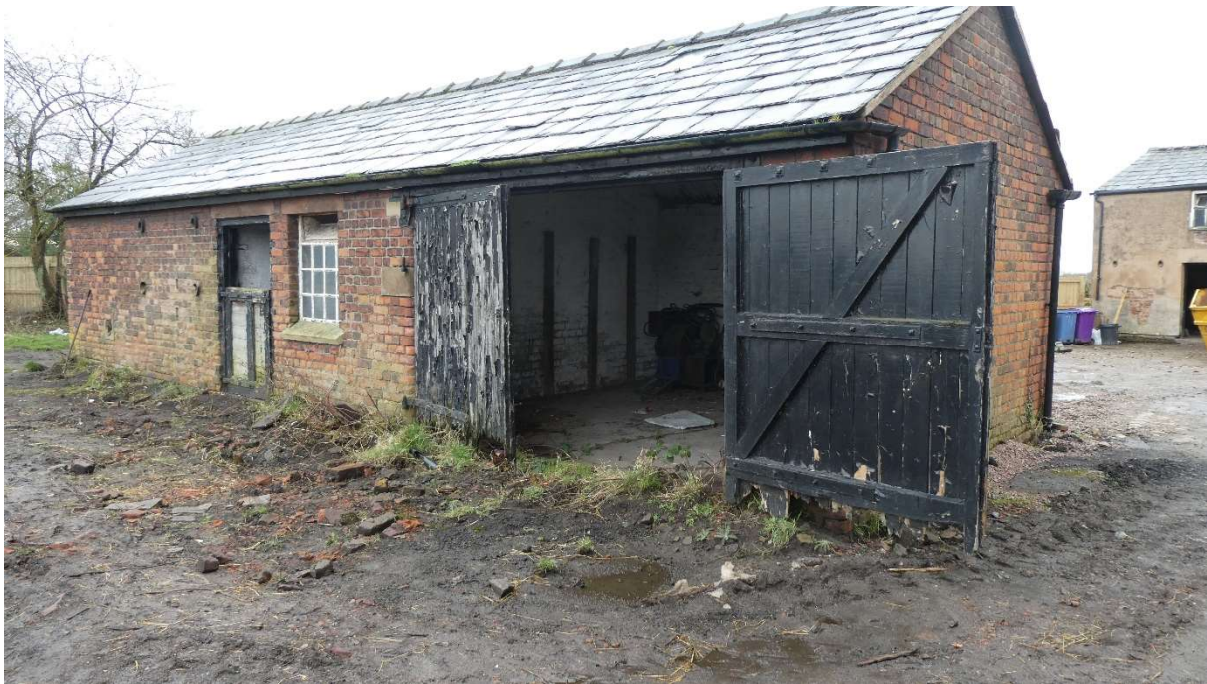
#### 2.1.4 Piggery

The building appears to have been built at the same time as the farmhouse and has been used as both a piggery and a garage for farm vehicles.

Overall there is little or no sign of movement or settlement, the brickwork being in good condition considering it's age..

The walls are constructed of 235mm thick brickwork built off brick thickened out foundations.

The roof is a slate roof on timber t & g boards on timber purlins supported at the open end on steel posts.

The floor is a concrete slab of unknown thickness and shows no sign of damp or cracking.

The roof may require support from new rafters between the existing purlins to support any insulation layer proposed.
