# Validation Completion Report

Site: Sonnet Gate, Prescott

Reference:15-292-R1

Date: July 2025

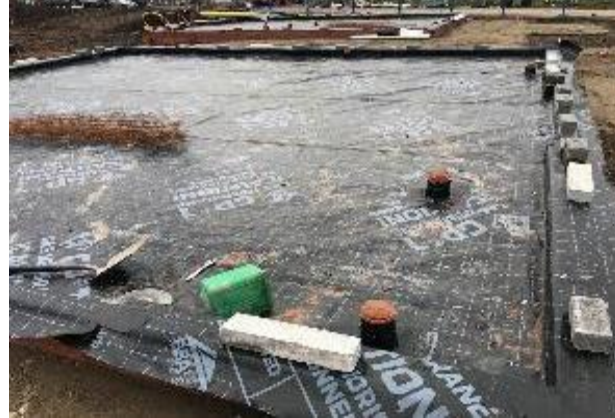
**Plot - 2**

**General Condition of Membrane-Good Condition**

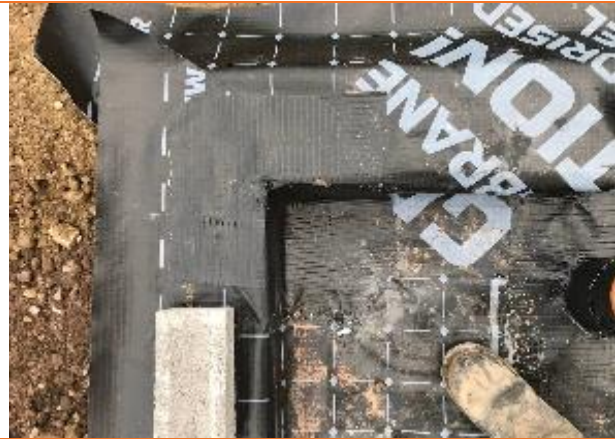
**Verification of Joints and Seals-Good Condition**

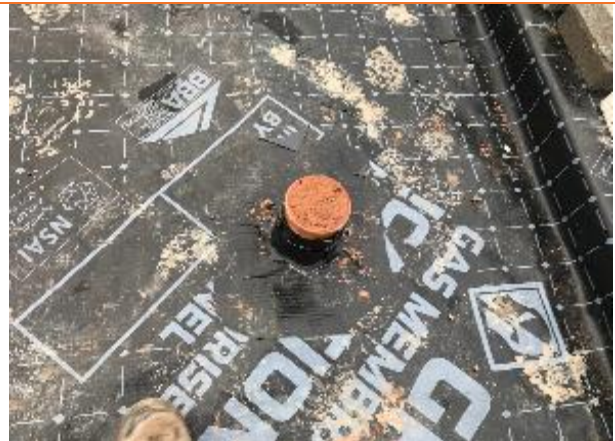
**Verification of Service Penetrations-Good Condition**

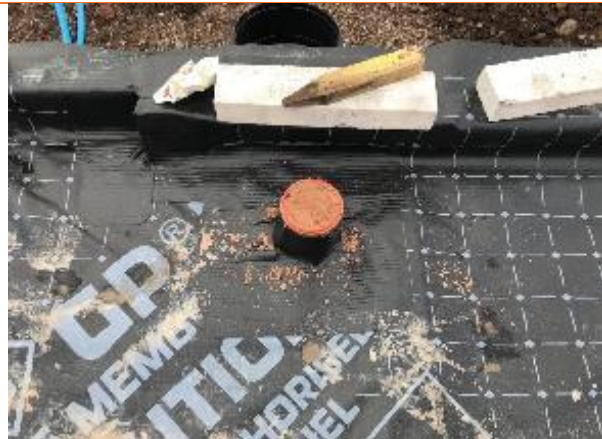
**Verification of Service Penetrations-Good Condition**

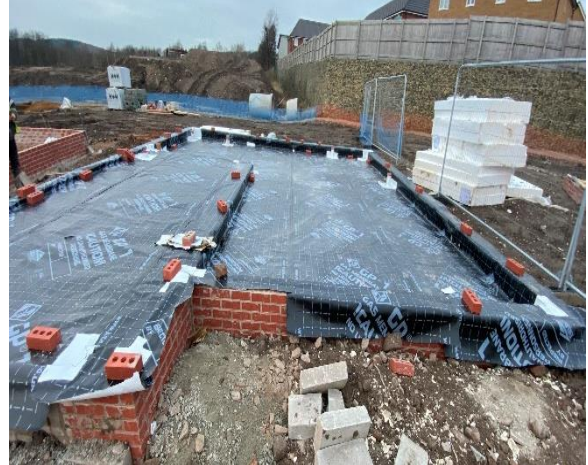
**Plot - 6**

**General Condition of Membrane-Good Condition**

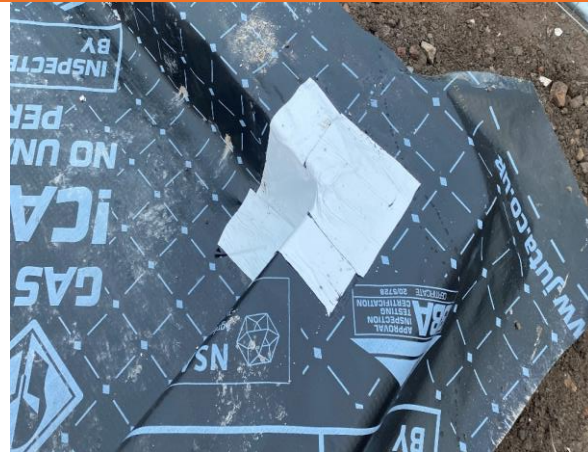
**Verification of Joints and Seals-Good Condition**

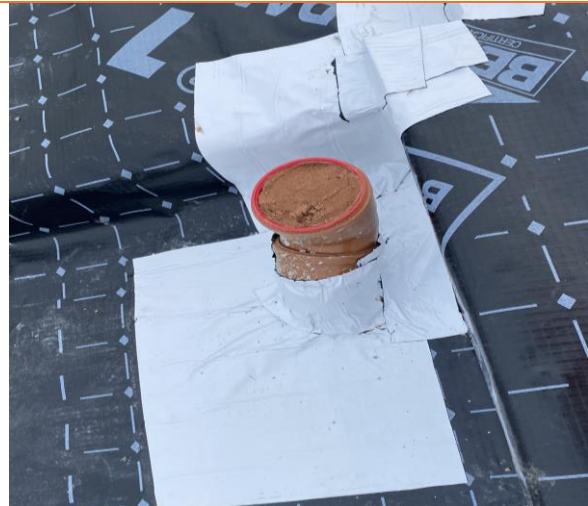
**Verification of Service Penetrations-Good Condition**

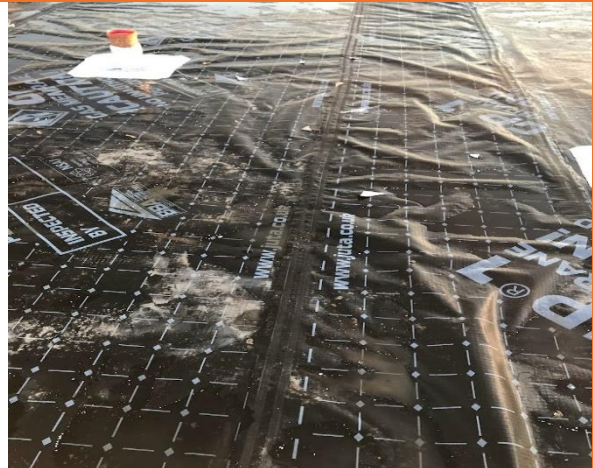
**Verification of Joints and Seals-Good Condition**

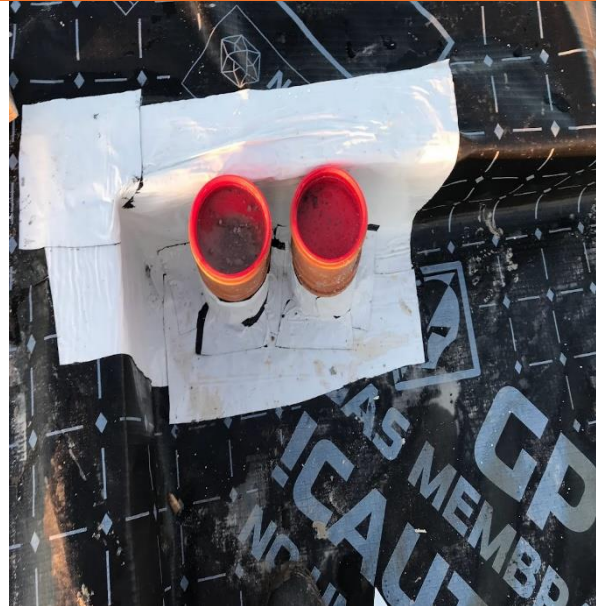
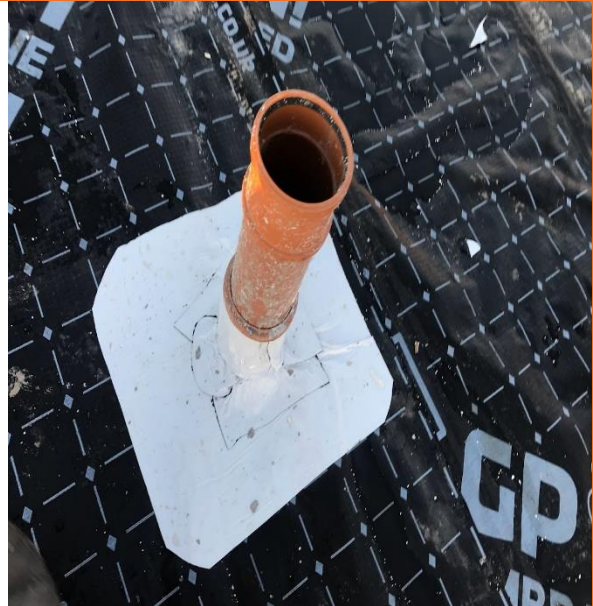
**Verification of Service Penetrations-Good Condition**

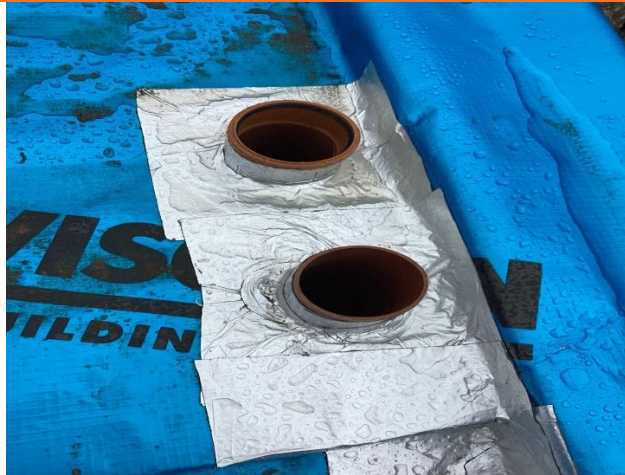
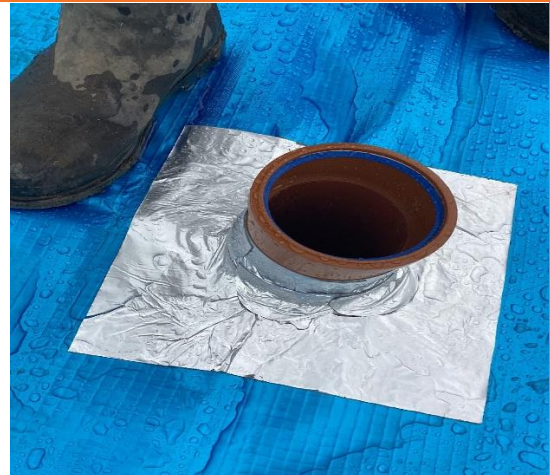
**Verification of Service Penetrations-Good Condition**
