Picture Palace, Prescot  
for Purcell

Second Floor & Roof Plans

Drawing No: X64/102    Rev: -    Scale: 1:200 @ A3    Date: July 2022

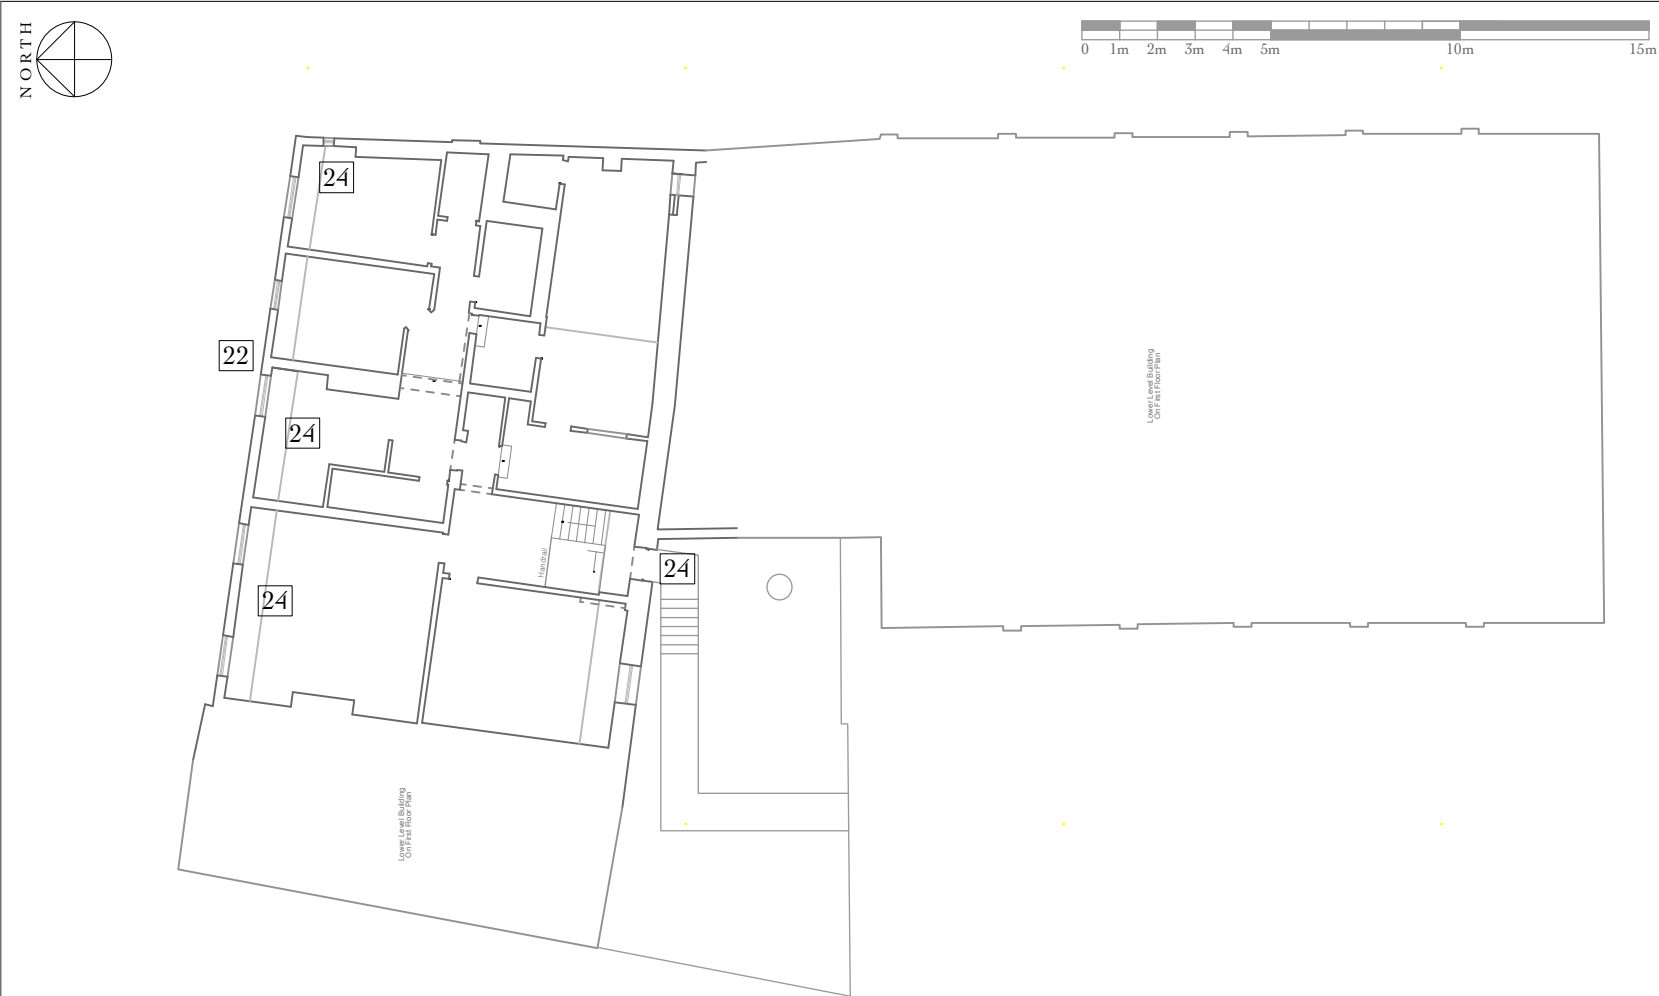
SECOND FLOOR PLAN

| Ref. | STRUCTURAL DEFECT |
|---|---|
| 18 | At the rear of the Georgian property there is a single storey extension. The once corrugated sheet roof (asbestos), remains and is concealed by the ceiling and over cladding in profiled pressed metal. |
| 19 | External to the south side of the auditorium there is a single storey lean to addition constructed in concrete blockwork with a felt roof. |
| 20 | At the rear there are steel ladders and steel accessways and stairs that relate to maintenance access and fire escapes. |
| 21 | At the junction between the Georgian property and the auditorium extension a structural steelwork frame was inserted as part of the extension to support the upper brick wall of the front residential building. |
| 22 | The render on the front and side gables of the building is trapping moisture in the brickwork. Driving any moisture from failed flashings and water goods into the building. This is resulting in damage to internal plaster finishes and embedded timber such as timber lintols over windows. |
| 23 | Where water entry has been extensive there is evidence of local areas of decay to the floorboards and the bearing ends of floor joists. |
| 24 | Water entry due to failed flashings is also apparent at roof level in isolated areas. |
| 25 | Ground floor to first floor chimney breast missing in 3No locations. |

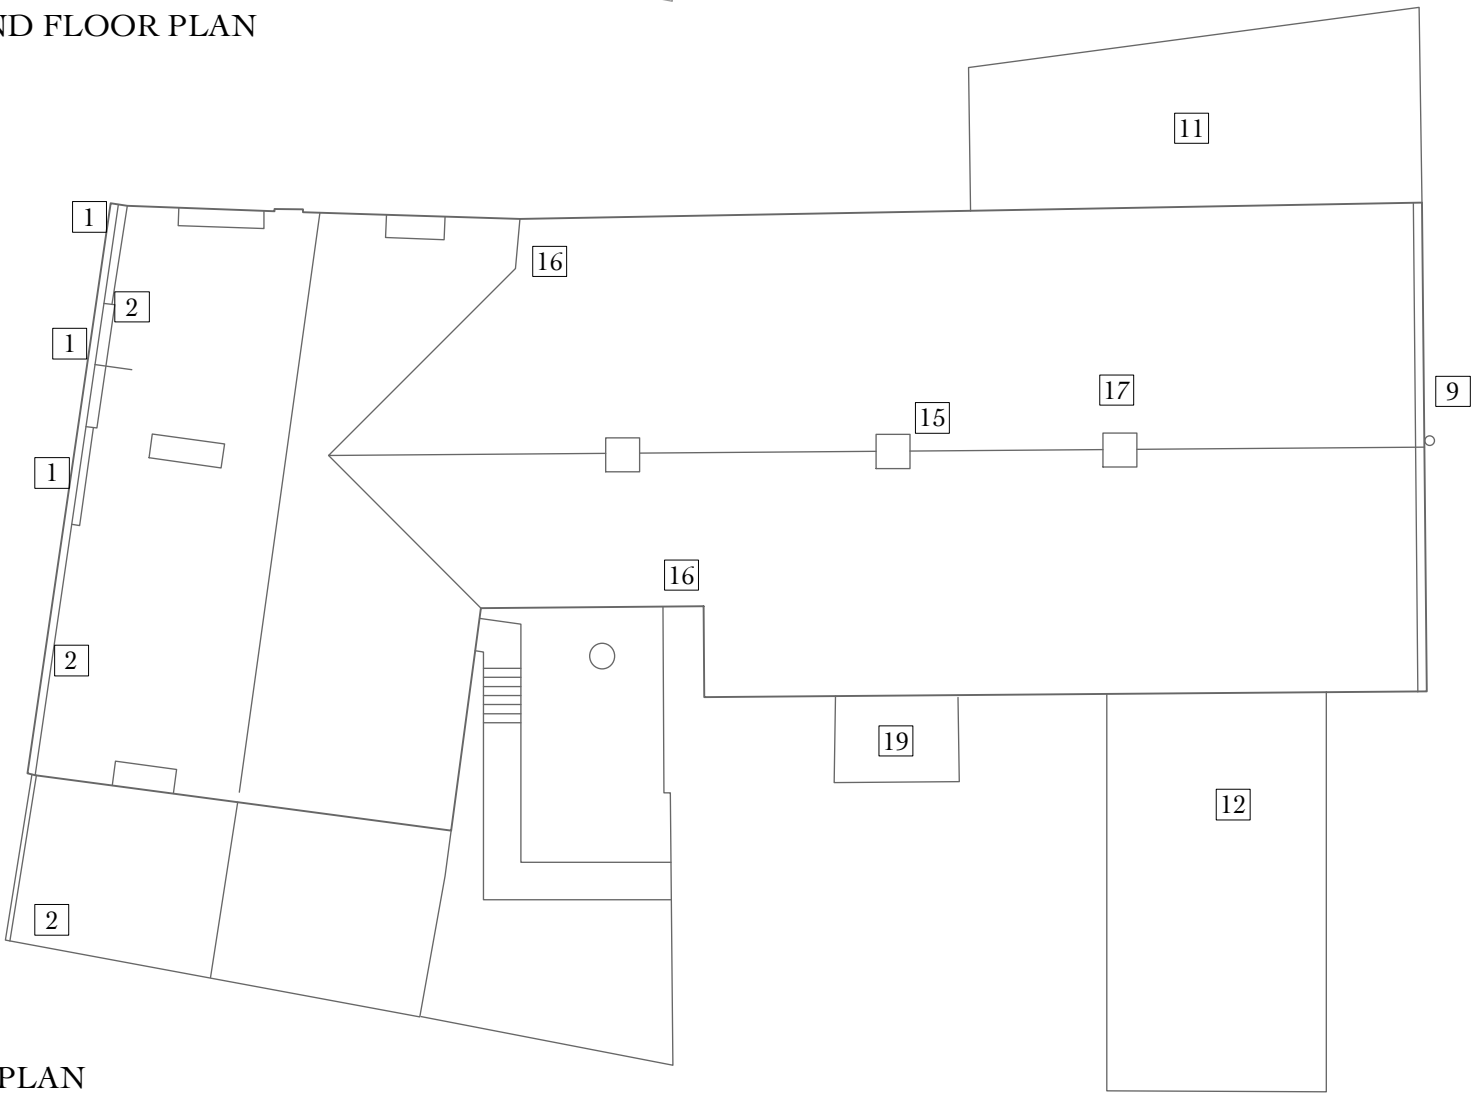
ROOF PLAN

| Ref. | STRUCTURAL DEFECT |
|---|---|
| 1 | Displacement and vegetation growth to front elevation main parapet. Roots well established and initial vegetation clearance works superficial |
| 2 | Decay caused by prolonged water entry at the rear of the front elevation parapet – jack rafter feet ends and timber wall plate. |
| 14 | At the rear of the auditorium the ground floor has been raised with a timber joist floor. This appears to be a relatively modern addition to increase the level space as part of the Church use of the building. |
| AUDITORIUM ROOF | |
