**Prescot Picture House**  
**8-14 Kemble Street, Prescot**

**Investigations into the condition of the historic ceiling and  
wall plasters within the main auditorium space**

**December 2022**

**M. WOMERSLEY**  
Historic Building Specialists

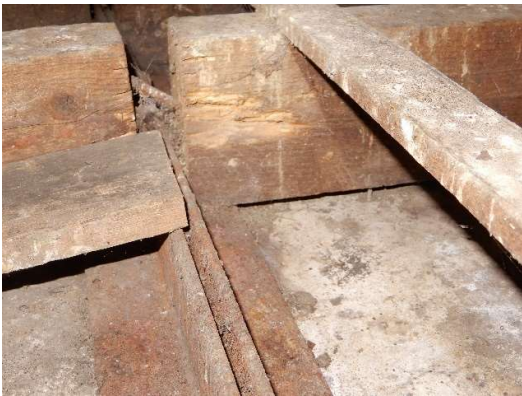
condition there is some localised signs of rot, see photo 9, and occasionally a lack of bearing on the lower members of the trusses.

Photo 9: Whilst generally the ceiling joists are in good condition there are some localised signs of rot and occasionally a lack of bearing on the lower members of the trusses.

| Allow for extending 10 ceiling joists where they lack bearing on the lower steel beams of the trusses and allow for installing new ones where there is any rot in them. | My main contractor |

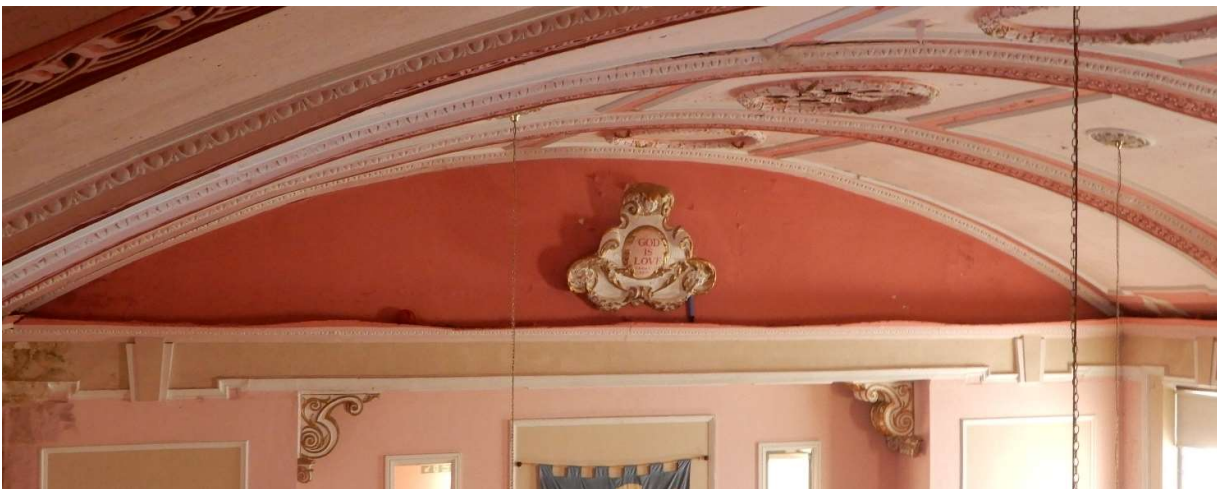
Photo 10: By contrast the enclosed proscenium arch and the proscenium beam below, carried by scroll console brackets, are created with lath and lime plaster gauged with gypsum.

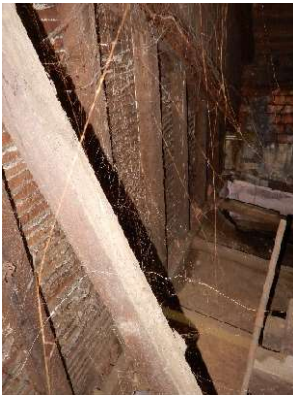
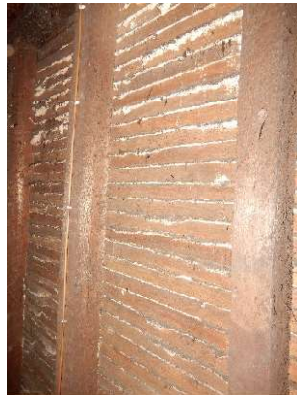
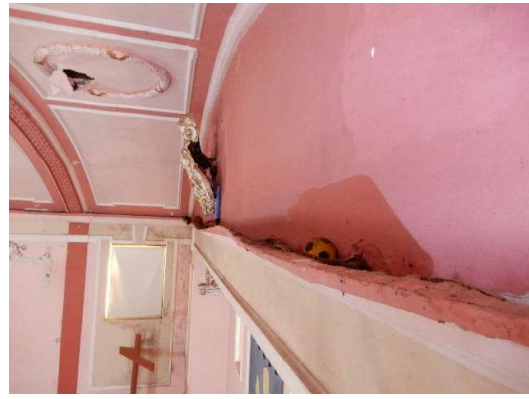
Photos 11, 12 &13: The lath and plaster, with minimal nibs, forming the proscenium arch and the badly warped and deteriorated projecting cornice to the front.

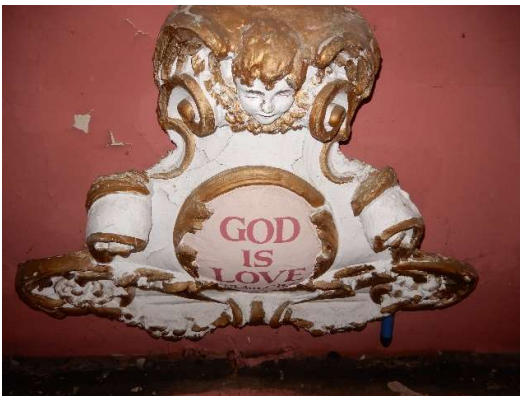
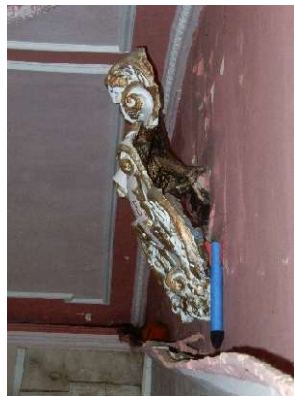
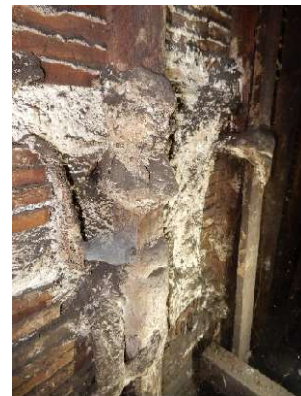
The scrolled corbel console brackets, both of which appear to have been fastened up 90 degrees in the wrong orientation, are hung through this soffit by wads that need replacing, with wire reinforced wads, see photos 20 & 21. Similarly, the central cartouche, rebranded by the previous church, is hung off the vertical timbers in the proscenium arch, and also needs new wires and wads installing and reinforcement with a blanket wad at the neck of the cast, as the top section is badly cracked and needs to be re-secured urgently, see photos 14, 15 & 16.

Photos 14, 15 &16: The cartouche, rebranded by the previous church, is hung off the vertical timbers carrying this lath and plaster work. Unfortunately, the top section is badly cracked and needs to be re-secured urgently.

| As emergency works install wires and wads, and blanket wads to make safe the cartouche that decorates the front of the proscenium arch | £1,800 |

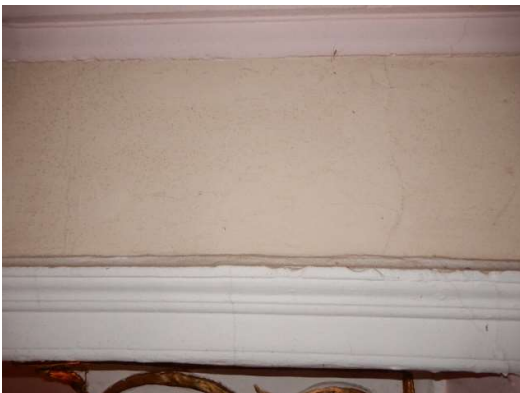
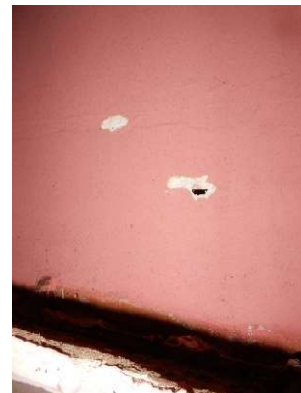
In contrast to the fibrous cast panel ceiling the enclosed proscenium arch and the proscenium beam below, carried by scroll console brackets, is created out of lath and lime plaster gauged with gypsum, see photo 10. This plaster needs conservation as does the vertical wall of the arch, as the plaster, in some areas, has only minimal supporting nibs, (but it is not deep enough to allow it to be secured back with sunken penny washers and screws), see photos 11 and 12. The projecting cornice, forming the springing point of this arch, is badly warped and deteriorated, see photo 13. Immediately below, the front of the proscenium beam is cracked, through the plaster on the lath, as is the soffit of the same beam, see photos 17-19.

Photos 17-19: The lower edge of the front of the proscenium beam, which is cracked through the plaster on the lath; above the back of the lath and plaster that forms the soffit of the same beam, and a thin coat of gauged lime plaster to the front of the infilled proscenium arch.

| Form approximately 585 linear metres of new nibs, using water glass reinforced lime plaster, Lime Green Silic8 AD2, to the rear of proscenium arch's plaster. | £3,450 |

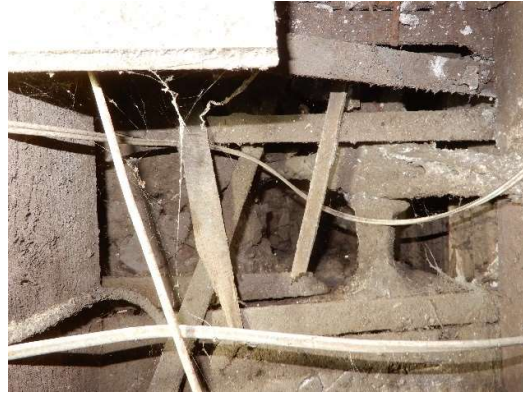
Photos 20 & 21: One of the scrolled corbel console brackets, both of which appear to have been fastened up 90 degrees in the wrong orientation; and the support from above the soffit of the proscenium beam.

| Install new wires and wads to carry corbel console brackets below the proscenium beam | £1,800 |

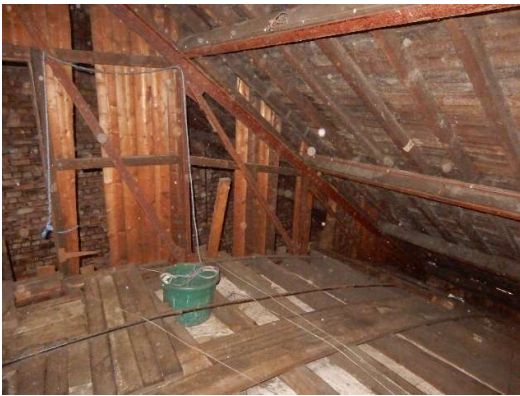
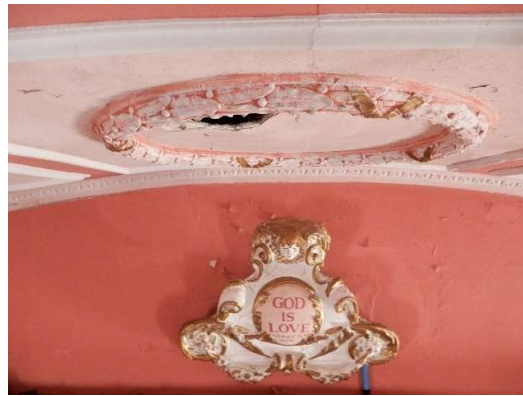
Photos 22 & 23: The first ceiling bay has suffered water and impact damage in the past and has been partly reskimmed or skimmed originally to create a more even arched plain plaster finish coat, but this is in part de-bonding.

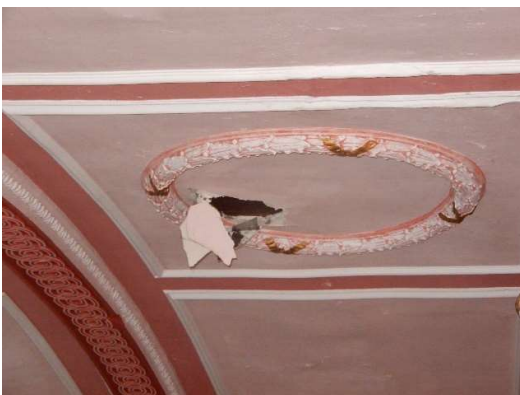
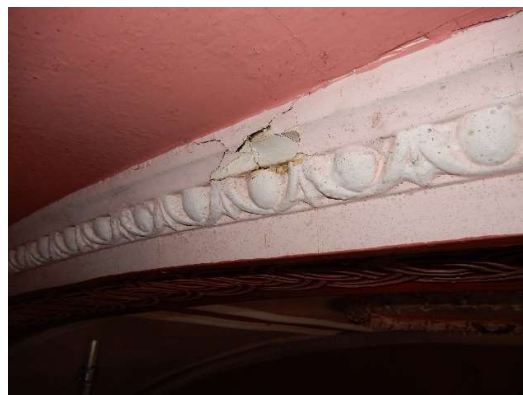
Photos 24 & 25: As well as the impact damage in this bay the adjacent rib has deteriorated with prolonged damp, held against it by guano deposits and requires sections of the fibrous cast replacing.

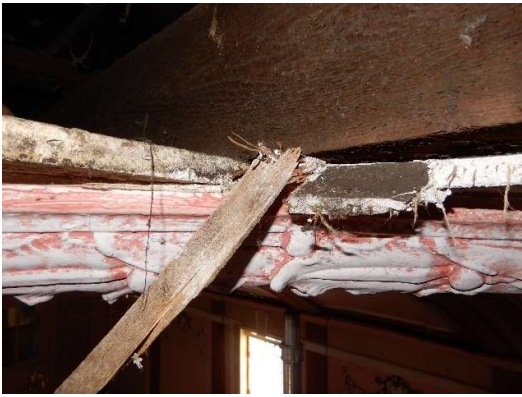
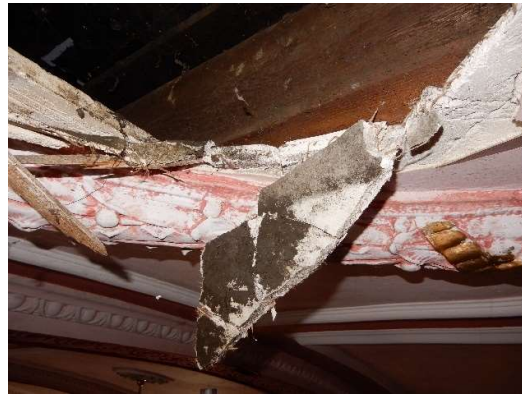
Photos 26 & 27: Broken cast panels in the centre of the first bay expose the nature of the fibrous cast panel and its over skim.

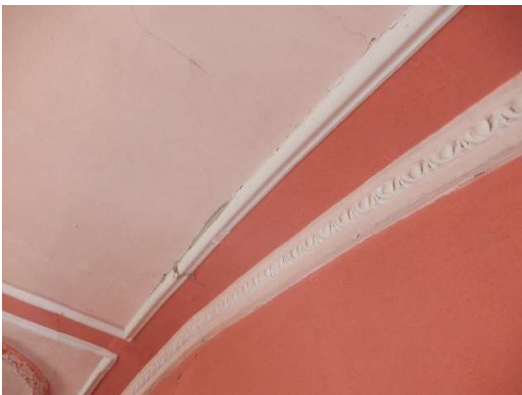
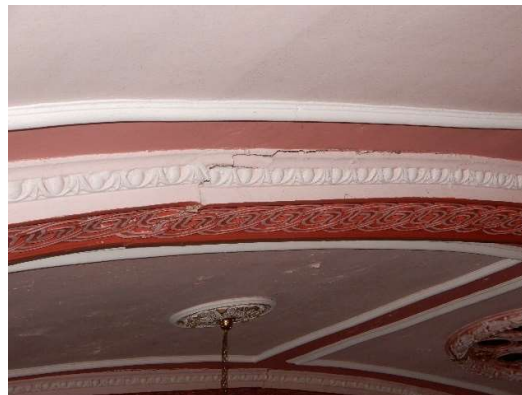
In the first bay nearest the stage, see diagram 2 above, the ceiling is badly cracked where it meets the front of the proscenium arch; and parts of the first fibrous rib, between bay 1 and 2, are beginning to fall, see photos 28 & 29, and there is an impact damaged hole within the plain plaster contained by the central plaster wreath, which is itself in reasonable condition. Excessive water damaged ceiling and wall plasters can be found at the eastern end of this first bay, see photo 30. The first ceiling bay has suffered water and impact damage in the past and has been partly reskimmed or skimmed originally to create a more even arched plain plaster finish coat, but this is in part de-bonding, see photos 22 & 23:

Photos 28 & 29: The ceiling is badly cracked where it meets the front of the proscenium arch; and parts of the first fibrous rib are beginning to fall.

| Activity | Budget Cost Estimate |
|---|---|
| As emergency work blanket wad 500 mm by 11 linear metres behind the existing rib between bay 1 and bay 2, where they can be saved and install approximately 27 supporting wired wads from the back, with new metal channel supports as required, remove 4 linear metres in four sections of damaged ribs. | £3,600 |

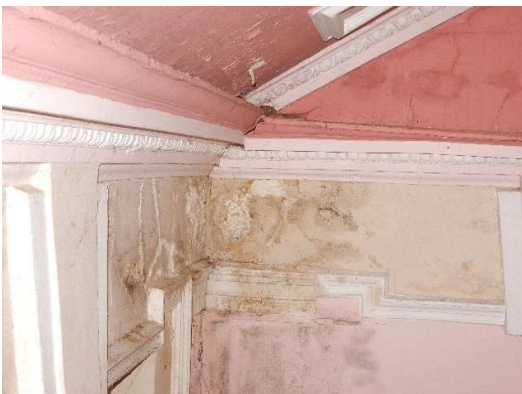
Photo 30: Excessive water damaged ceiling and wall plaster can be found at the eastern end of the first bay

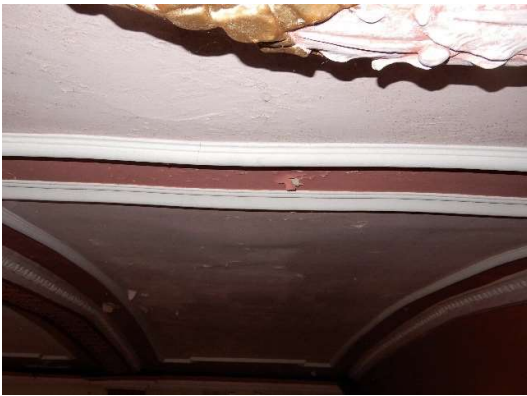
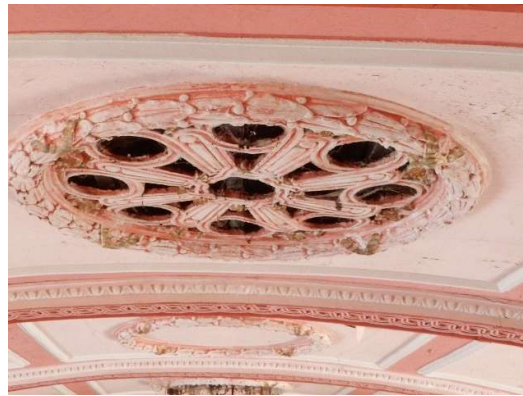
In bay 2, whilst the ornamental ventilation cover is in reasonable condition, the surrounding plain plaster and the planted on panel mouldings are cracked and there is some debonding of skim plaster, see photos 33 & 34. However, as well as the impact damage in this bay the adjacent rib, between bay 2 and 3 has deteriorated with prolonged damp, held against it by guano deposits, and is in a dangerous state and requires sections of the fibrous cast replacing, photos 24 & 25. It is only supported at its eastern end by the cornice below, see photos 35 & 36. The ribs do not appear to have been cast to the correct radius and the unevenness of the curve underlies other visible distress.

Photos 33 & 34: Whilst the ornamental ventilation cover is in reasonable condition the surrounding plain plaster and the planted on panel mouldings are cracked and there is some debonding of skim plaster.

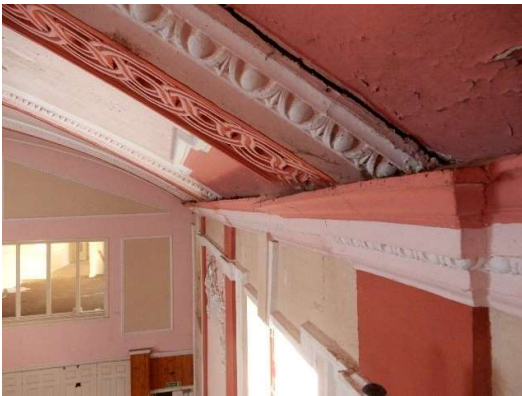
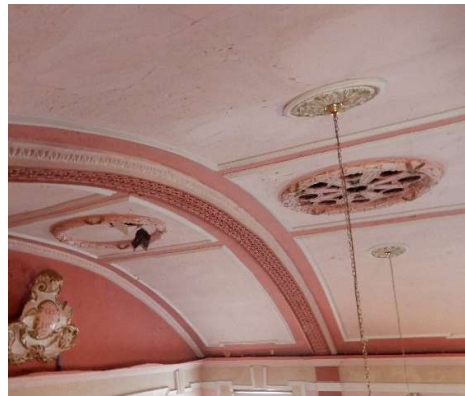
Photos 35 & 36: The first fibrous plaster rib nearest the stage is falling and only supported at its eastern end by the cornice below. The ribs do not appear to have been cast to the correct radius and the unevenness of the curve underlies other visible distress in them.

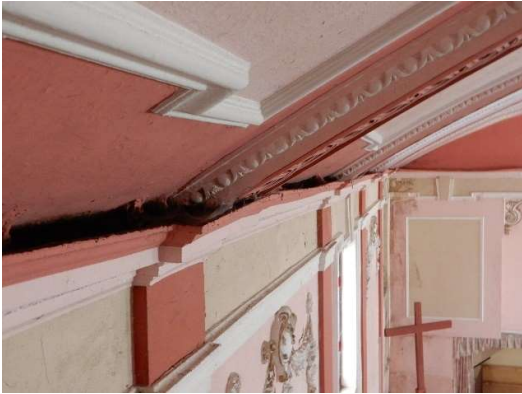
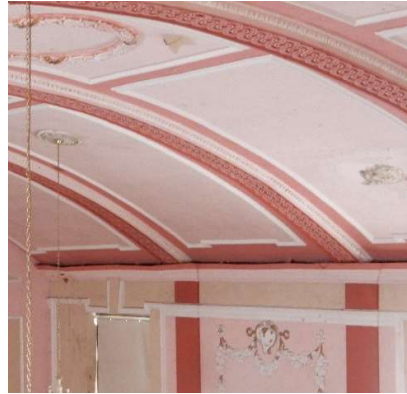
Bay 3, like the previous two, is edged by a distorted and failing cornice, and has areas of debonding skim plaster, and an area of particular distress can be found in the centre of the western end of this bay, see photos 37 & 38. The plaster ventilation grill in the fourth bay is cracked and requires repair and wiring up, photos 39 & 40. The cornice on the western end of the 4<sup>th</sup> bay is almost completely decayed, and the rib between the 4<sup>th</sup> and 5<sup>th</sup> bay is badly cracked all along its edge, and there is an overturning cornice on the east wall, see photos 41 & 42.

Photos 37 & 38: The distorted and failing cornice can be seen in the first picture; and debonding skim and the area of distress in the centre of the western end of this bay, in the second.

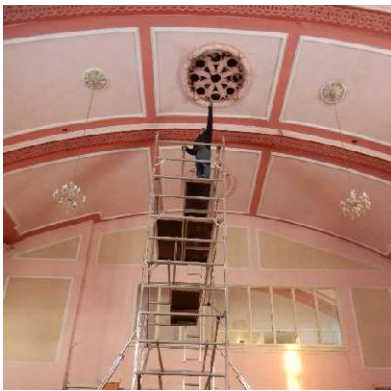
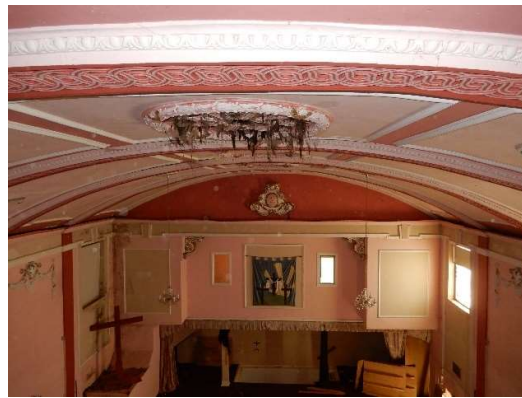
Photos 39 & 40: The plaster ventilation grill in the fourth bay is cracked and requires repair and wiring up.

| Repair the damaged ceiling ventilation grill in the fourth bay, using wires and small clip wads | £1,800 |

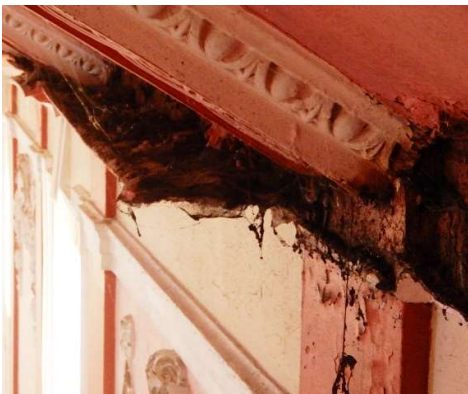
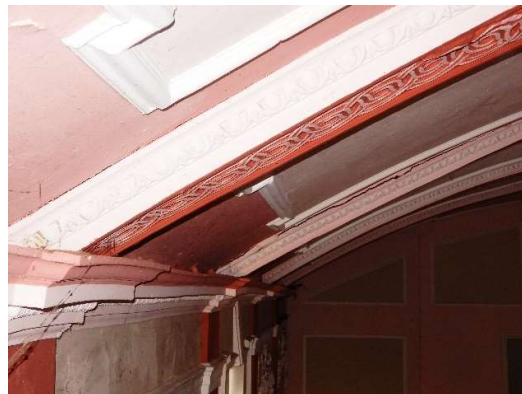
Photos 41 & 42: The almost completely decayed cornice on the western end of the bay; and a cracked edge all the way along the rib between the 4<sup>th</sup> and 5<sup>th</sup> bay, and the overturning cornice on the east wall.

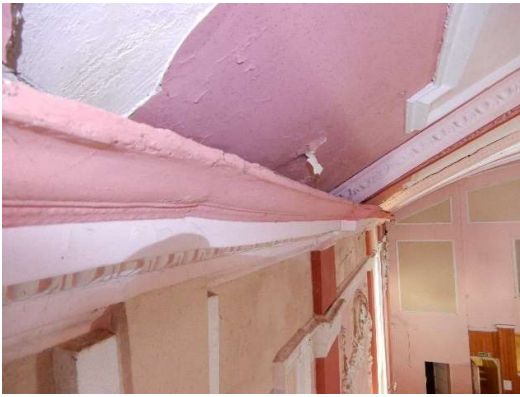
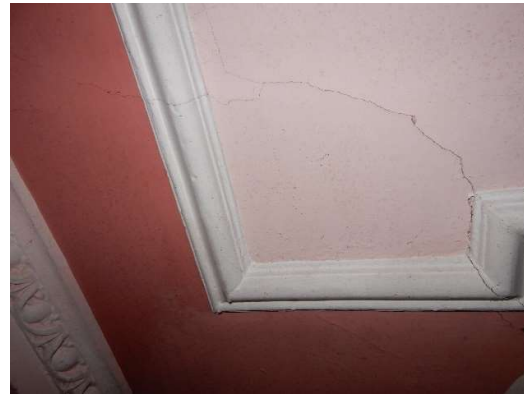
Photos 43 & 44: Debonding and cracked skimmed plaster at the eastern edge of the bay.

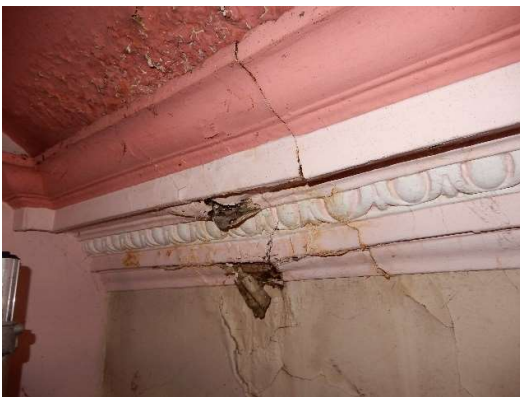
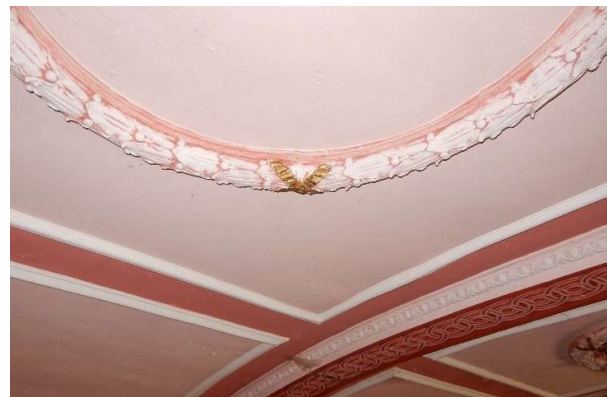
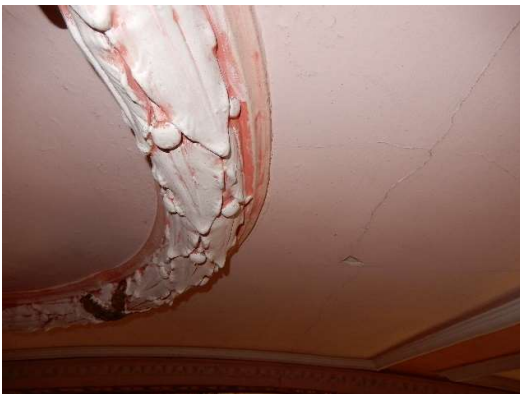
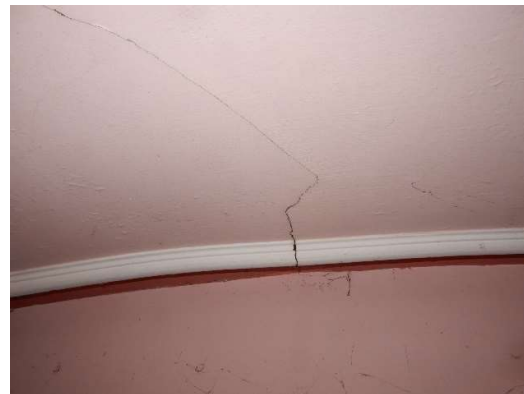
Bay 5 has badly water damaged wall and ceiling plaster at the eastern end of the bay; and cracking and debonding can be seen below the cast ceiling panels, see photos 45-48. In addition, the failing rib between the 5<sup>th</sup> and 4<sup>th</sup> bay is clearly visible, see photos 49 & 50. There is debonding and cracked skimming plaster at the eastern edge of the bay, see photos 43 & 44, and water damage has caused the cornice at the western

Photos 45-48: Badly water damaged wall and ceiling plaster at the eastern end of the 5<sup>th</sup> bay; and cracking and debonding can be seen below the cast ceiling panels.

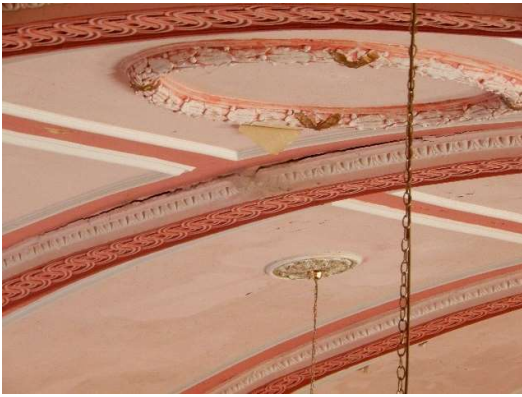
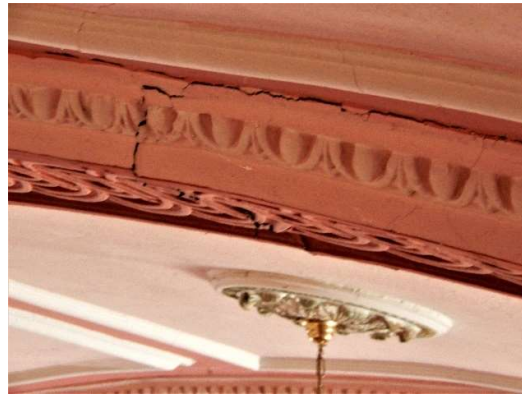
Photos 49 & 50: The failing rib between the 5<sup>th</sup> and 4<sup>th</sup> bay is clearly visible.

| Activity | Budget Cost Estimate |
|---|---|
| As emergency work blanket wad 500 mm by 9 linear metres behind the existing rib between bay 4 and bay 5, where they can be saved and install approximately 27 supporting wired wads from the back, with new metal channel supports as required, remove 6 linear metres in four sections of damaged ribs. | £3,600 |

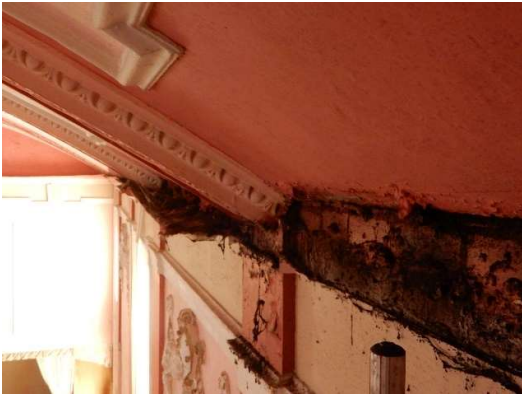
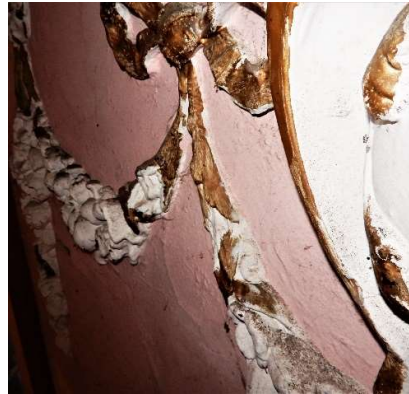
end to be lost. The plaster behind the decorative swags, as is found on all the other wall areas, has significantly de-bonded from the brick background, see photos 51 & 52.

Photos 51 & 52: Water damage has caused the cornice at the western end to be lost and the plaster behind the decorative swags on all the walls has significantly de-bonded from the brick background.

| As emergency works using plugs, stainless steel screws, sometimes with small penny washers, re-secure the six wall swags back to the walls behind, through the de-bonding plaster. Recess and fill over screws and washers. | £5,400 |

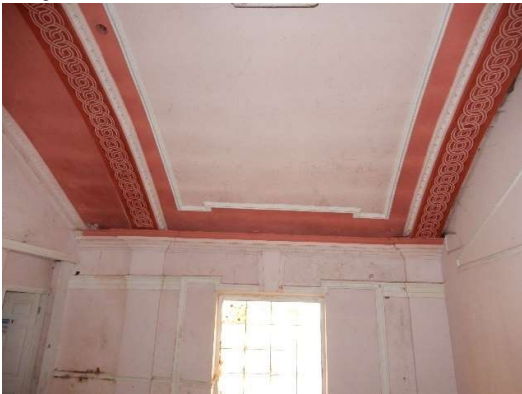
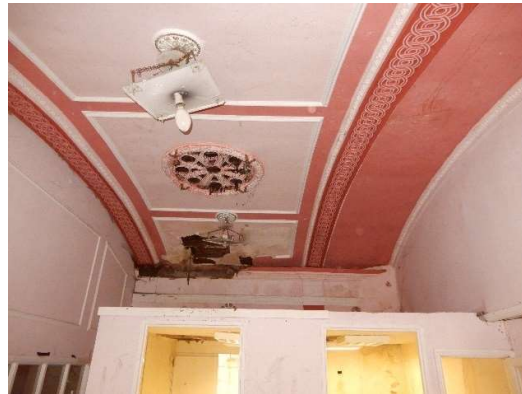
In bay 6 the eastern third of the bay is distressed and the plaster has collapsed above its western end, because of rot in the supporting timbers, although the adjacent plaster ventilation grill is in reasonable condition, see photos 53, 54 and 55. The wall plasters are cracked and de-bonded and there are missing plaster wads, that should be holding the rib up between the 6<sup>th</sup> and 7<sup>th</sup> bay, see photos 56 and 57. Although evidence of missing and damaged wads can be seen above every rib on this ceiling, see photos 72-73.

Photos 53 and 54: The distressed eastern third of the 6<sup>th</sup> bay; and the collapsed western end, although the plaster ventilation grill is in reasonable condition.

| Replace the damaged ceiling area in bay 6, including casting 12 square metres of plain ceiling panels on a radius, and fix in the area outlined in red on diagram 1, and cast and fix approx. 6 linear metres of rib moulding 500 x 150 mm, in two pieces, with four straight joints, 8 linear metres of ceiling panel moulding approx. 100 x 60 mm, with 6 external comers and 2 internal corners. | £8,114 |

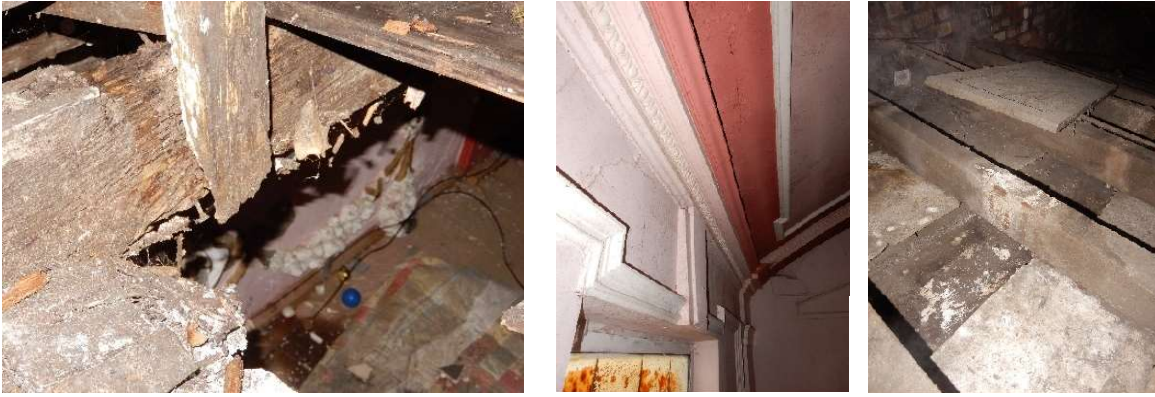
Photos 55-57: The rotten timbers above the western third of the 6<sup>th</sup> bay; the cracked and de-bonded wall plaster on the wall; and the missing plaster wads that should be holding the rib up between the 6<sup>th</sup> and 7<sup>th</sup> bay.

| Activity | Budget Cost Estimate |
|---|---|
| As emergency works screw up and install plaster wads, and cut a plaster joint line, to allow the main contractor to take down and replace the rotten timberwork in the western half of the 6 <sup>th</sup> bay, as indicated by the red square on diagram 2. | £1,800 |
| As emergency works take down and replace the rotten timberwork in the western half of the bay, as indicated by the red square on diagram 2, and replace with new timber joists, to the same strength and dimensions of the existing. | My main contractor |

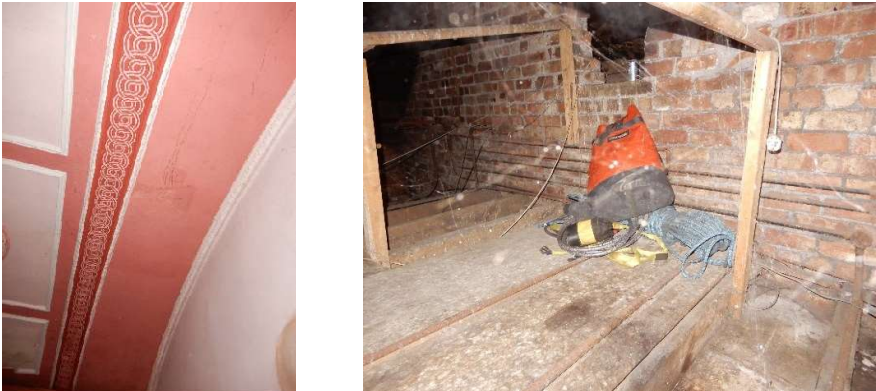
The partial small 7<sup>th</sup> bay, which is 800 mm wider at its western end, has a damaged apex caused by people using the main access point above, see photos 58 & 59. Interestingly, the extra width of the bay at the eastern end has been formed using lath and plaster, it is not clear if this predates or postdates the cast panelled ceiling, see photo 60.

Photos 58 & 59: The partial small 7<sup>th</sup> bay which is 800 mm wider at its western end. The plaster at its apex is damaged; From above it is clear that this damage has been caused by people using the main access point above.

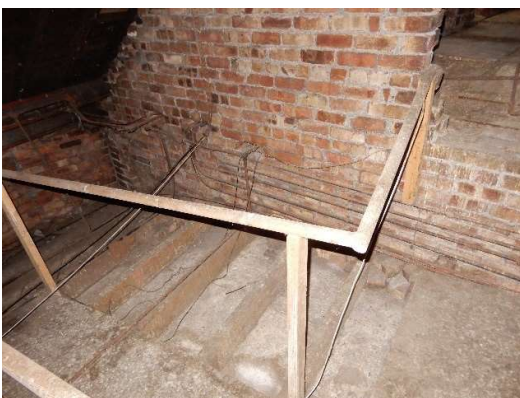
Photo 60: The extra width of the bay at the eastern end has been formed using lath and plaster.

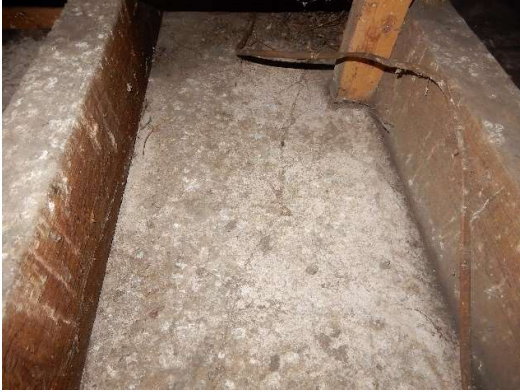
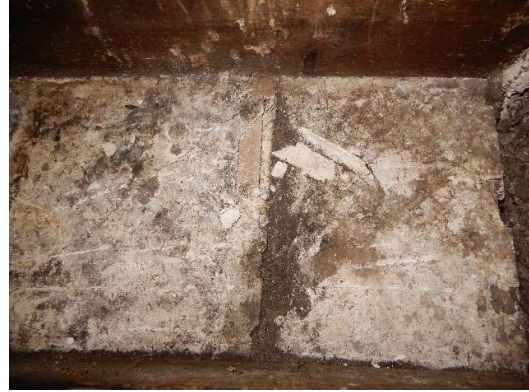
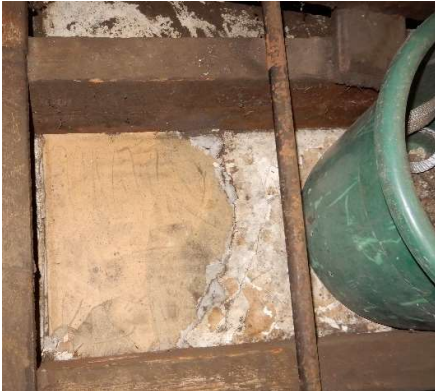
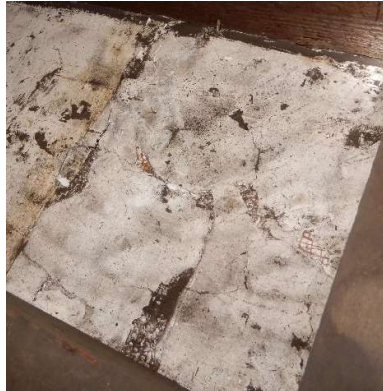
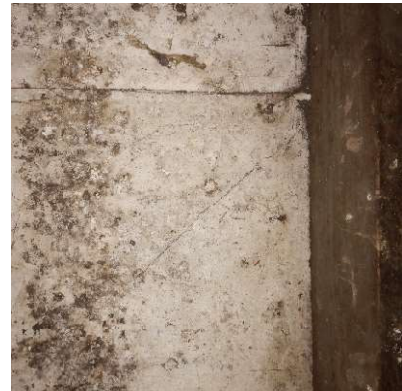
Photos 61-65: Cracked cast fibrous plaster plain panels, exposed hessian and laths within the casts after deterioration of the upper surfaces and patching after a fall of part of a panel.

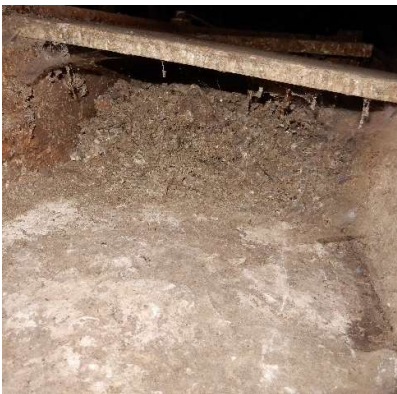
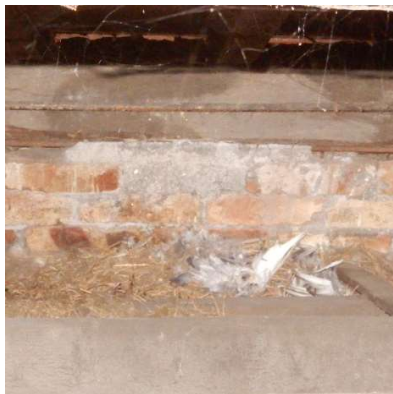
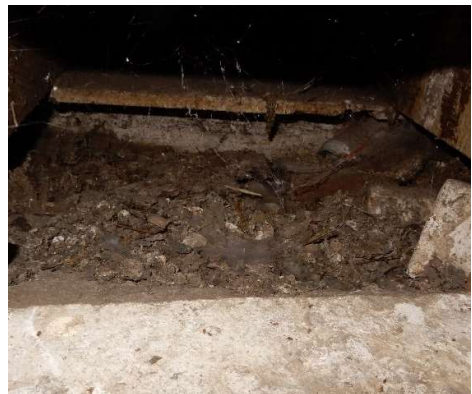
Overall, the ceiling, despite been cleaned of excessive levels of guano and dead birds, has pockets still remaining, see photos 66-68, reminding us of the extent of weight and moisture previously present in the back of this ceiling, which has caused extensive decay and damage to the fabric of all the gypsum plaster. With many of the cast panels warped, and some are pulling off the bottom of the ceiling joists which they are nailed on to, see photos 69-71. Similarly, the cast cornices are water damaged and warped and their supporting wads are failing, see photos 74-75.

Photos 66-68: Whilst the ceiling void has been cleaned of excessive levels of guano and dead birds, some pockets still remain, reminding us of the extent of weight and moisture previously present in the back of this ceiling.

| Activity | Budget Cost Estimate |
|---|---|
| Clean all the backs of the ribs and ceiling plasterwork of the remaining guano | My main contractor |

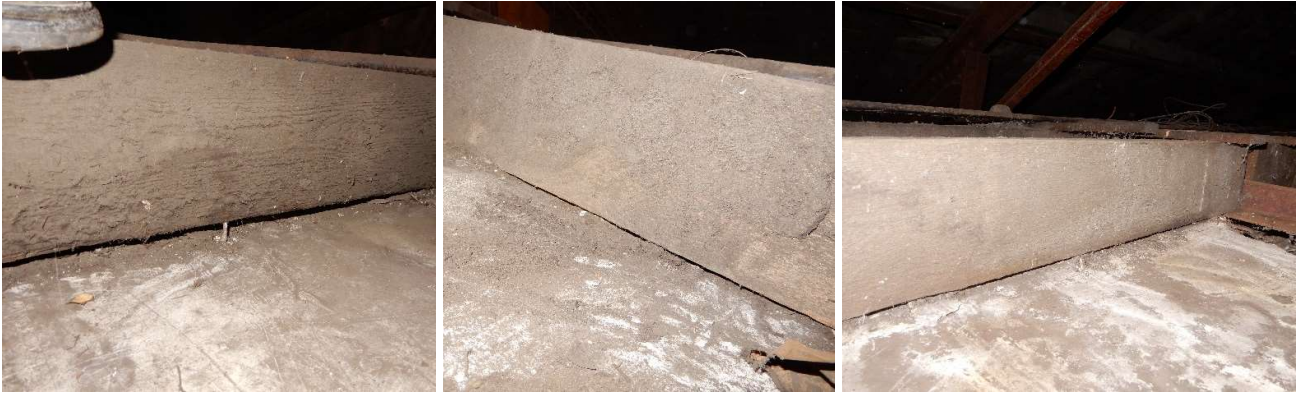
Photos 69-71: Many of the cast panels are warped and some are pulling off the bottom of the ceiling joists which they are nailed on to.

| As emergency work resecure the plain curving cast panels back to the ceiling joists with approximately 1550 number counter sunk 50 mm screws and fill over screw heads with fine casting plaster. | £32,400 |

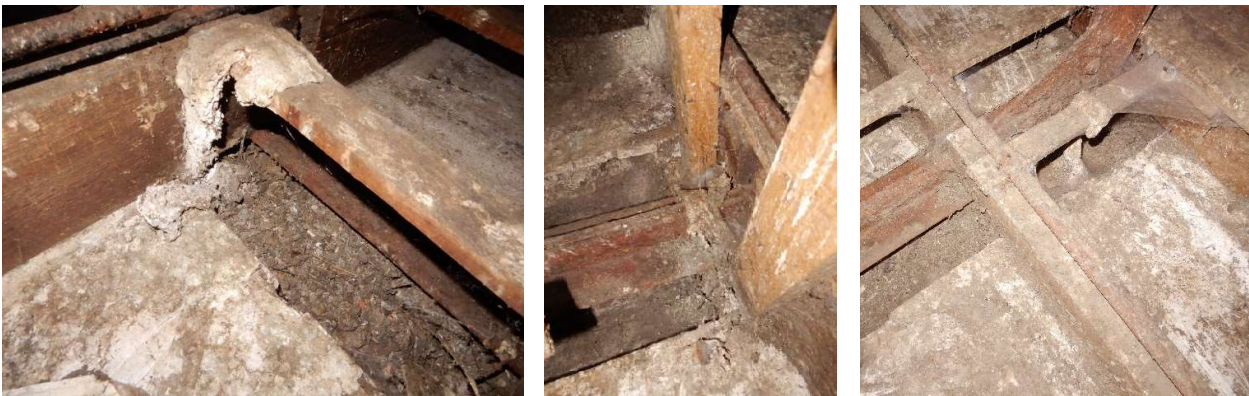
Photos 72-73: The few remaining plaster and hessian only nibs have deteriorated and snapped.

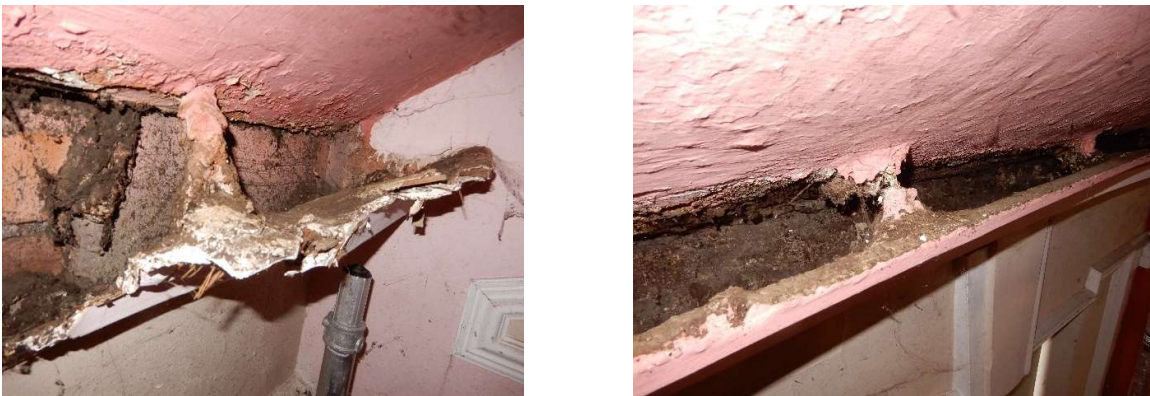
Photos 74-75: With also failing wads trying to support a water damaged and warped cornice below

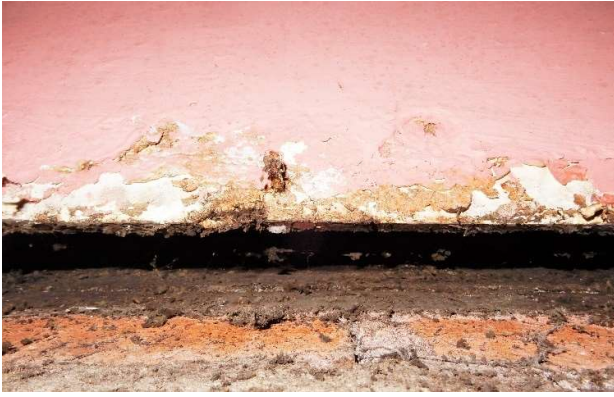
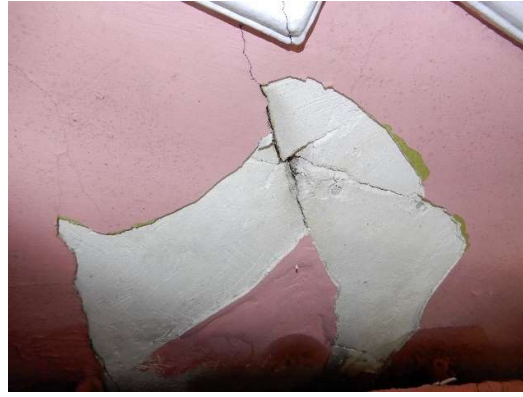
Photos 76 & 77: The cast plaster panels are carried off ceiling joists parallel but not touching the external brickwork, has reduced the amount of damage at the ceiling edges; damp and impact damage however has still caused debonding of the skim found under some of the boards.

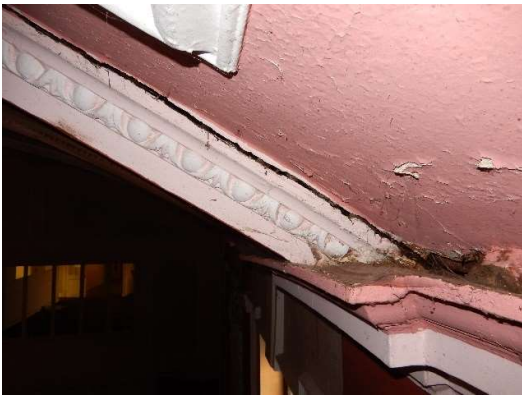
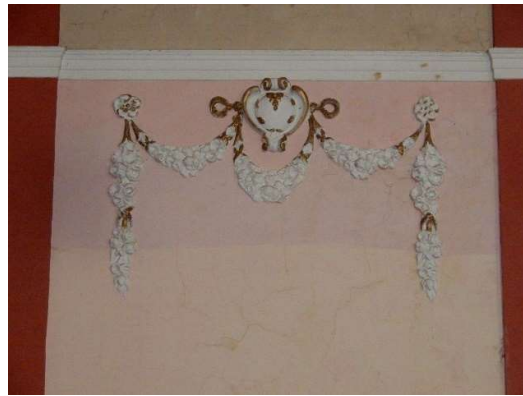
Photos 78 & 79: Damp induced decay of the hessian in the plaster wads carrying the cornices has also meant some ribs may fall soon; and damp in the walls has caused extensive debonding in the wall's plasters, including those carrying the decorative swags.

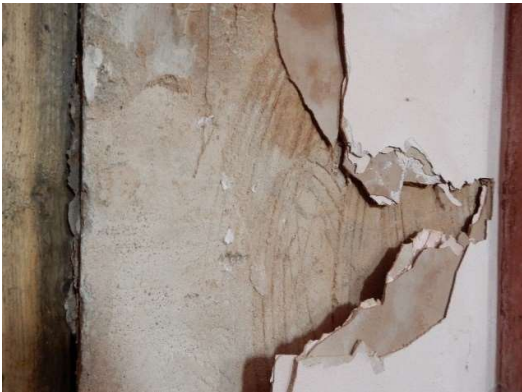
It is not clear if the skim below most of the cast panels was introduced later or at the time of insertion, especially as it runs behind applied mouldings. However, because of movement, damp, and weight on the boards, in many areas it is de-bonding, see photo 77. The wall plaster to both the east and west walls has significantly de-bonded, which is compromising the fibrous cast decorative swags, frieze bands, and window surrounds, see photo 79. Below the original cement-lime bound plasters, near the frieze band, are more modern plasters, applied pilasters and wooden vertical architraves, continuing the window surrounds, and modern gypsum over skim, which is debonding, see photo 80, in the areas previously below the balconies.

Photo 80: De-bonding modern gypsum based plasters, which has been used to over skim the areas enclosed by and below the balconies, after they were removed.
