**WATERPARK DRIVE, STOCKBRIDGE**

**Remediation Earthworks Completion Report**

**January 2019**

**Report Ref: R2469-R01-v4 FINAL**

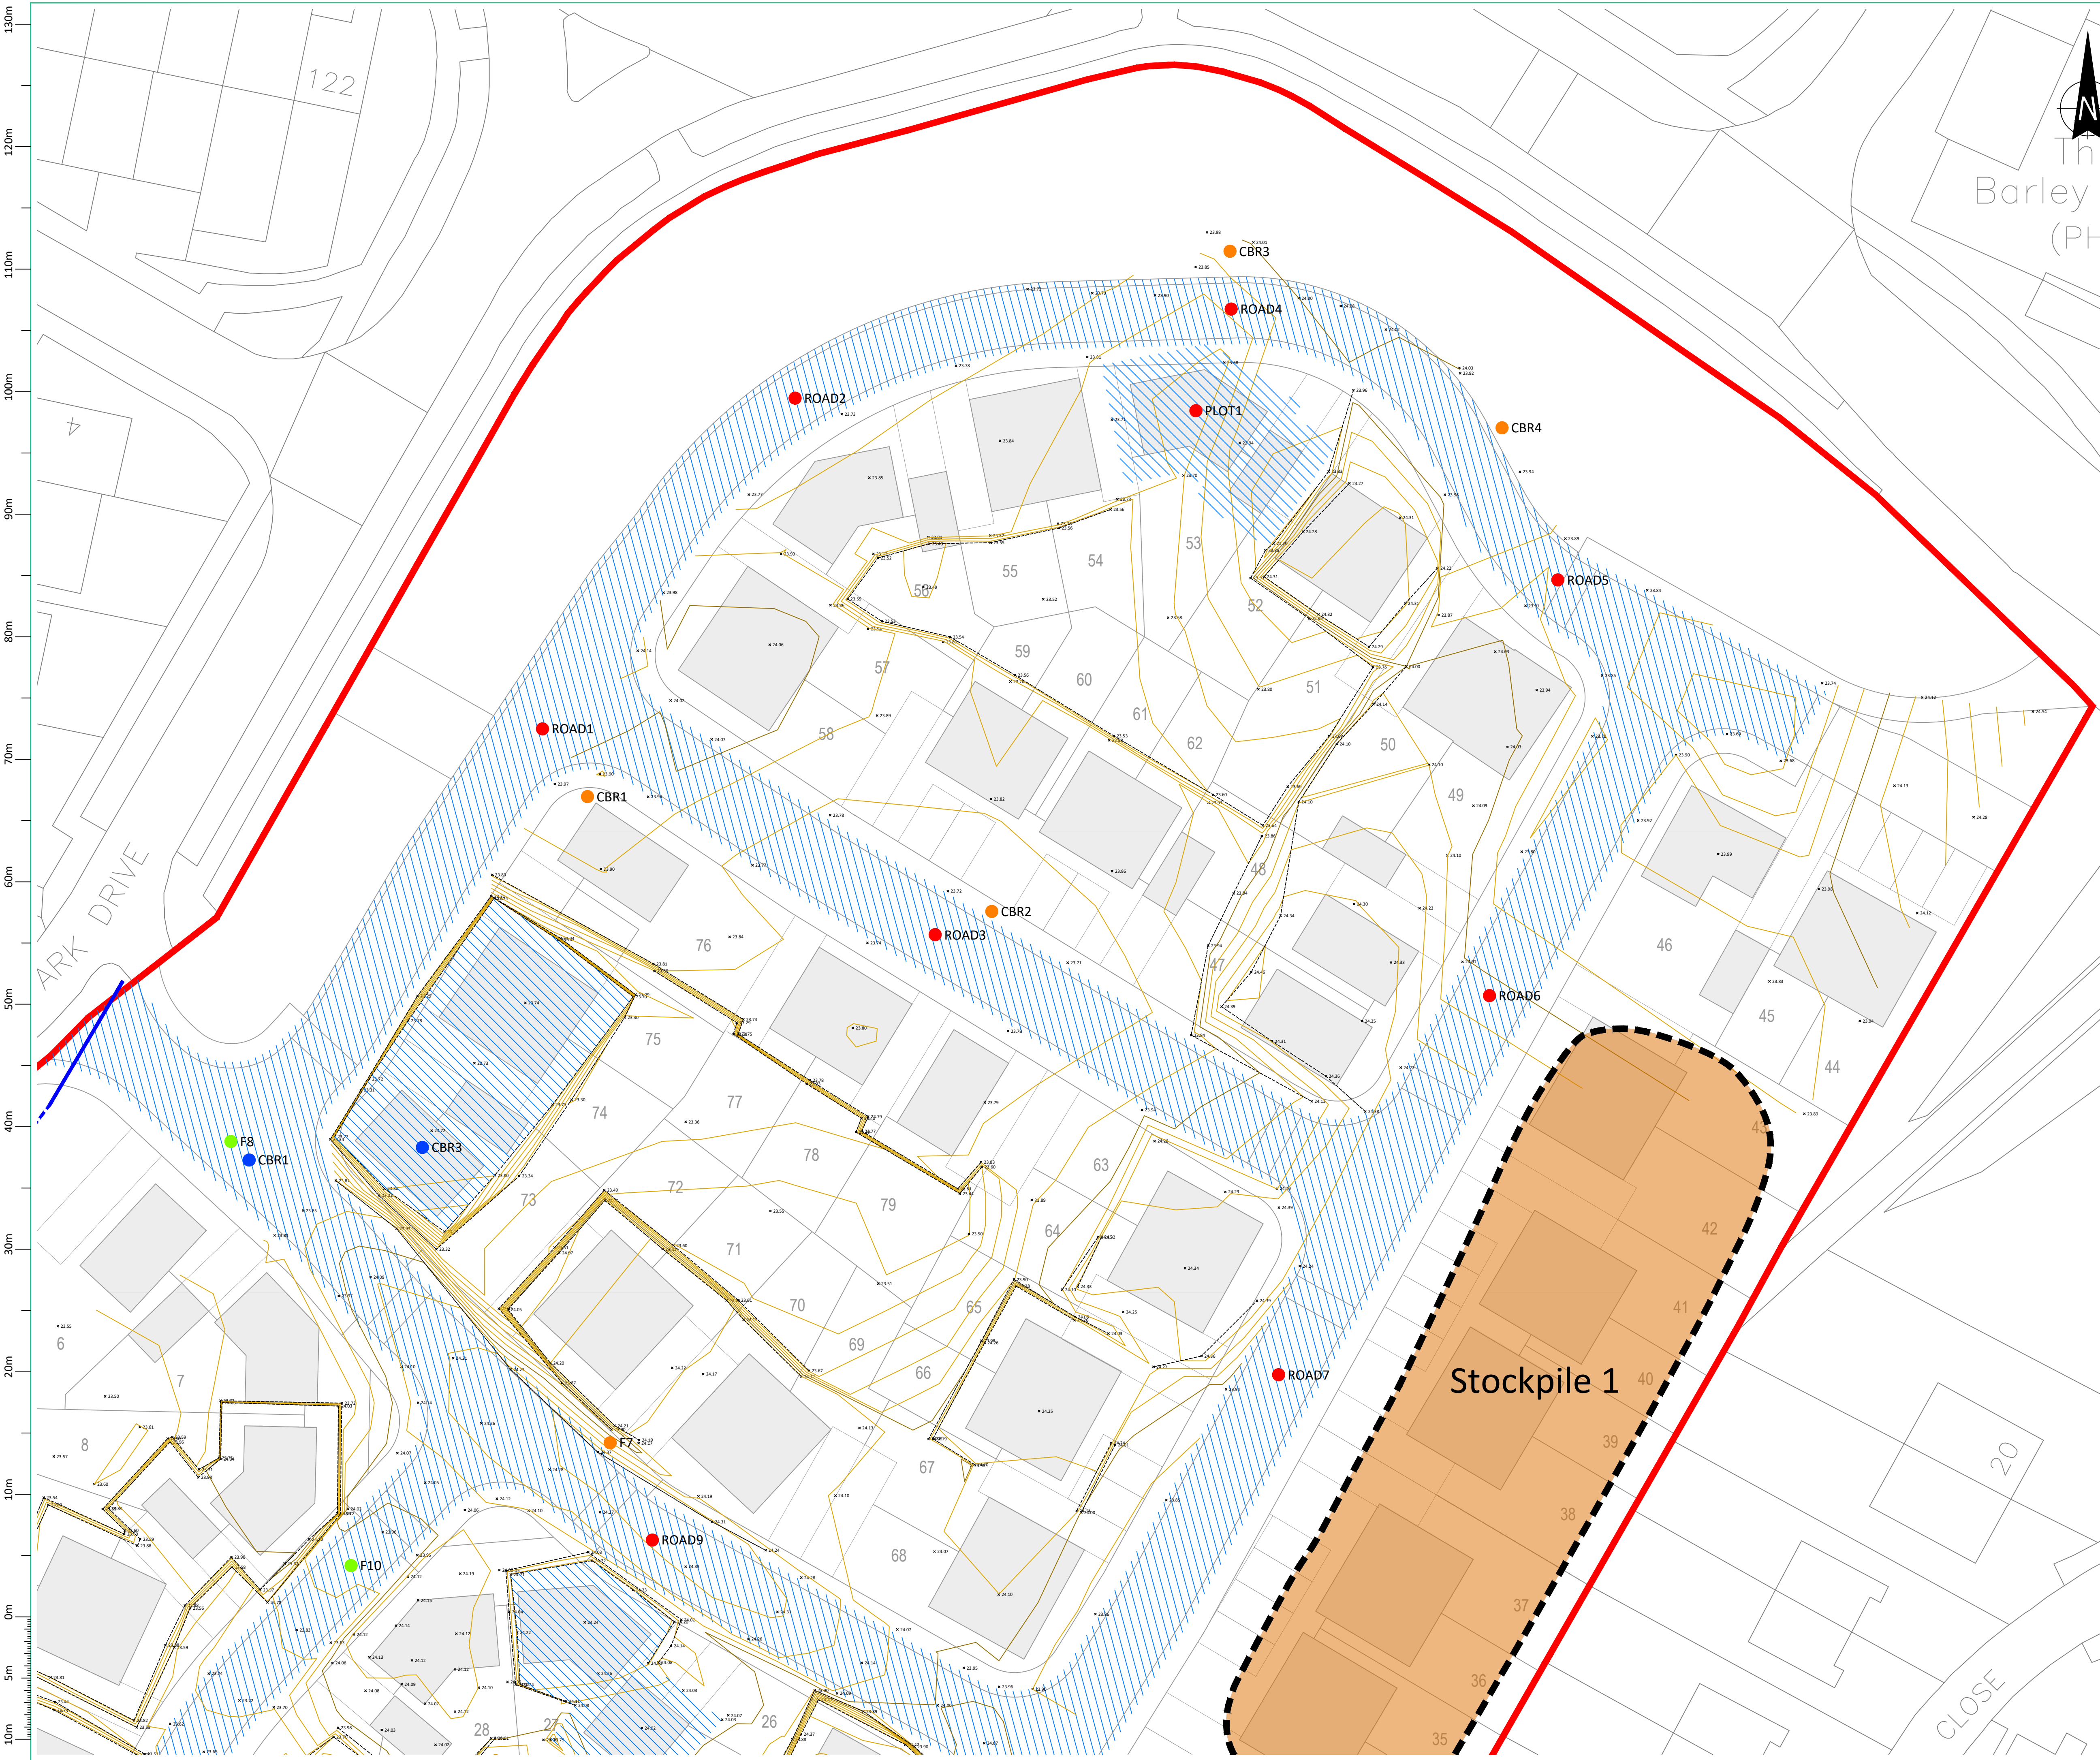
292-001-01

4. A manhole associated with the live sewer (185mm - 275mm) entering onto site was removed during remediation works. A length of uPVC corrugated 225 mm dia' pipe was installed to enable a temporary repair.

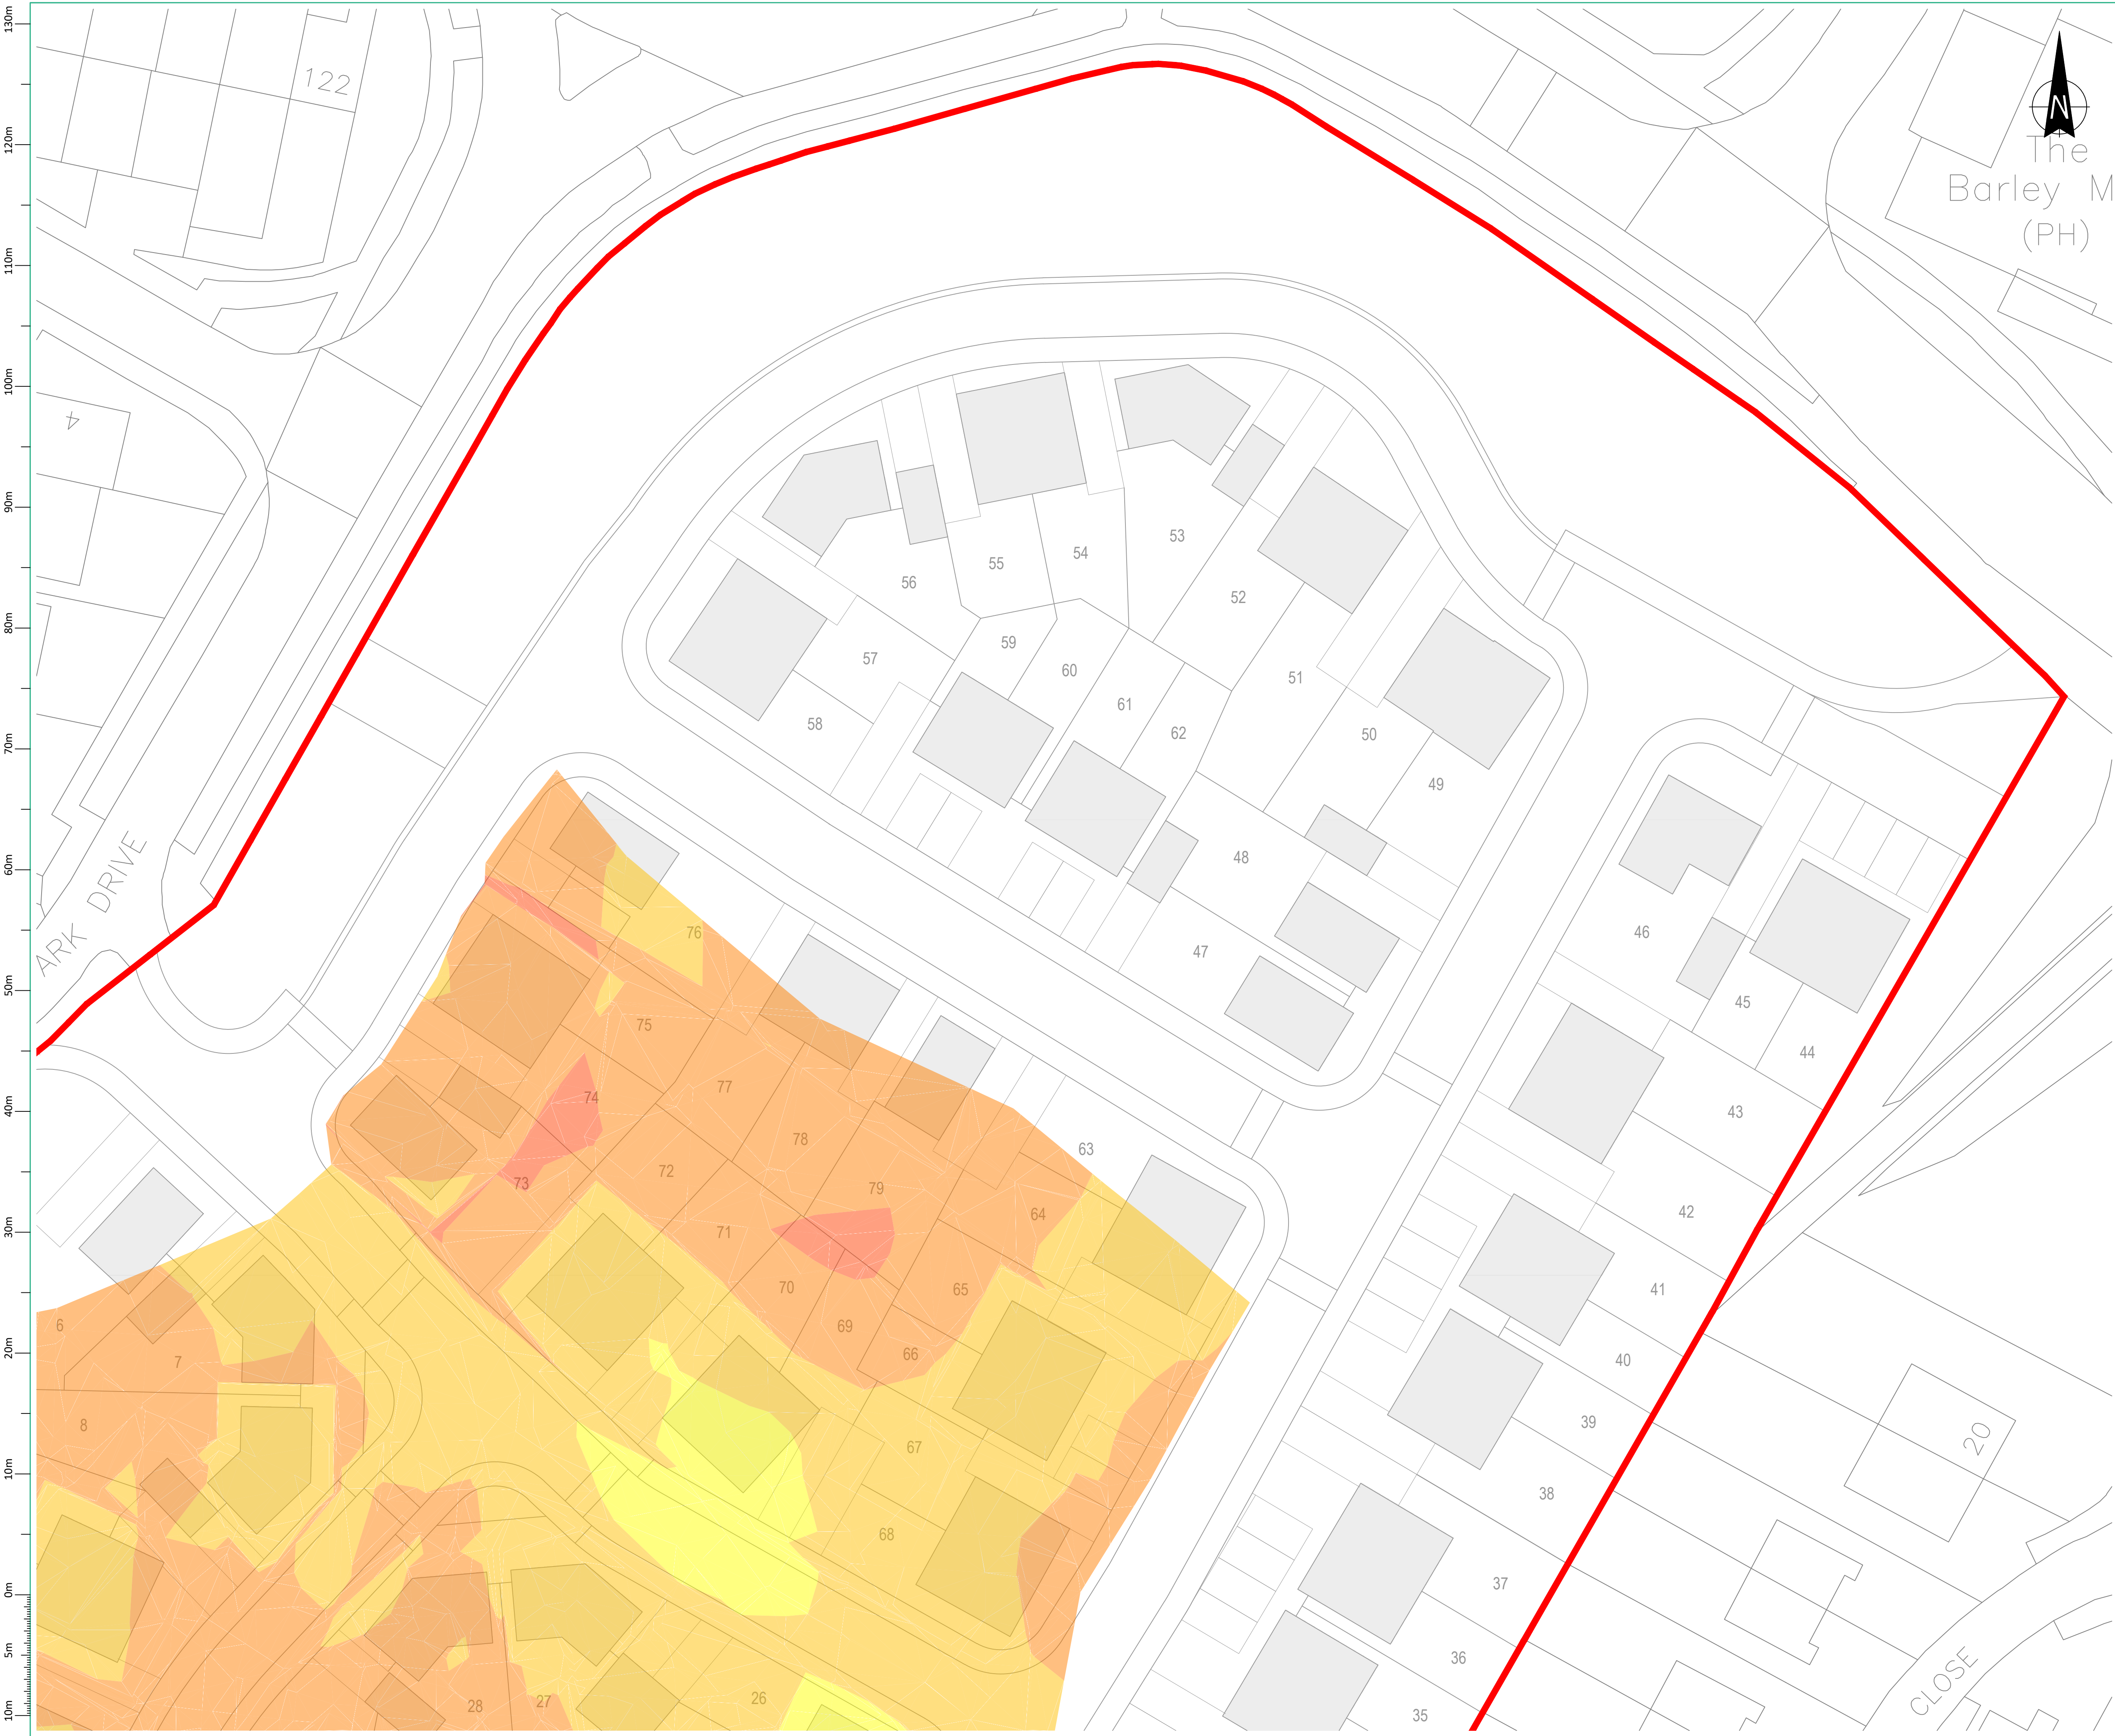
292-001-02

3. All CBR tests were carried out by TC Construction Testing Ltd.
4. The culvert associated with the level 100 (100.00 - 75mm) entering onto site was removed during remediation works. A length of uPVC corrugated 225 mm dia' pipe was installed to enable a temporary repair.

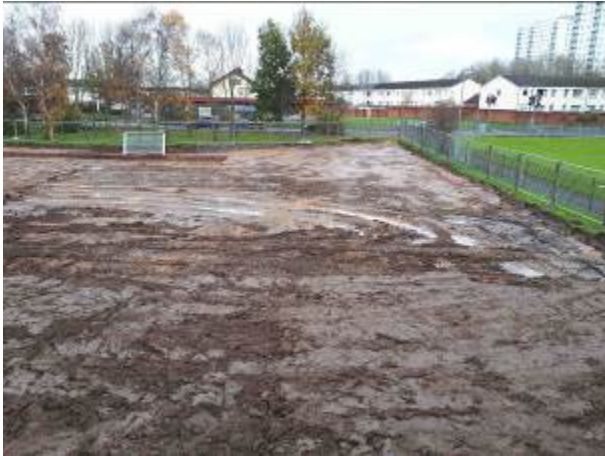
1.

14.11.17 –View of northeast corner of site; vegetation and topsoil strip completed prior to inspection.

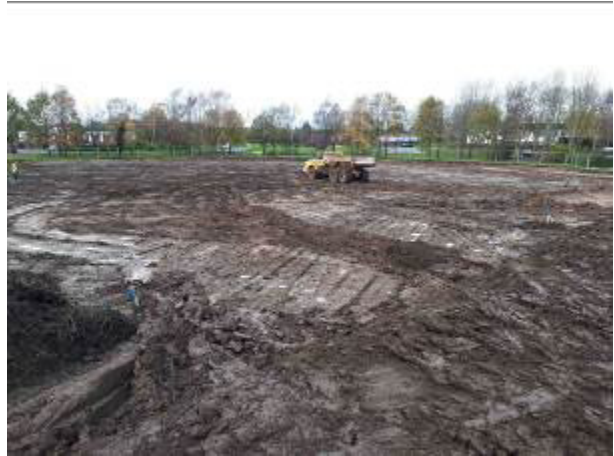
2.

14.11.17 –View northwest across site from northern part of southeast boundary; vegetation and topsoil strip completed prior to inspection.

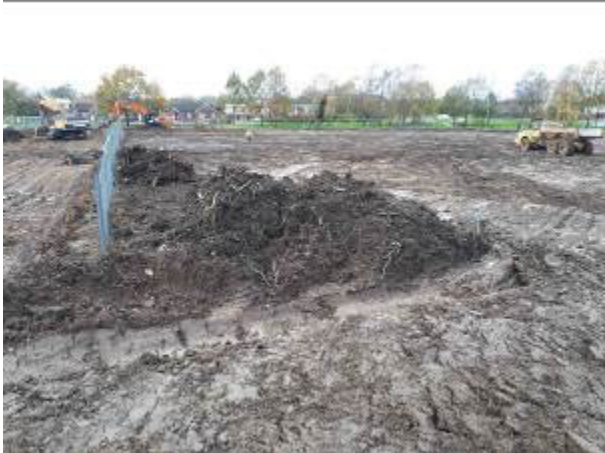
3.

14.11.17 –View west-northwest across site from northern part of southeast boundary; vegetation and topsoil strip completed prior to inspection and small stockpiles of stripped vegetation visible.

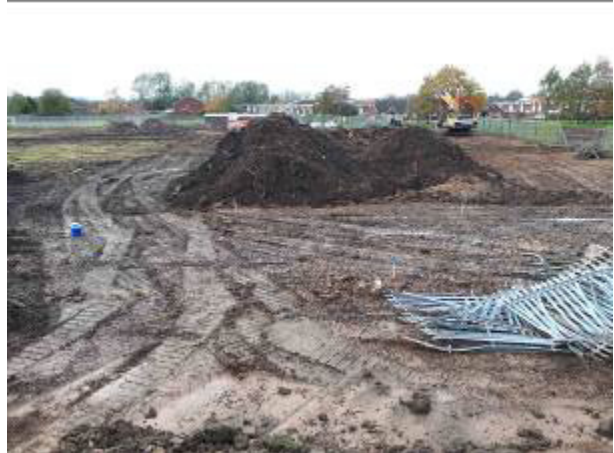
4.

14.11.17 –View west across site from north of southeast boundary; vegetation and topsoil strip completed prior to inspection and stockpile of stripped vegetation visible.

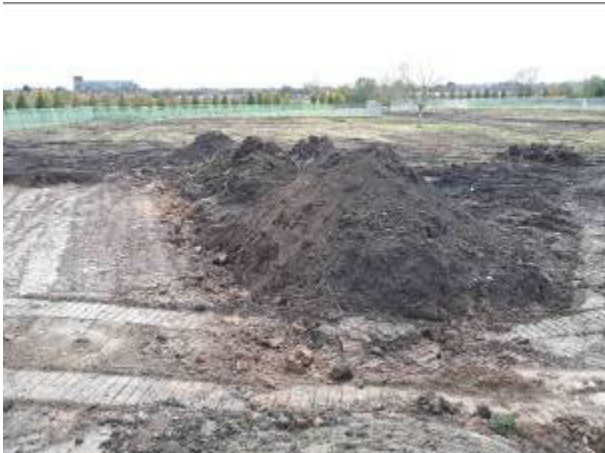
5.

14.11.17 –View west across site from centre of southeast boundary; extent of vegetation / topsoil strip and stockpile of stripped vegetation visible.

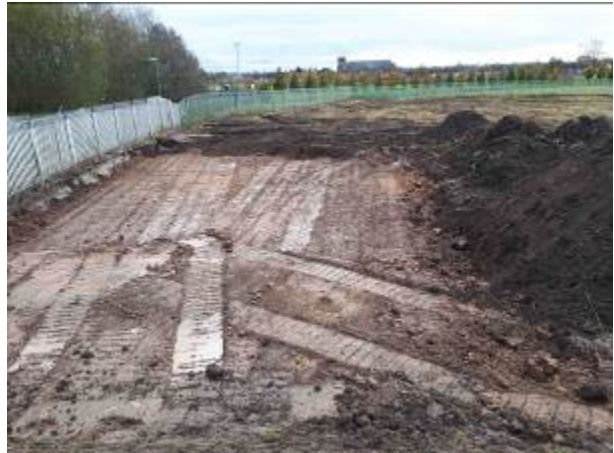
6.

14.11.17 – View of southernmost part of the site including parts of the southeast and southern boundaries; extent of vegetation / topsoil strip visible.

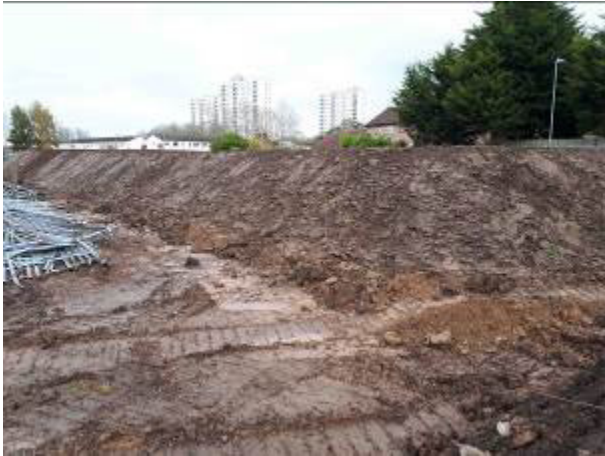
7.

14.11.17 – Topsoil stockpile positioned long southeast boundary, stripped from northern, greenfield parts of site.

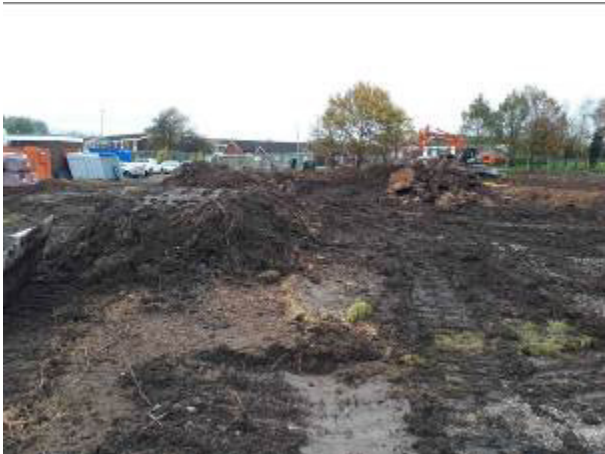
11.

14.11.17 – View west-northwest from centre of site; small stockpiles of stripped vegetation and recovered hardstanding visible following turnover of made ground soils in area.

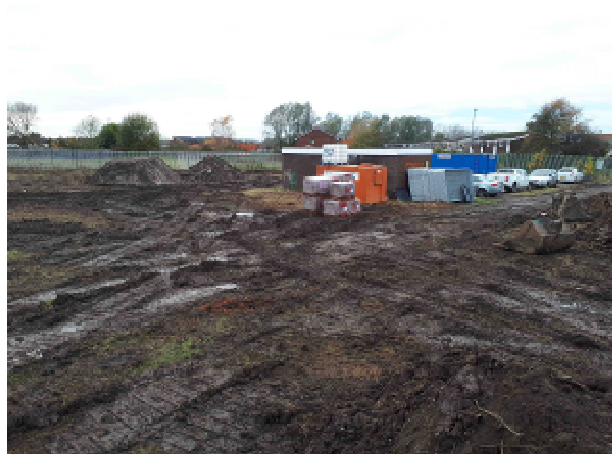
12.

14.11.17 – View west from centre of site; electricity substation visible.

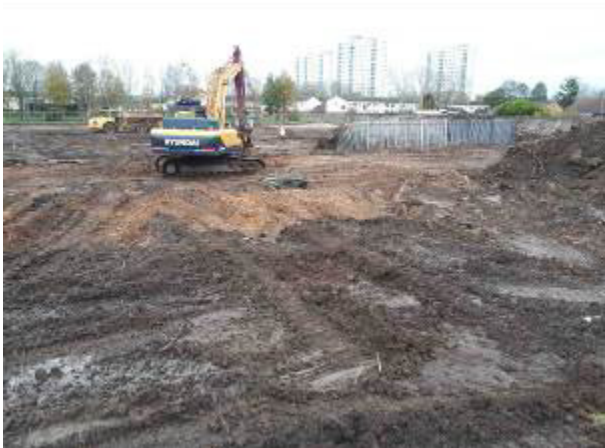
13.

14.11.17 – Turnover of made ground soils with excavator in centre-west part of site.

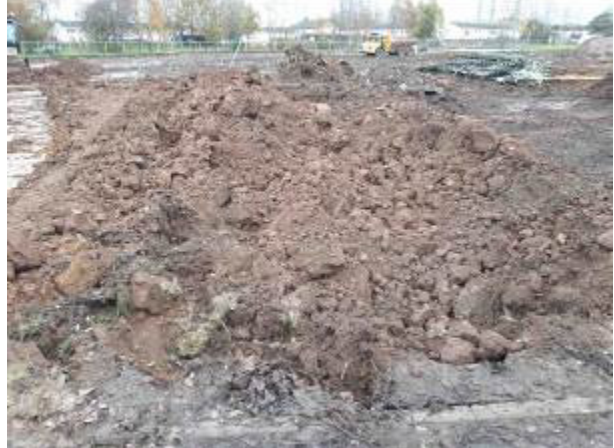
14.

14.11.17 – Turned over made ground soils in centre-west part of site prior to recompaction.

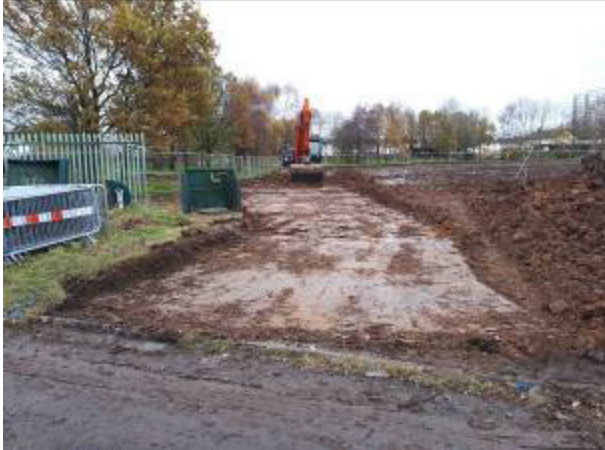
15.

14.11.17 – Digging out of road footprint with excavator along northwest boundary.

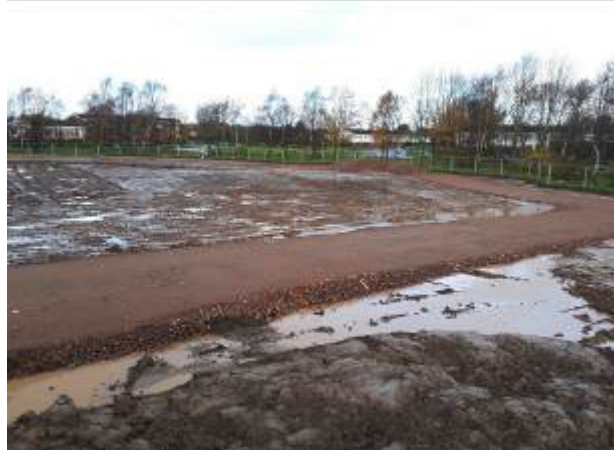
16.

23.11.17 – Laid crushed aggregate in road positions in north of site.

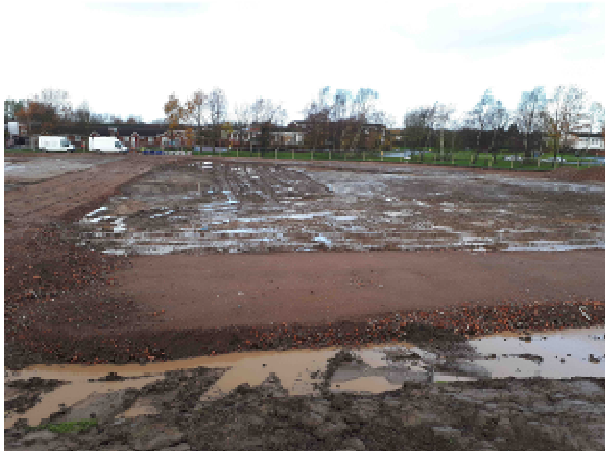
17.

23.11.17 – Laid crushed aggregate in road positions in centre-north of site.

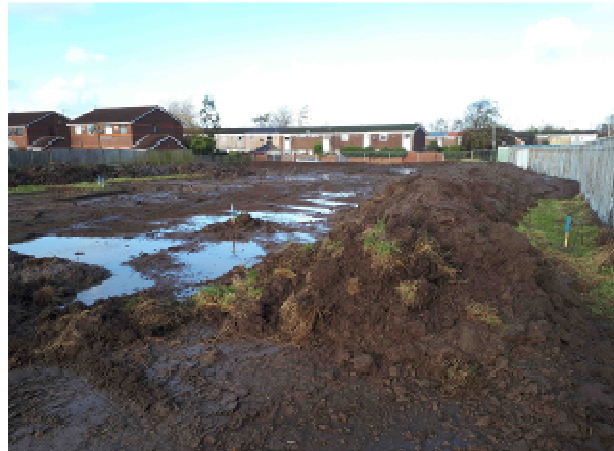
18.

23.11.17 - Vegetation and topsoil strip in the northern part of the western section of site completed prior to inspection.

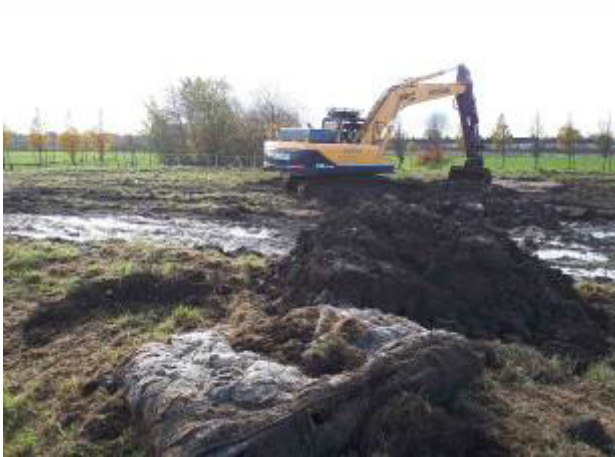
19.

23.11.17 - Vegetation and topsoil strip in the central part of the western section of site.

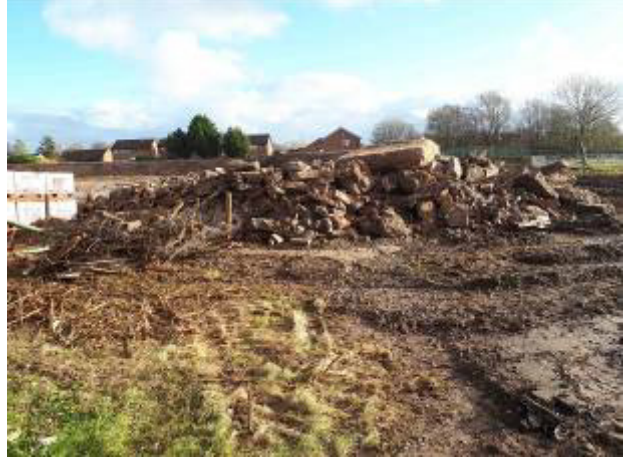
20.

23.11.17 – Stockpile of hardstanding in centre of site recovered from turnover of made ground soils in central parts of site.

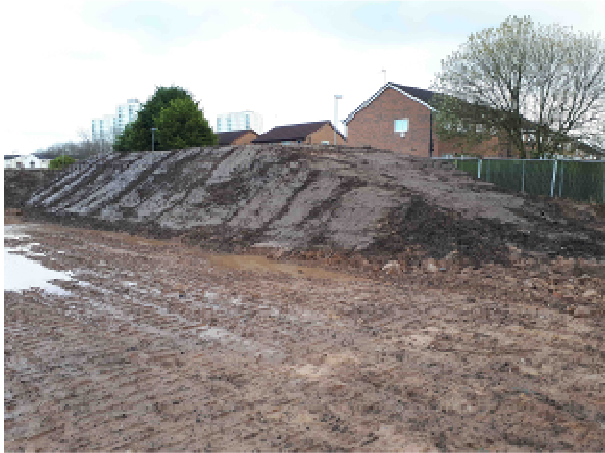
21.

23.11.17 – Stockpile of consolidated stripped vegetation positioned along southeast boundary.

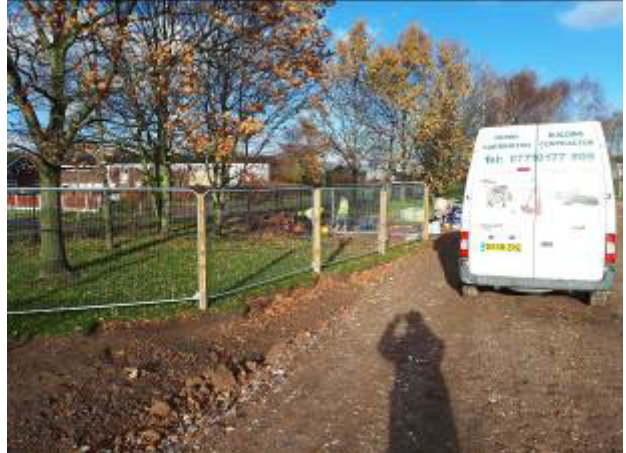
22.

23.11.17 – Construction of electricity substation located along centre of northwest boundary in progress.

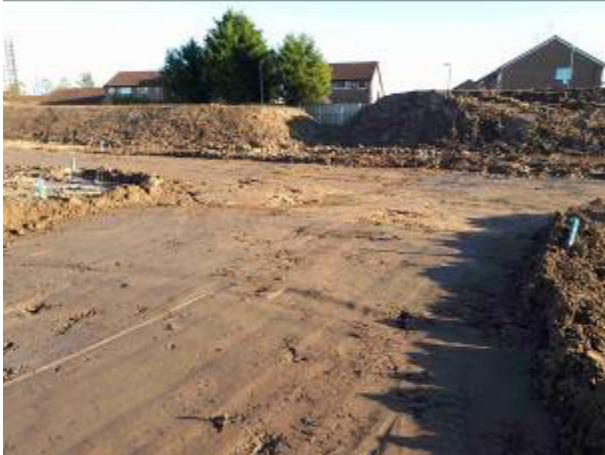
23.

30.11.17 – Footprints of roads dug out in central / eastern parts of site (1/3).

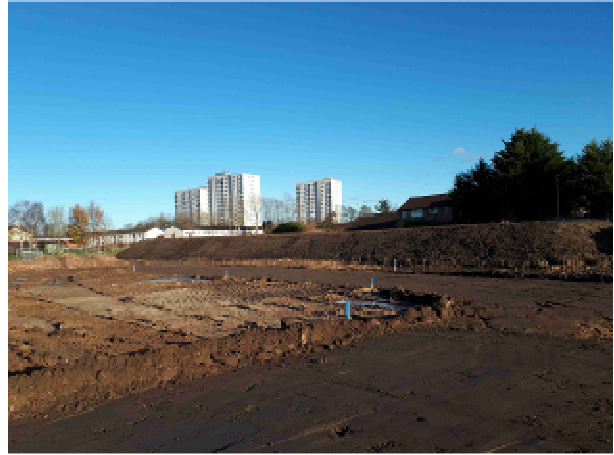
24.

30.11.17 – Footprints of roads dug out in central / eastern parts of site (2/3).

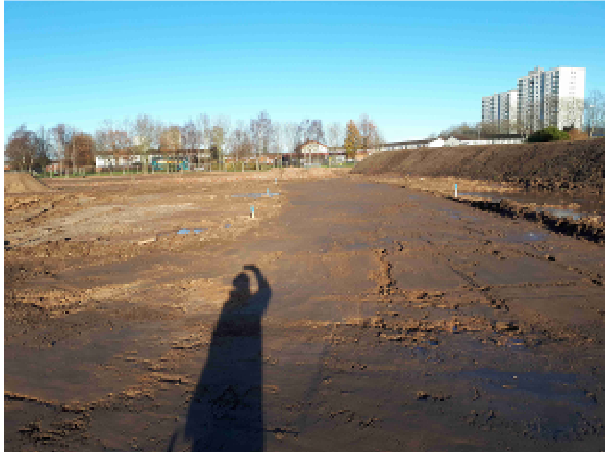
25.

30.11.17 – Footprints of roads dug out in central / eastern parts of site (3/3).

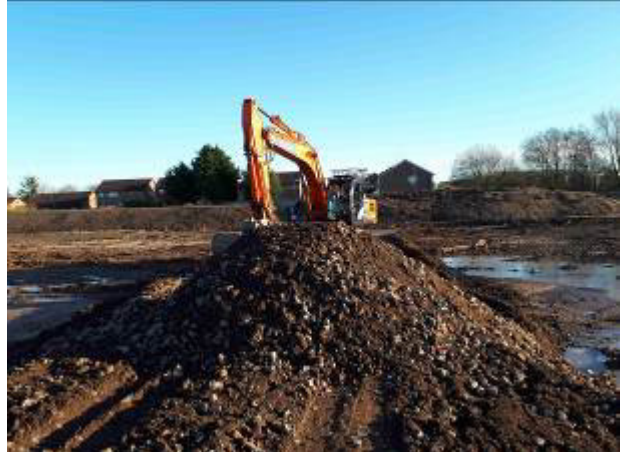
26.

30.11.17 – Laying crushed aggregate in road positions in centre of site with excavator.

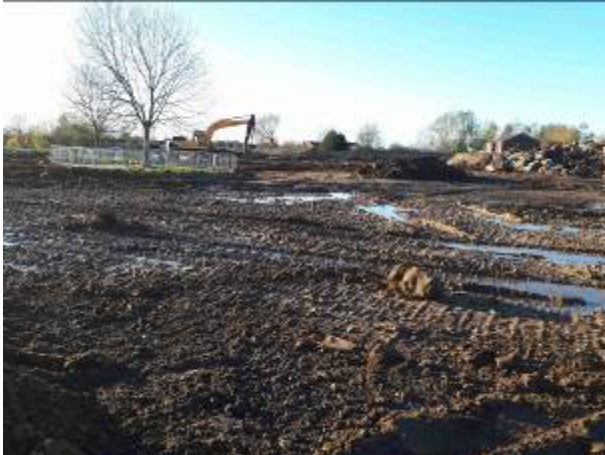
27.

30.11.17 – Turnover of soils in in centre-south of site with excavator (in far distance).

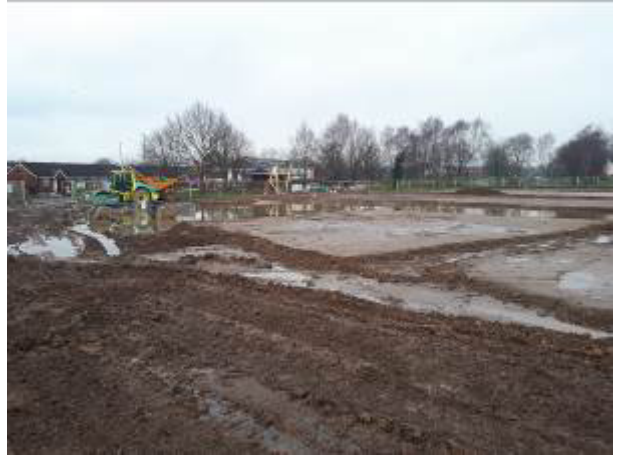
28.

18.12.17 – Crushed aggregate placed in plot footprints in central/northern parts of the site (1/3).

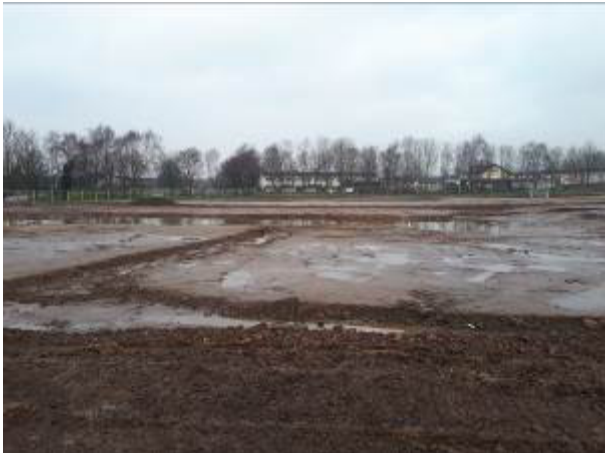
29.

18.12.17 – Crushed aggregate placed in plot footprints in central/northern parts of the site (2/3).

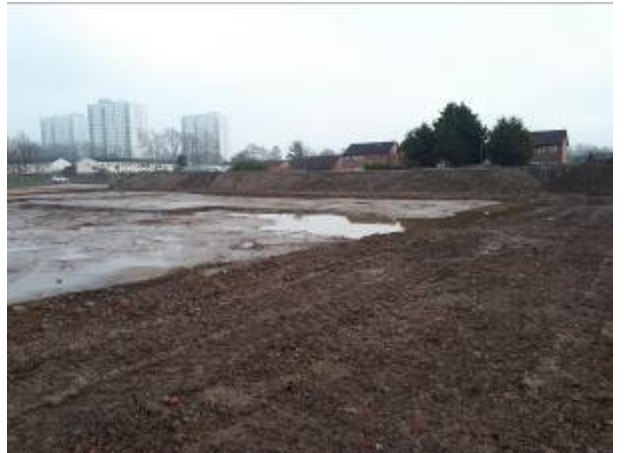
30.

18.12.17 – Crushed aggregate placed in plot footprints in central/northern parts of the site (3/3).

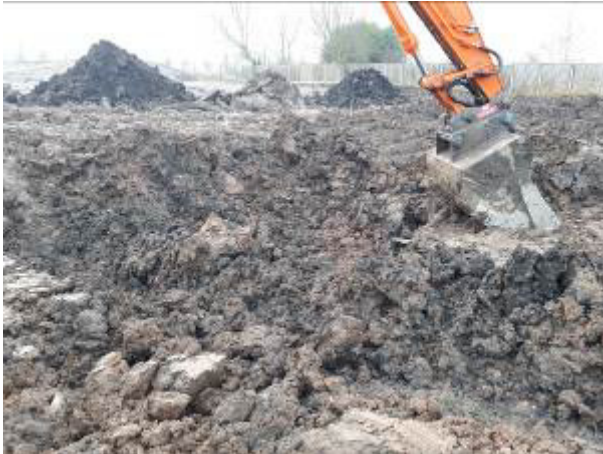
31.

18.12.17 – Turnover of soils and excavation of peat in the northern part of the western section of site; peat stockpiles visible in background.

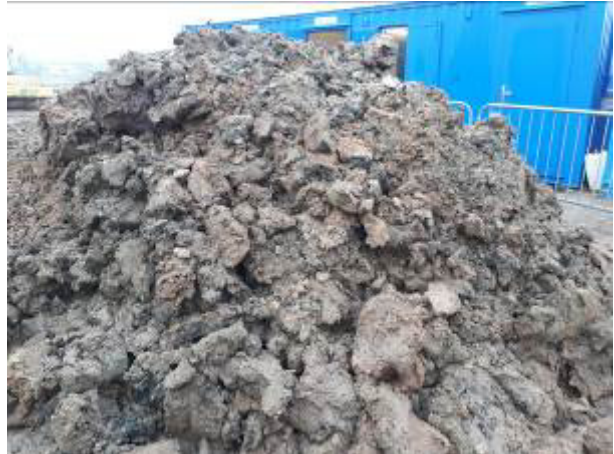
32.

18.12.17 – Clay / peat stockpile excavated from the northern part of the western section of site.

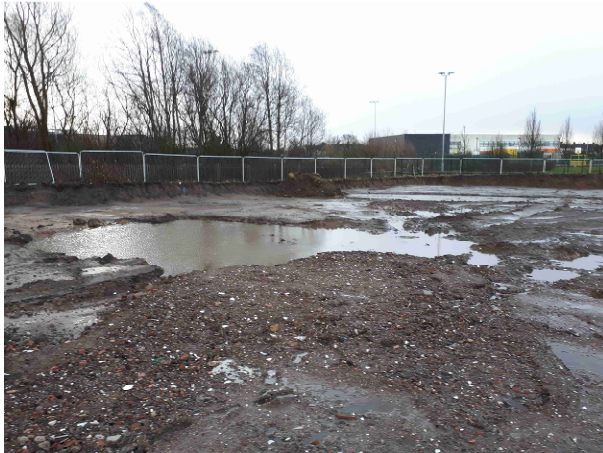
33.

15.01.18 – Topsoil / vegetation strip and turnover of soils completed in southern part of site; placed 6F2 aggregate for basal road construction in south east visible in foreground.

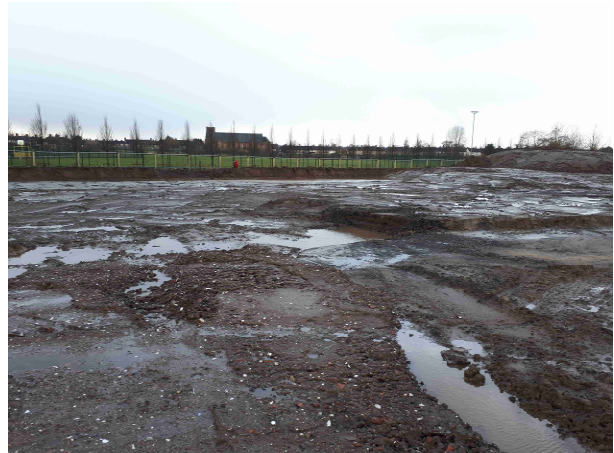
34.

15.01.18 – Topsoil / vegetation strip and turnover of soils completed in the central part of the western section of site; placed 6F2 aggregate for basal road construction in south east visible in foreground.

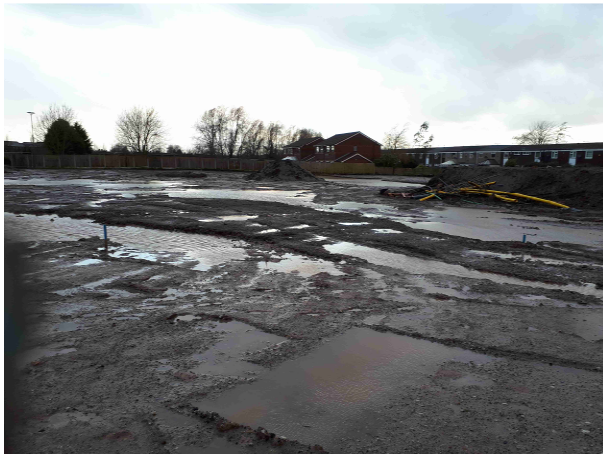
35.

15.01.18 – Topsoil / vegetation strip and turnover of soils completed in in the northern part of the western section of site; peat stockpiles visible.

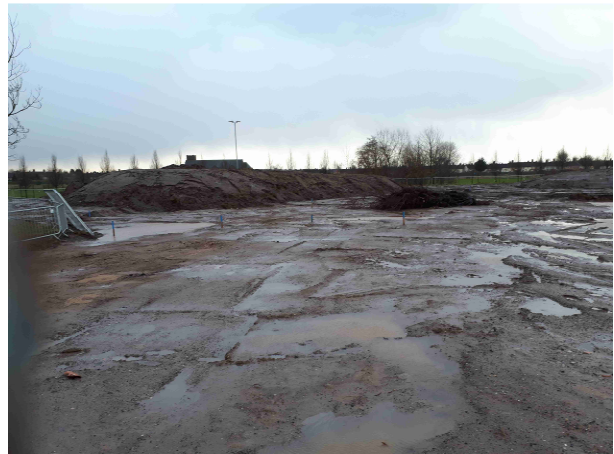
36.

15.01.18 – Topsoil stockpile in southwest of site.
