**Project Name:** DJL CONSTRUCTION - 35 WILSON ROAD HUYTON

**Project Date:** 11/08/2026

**Inspection Standard:** MSCC5 Sewers & Drainage GB (SRM5 Scoring)

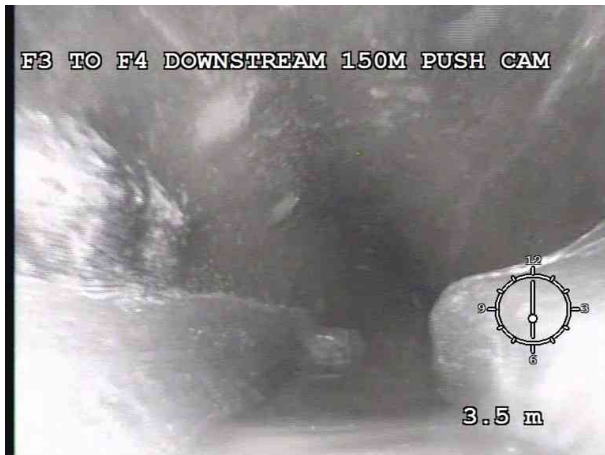
| <b>Comments:</b> | Blistered at 3.50m & fractured at 13.40m | | | | |

| Depth: m | Code | Observation | MPEG | Photo | Grade |
|---|---|---|---|---|---|
| 3.50 | GP | General photograph taken at this point: Blisters in pipe | 00:00:22 | 1 | |

1, 00:00:22, 3.50 m  
General photograph taken at this point, Blisters in pipe

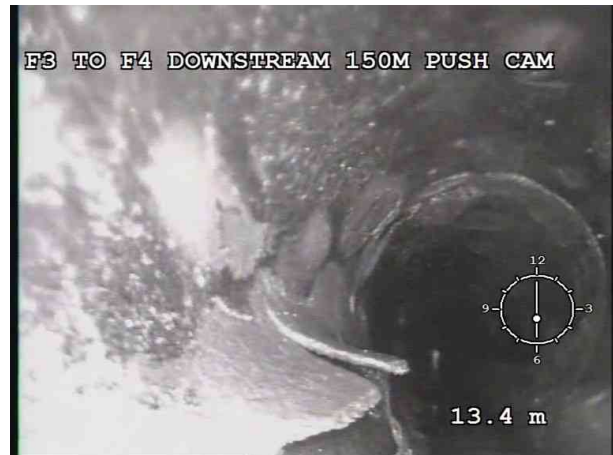
| Depth: m | Code | Observation | MPEG | Photo | Grade |
|---|---|---|---|---|---|
| 13.40 | FC | Fracture, circumferential from 7 o'clock to 8 o'clock | 00:01:07 | 2 | 3 / 2 |

2, 00:01:07, 13.40 m  
Fracture, circumferential from 7 o'clock to 8 o'clock
