## Heritage, Design and Access Statement

Stable Block at The Clock Face, Derby  
Street, Prescott, L34 3LL

Daniel Thwaites Plc

JANUARY 2025

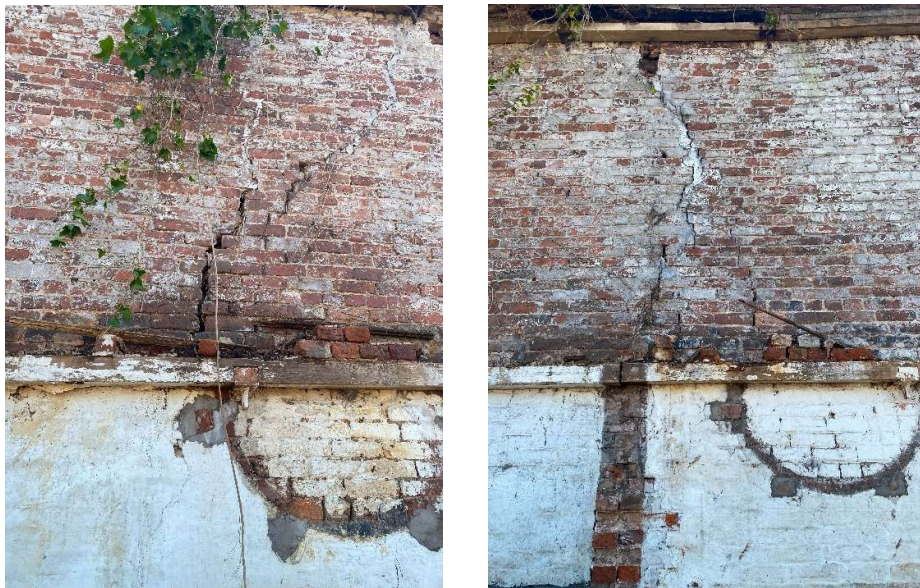
- 3.1 Following demolition of the lean-to structure 2no diagonal cracks to the external face of the brickwork were exposed at first floor level. The cracks extended from two joist holes and travelling vertically the elevation towards timber beam inserted to support the first floor joists. No cracking is visible to the internal faces of the building.
- 3.2 To remedy 2no. cracks identified following the removal of the lean-to it is proposed to that the sections of the elevations surrounding the cracks are rebuilt in line with the specification presented within Thwaites specification of works.

*Plates 1 and 2 - Vertical cracking exposed to the first floor of the north elevation.*

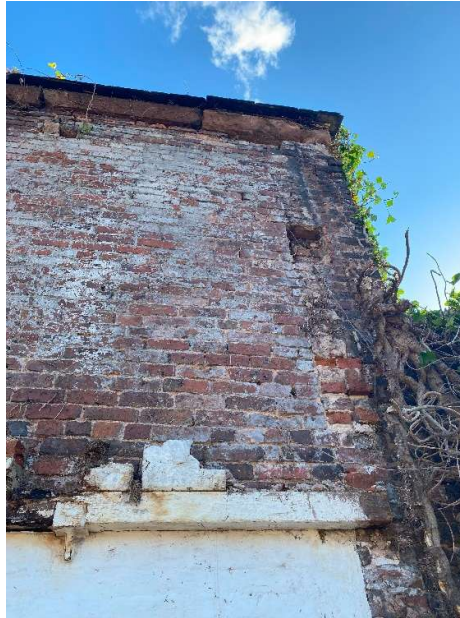
- 3.7 Damaged bricks are present where the lean-to structure was previously tied into the northwest elevation of the stable block. These areas are limited to the northeast and southwest ends of the elevation where the end walls of the lean-to were intermittently tied in at high level only.
- 3.8 The damaged, rough edge bricks are to be carefully cut out by hand or mechanically, using a small handheld grinder and a vacuum attachment to cut down the amount of dust from becoming airborne. Replacement bricks salvaged from the lean-to structure during the demolition are to be instated. These bricks match the colour, texture and size of the bricks present to the stable block and their use was agreed at a site meeting with officers of Knowsley Borough Council on 27<sup>th</sup> September 2024.

*Plate 3 – Typical example of damaged bricks where brickwork replacement is proposed*

- 3.9 The replacement bricks are to be bed and pointed in a lime and sand mortar in accordance with the methodology set out above.

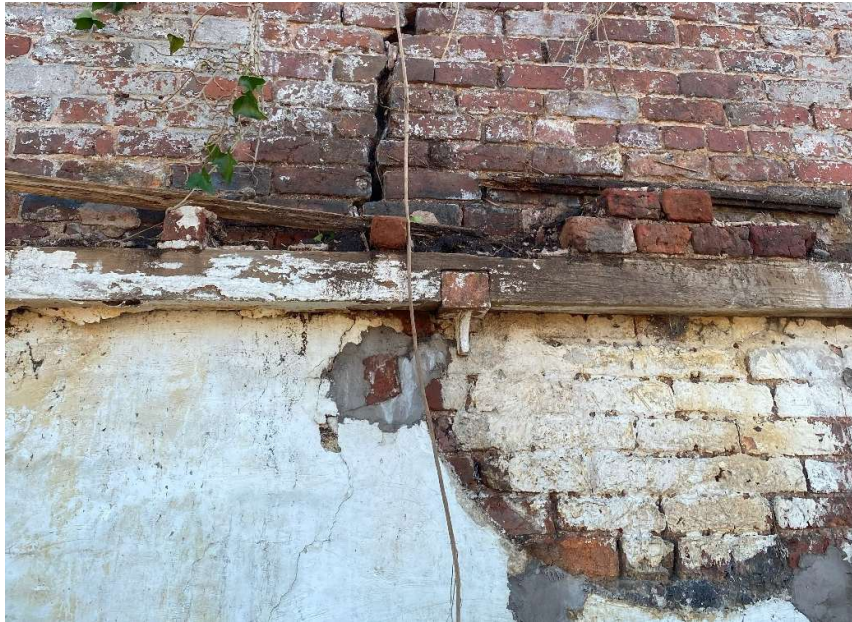
- 3.10 Isolated timbers, brackets, slates and lead flashings remain fixed to the northwest elevation. These features were associated the roof and internal structure of the lean-to.
- 3.11 The remaining timbers appear to set against the brickwork the northwest elevation and carried on metal brackets.
- 3.12 Open mortar joints exposed by the removal of flashings, slates and brackets are to be pointed in accordance with the methodology presented above.
- 3.13 Where insertion of the metal hanger brackets and timbers has caused damage to the brickwork, the brickwork will be careful cut out and replaced with bricks salvaged from the lean-to structure during the demolition.
- 3.14 Replacement bricks are to be bed and pointed in a lime and sand mortar in accordance with the methodology set out above.

*Plate 4 – Remaining timber and metal bracket to be removed.*

Where fixings leave holes in brickwork, the resulting hole shall be cleaned with water to remove dust & debris prior to being infilled with lime mortar ensuring it has been well compacted, and the mortar is colour toned to match the brickwork as best as possible.

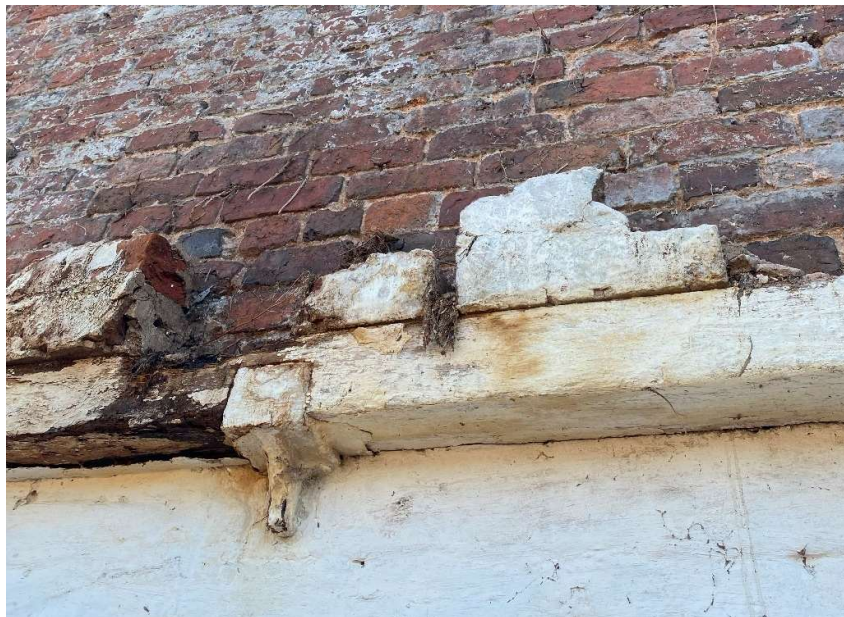
*Plate 5 – Remaining timber and metal bracket to be removed.*

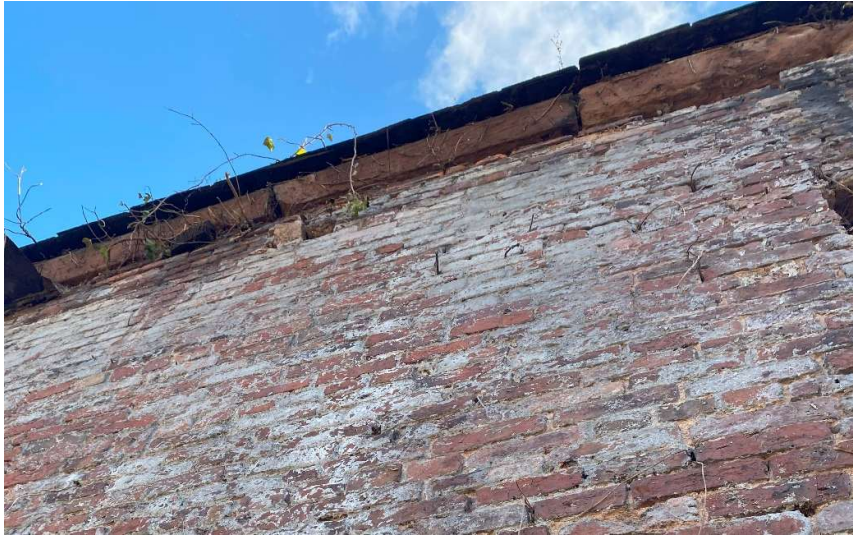
Plate 6 – Red stone blocks to be re-bed to the northwest rear elevation.

- 3.18 Whilst the roof is stripped, the red sandstone gutter blocks are to be re-set, bed and pointed using the agreed mortar.
- 3.19 The existing stone blocks are to be inspected once the roof is stripped and discussion with the LPA on the rainwater collection system held on site with new guttering and downpipe detail is to be secured by condition.
- 3.20 Cast iron gutting to match the existing is to be reinstated to the southeast courtyard elevation. The guttering shall be carried on brackets as per the existing arrangement.
