**Structural Appraisal**  
**of**  
**Boundary Wall**  
**at**  
**The Orchard, Huyton**

**Alderley Partnerships**

**Ref: B05**

**REV B. July 2025**

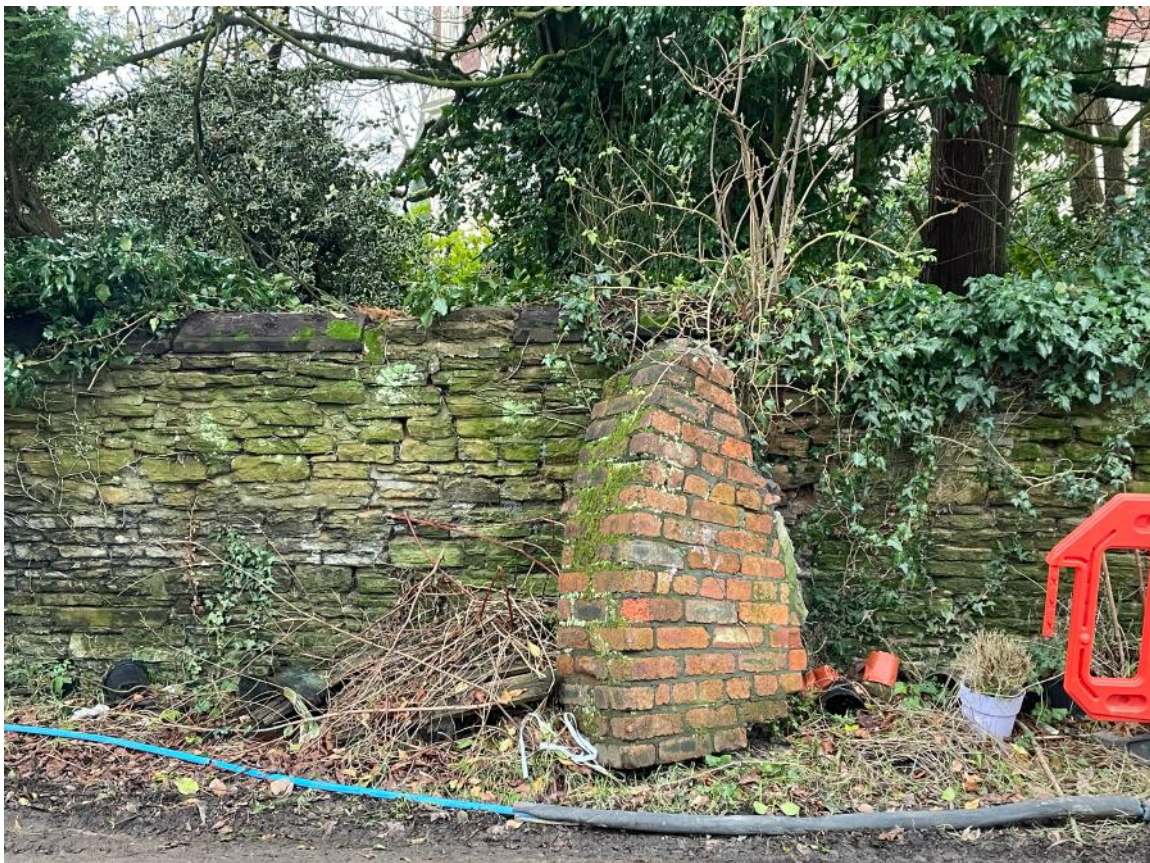
Around 40m of the length of wall under consideration is propped by five brick buttresses, one of which has been knocked over. There are two sections between the buttresses which are leaning outward to an unacceptable degree and additional buttresses are recommended. There are two areas where some local re-building is required, and some of the copings are loose or missing.

Photo 4: North Side of Wall - Broken Buttress

2. Remove fallen buttress. Construct new buttress on concrete pad footing using the same bricks or new matching bricks and lime mortar.
3. Construct 2 new brick buttresses on concrete pad footings using matching bricks and lime mortar.

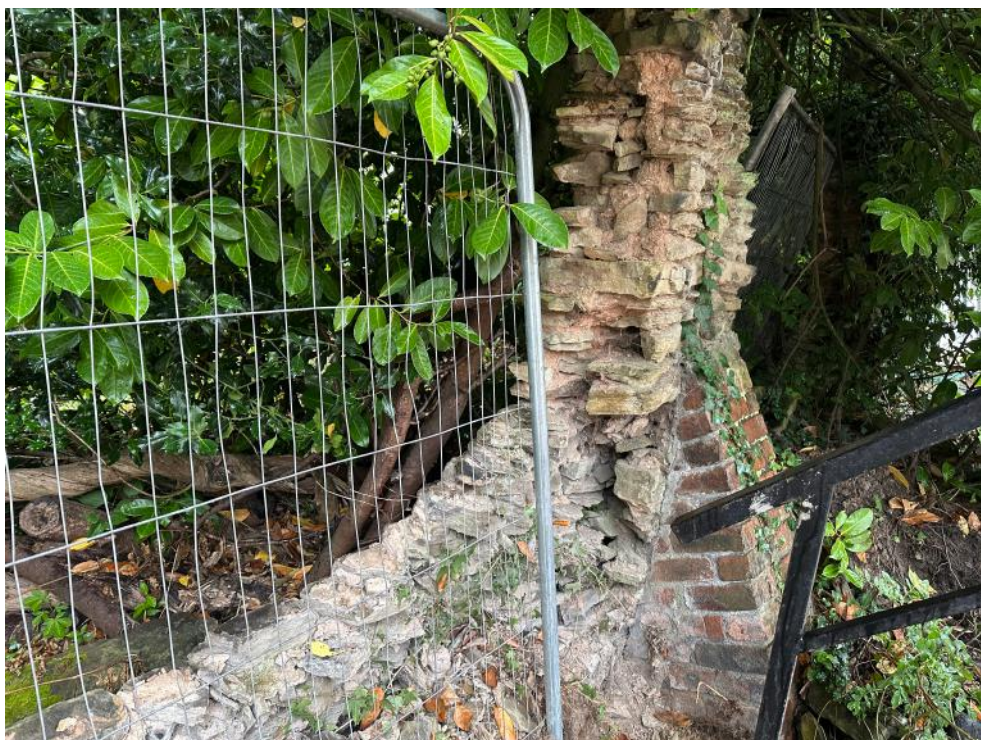
Further on to the south there is 8m section of heightened wall which has collapsed.

Photo 10: Collapsed section of High Wall

5. Use lime mortar.
6. Allow 5 linear metres of new coping stones bedded in lime mortar. Stones to be hand finished without any sawmarks visible.
7. Allow 3 square metres of patch repairs and making good.
8. Rebuild 8 linear metres of wall where fallen down, to a height of 2.5 metres. Provide make-up matching stone. Use lime mortar.

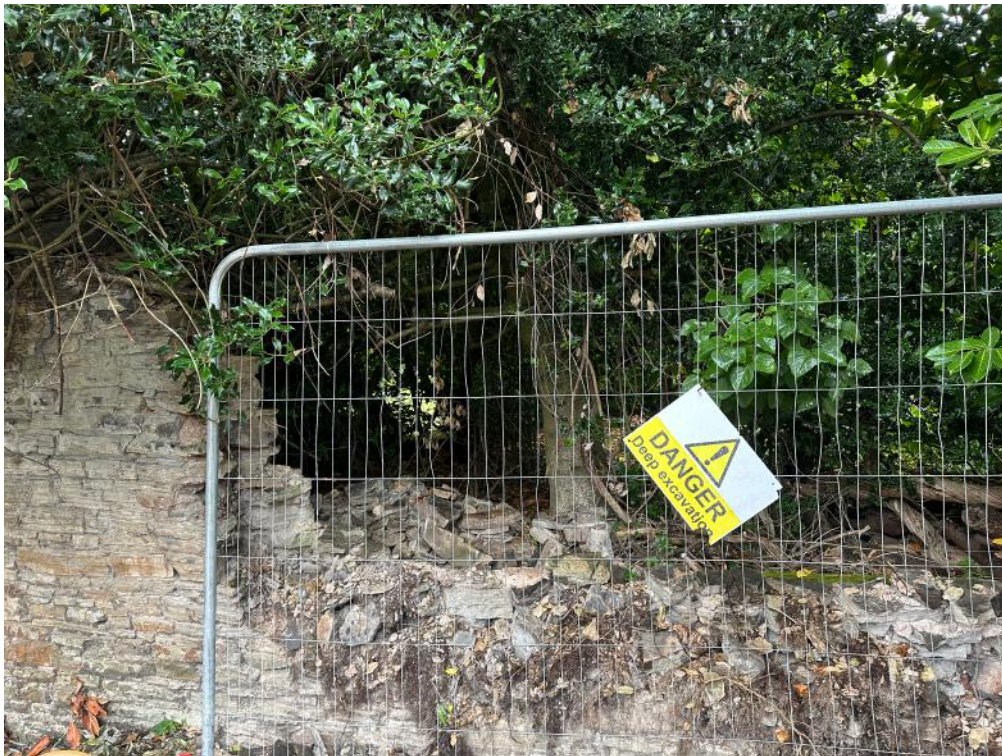
Photo 11: Collapsed section of high wall
