## Demolition Survey (with MA only)

Halewood  
Speke Boulevard  
Liverpool  
L24 9BJ

| Job Number: | J015295 | | |

Demolition Survey Traffic Office -Client to supply MEWP -Building to be fully isolated by the client.

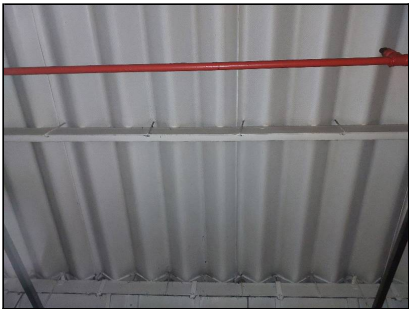
| Item No. | Location | Description | Approx Extent of Material | Sample reference | Asbestos Type | Product Type | Damage / Deterioration | Surface Treatment | MRA | Recommendations |
|---|---|---|---|---|---|---|---|---|---|---|
| 3 | Traffic Office / Ground Floor / storage area (G/02) | cement | 25m <sup>2</sup> | KC000904 | Chrysotile (1) | Asbestos Cement (1) | Good Condition (0) | Sealed (0) | 2 | Remove/manage |

| | 3 | Gregory Zander | Demolition Survey | Ground Floor | Chrysotile (1) |

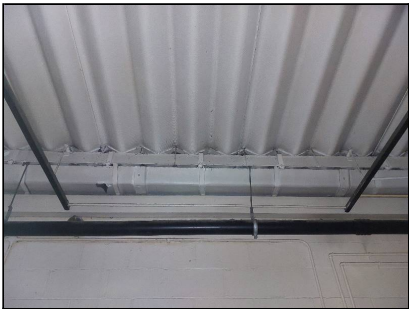
| Item No. | Location | Description | Approx Extent of Material | Sample reference | Asbestos Type | Product Type | Damage / Deterioration | Surface Treatment | MRA | Recommendations |
|---|---|---|---|---|---|---|---|---|---|---|
| 4 | Traffic Office / Ground Floor / storage area (G/02) | cement | 5lm | KC000905 | Chrysotile (1) | Asbestos Cement (1) | Good Condition (0) | Sealed (0) | 2 | Remove/manage |

| | 4 | Gregory Zander | Demolition Survey | Ground Floor | Chrysotile (1) |

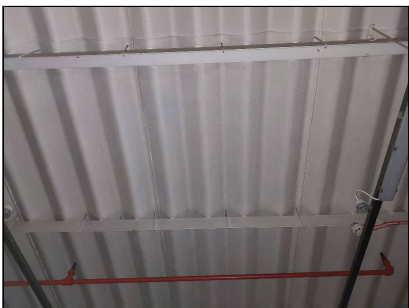
| Item No. | Location | Description | Approx Extent of Material | Sample reference | Asbestos Type | Product Type | Damage / Deterioration | Surface Treatment | MRA | Recommendations |
|---|---|---|---|---|---|---|---|---|---|---|
| 6 | Traffic Office / Ground Floor / garage (G/03) | cement | 25m <sup>2</sup> | As KC000904 | Chrysotile (1) | Asbestos Cement (1) | Good Condition (0) | Sealed (0) | 2 | Remove/manage |

| | 6 | Gregory Zander | Demolition Survey | Ground Floor | Chrysotile (1) |

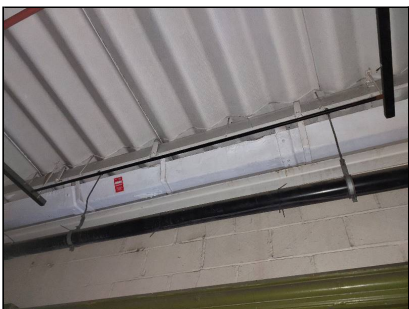
| Item No. | Location | Description | Approx Extent of Material | Sample reference | Asbestos Type | Product Type | Damage / Deterioration | Surface Treatment | MRA | Recommendations |
|---|---|---|---|---|---|---|---|---|---|---|
| 7 | Traffic Office / Ground Floor / garage (G/03) | cement | 5lm | As KC000905 | Chrysotile (1) | Asbestos Cement (1) | Good Condition (0) | Sealed (0) | 2 | Remove/manage |

| | 7 | Gregory Zander | Demolition Survey | Ground Floor | Chrysotile (1) |

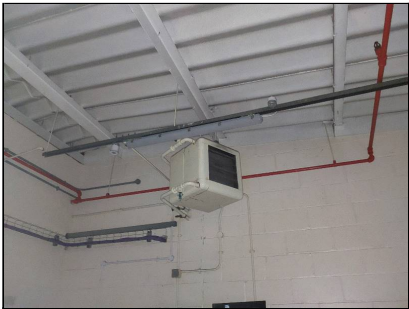
| | 9 | Gregory Zander | Demolition Survey | Ground Floor | N/A |
| Surveyor comments | | no safe access | | | |

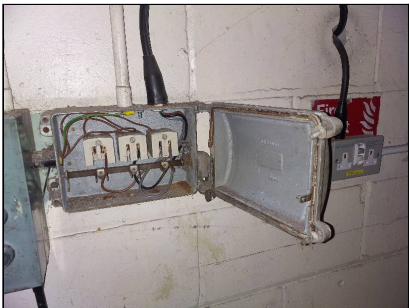
| Item No. | Location | Description | Approx Extent of Material | Sample reference | Asbestos Type | Product Type | Damage / Deterioration | Surface Treatment | MRA | Recommendations |
|---|---|---|---|---|---|---|---|---|---|---|
| 10 | Traffic Office / Ground Floor / garage (G/03) | mastic seal | 0.5lm | KC000907 | Chrysotile (1) | Mastic/Putty (1) | Low Damage (1) | Sealed (0) | 3 | Remove/manage |

| | 10 | Gregory Zander | Demolition Survey | Ground Floor | Chrysotile (1) |

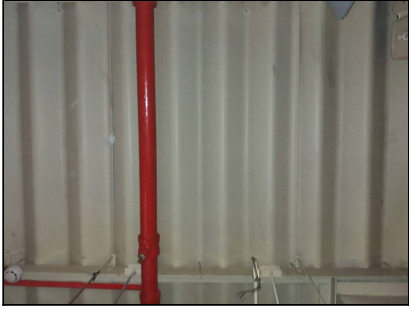
| Item No. | Location | Description | Approx Extent of Material | Sample reference | Asbestos Type | Product Type | Damage / Deterioration | Surface Treatment | MRA | Recommendations |
|---|---|---|---|---|---|---|---|---|---|---|
| 11 | Traffic Office / Ground Floor / boiler room (G/04) | cement | 20m <sup>2</sup> | As KC000904 | Chrysotile (1) | Asbestos Cement (1) | Good Condition (0) | Sealed (0) | 2 | Remove/manage |

| | 11 | Gregory Zander | Demolition Survey | Ground Floor | Chrysotile (1) |

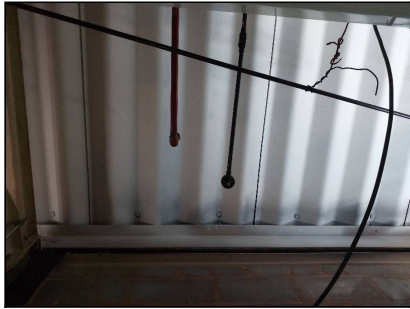
| | 17 | Gregory Zander | Demolition Survey | Ground Floor | Chrysotile (1) |

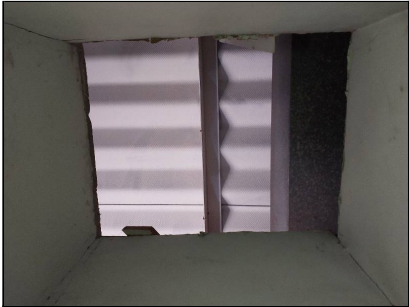
| | 18 | Gregory Zander | Demolition Survey | Ground Floor | Chrysotile (1) |

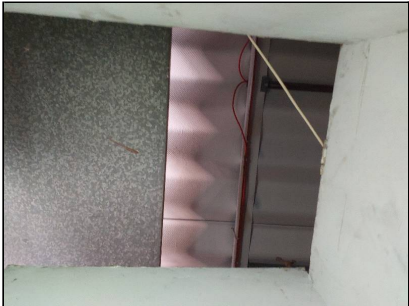
| | 19 | Gregory Zander | Demolition Survey | Ground Floor | Chrysotile (1) |

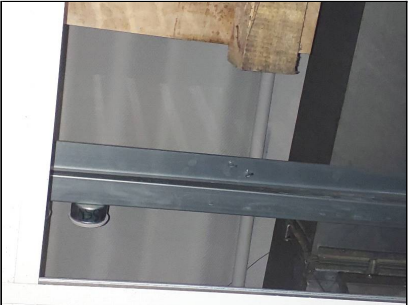
| | Item No: | Lead Surveyor | Survey Type | Floor | Analysis |
|---|---|---|---|---|---|
| | 20 | Gregory Zander | Demolition Survey | Ground Floor | Chrysotile (1) |

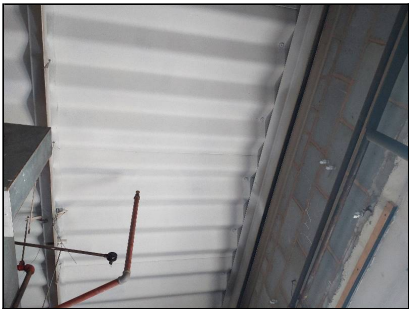
| | 23 | Gregory Zander | Demolition Survey | Ground Floor | Chrysotile (1) |

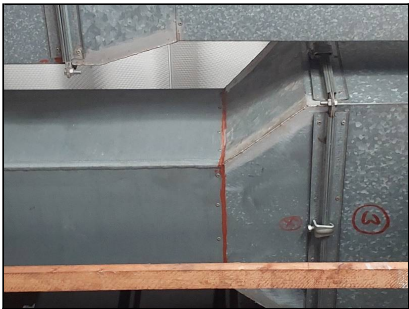
| | 24 | Gregory Zander | Demolition Survey | Ground Floor | Chrysotile (1) |

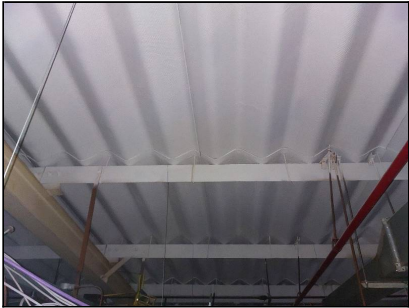
| | 36 | Gregory Zander | Demolition Survey | Roof Void | Chrysotile (1) |

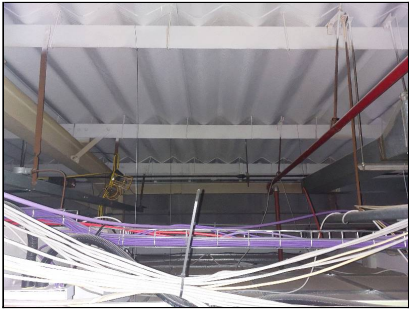
| | Item No: | Lead Surveyor | Survey Type | Floor | Analysis |
|---|---|---|---|---|---|
| | 37 | Gregory Zander | Demolition Survey | Roof Void | Chrysotile (1) |

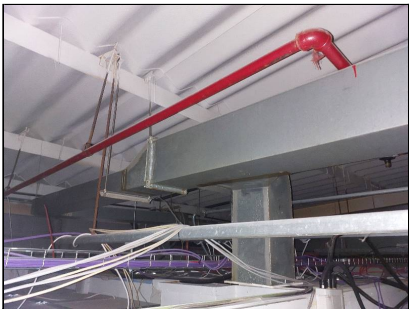
| | Item No: | Lead Surveyor | Survey Type | Floor | Analysis |
|---|---|---|---|---|---|
| | 39 | Gregory Zander | Demolition Survey | Roof Void | Chrysotile (1) |

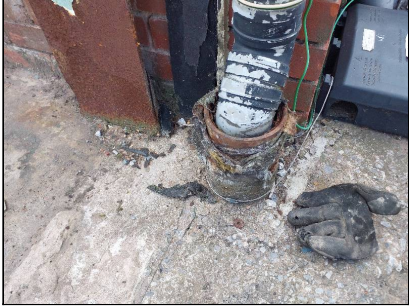
| | Item No: | Lead Surveyor | Survey Type | Floor | Analysis |
|---|---|---|---|---|---|
| | 44 | Gregory Zander | Demolition Survey | External | Chrysotile (1) |

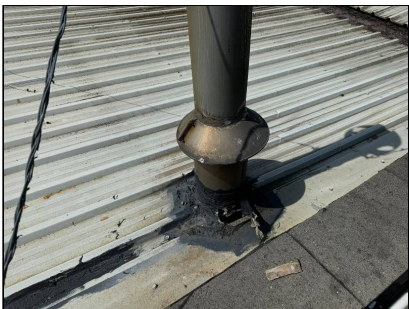
| | Item No: | Lead Surveyor | Survey Type | Floor | Analysis |
|---|---|---|---|---|---|
| | 49 | Gregory Zander | Demolition Survey | External | Chrysotile (1) |
