### **'WOODLANDS, LODGE LANE, CRONTON, WIDNES'**

### **PROTECTED SPECIES SURVEY STATEMENT**

**"Woodlands, Lodge Lane., Cronton, Widnes, WA8 4QB"**

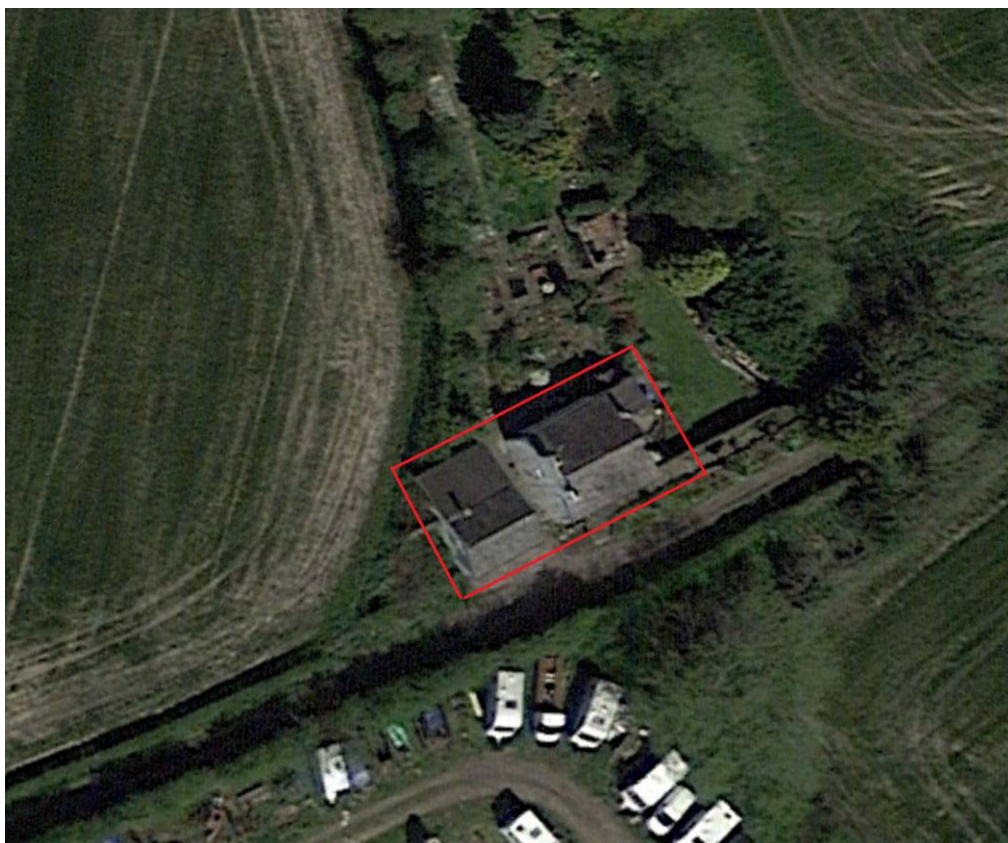
**Figure 1:** Aerial view of site. *Note: The surveyed buildings are identified by red boxing. The residential structure is to the right and the detached workshop to the left.*

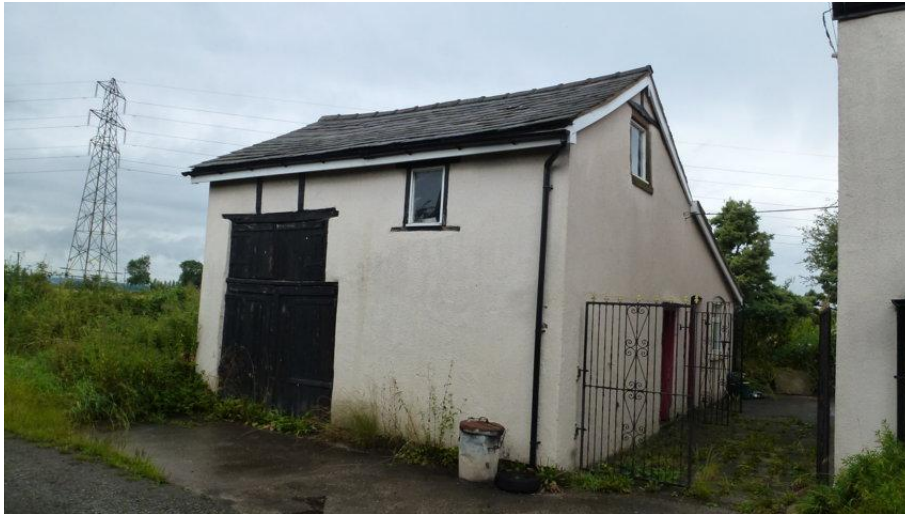
**Photograph H:** View of south and east facing frontages to detached workshop/garage structure.

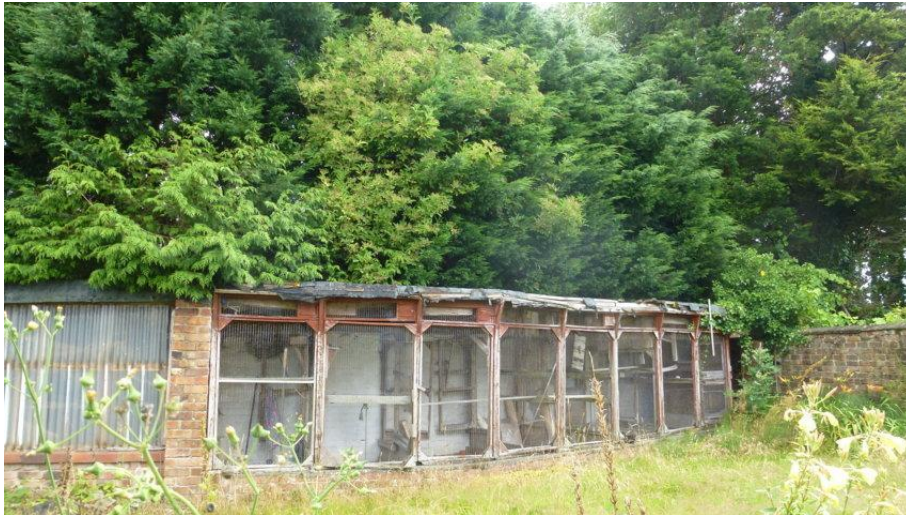
**Photograph N:** View of garden and abandoned kennels to east of residential building.

*Note: The mature trees immediately beyond the site boundary. The trees were assessed to have low bat roost potential and moderate breeding bird potential. As the trees are over 8m from the nearest frontage of the residential building, the risk to wildlife which may be associated with the trees is assessed as negligible.*

Mature trees located just beyond the eastern site boundary (**Photograph N**) were provisionally assessed to have 'Low' potential to support roosting bats, however the trees are over 8m away from the buildings and the risk of harmful disturbance is assessed as negligible. The trees within and around the site can however be expected to attract foraging bats.

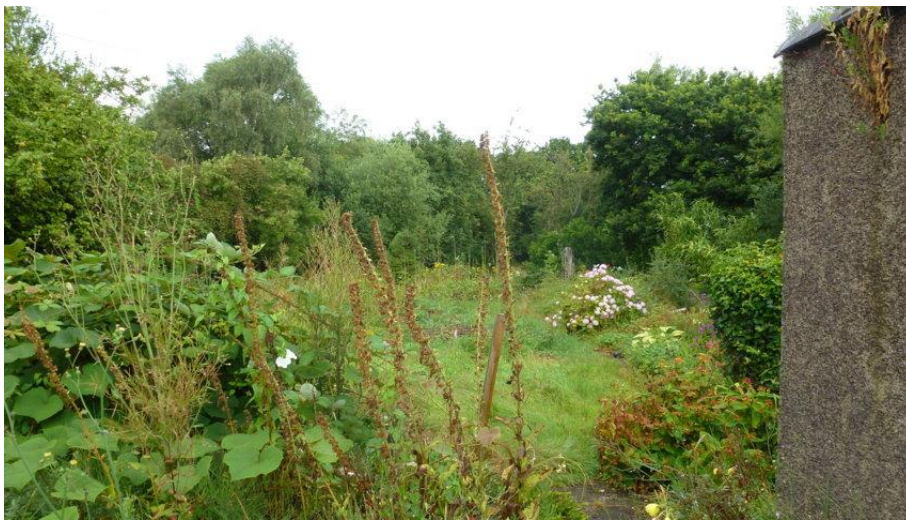
**Photograph Q: View of large rear garden to residential building.**

*Note: The garden is currently unmanaged; however amenity grassland remains dominant with scrubs and trees to the site boundaries.*

The rear garden area with its numerous trees and small stands of scrub (Photograph O) can be expected to offer opportunities to a range of common passerine bird species for breeding, refuge & foraging. A targeted breeding bird survey was not completed, however the shrubs and trees are all more than 10m away and therefore the risk to breeding birds from the proposed demolition works is assessed as negligible.

If however wider site vegetation clearance is proposed then a breeding birds survey is recommended and should be completed by a suitably qualified person in advance of commencement of works.
