Heritage Design and Access Statement

Wayside

Pex Hill

Cronton

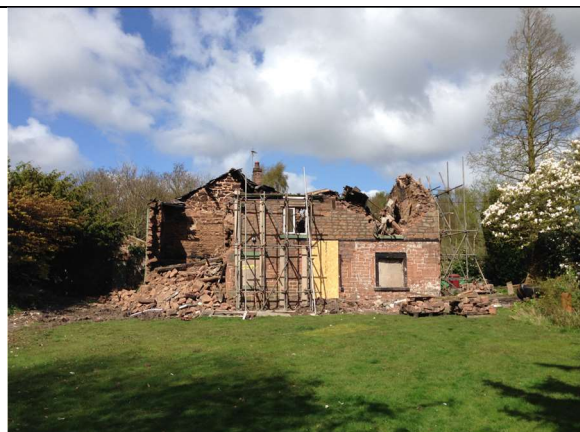
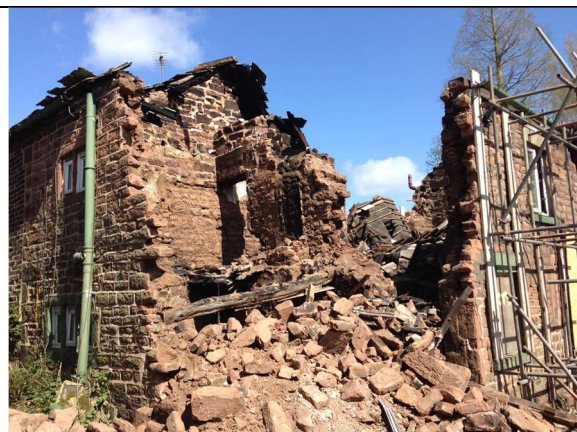
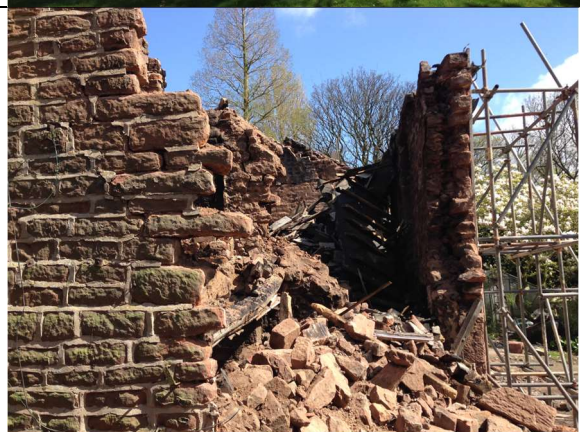
Photos showing the condition of the property following the fire in 2014.

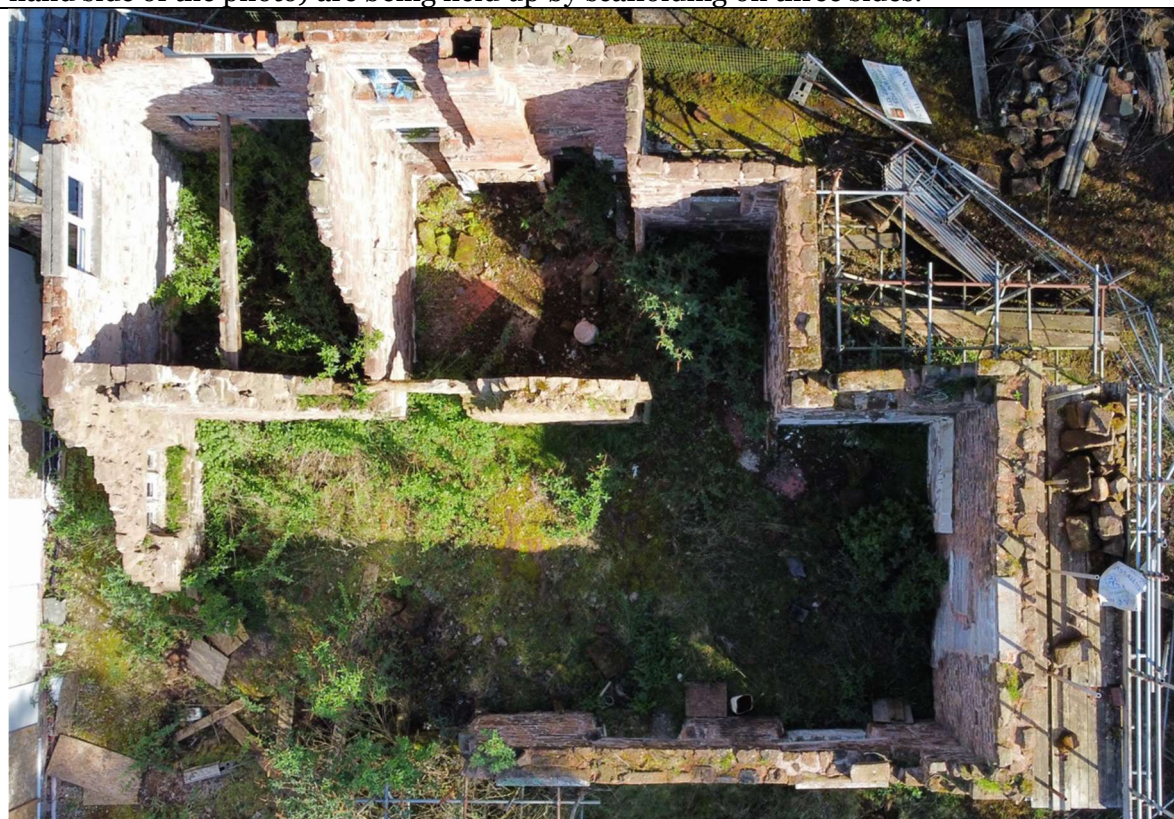
Overhead photo of the original (ruin) Wayside. Note that the eastern elevations (right-hand side of the photo) are being held up by scaffolding on three sides.

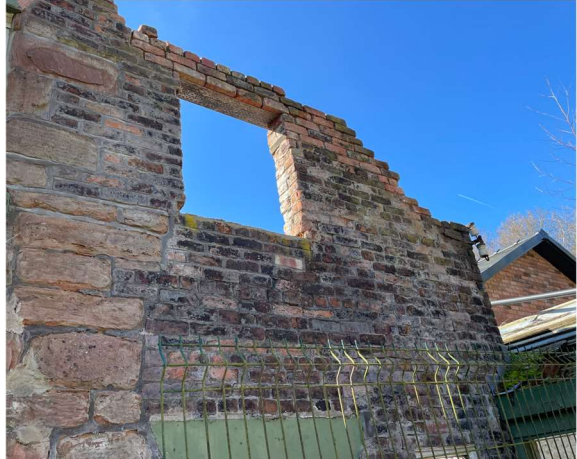
| <p>North elevation – the western end of the north elevation has been previously rebuilt after a fire. This was constructed to a poor standard, in part reclaimed brickwork with modern structural elements.</p> | |

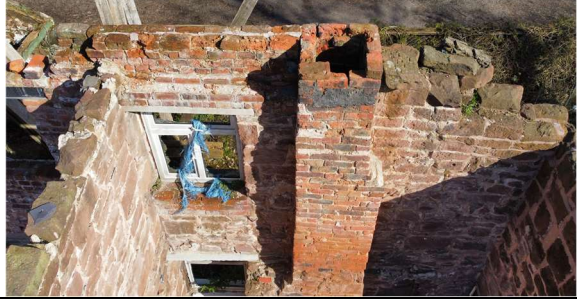
| <p>Example photo of the condition of the wallheads.</p> <p>Note the modern uPVC window frames.</p> | |

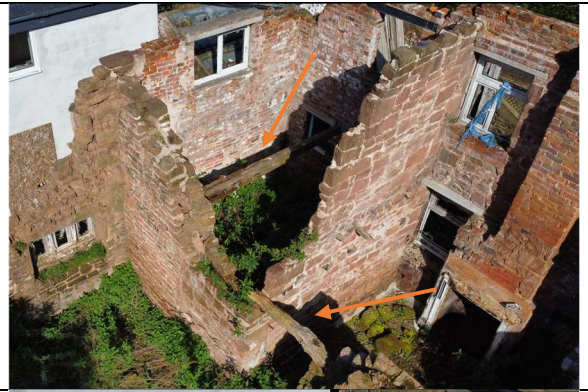
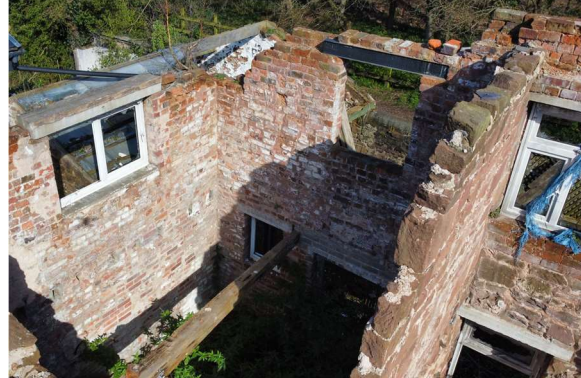
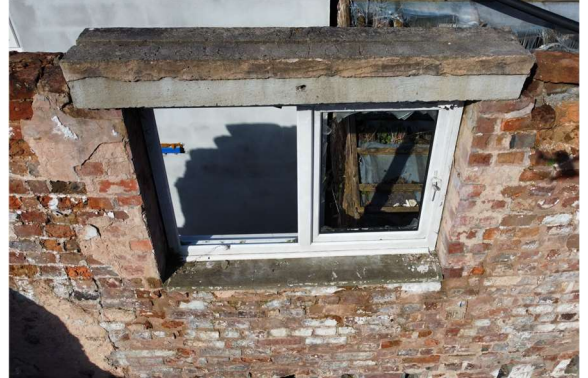
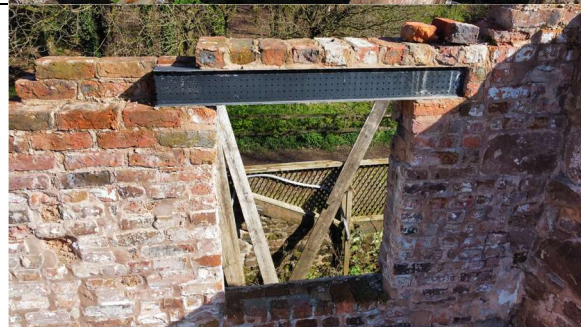
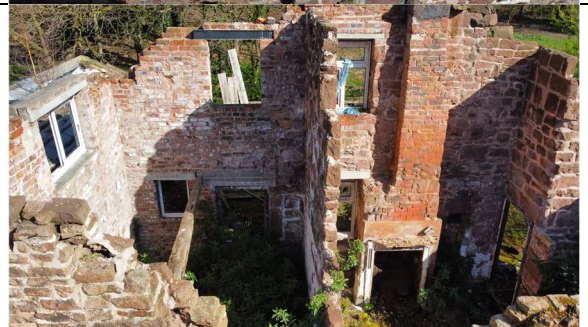
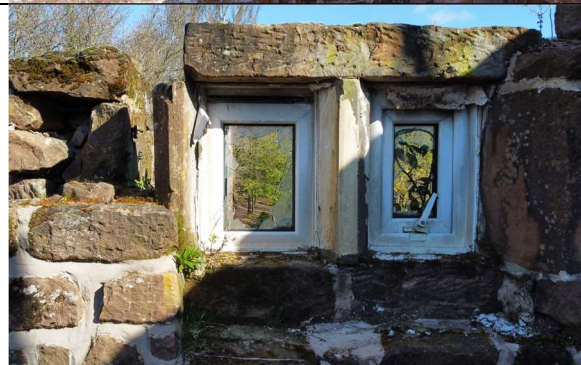
View of the northern and western elevations.

Two of the three remaining structural timbers are shown with the orange arrows.

Note the modern uPVC window frames, concrete lintels and RSJ's.

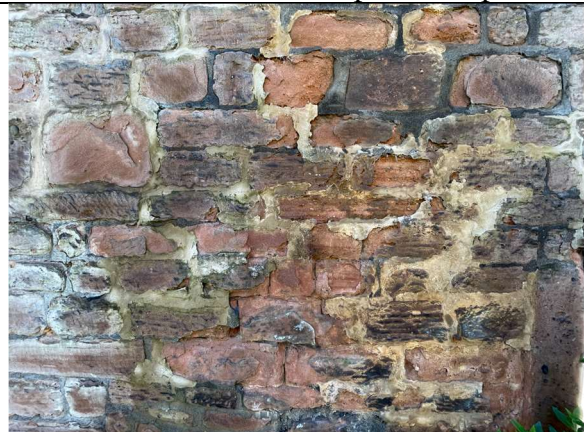
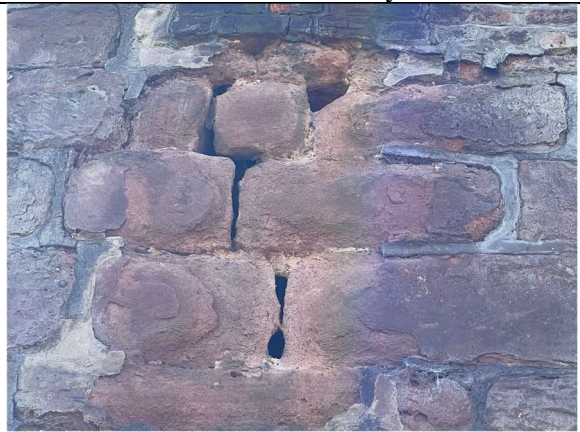
North elevation – an example of the poor condition of the stone and masonry.

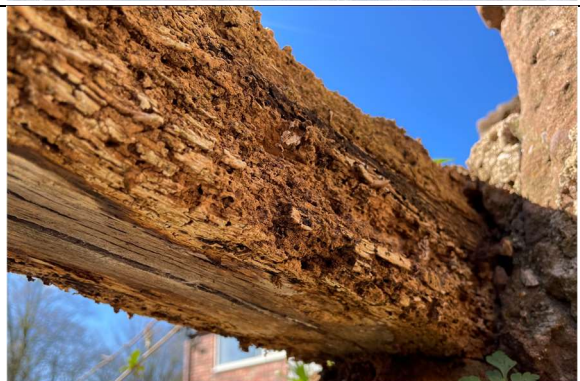
Example photo of the decay of one of the three remaining 'original' timbers.

This timber is not suitable for re-use as a structural element of the building.

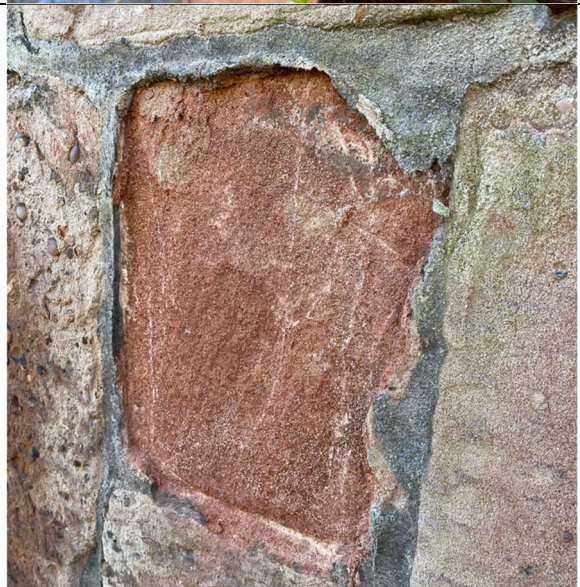
Example of cementitious mortars accelerating the decay of the soft local red sandstone.

Where the stones are damaged (many of the stones), they would need to be de-frassed/re-faced before they would be suitable for re-use.

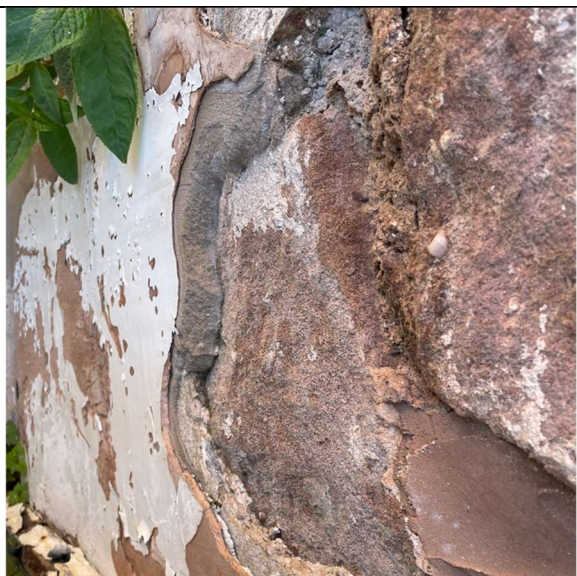
Example photo of the original red sandstone with a cementitious render coat, and plastic-based paint, which has then had a gypsum-based skim and further coat of plastic-based paint.

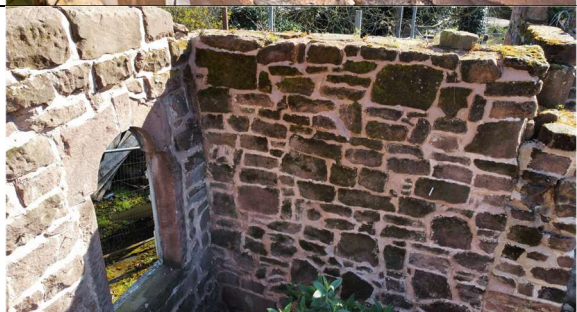
Northeast elevation - example photo of works that have been undertaken with inappropriate materials in an inappropriate style.

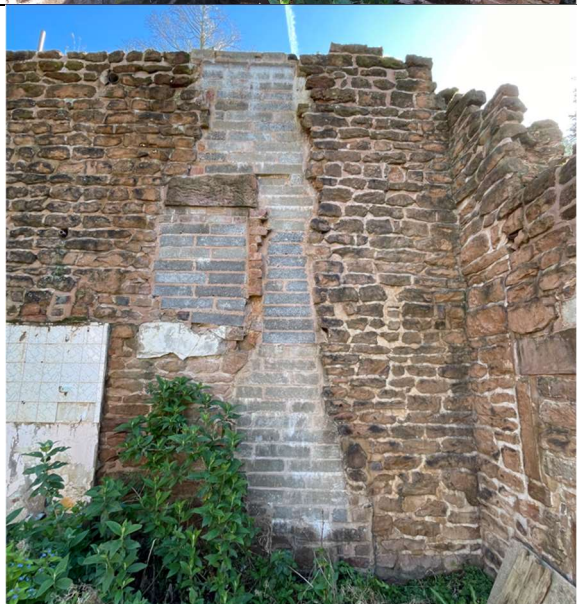
East elevation – blockwork has been inserted in the redundant chimney flue in an effort to provide some stability to this elevation, which is presently held up with an engineered scaffold (on the other side of this wall).

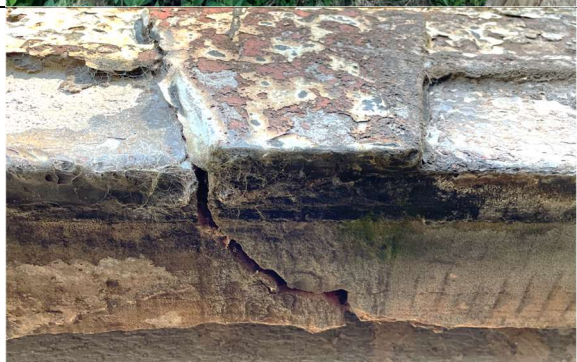
Example of a cracked lintel on the south elevation.

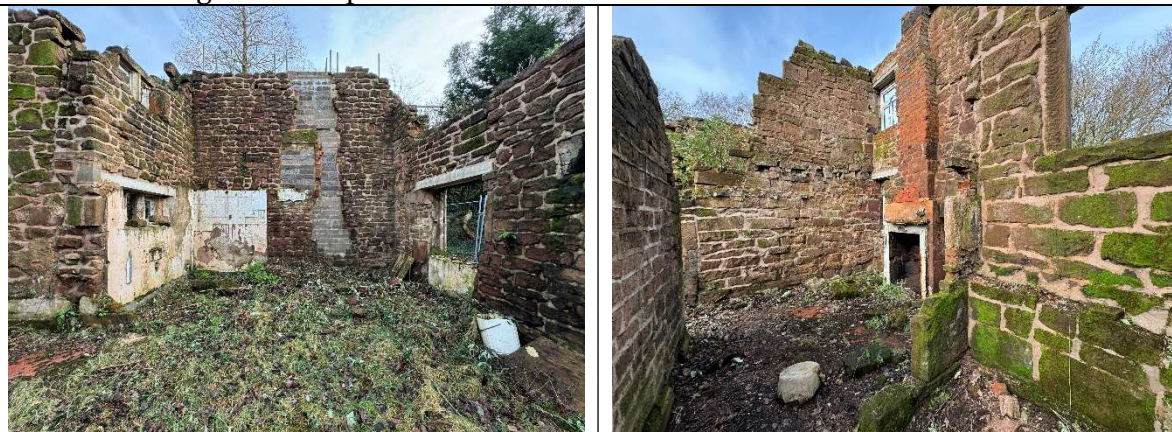
Photos of the general condition of the interior of the structure, February 2024. These photos were taken at the site meeting with Historic England and two representatives from the Local Planning Authority.

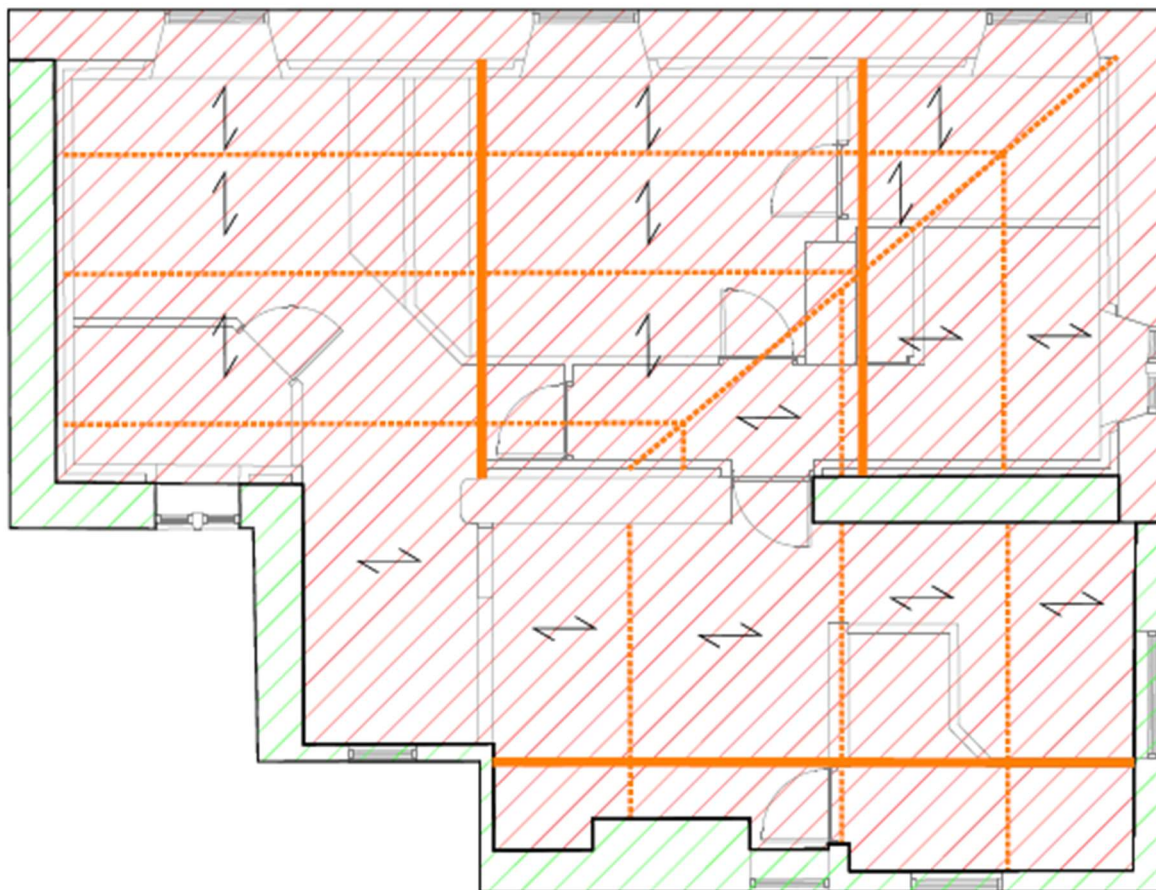
Below is the first-floor plan that ADS Structures have prepared, detailing their opinion on the recommended course of action for the remaining walls. The red hatching represents areas that have collapsed, and the green hatching represents areas that require taking down. The orange lines represent the former roof structure (now no longer present following the fires).

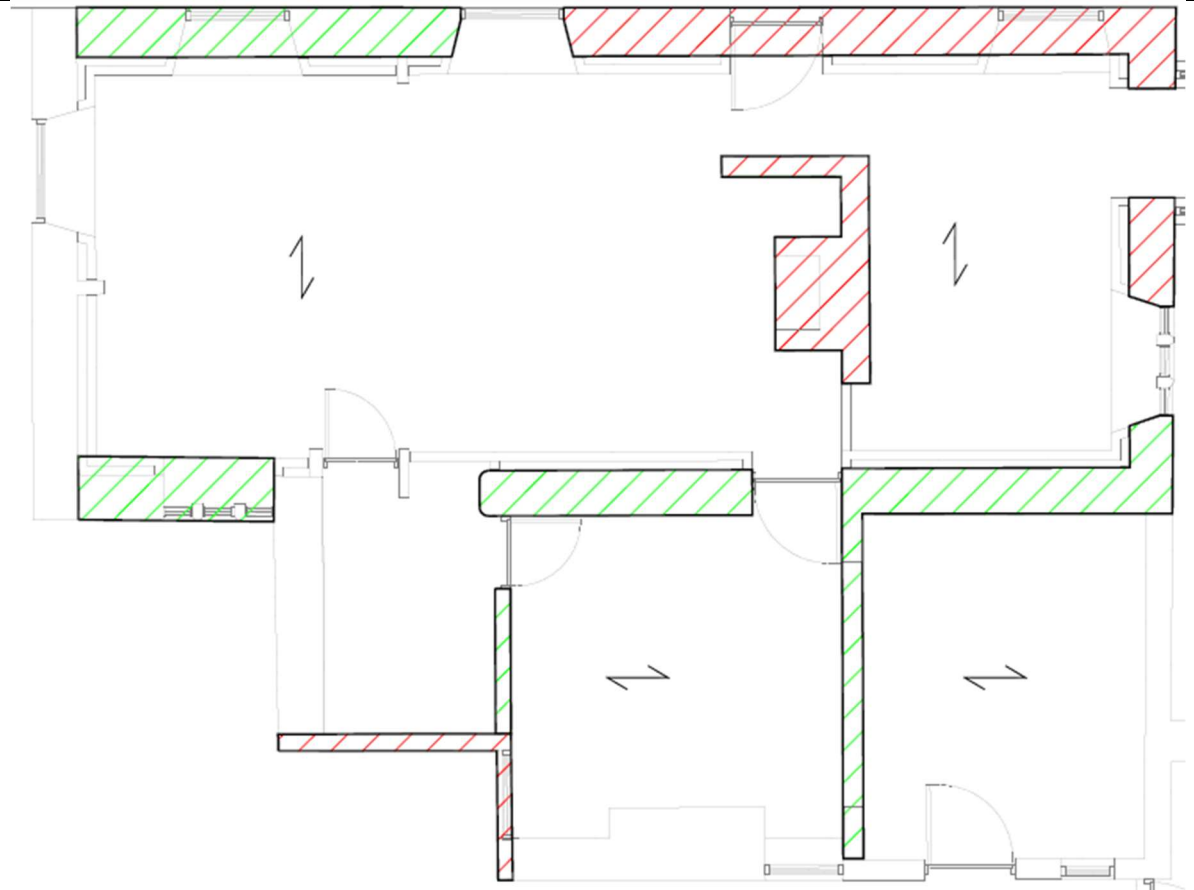
Below is the ground floor plan that ADS Structures have prepared, detailing their opinion on the recommended course of action for the remaining walls. The red hatching represents areas that have collapsed, and the green hatching represents areas that require taking down.

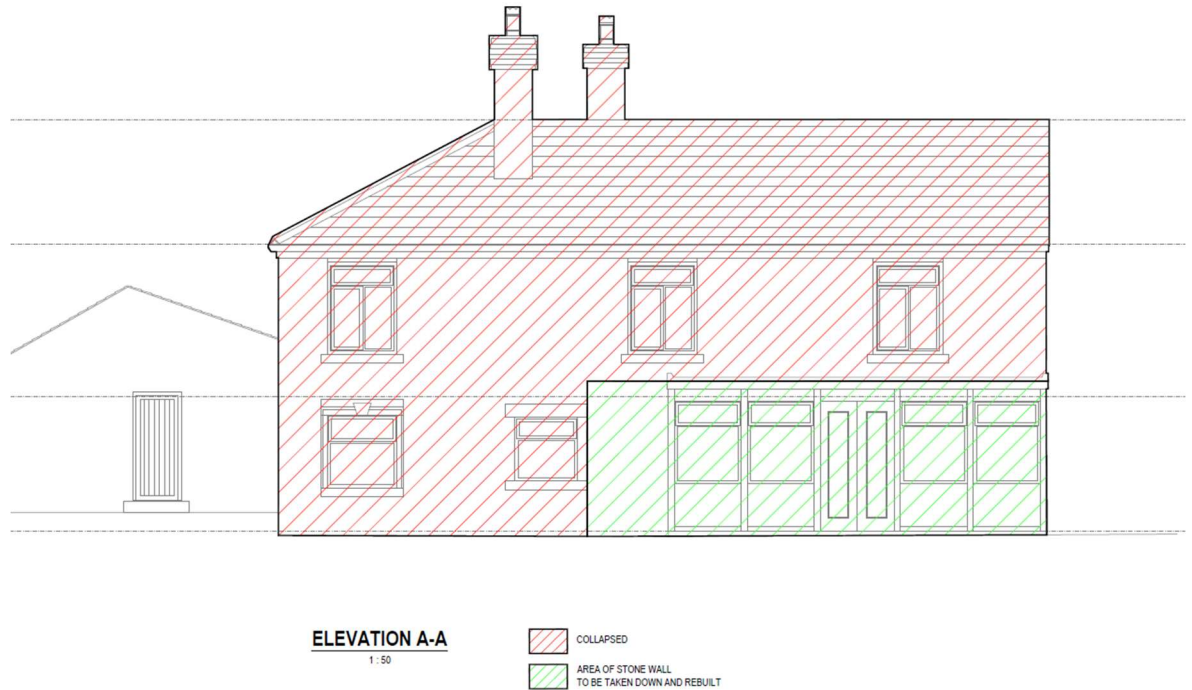
South Elevation

Below are ADS's elevation plans detailing their opinion on the recommended course of action for the remaining walls; the red hatching represents areas that have collapsed, and the green hatching represents areas that require taking down. In the elevation below, the former 'sun room' (hatched green) has already been taken down.

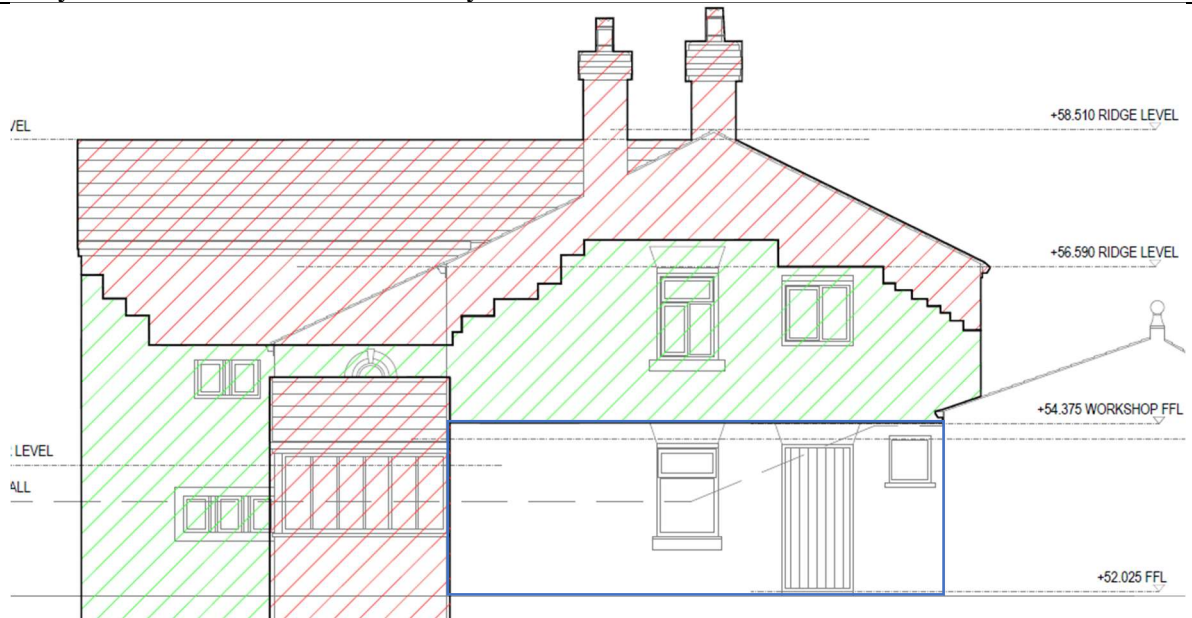
North Elevation

Only the section in the blue box may be suitable for retention.

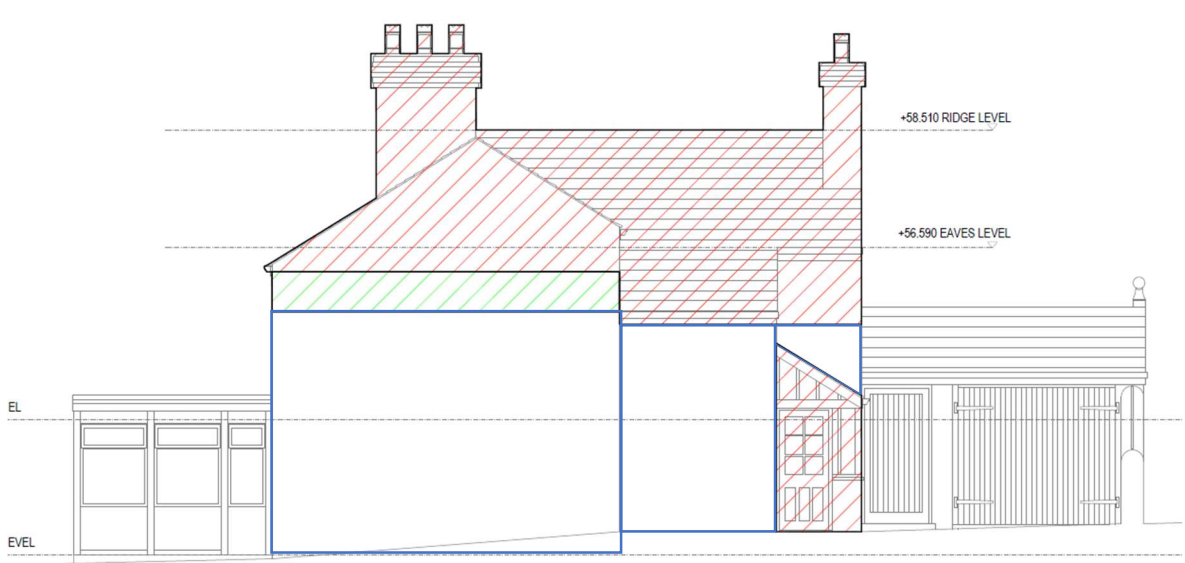
| East Elevation |
|---|
| Only the sections in blue <i>may</i> be suitable for retention. |

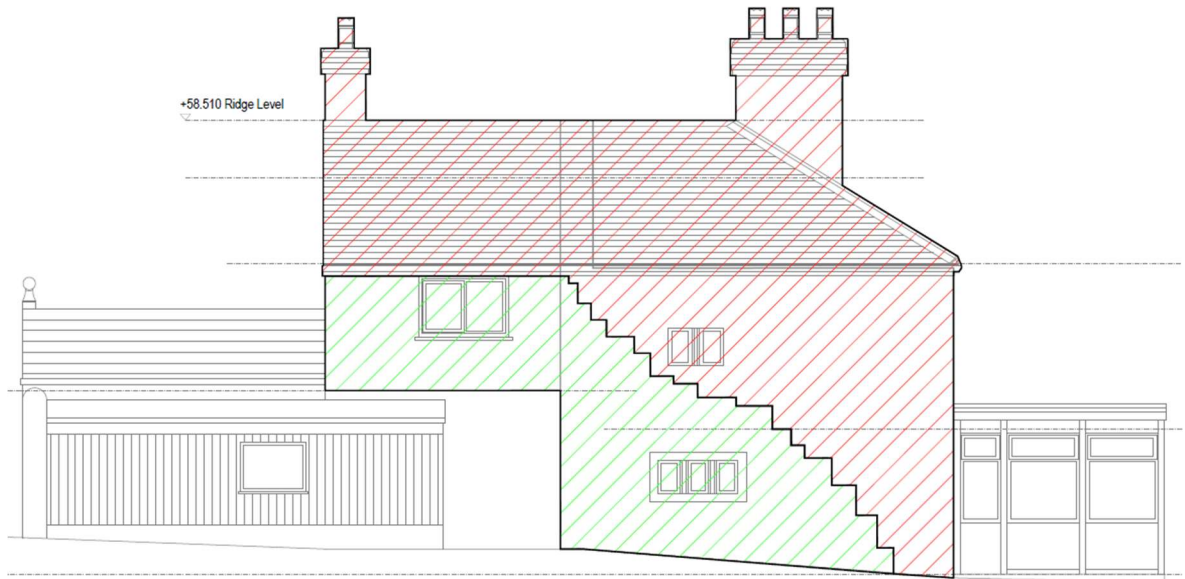
| East Elevation |
|---|
| <p>In summary, the sections that ADS structures have said may not need to be taken down and rebuilt are part of the east elevation (the section currently held up by scaffold and blockwork in the chimney flue) and a small area of the ground floor on the north elevation.</p> <p>ADS have stated that in their experience, it is often necessary to undertake more work as and when the structure is opened up.</p> |

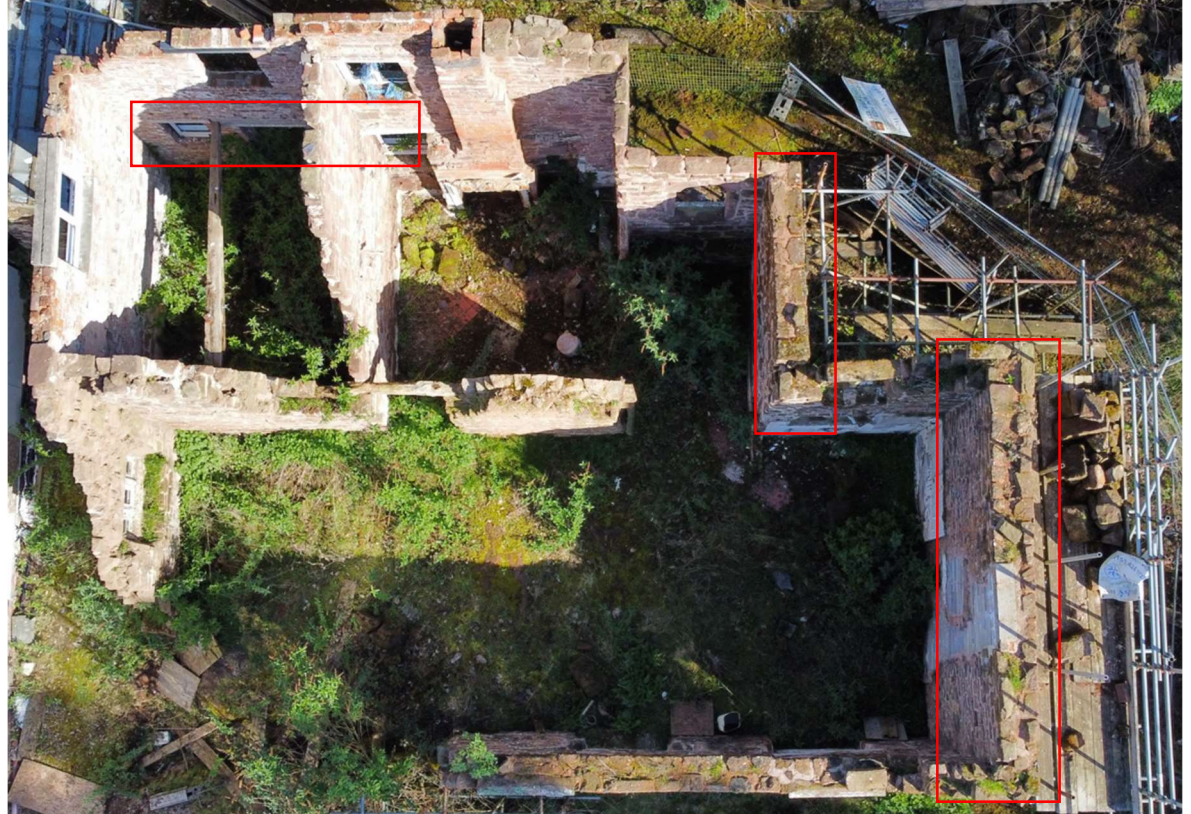
The left-hand box (north of the site) – the section that may be able to be retained is the ground floor section only.

The two sections to the right may be salvageable to between the first and second-floor heights.
