### **'WOODLANDS, LODGE LANE, CRONTON, WIDNES'**

### **PROTECTED SPECIES SURVEY STATEMENT**

**"Woodlands, Lodge Lane., Cronton, Widnes, WA8 4QB"**

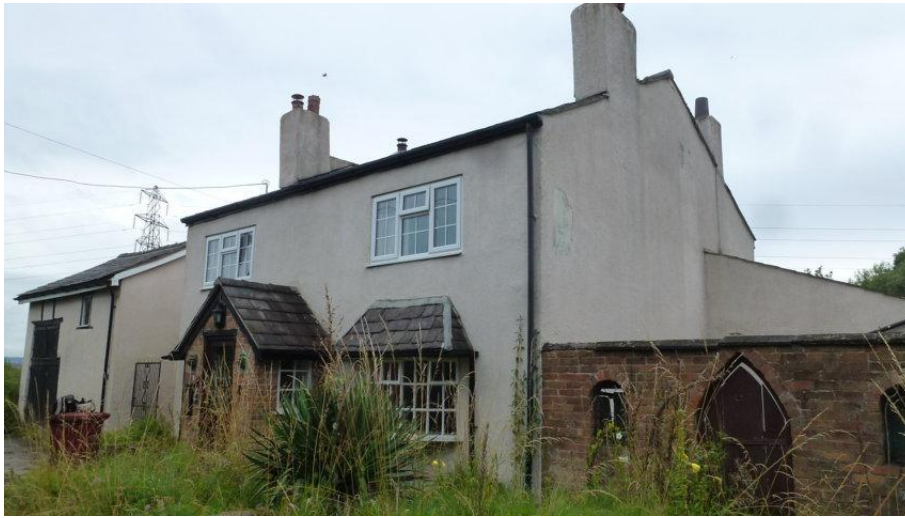
**Photograph A:** General View of front (south facing) and east facing gable end to residential building.

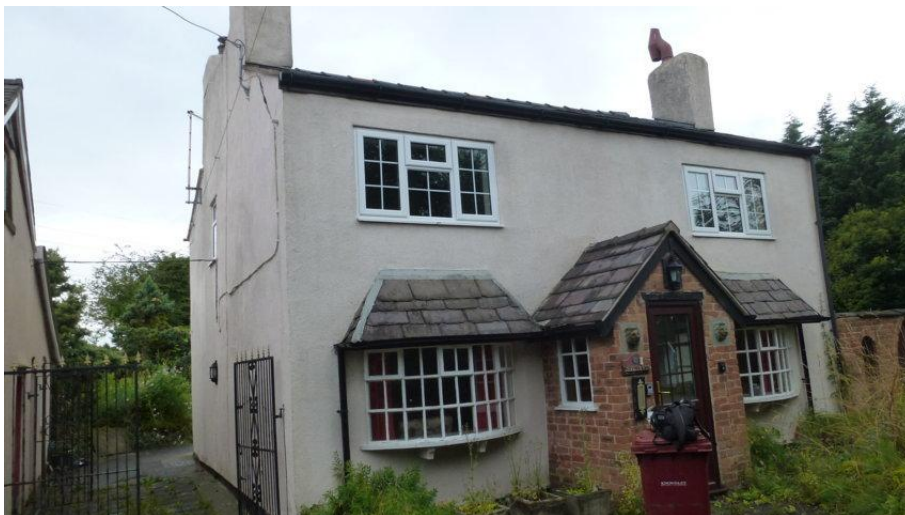
**Photograph B:** General view of frontage and west facing gable end to residential building.

*Note: render coverage of walls is in good condition and well sealed with no apparent access opportunities for bats to gain access. Windows and doors are well sealed.*

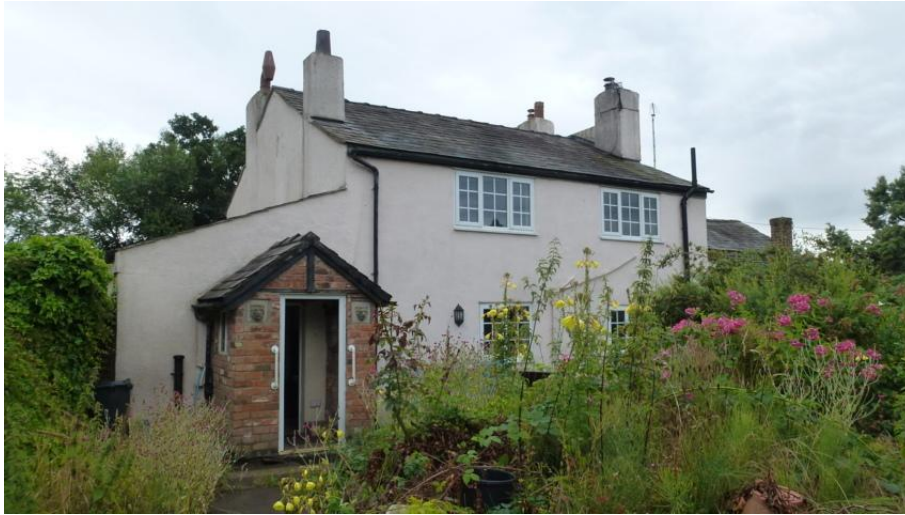
**Photograph C: General view of rear (north facing) frontage to residential building.**

*Note: Single storey extension with sloping slate covered roofing..*

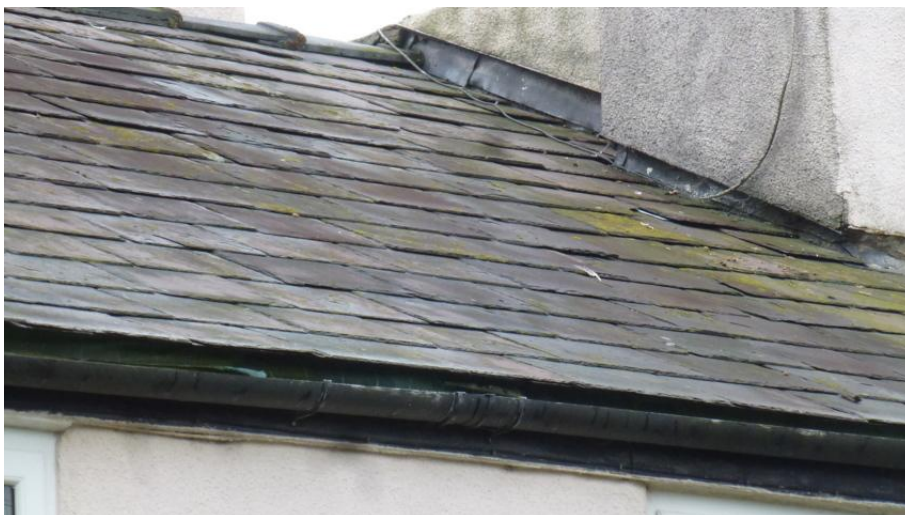
**Photograph D: Sample close up view of slate roofing to residential building.**

*Note: The state roofing is in good general condition, with no significant gapping or missing slates recorded. Ridge tiles are well bedded down, and flashing to base of chimney stacks is well sealed. Timber barge boarding supporting guttering at wall/roof interfaces is in good repair and well sealed.*

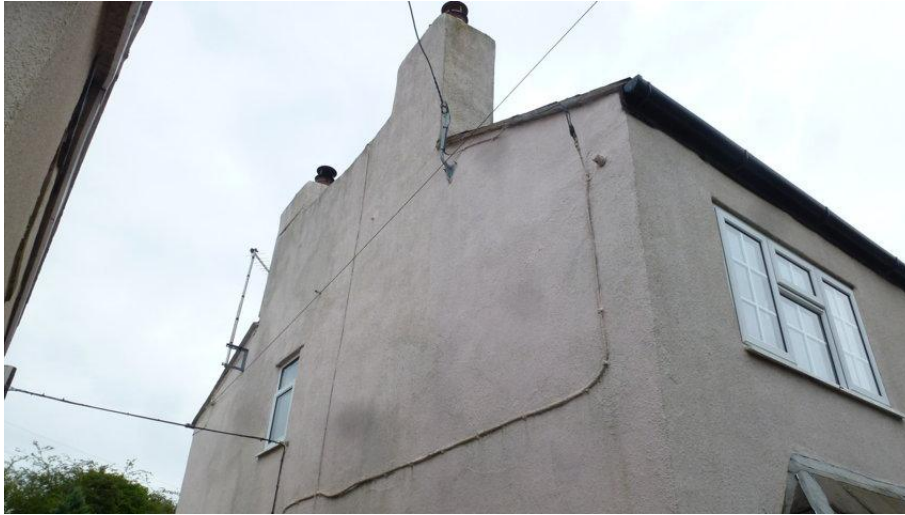
**Photograph E: Close up east facing gable end to residential building.**

*Note: Mortar dry verge seal is in good repair and well sealed. All chimney stacks are in good repair with no access opportunities for bats or birds recorded.*

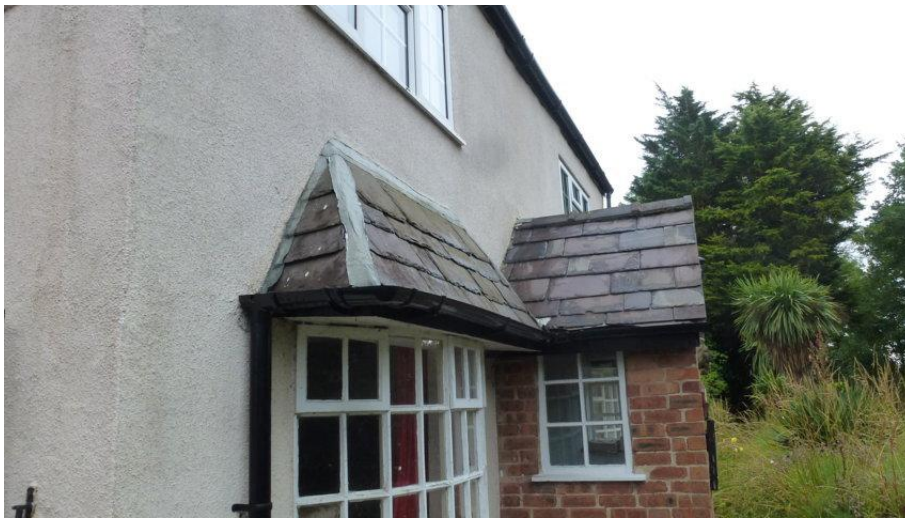
**Photograph F: Close up sample view of slate coverings to windows and front door porch.**

*Note: The states, ridge tiles and flashing are all in good repair and well sealed.*

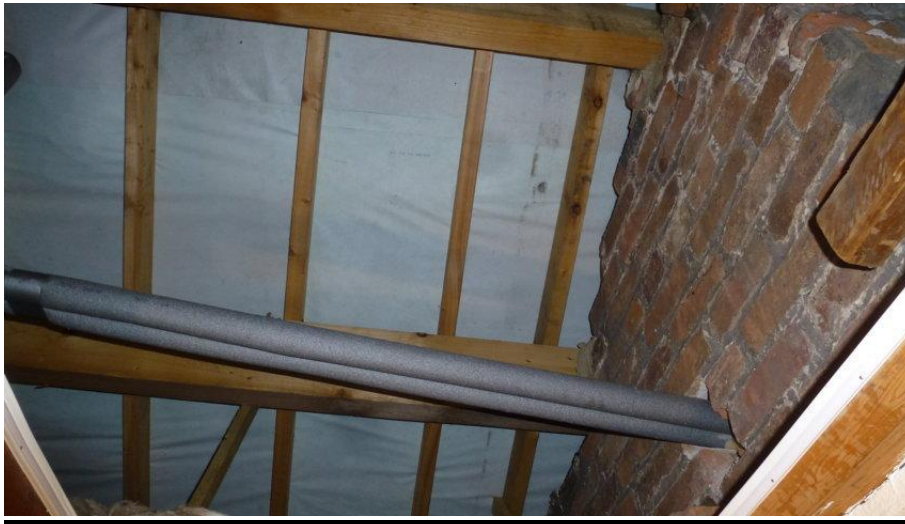
**Photograph G: Sample view of plastic sheet backing to slate roofing, exposed within single roof chamber/loft above residential building.**

*Note: The sheeting is in good repair throughout, with no significant tears or holes recorded. The loft chamber is well sealed to wall/roof interfaces with no access opportunities for bats or birds recorded.*

The plastic sheet backing to the roof slates internally which is good repair and well sealed throughout thus eliminating any direct access opportunities into the loft chamber.

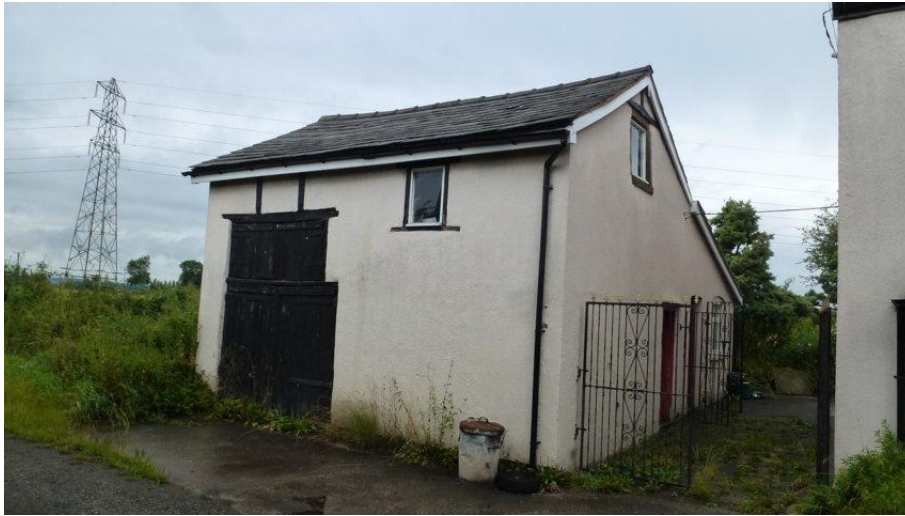
**Photograph H:** View of south and east facing frontages to detached workshop/garage structure.

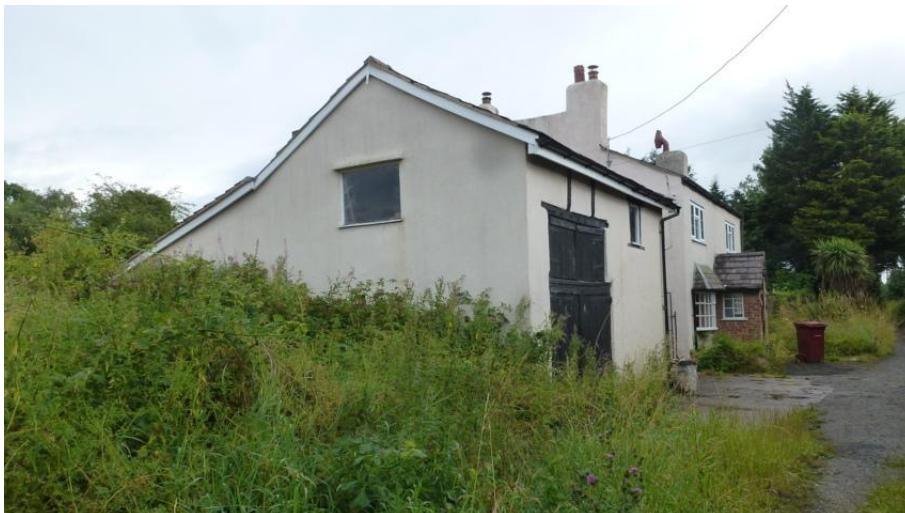
**Photograph I:** View of west facing frontage to workshop structure.

*Note: The structure is two storey to the front with a single storey extension to rear. Slate roofing covers the entire building. The render covering the walls of the structure is in good repair throughout.*

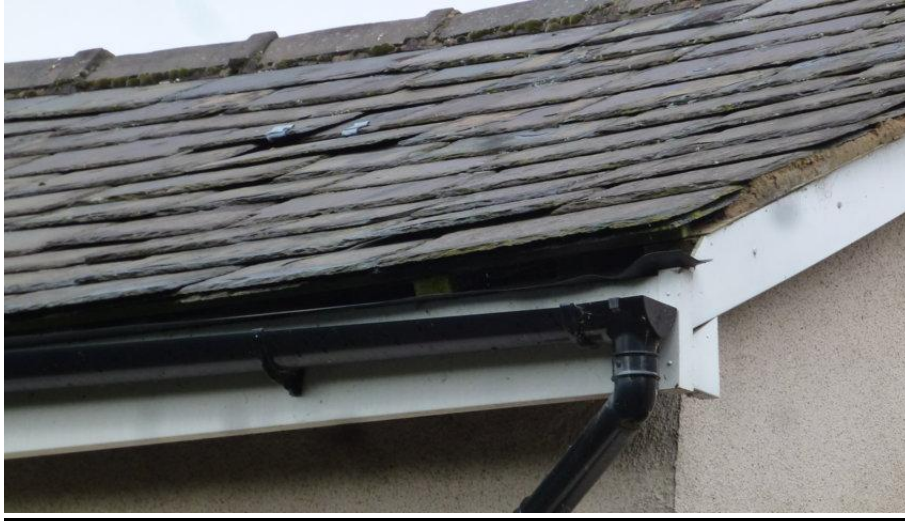
**Photograph J: Sample close up view of roofing to workshop structure.**

*Note: The slate roofing and ridge tiles are generally in good repair and well sealed.*

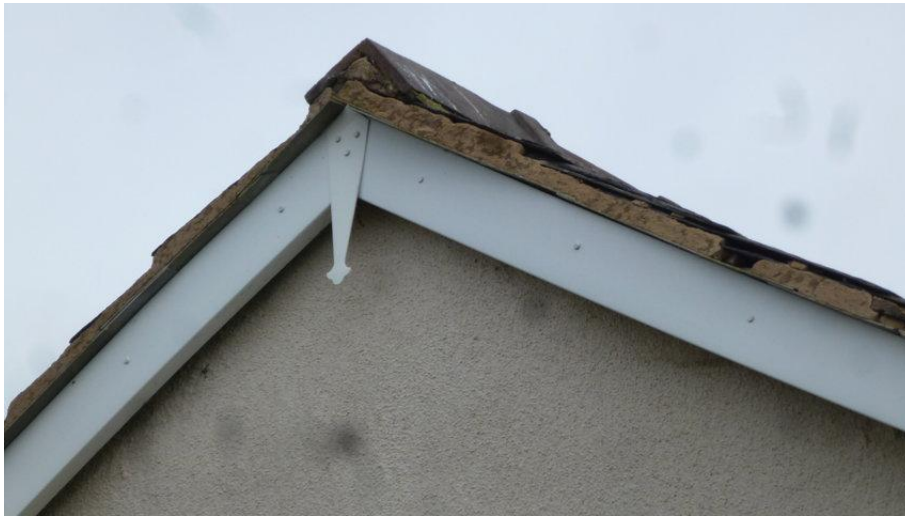
**Photograph K: Sample close up view of west facing gable end apex to workshop structure.**

*Note: uPVC fascia common to both gable ends of the structure is in good repair and well sealed. Minor dry verge mortar loss was recorded, as seen in the image.*

A number of examples of missing mortar to roof verges (Photograph K) did warrant special attention however on close inspection viable opportunities for bat entry were assessed as low and no evidence of bat entry was recorded.

As the risk to bats is assessed as negligible, Phase 2 bat surveys are not considered justified and are not recommended.

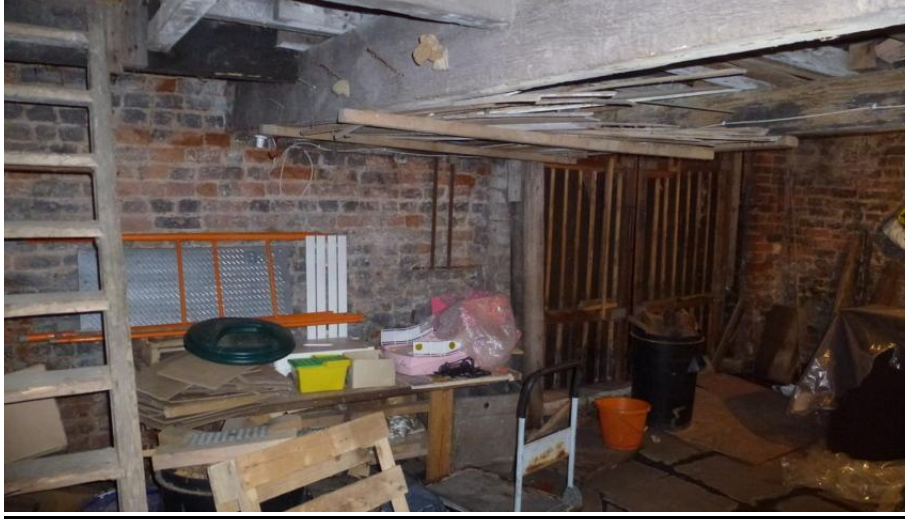
**Photograph L: Internal ground floor view of workshop structure.**

*Note: The workshop chambers are well sealed internally. The steps leading to first floor chamber can be seen to the left of image.*

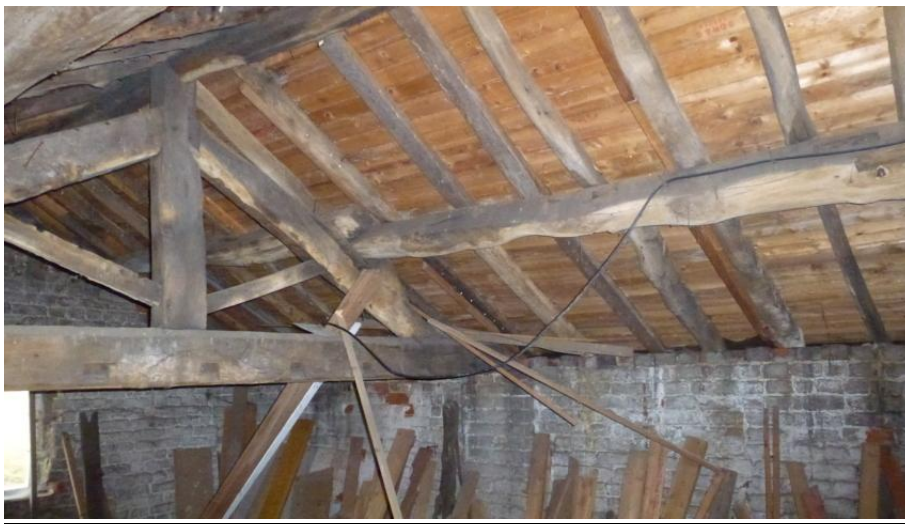
**Photograph M: View of exposed roofing above workshop first floor chamber.**

*Note: The internal timber panelling backing the slate roofing. The roofing is in good repair and no access opportunities for bats or birds were recorded.*

The slate roofing is backed internally with wood panelling (Photograph M) which is well sealed, and no opening in the roofing or at roof/wall interfaces were recorded

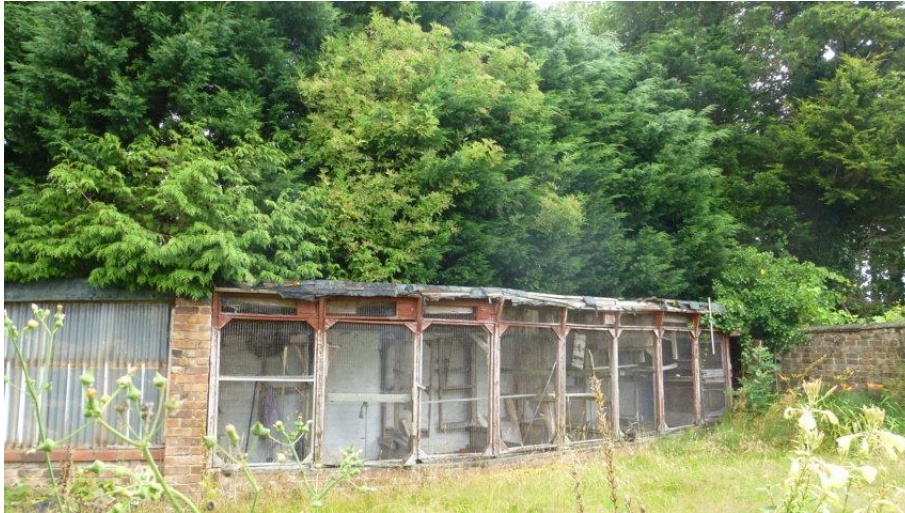
**Photograph N: View of garden and abandoned kennels to east of residential building.**

*Note: The mature trees immediately beyond the site boundary. The trees were assessed to have low bat roost potential and moderate breeding bird potential. As the trees are over 8m from the nearest frontage of the residential building, the risk to wildlife which may be associated with the trees is assessed as negligible.*

Mature trees located just beyond the eastern site boundary (**Photograph N**) were provisionally assessed to have 'Low' potential to support roosting bats, however the trees are over 8m away from the buildings and the risk of harmful disturbance is assessed as negligible. The trees within and around the site can however be expected to attract foraging bats.

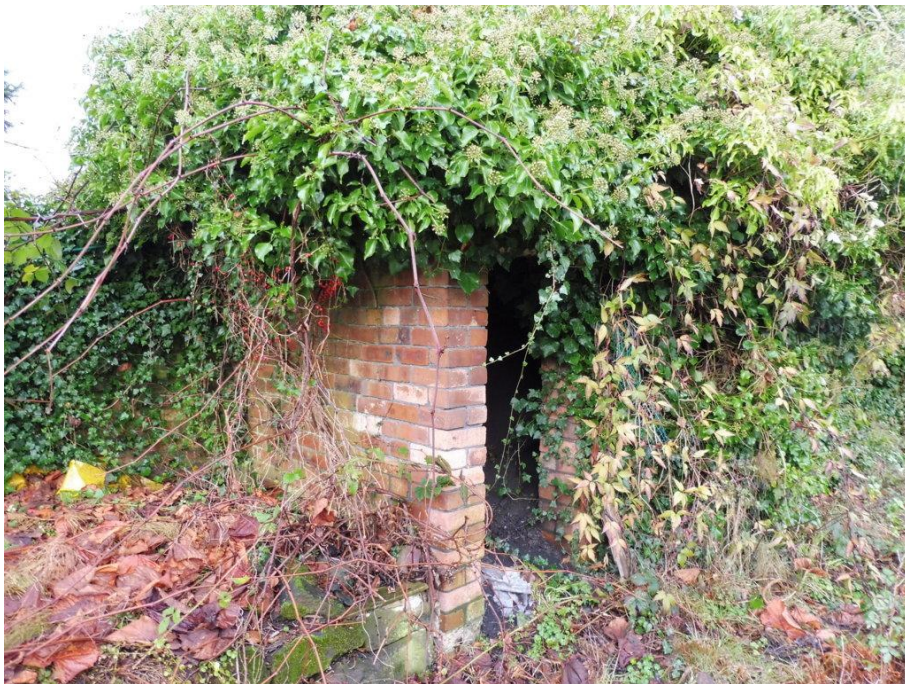
**Photograph O: View of small brick storage building located to west margin to rear garden.**

*Note: The structure is 2m tall, has just one opening, and is covered in dense ivy growth.*

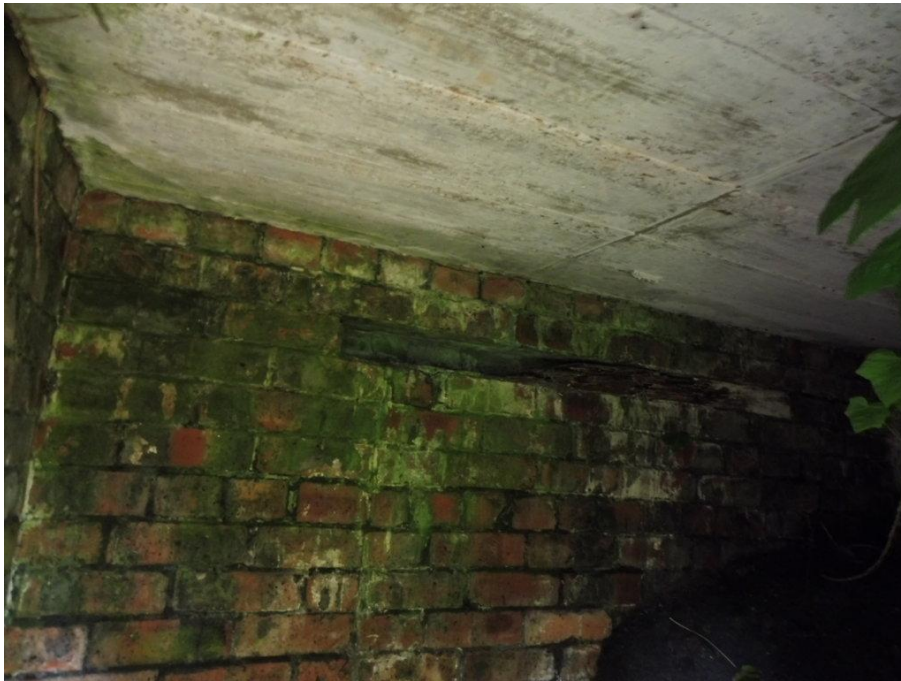
**Photograph P: Internal view of brick storage building.**

*Note: The roofing and wall/roof interfaces are well sealed, and there are no internal roosting opportunities for bats.*

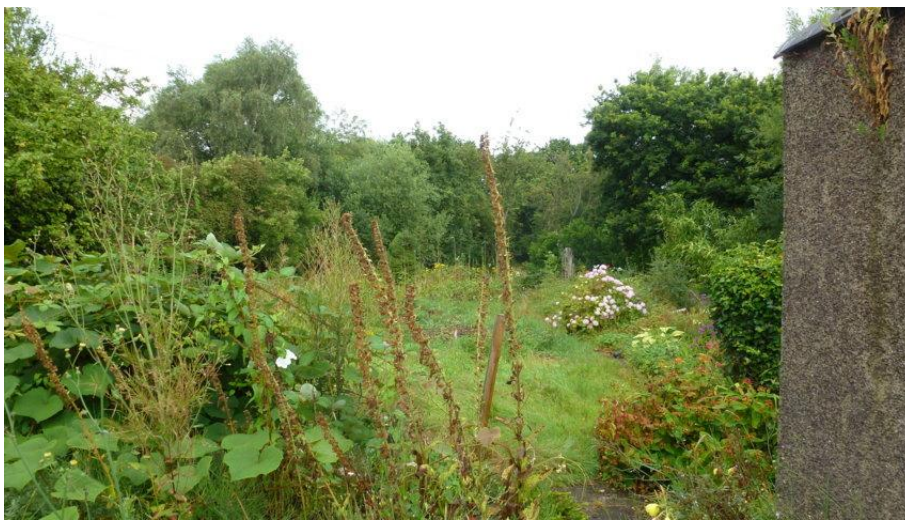
**Photograph Q: View of large rear garden to residential building.**

*Note: The garden is currently unmanaged; however amenity grassland remains dominant with scrubs and trees to the site boundaries.*

The rear garden area with its numerous trees and small stands of scrub (Photograph Q) can be expected to offer opportunities to a range of common passerine bird species for breeding, refuge & foraging. A targeted breeding bird survey was not completed, however the shrubs and trees are all more than 10m away and therefore the risk to breeding birds from the proposed demolition works is assessed as negligible.

If however wider site vegetation clearance is proposed than a breeding birds survey is recommended and should be completed by a suitably qualified person in advance of commencement of works.

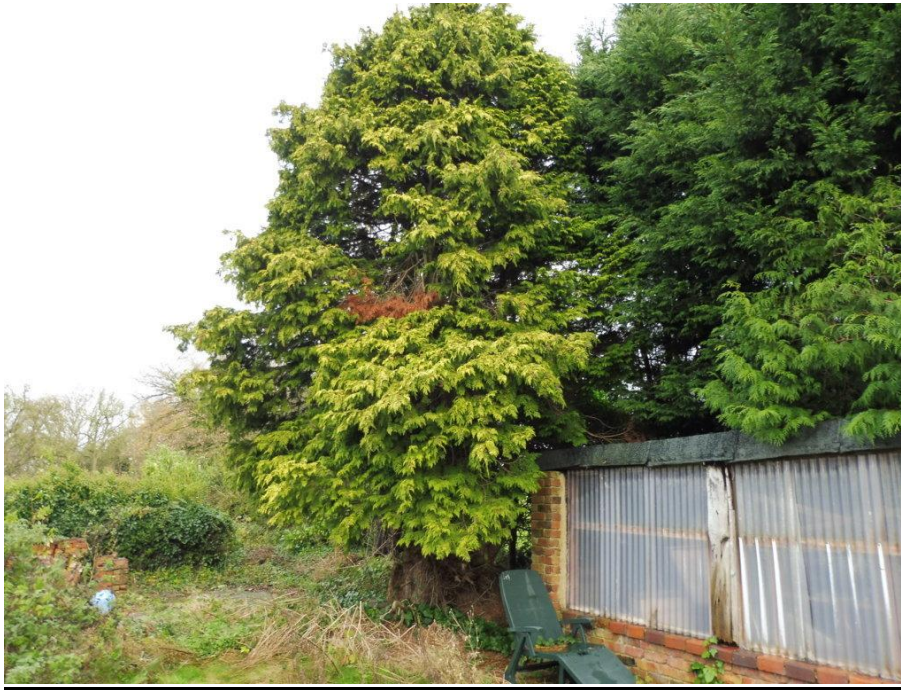
A mature conifer tree (reference in arboriculture report as 'T7') (Photograph R) has been scheduled for removal to facilitate the proposed redevelopment. The tree is located to the eastern margin of the rear garden area. The tree was subject to survey (Photograph T) and assessed to have negligible bat roost potential. No further trees are currently under threat of removal.

**Photograph R: View of conifer tree (Referenced as 'T7') to be lost.**

*Note: The tree is located to the eastern margin of the rear garden area and approximately 12m from the nearest residential building to be demolished.*

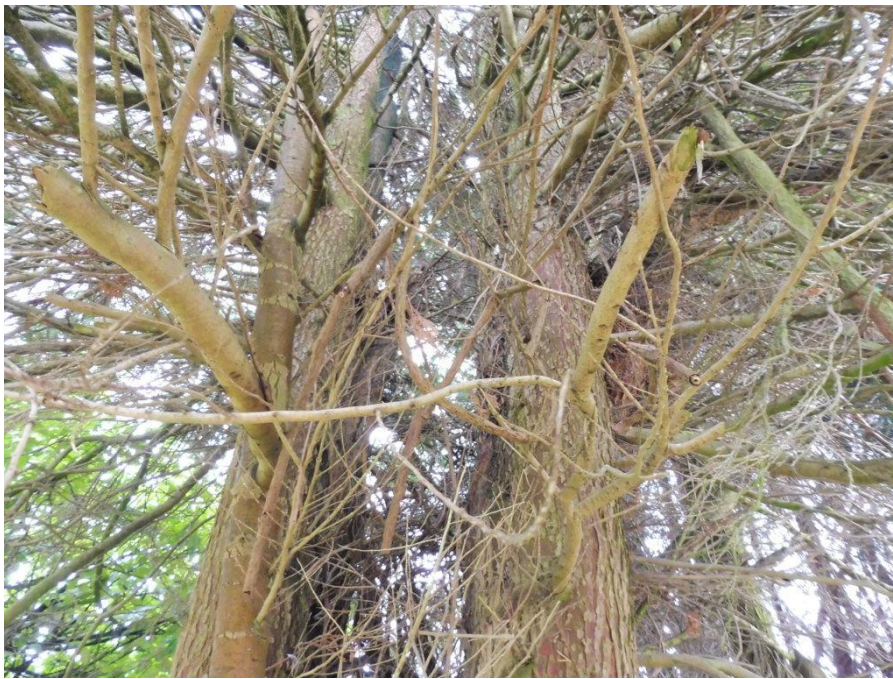
**Photograph T: View up into the internal canopy of Tree T7.**

*Note: The tree was assessed to have negligible bat roost potential.*
