# TREE HEALTH ASSESSMENT

Hey Park, Huyton

August 2022

Ref: 22/00043/THA

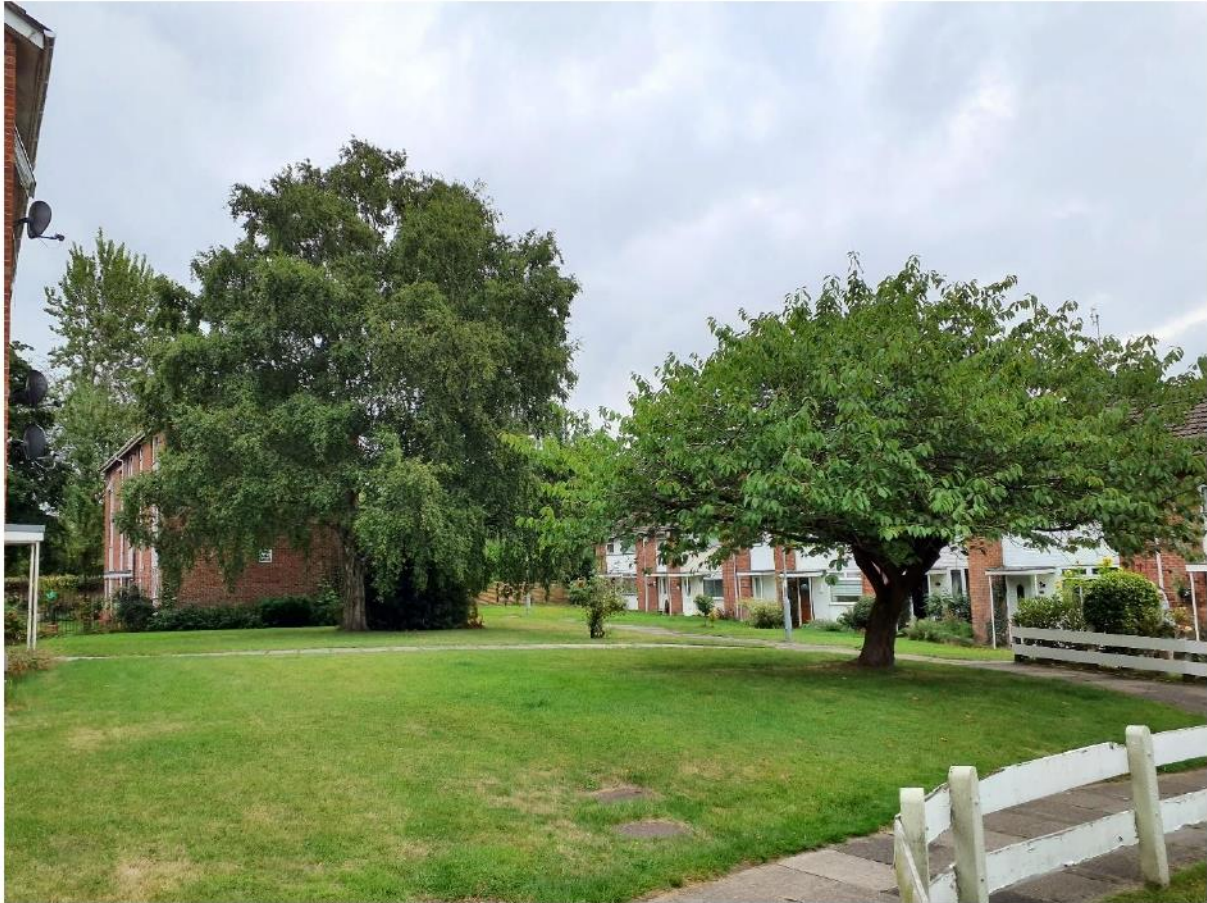
An image showing T10 and T11 (L) and T9 (R).

| Tree No. | Species | Height (M) | Age | Condition Rating | Comments And Management Recommendations | Priority Rating |
|---|---|---|---|---|---|---|
| T9 | Cherry | 5.1 - 10 | FM | Good | Good shape and form. Low hanging branches over adjacent footpath. Minor deadwood in the crown. No major visible defects. Remove low hanging branches over footpath. | 2 |
| T10 | Silver Birch | 15.1 - 20 | FM | Good | Good shape and form. Witches broom in crown caused by minor fungal infection, unlikely to cause any long-term implications to the tree. Minor deadwood in the crown. No major visible defects. | |
| T11 | Silver Birch | 15.1 - 20 | M | Good | Good shape and form. Limited view of stem base due to dense surrounding vegetation. Minor deadwood in the crown. No major visible defects. | |

During the survey, it was noted that both T6, a Sycamore, and T9, a Cherry, had low hanging branches over the adjacent footpaths. To enable free use of these footpaths, it is recommended that both features are crown raised to 3m above ground level.

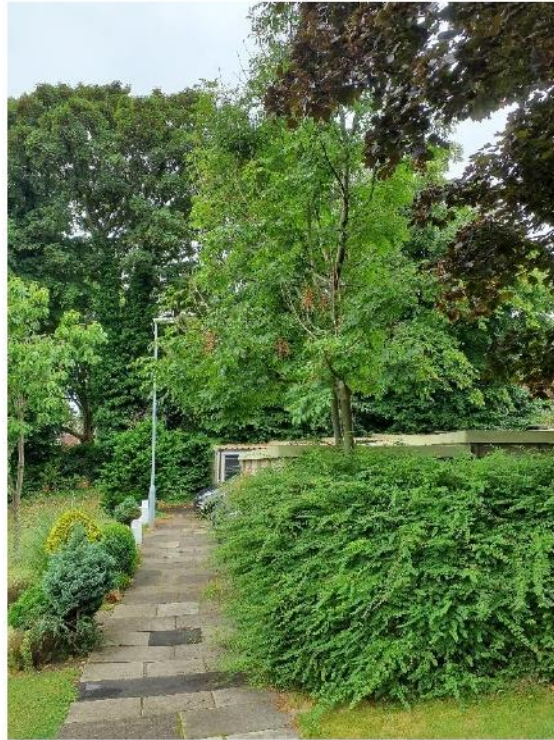
Upon inspection of T4, an Ash tree, it was considered that the tree is likely self-seeded and is in a poor location adjacent to some garages. Even though the tree is healthy and has the potential to live for many years, the location the tree means it will likely outgrow its space which could potentially lead to the tree causing damage to the adjacent garages. To prevent these potential future problems, it is recommended that this tree is removed, and the stump is treated to prevent future re-growth.

Image 4.2 Showing T4 and its location adjacent to some garages on site.

| Tree No. | Species | Height (M) | Age | Condition Rating | Comments And Management Recommendations | Priority Rating |
|---|---|---|---|---|---|---|
| T4 | Ash | 5.1 - 10 | SM | Fair | Reasonable shape and form. Likely self-seeded. Displaying symptoms of ash dieback in the crown. Likely future conflict with adjacent garage. Fell. | 2 |
