ALLIED PROPERTIES  
FALLOWS WAY, PRESCOT, L35 1RZ

edward  
architecture

## GROUND INVESTIGATION STAGE 1 DESKTOP STUDY

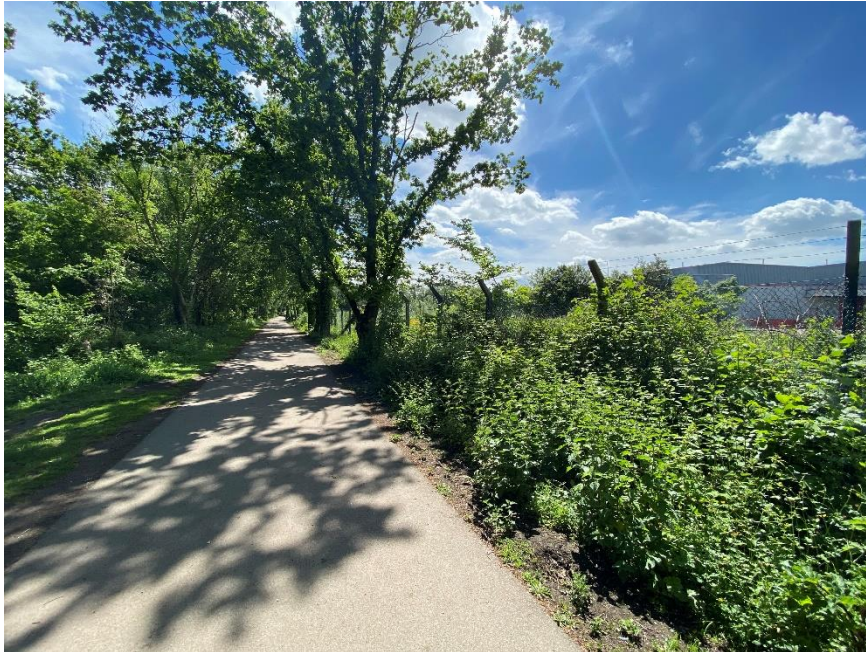
Footpath to northern boundary of the site looking east.

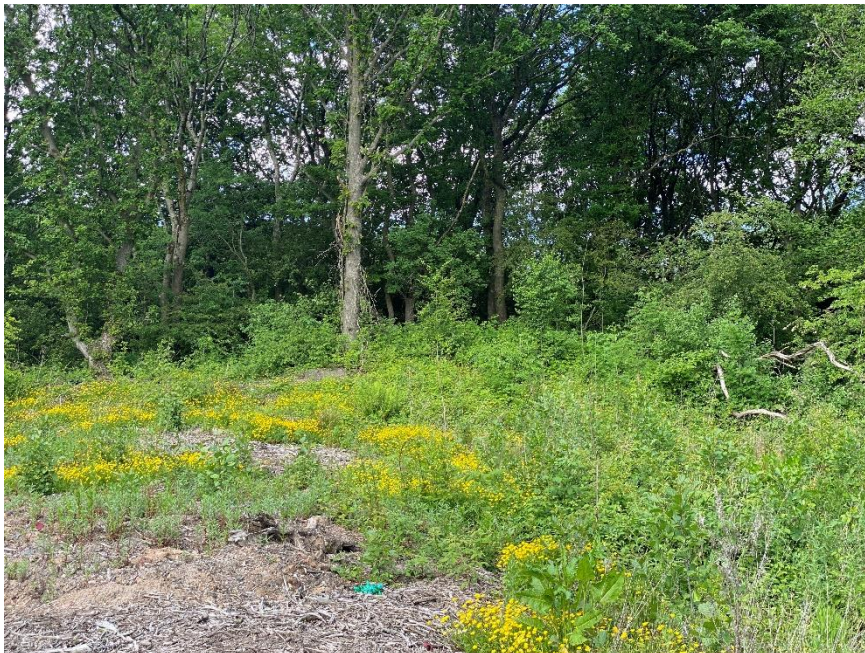
View within site looking northwest

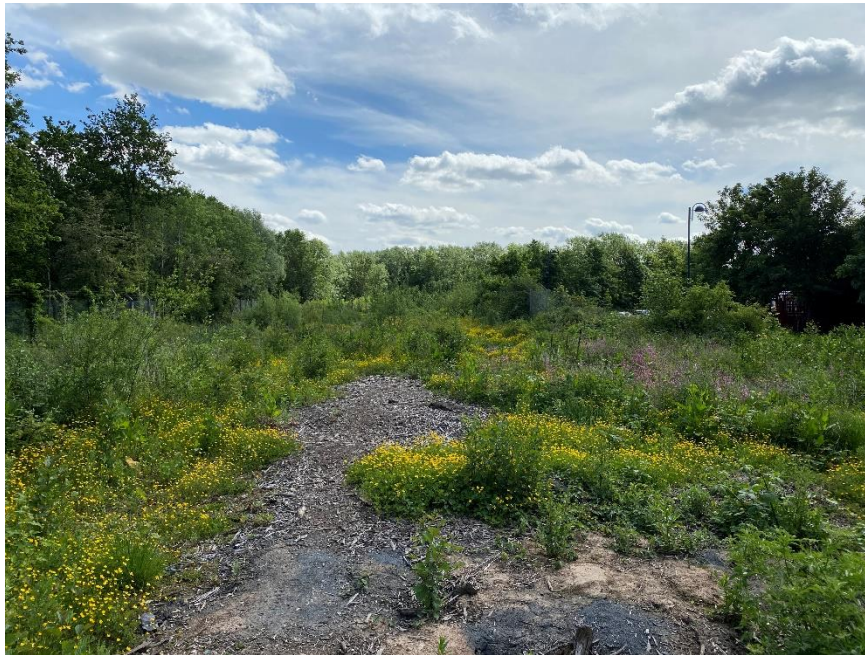
View within site looking east
