MURRAY  
TREE CONSULTANCY

## TREE CONDITION ASSESSMENT

4-5 ALMOND CLOSE  
LIVERPOOL  
L26 1XL

September 2024

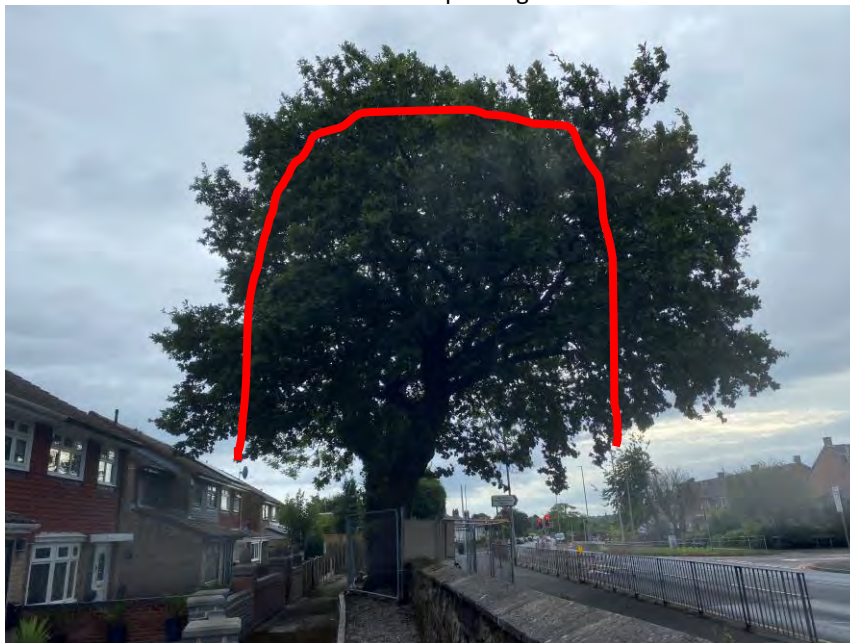
Recommended pruning of T1

- 2.2.1 The Oak tree (T1) is in good condition for its age, species and location although it has not received much maintenance in recent years. The crown is very unbalanced and has low foliage over the highway with some deadwood present. It has been previously pruned on the housing side adding to the balance issues. The only evidence of surface roots are within the internal footpath, which has been repaired but needs uncovering again and attending to. The crown also requires pruning to address the balance issues and prune low foliage away from passing vehicles as well as removing any significant deadwood.

- 2.2.2 It is recommended that the crown be reduced and re-shaped, pruning mostly on the southern side in order to create a more balanced tree. The pruning should broadly be as illustrated within the photograph below. Pruning approximately 1-2m from the house side, 3-4m from the highway side also creating a 5.5m height clearance and approximately 1m from the top. Any significant deadwood should be removed at the same time.

| Priority | Tree Number | Species | Description of Works |
|---|---|---|---|
| 2 | T1 | Oak | Reduce and re-shape tree to create a more balanced crown pruning mostly on southern/highway side as illustrated within section 2.2 of the main report.<br>Remove significant deadwood.<br>Protruding root – carefully remove tarmac and dig out subbase to expose root. Under consultation decide on whether to root prune or not. Add thin layer of sub-base and re-surface. |

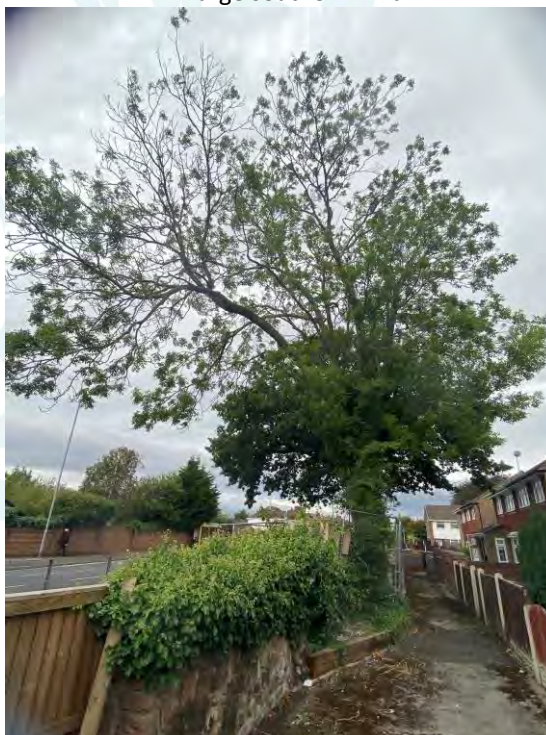
T2 large southern limb

- 2.2.3 The Ash (T2) is suffering with Ash Dieback and is difficult to say how it will affect this tree long term. This tree is also very unbalanced, which can be mostly attributed to a large southern limb that has been recommended for removal. This tree has also be recommended to be reduced by approximately 1-2m in order to remove dead branch tips and promote healthy growth. The Ivy also need stripping from around the base and removing form the wall.

| Priority | Tree Number | Species | Description of Works |
|---|---|---|---|
| 2 | T2 | Ash | Reduce and re-shape tree by approximately 1-2m removing dead branch tips and remove large southern limb.<br>Sever Ivy at base to 1m.<br>Remove significant deadwood. |

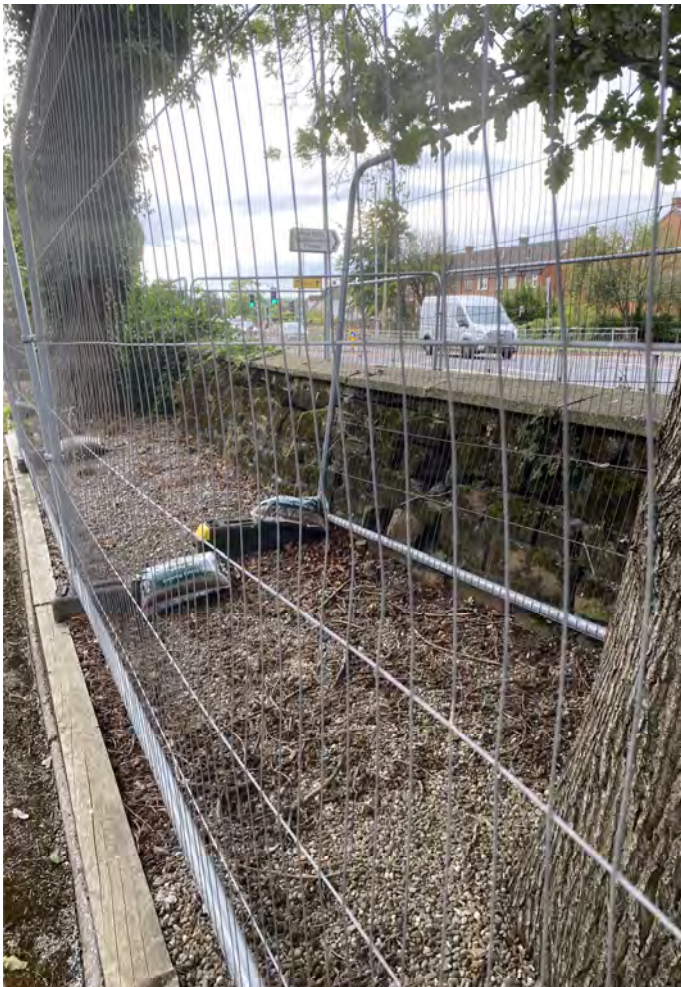
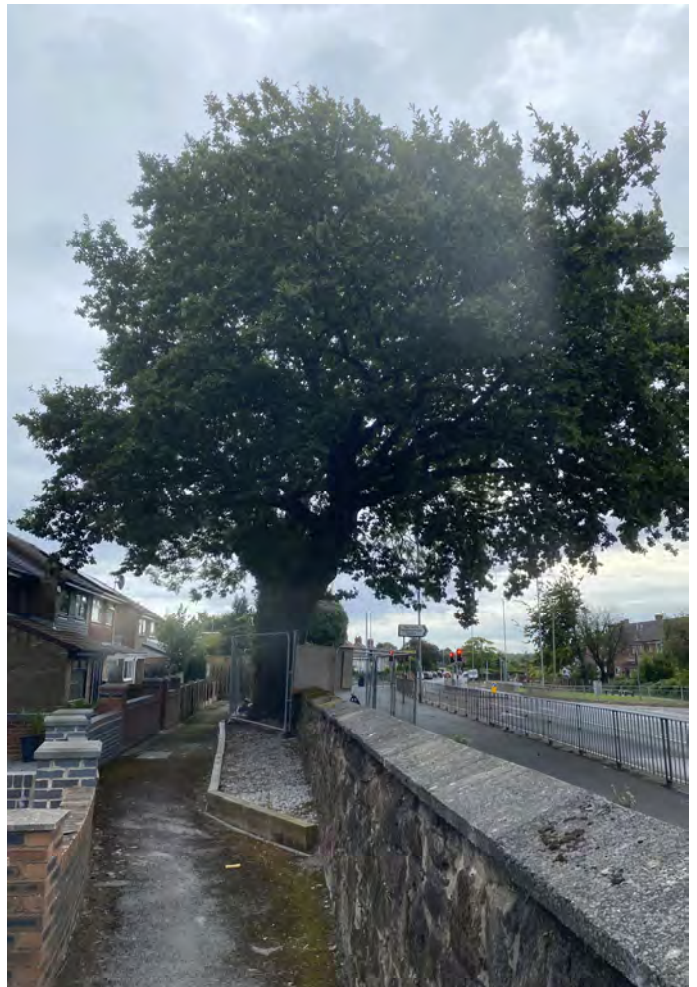
T1 Oak unbalanced crown

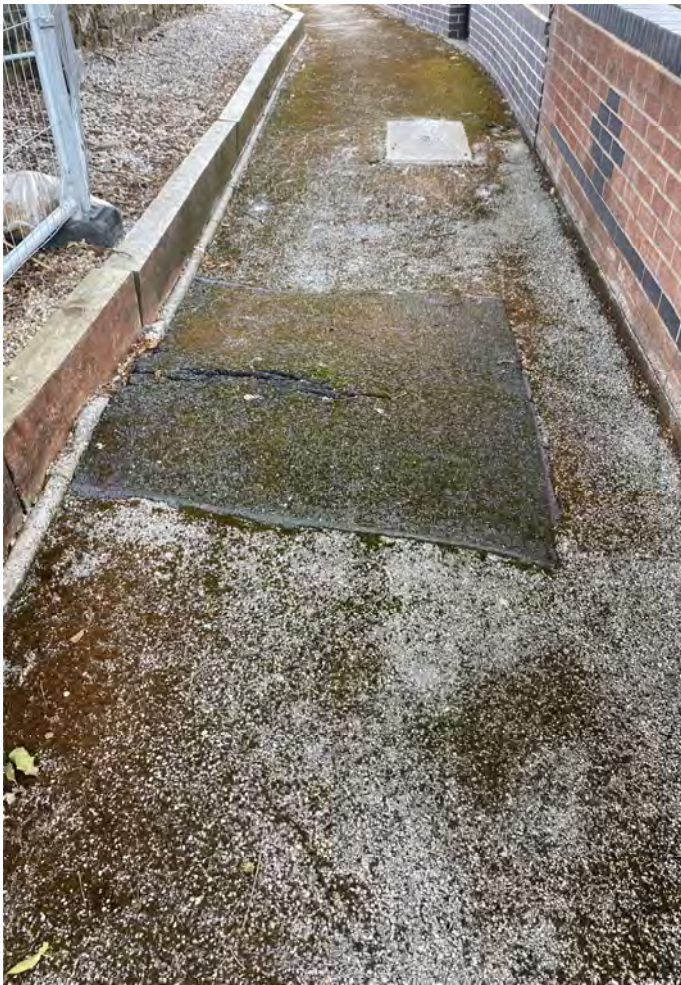
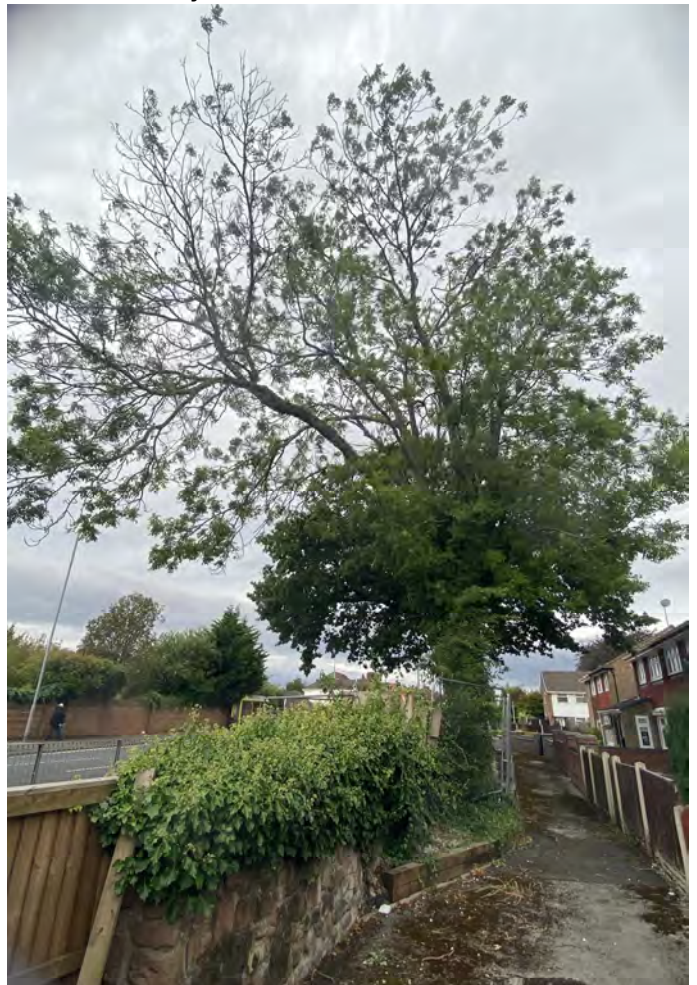
T1 major root disturbance to internal path

T2 Ash major southern limb and Ash Dieback

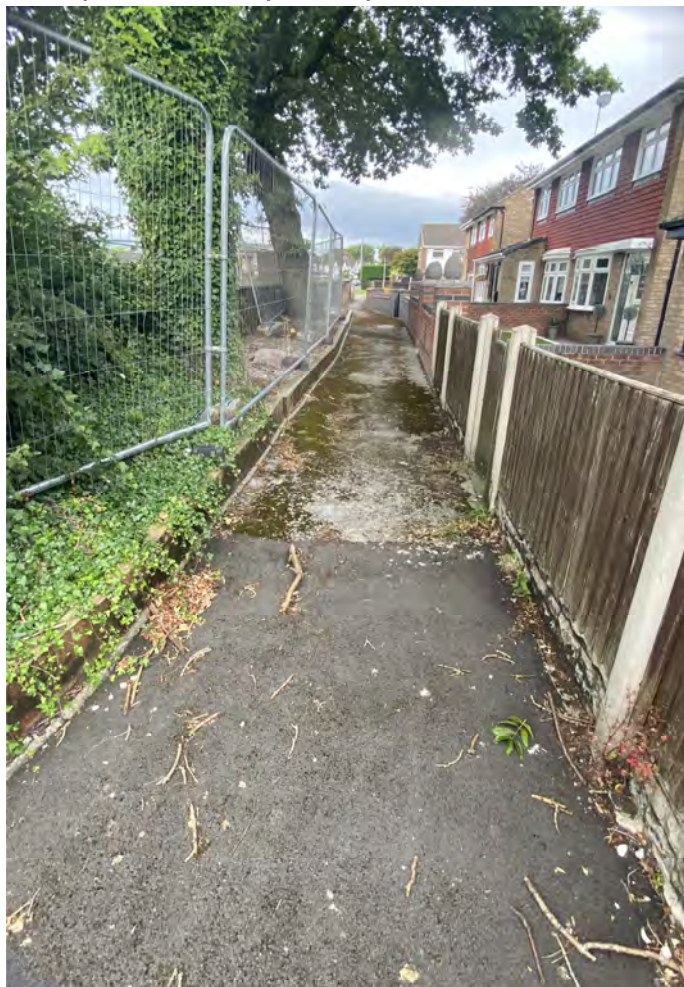
T2 previous footpath repair

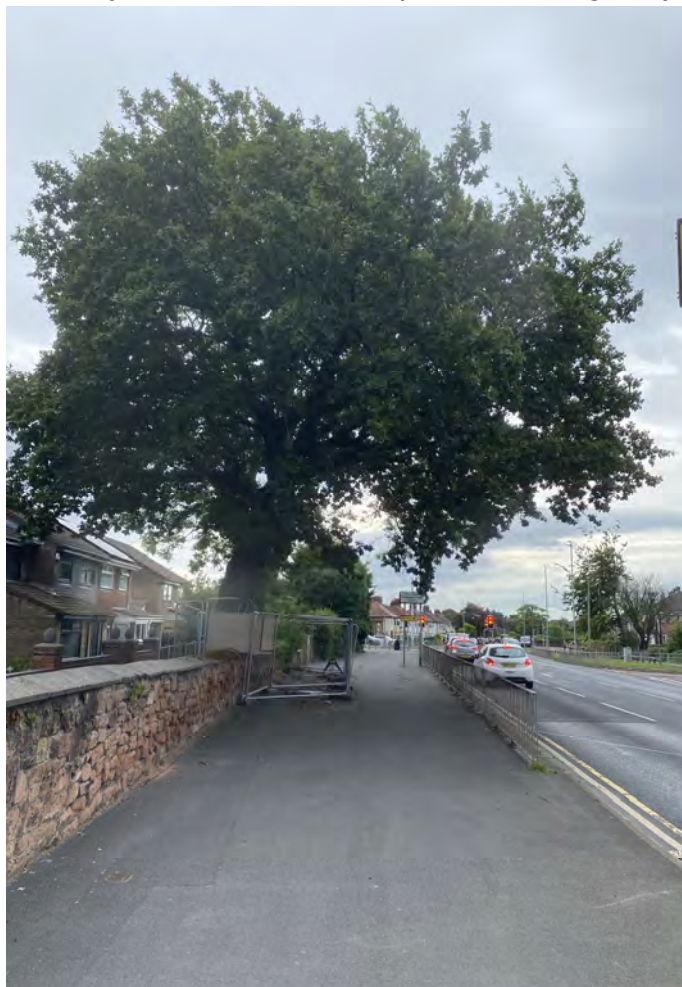
T1 major southern crown spread over highway

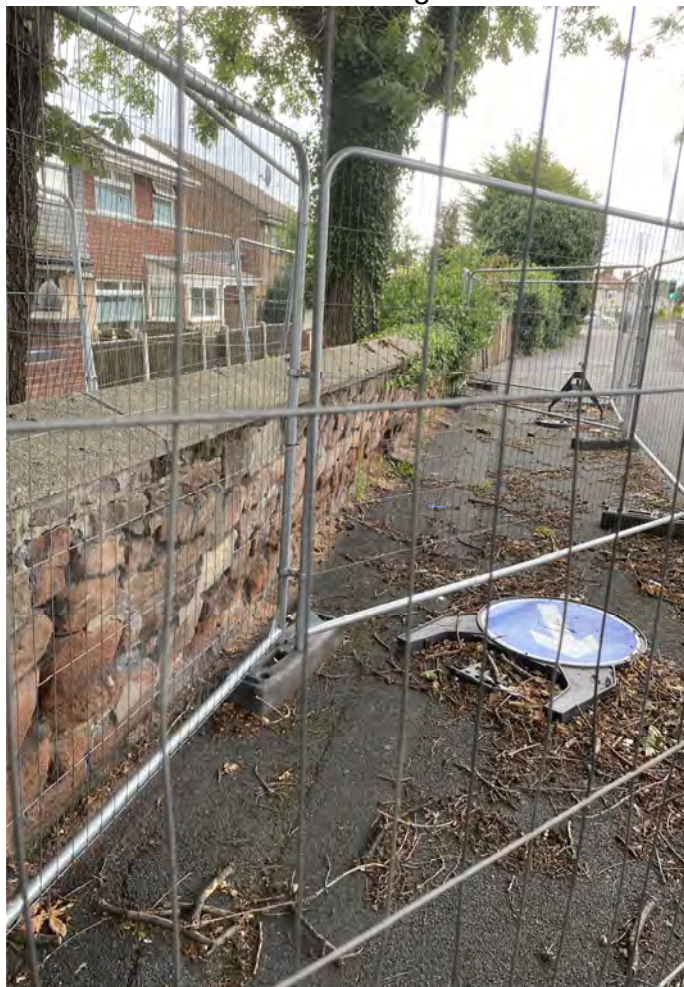
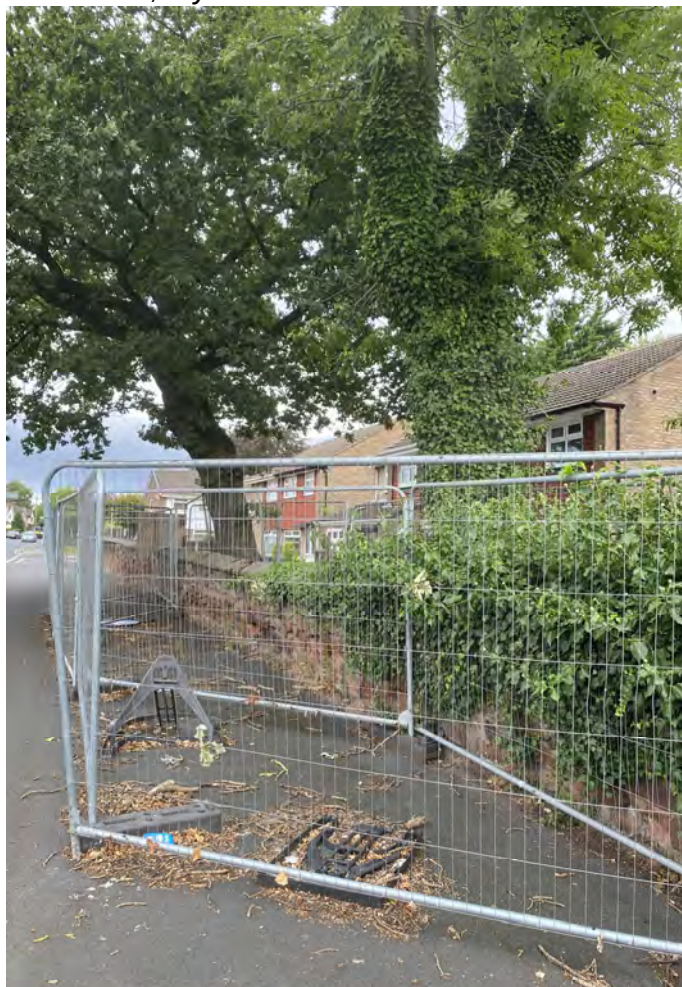
- 2.2.5 The stone wall is significantly buckled between these two trees with missing mortar and masonry. None of the trees appear to be physically touching the wall and it is hard to say what affect the buttress area and root systems of these two trees is having on the wall. As stated within the data tables of Appendix B no surface root activity is evident on the highway side.

Listing wall and deadwood from trees, Ivy on wall.

- 2.2.6 The only way to establish the impact of roots on this wall and indeed repair the wall is to carefully take it down by hand and then decide how it is to be re-built. Some roots may need pruning or bridging over dependent on their size and importance to the trees stability. Therefore, some input from a competent arborist and engineer will be required once the foundations are uncovered. First impressions are that this wall can be repaired whilst retaining the trees.
