## STRUCTURAL ENGINEERS REPORT

C15403

Huyton Cricket Club Pavillion  
Huyton Lane, Knowsley  
Liverpool L36 7XD

13 June 2025

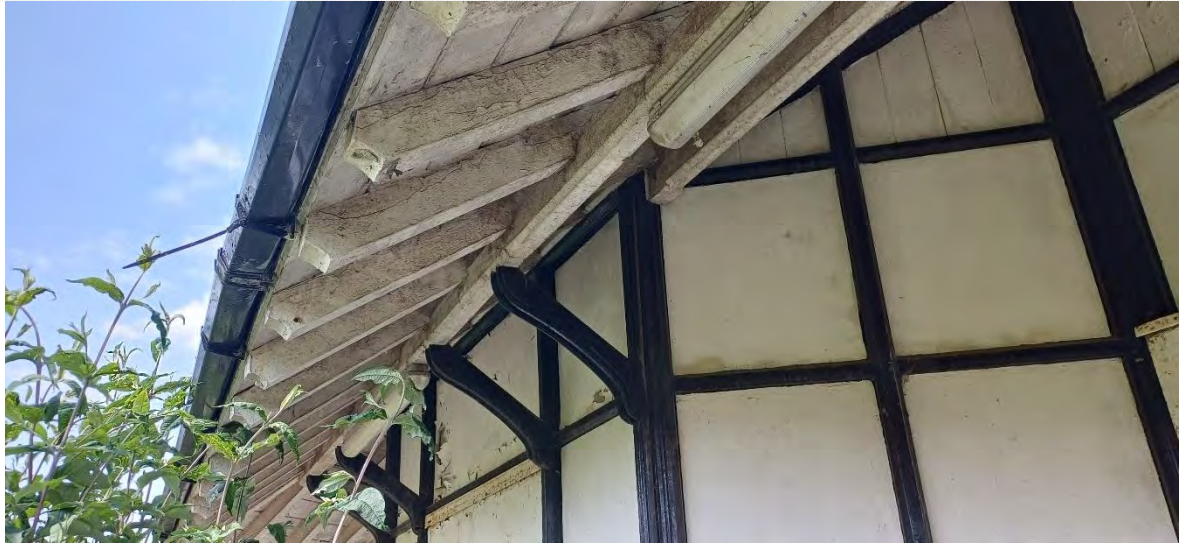
*Figure 3 – Timber brackets to roof*

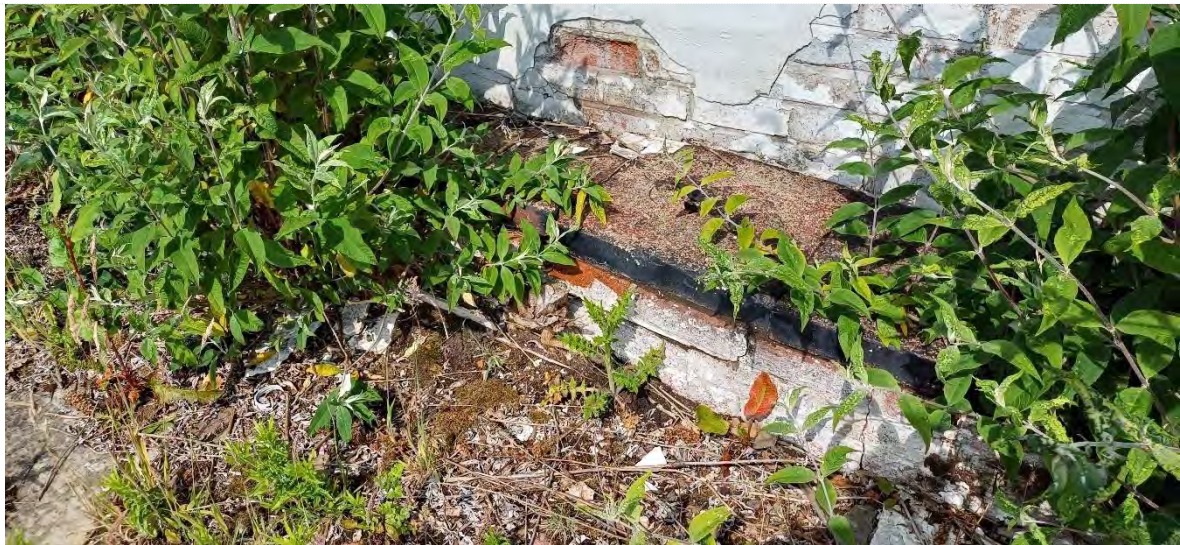
The main roof is duo-pitched from front to rear and is plain clay tiled. The roof overhangs a veranda which is supported by timber posts and angled brackets. Across the main part of this elevation is decking. This decking runs to a rendered retaining wall. The retaining wall has brickwork in front of it which is settling/collapsing.

*Figure 6 – Settling brickwork in front of retaining wall*

1. Carry out a dimensional survey of the structural members – this is likely to need a contractor to open-up and make areas safe
2. Replace all damaged and rotting panels to the elevations with new T&G to match existing
3. Replace affected vertical and horizontal timbers to the front, rear and sides
4. Rebuild the front retaining wall
5. Replace the suspended ground floor structure
6. Provide suitable beams over the kitchen opening

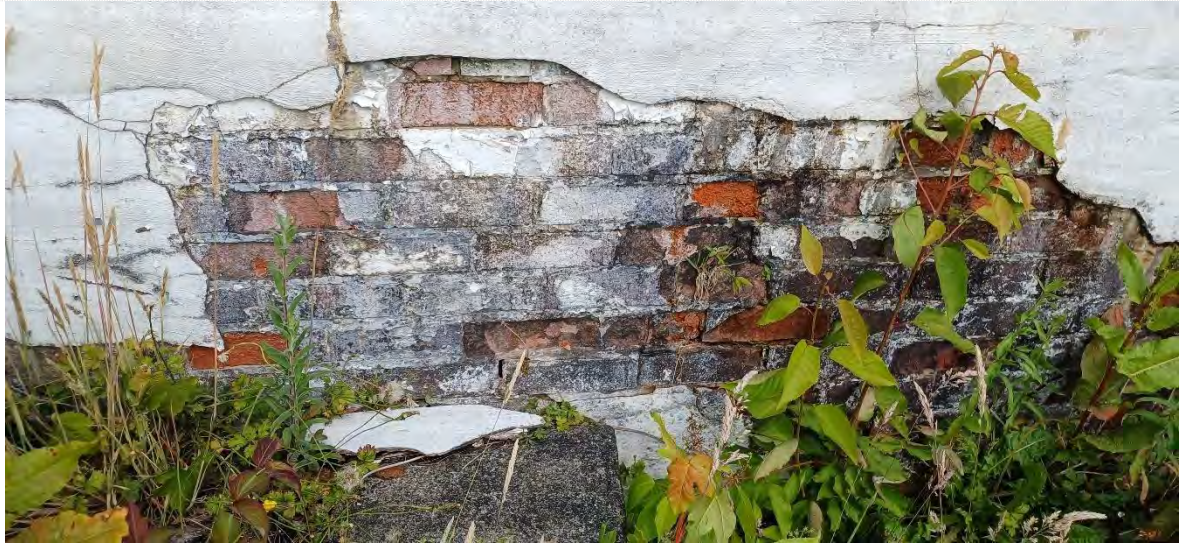
*Figure 7 – Damaged brickwork/render to retaining wall*

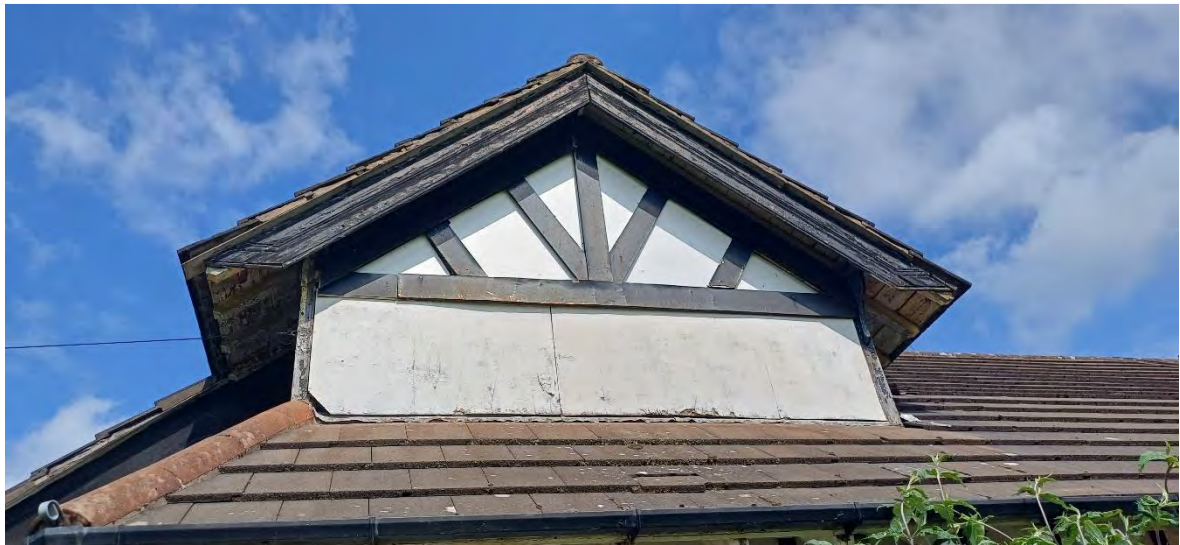
*Figure 10 – Left dormer*

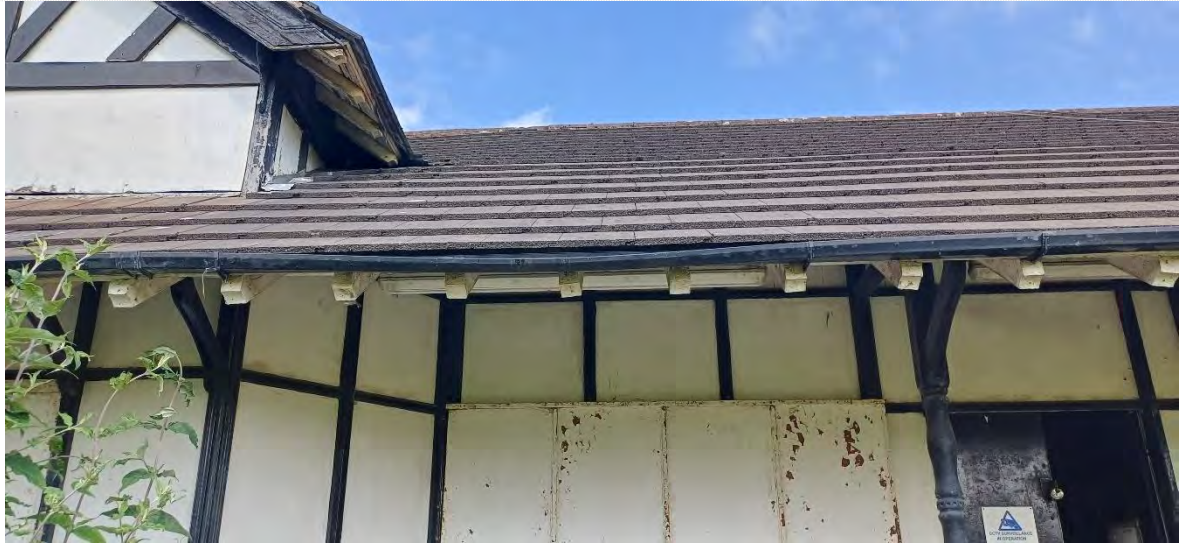
*Figure 13 – Sagging gutter to central part*

1. Rainwater goods – these are missing or incomplete around the building
2. Flashing details – some repairs have been made but generally new flashing is required to the gables, dormers and possibly the valleys
3. The roof tiles are dislodged or missing, with felt in some areas and not in others – hopefully this could be addressed by re-roofing with appropriate materials
4. We noted that stained glass windows are damaged where boarded over
5. Connect drainage to a formal system

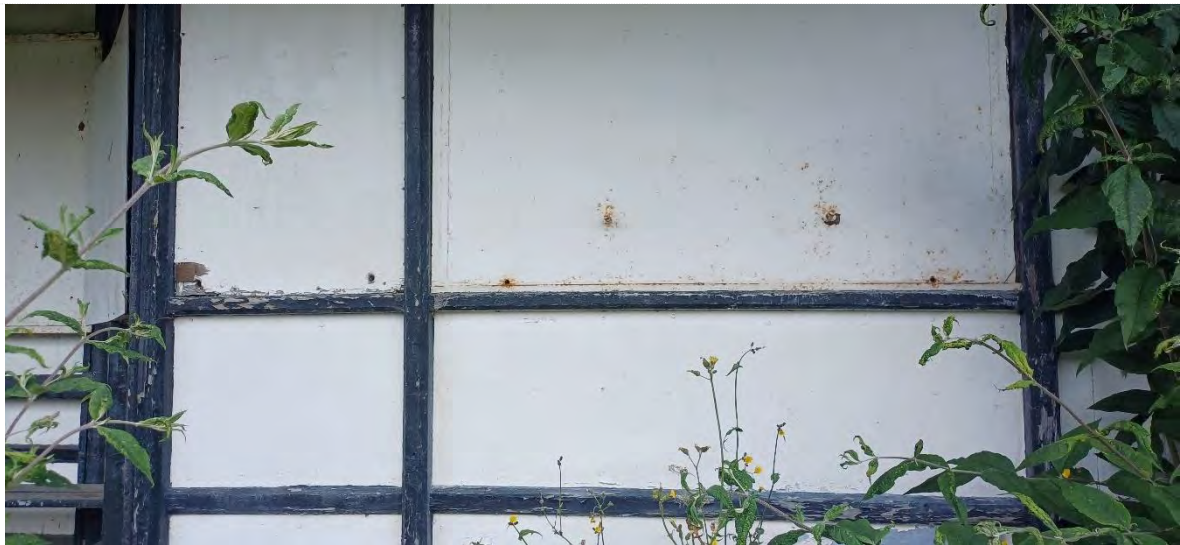
*Figure 14 – Peeling paint to walling*

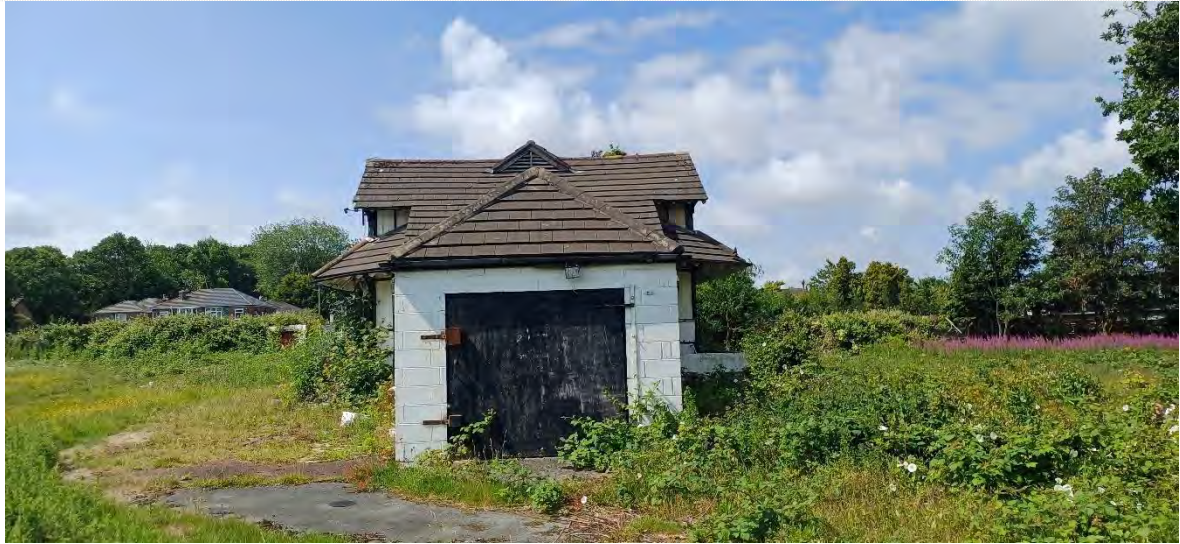
*Figure 21 – Right elevation*

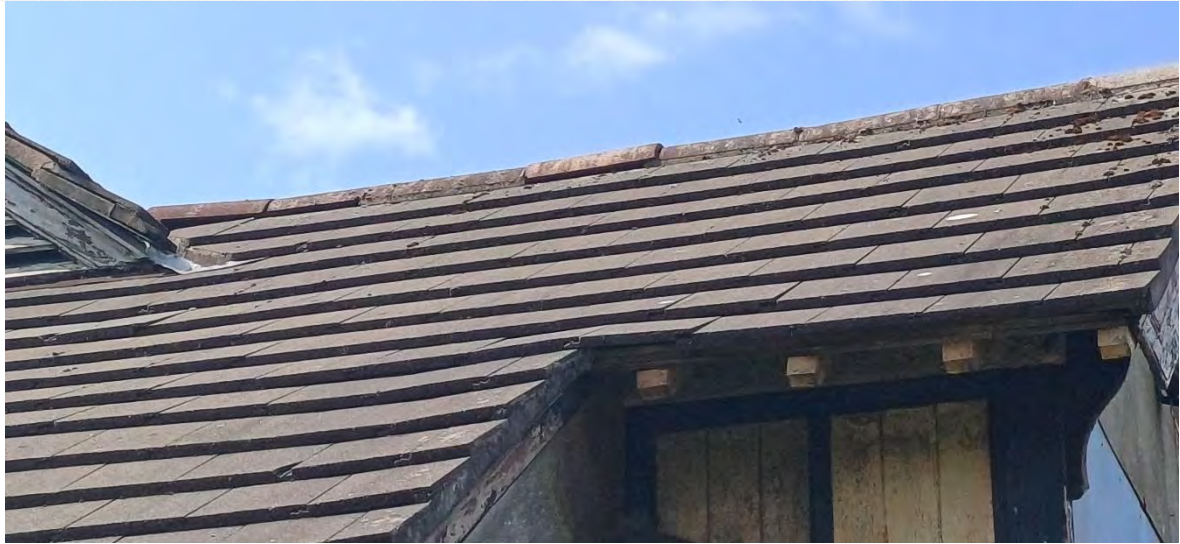
*Figure 25 – Uneven ridge tiles, right side, rear*

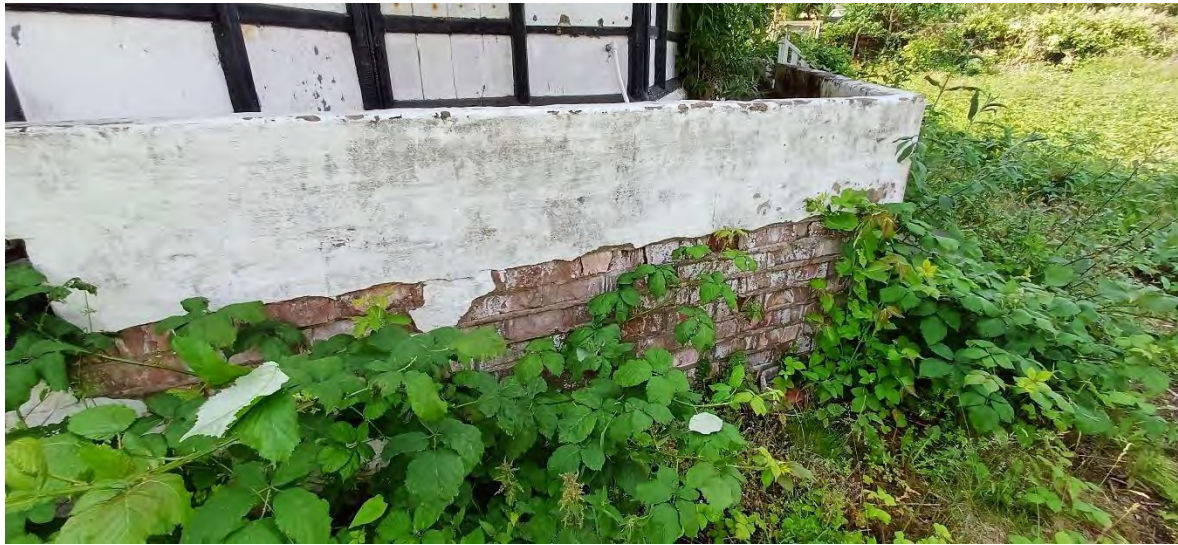
*Figure 28 – Retaining wall to rear veranda*

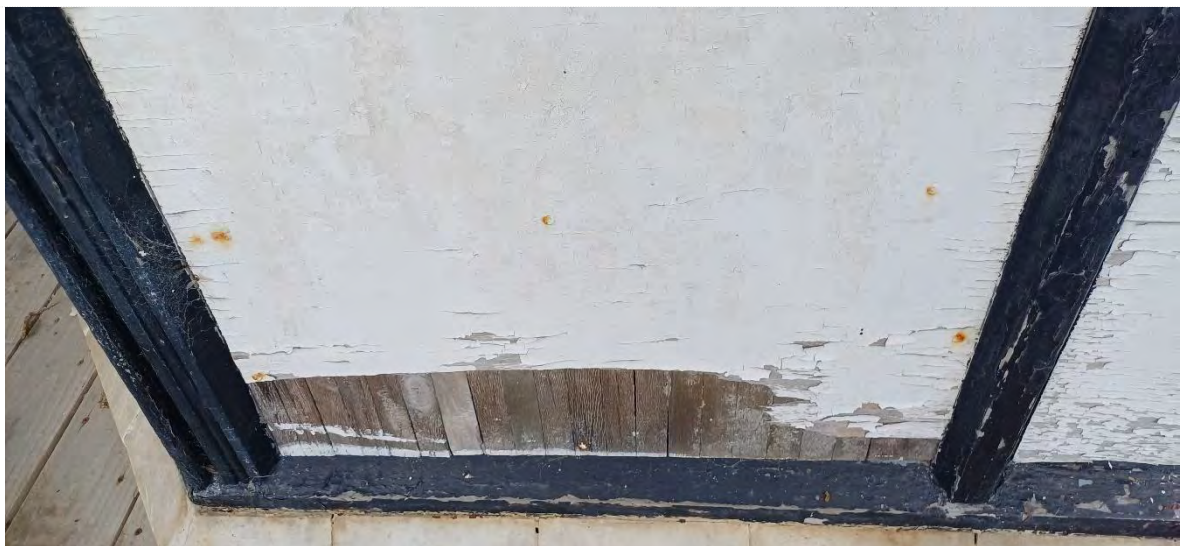
*Figure 37 – Left side, rear – timber lathes*

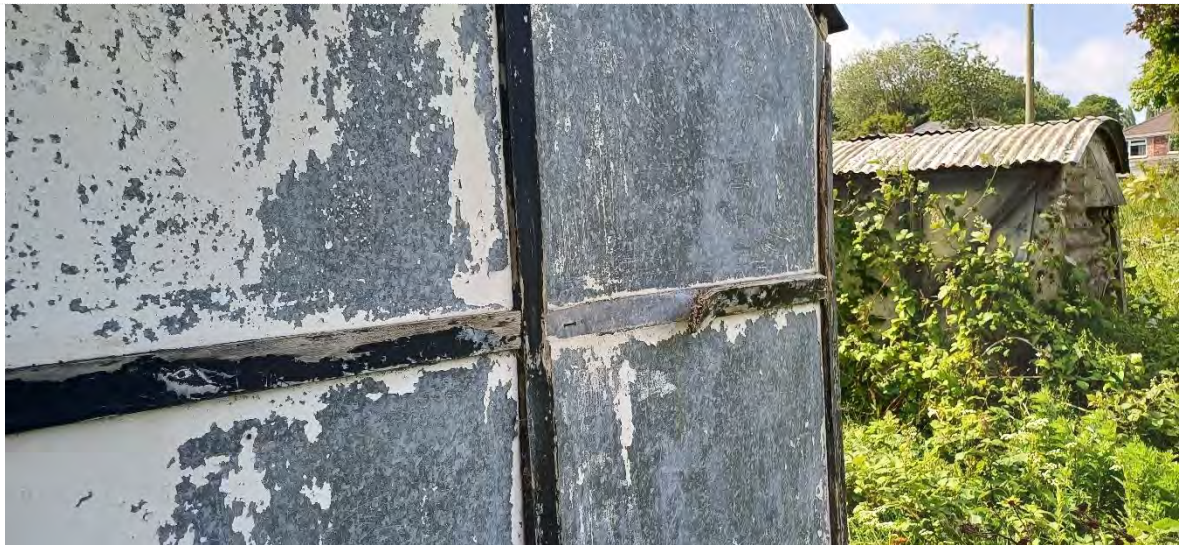
*Figure 41 – Loose cladding*

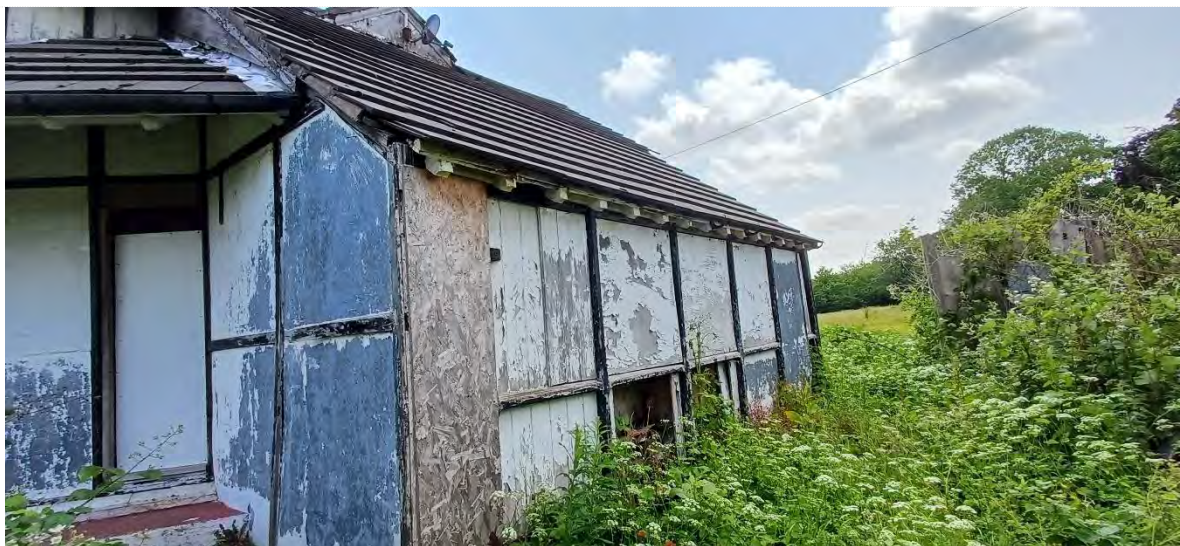
*Figure 44 – Left elevation*

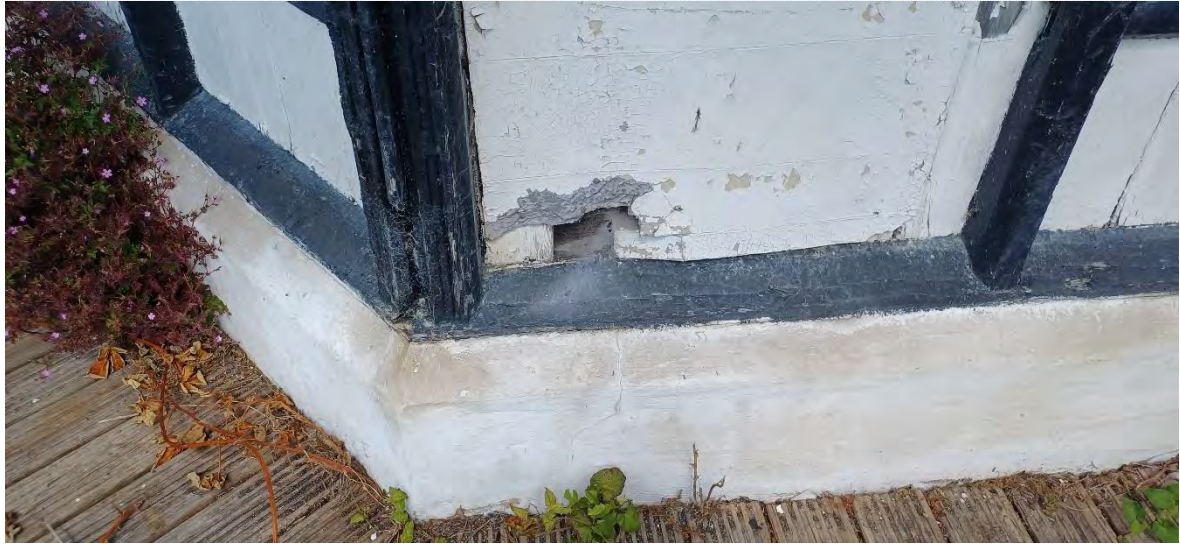
*Figure 52 – Hole in boarding, left side, front wall*

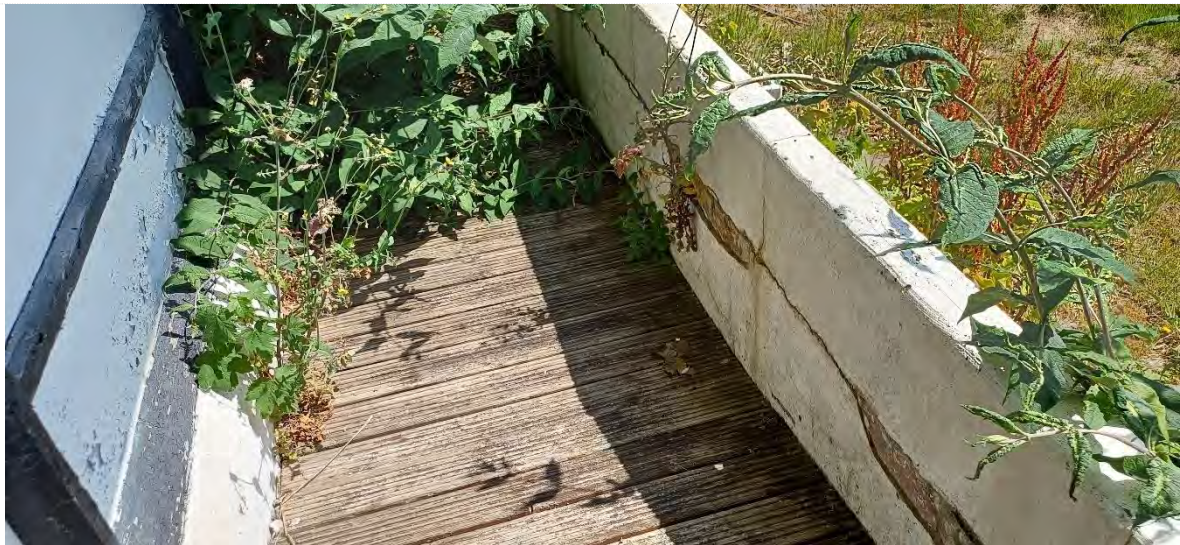
*Figure 53 – Cracking to retaining wall, front right*

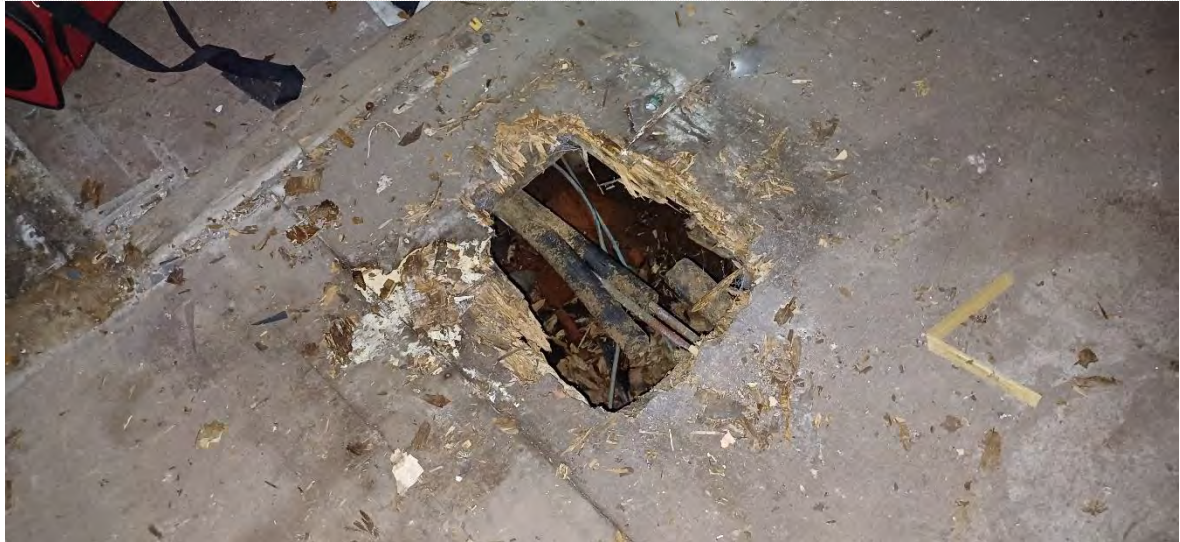
This has a suspended timber floor. Although all the floor area could not be viewed, we did note 2 areas where floor boarding has decayed and collapsed. There is timber panelling finished with T&G boards as well as plain boarding and some of this is loose to the ceiling in the rear part.

*Figure 64 – Hole in floor, right hand room*

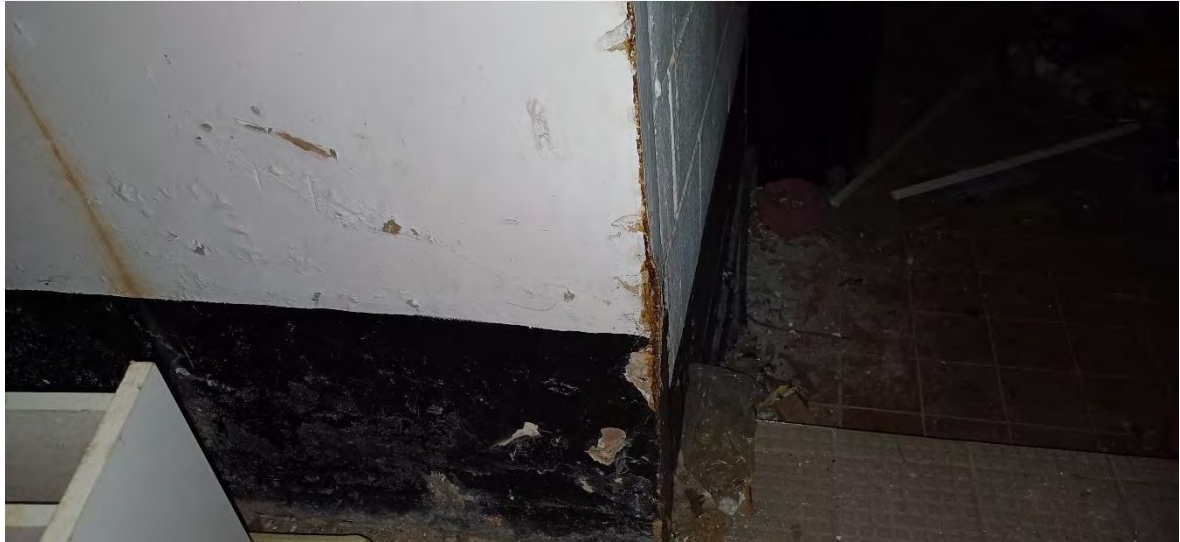
*Figure 72 – Rust to beading, rear right wall*

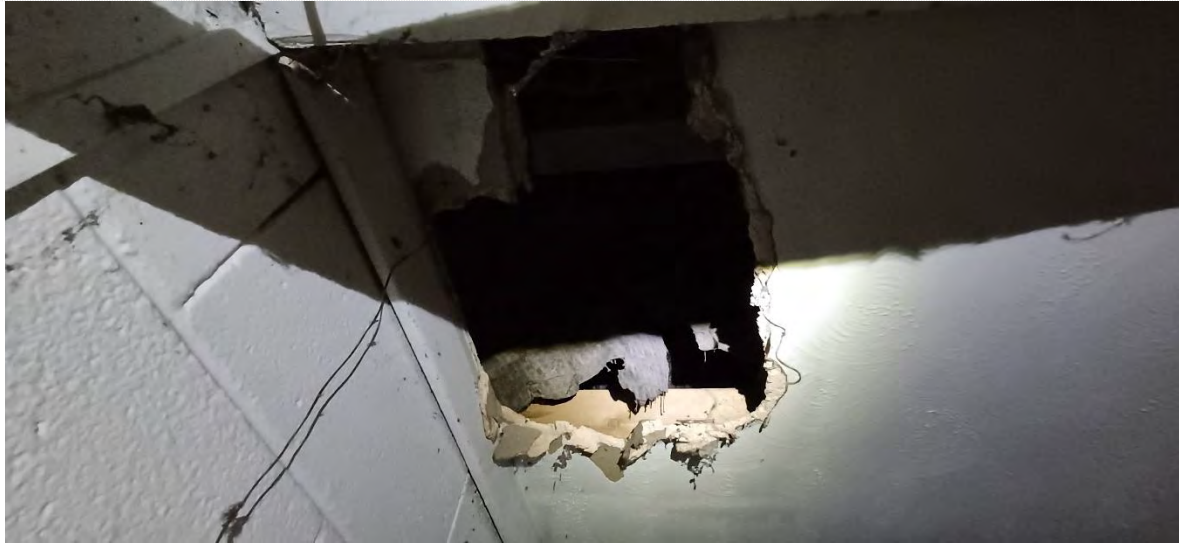
*Figure 74 – Damage to ceiling, toilets*

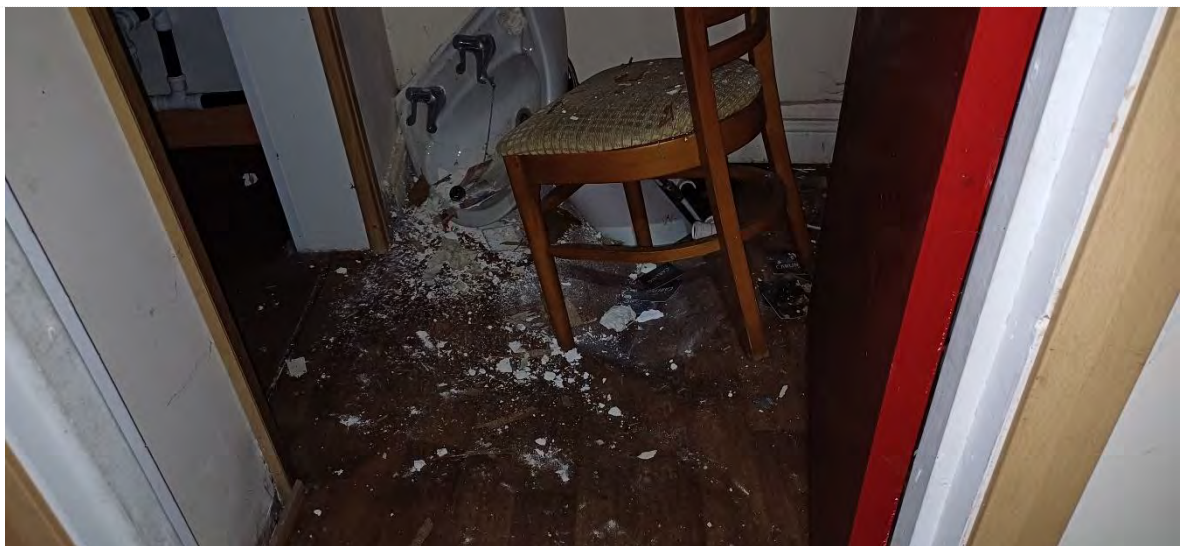
This is part of the timber framed structure and is the same floor construction as the main room. To the toilet area to the front the floor is collapsing and the walls are damaged. Vegetation is penetrating the front left corner. There is an opening detail to the kitchen ceiling which appears to be collapsing.

*Figure 81 – Left toilet area, collapsing floor*

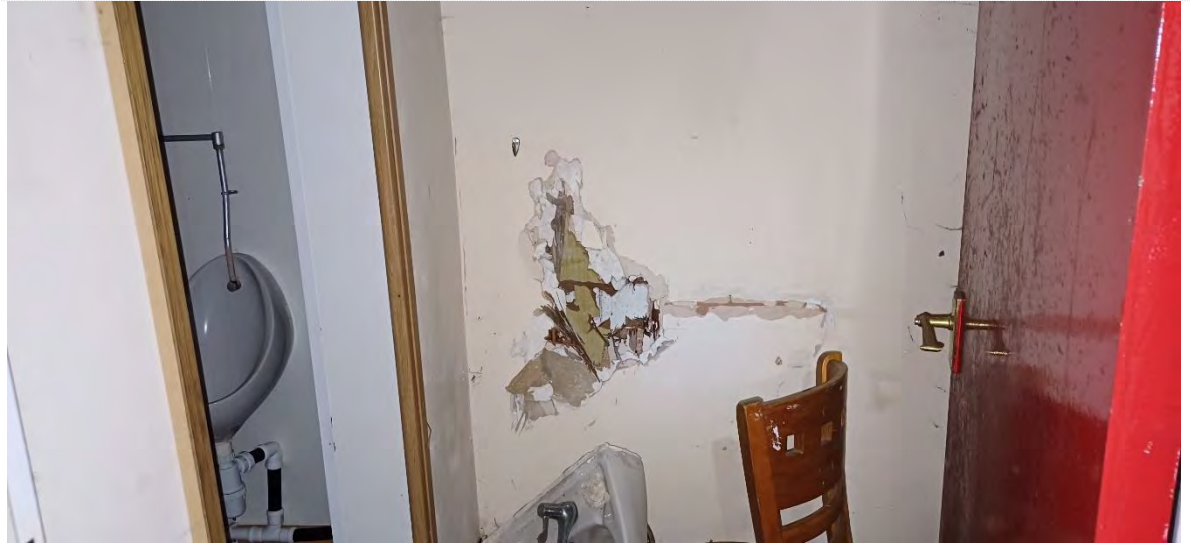
*Figure 82 – Damage to rear wall, left toilets*

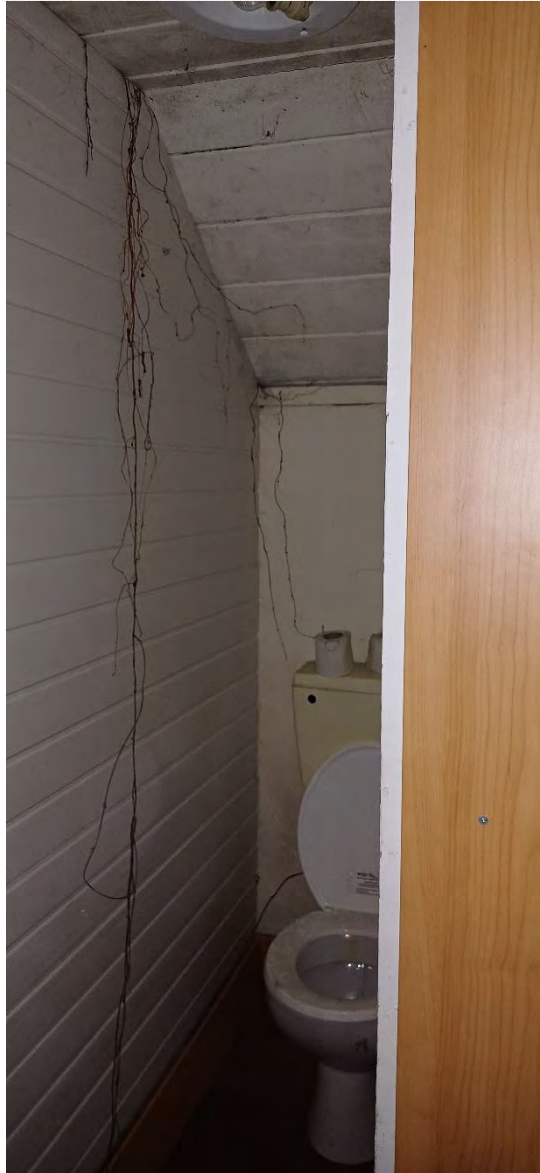
*Figure 83 – Vegetation penetrating front left corner*

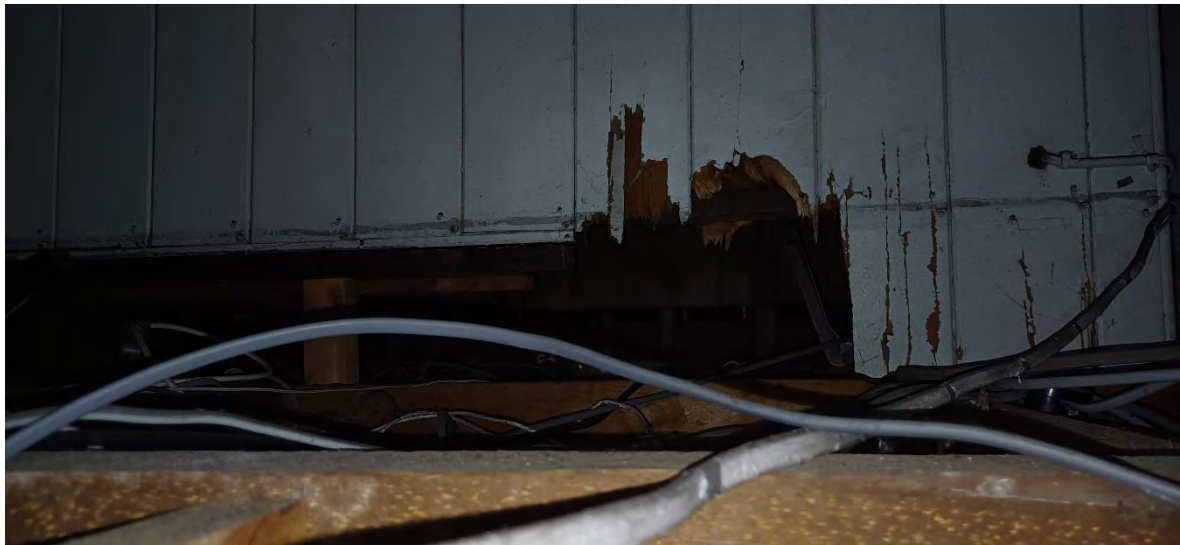
*Figure 95 – Ceiling*
