| Ref. | STRUCTURAL DEFECT |

Picture Palace, Prescott  
for Purcell

Ground & First Floor Plans

Drawing No: X64/101 Rev: - Scale: 1:200 @ A3 Date: July 2022

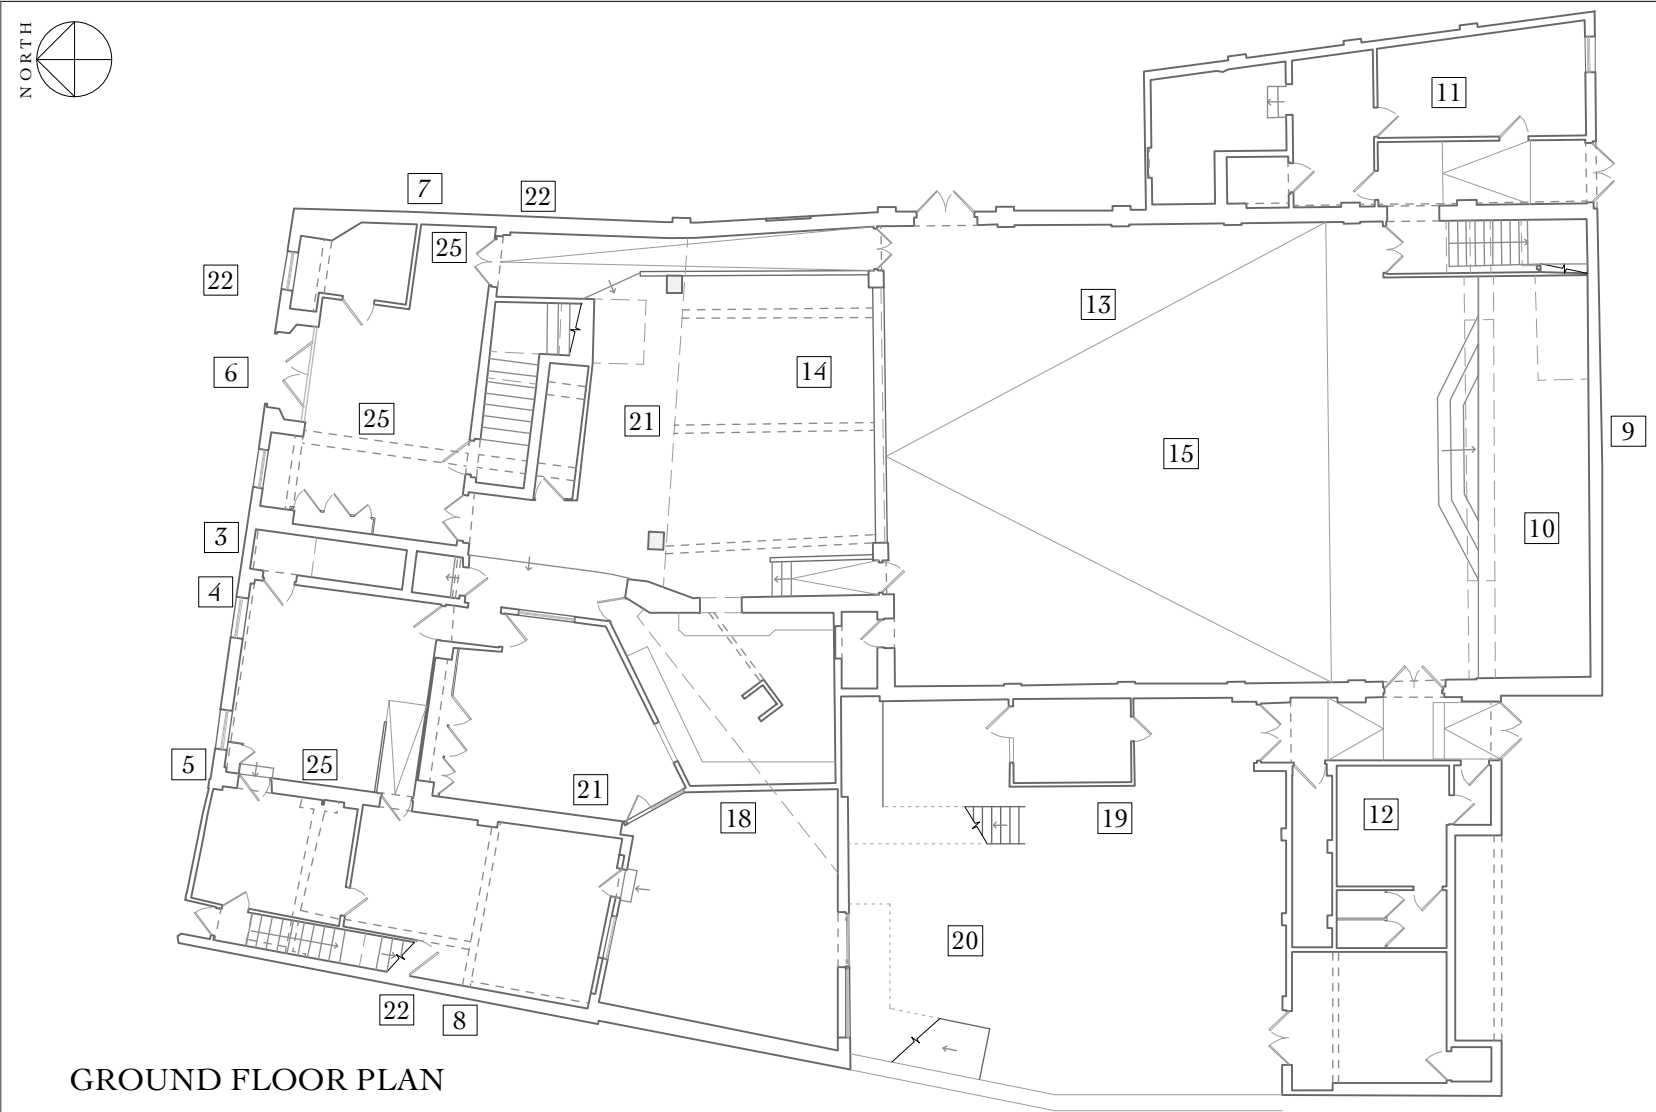
GROUND FLOOR PLAN

| Ref. | STRUCTURAL DEFECT |
|---|---|
| 4 | Vertical and diagonal cracking in the low level ashlar rendering, due to local movement and previous alterations to the entrance position. |
| 9 | The external rear wall to the auditorium has distorted probably due to a lack of adequate restraint at roof level and the internal arrangement of the roof structure above the stage area. Horizontal forces from an inclined ceiling structure. |
| 10 | There is a large baptism plunge pool within the raised stage structure. |
| 11 | Water penetration through the roof finishes of the north east single storey amenity block has resulted in extensive dry rot outbreak and damage to structural timber lintols. |
| 12 | Water penetration through the roof finishes of the south east single storey amenity block has resulted in extensive dry rot outbreak and damage to structural timber lintols. |
| 13 | There are service trenches within the sloped ground floor from the small basement mechanical plant to grilles at the edges of the auditorium aisles. The covers of which in places have decayed and collapsed. |
| 14 | At the rear of the auditorium the ground floor has been raised with a timber joist floor. This appears to be a relatively modern addition to increase the level space as part of the Church use of the building. |

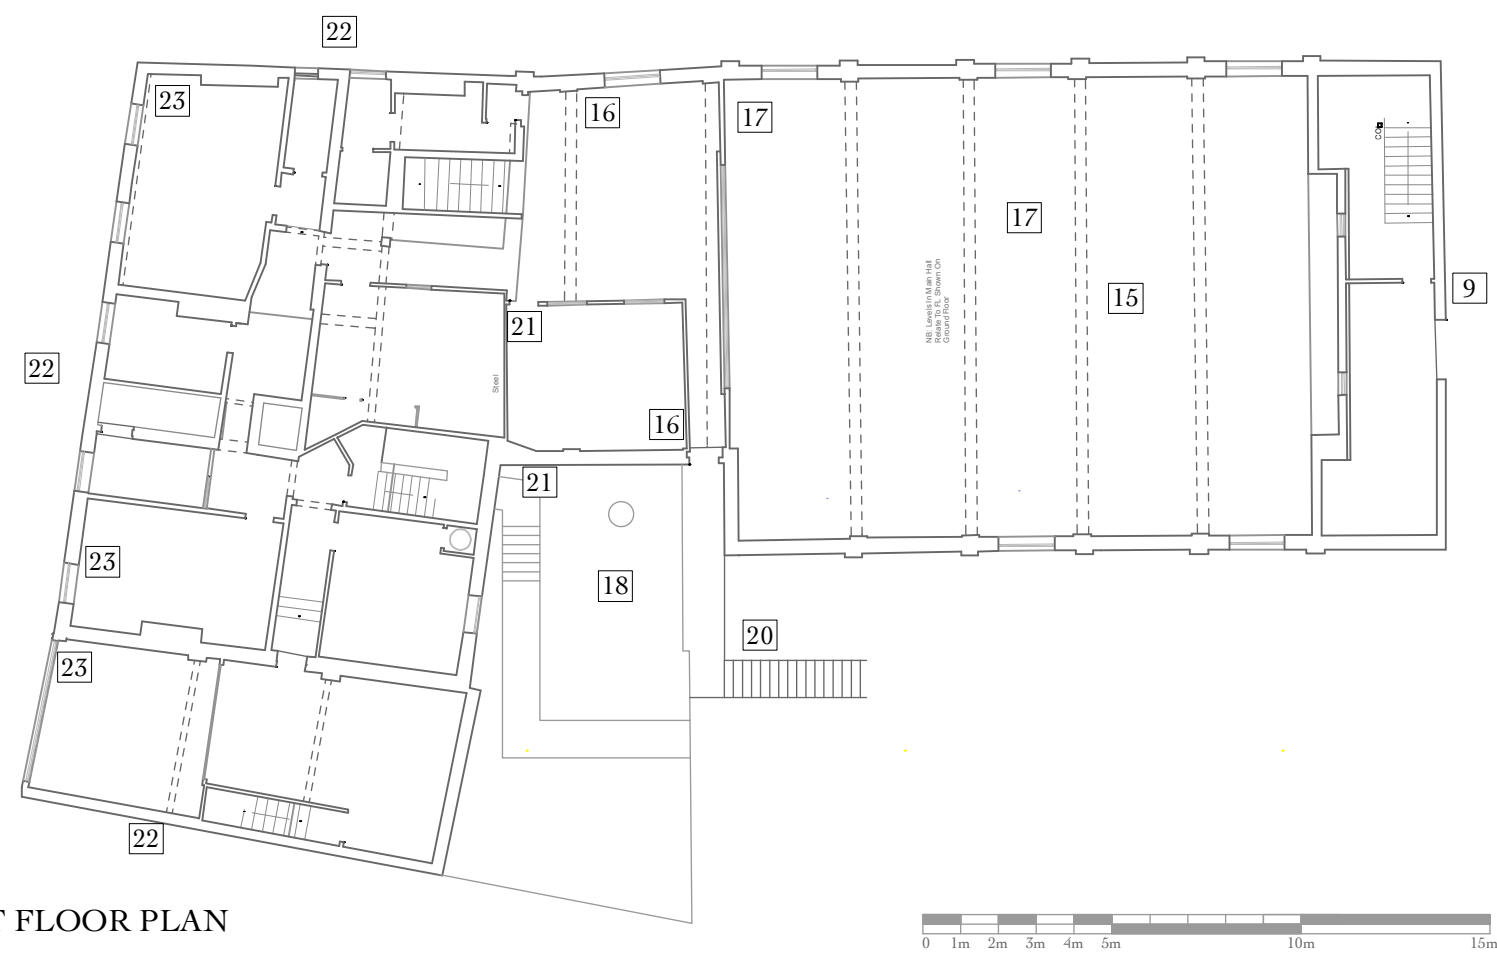
FIRST FLOOR PLAN

| Ref. | STRUCTURAL DEFECT |
|---|---|
| 15 | The existing vaulted ceiling is a fibrous plaster construction with lath and plaster and mouldings. |
| 16 | At the west end of the auditorium ceiling, at the junction with the external walls there are areas of prolonged water entry that have resulted in local areas of ceiling collapse. |
| 17 | There are also a couple of isolated areas of water penetration towards the central areas of the vaulted ceiling. |
| 21 | At the junction between the Georgian property and the auditorium extension a structural steelwork frame was inserted as part of the extension to support the upper brick wall of the front residential building. |
| 22 | The render on the front and side gables of the building is trapping moisture in the brickwork. Driving any moisture from failed flashings and water goods into the building. This is resulting in damage to internal plaster finishes and embedded timber such as timber lintols over windows. |
| 23 | Where water entry has been extensive there is evidence of local areas of decay to the floorboards and the bearing ends of floor joists. |
| 24 | Water entry due to failed flashings is also apparent at roof level in isolated areas. |
| 25 | Ground floor to first floor chimney breast missing in 3No locations. |
