SF3422 Earlsfield Park

ARBORICULTURAL SURVEY REPORT | BS 5837:2012

June Revision A 2023

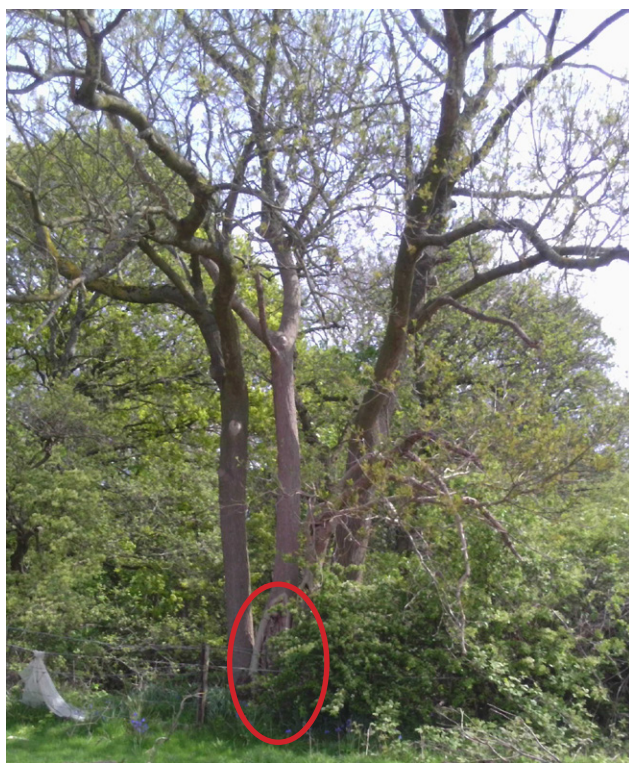
| Tree No. | Species | Top Height (crown height) m | Branch Spread (m) | | | | Stem Dia. (mm) | Age Class | Water Demand | Condition | Comments | ERC (years) | Recommendations | Category |
|---|---|---|---|---|---|---|---|---|---|---|---|---|---|---|
| T1 | Fraxinus excelsior (Ash) | 14(3) | 4 | 4 | 5 | 5 | 560 | M | M | Poor | Large cavity on stem at 1m-dangerous. Stem divides at ground level. Ash dieback. | <10 | Remove | U |

- 6.1 The proposed development produced by Building Management Services Ltd. has been assessed in relation to the existing trees on drawing SF3422 AIA01 (Appendix C).
- 6.1.2 T1 was found to be in danger of failure due to the presence of ash die-back and a large cavity on the stem which is in excess of an expectable threshold for such a defect (see figure 2). It is therefore recommended for removal.

Figure 2 – T1 showing large cavity

| Tree No. | Species | Proposed Works | Category |
|---|---|---|---|
| T1 | Fraxinus excelsior (Ash) | Removal | U |

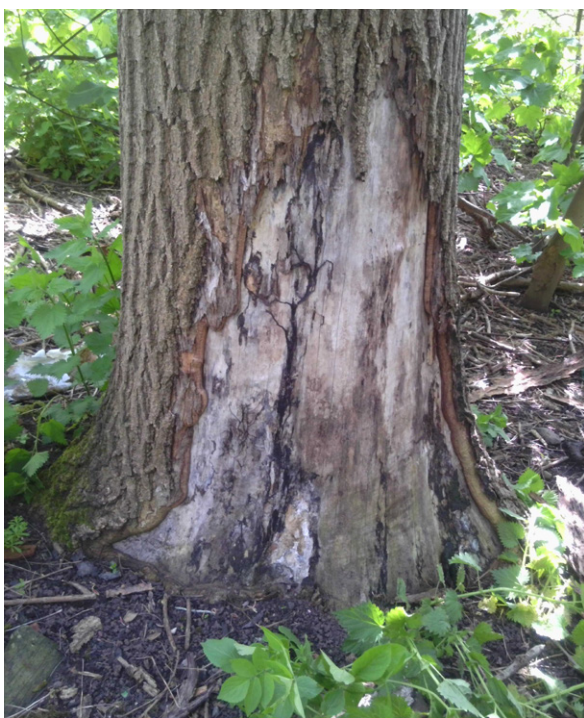
| Tree No. | Species | Top Height (crown height) m | Branch Spread (m) | | | | Stem Dia. (mm) | Age Class | Water Demand | Condition | Comments | ERC (years) | Recommendations | Category |
|---|---|---|---|---|---|---|---|---|---|---|---|---|---|---|
| W2 | Acer pseudoplatanus (Sycamore), Fraxinus excelsior (Ash), Quercus robur (Common Oak), Crataegus monogyna (Hawthorn) | 12(0) | 3.5 | 3.5 | 3.5 | 3.5 | 530 | M | M | Fair | Moderate deadwood in live trees. 3 standing dead trees. Evidence of active Armillaria on some live trees on the south edge of the woodland. | 10+ | Remove trees infected with Armillaria as part of good woodland management. | C2 |

- 6.1.3 Armillaria is present in Woodland 2 (See figures 3 and 4). Armillaria should be managed by removal of infected trees from site to help reduce the spread.

Figure 3 – Example of Armillaria 'bootlaces' on ash in W2, with decay damage

| Tree No. | Species | Proposed Works | Category |
|---|---|---|---|
| W2 | Acer pseudoplatanus (Sycamore), Fraxinus excelsior (Ash), Quercus robur (Common Oak), Crataegus monogyna (Hawthorn) | Remove trees infected with Armillaria as part of good woodland management. | C2 |

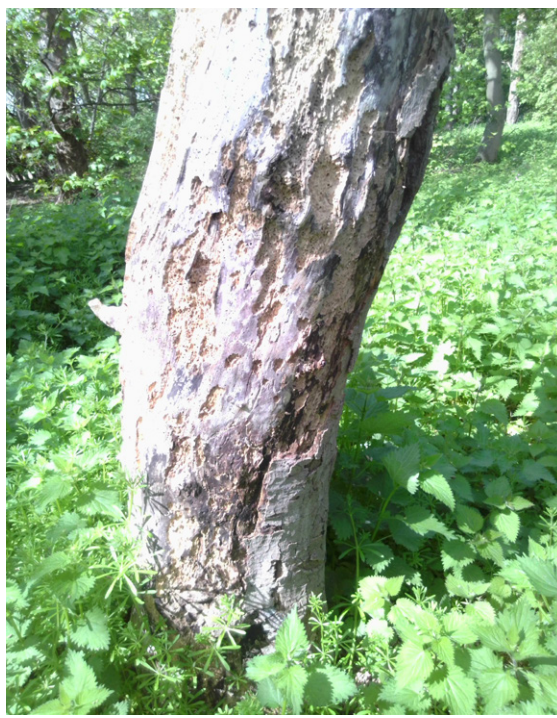
Figure 4 – Example of standing dead tree in W2 as probable result of Armillaria.
