## **STRUCTURAL ENGINEERS REPORT**

### **Addendum report**

Wayside  
Pexhill  
Cronton  
Wirral

19-AC-3748a

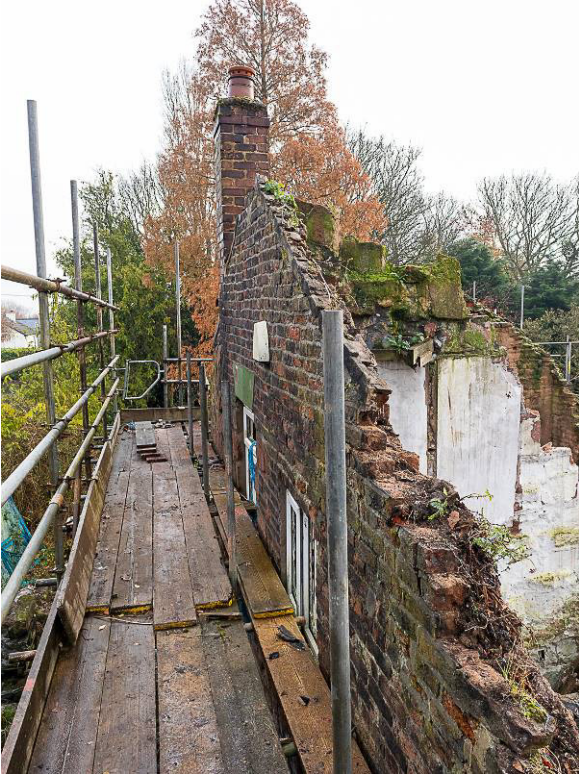
**Photograph 1**

- a) The hanging roof has disturbed the masonry. Removal of the roof to the later extension has left the laterally unsupported gable pike frail. The top 3 or 4 courses of the brickwork is well weathered. Slight pressure on the face of the wall causes it to move. A heavy gale is likely to cause the top section to fail. See Photo 1
- b) There is a large hole on the face of the wall on the line of the chimney shaft. A combination of heat damage and exfoliation of the stone face had led to this damage. See Photo 2

View looking onto the north elevation showing the outward lean of the chimney: the weathered top of the wall and the laterally unrestrained gable pike.

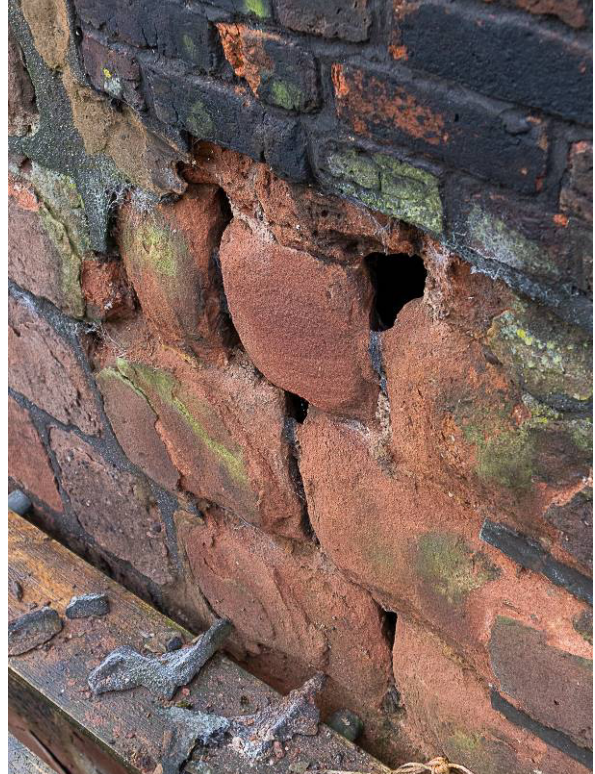
**Photograph 2**

Stonework on the North wall at the chimney stack. Note the void at the exfoliated stone face which has been caused by the combined action of heat and weathering of poorer quality stone. The brickwork above is smoke stained and is believed to be part of the second phase extension

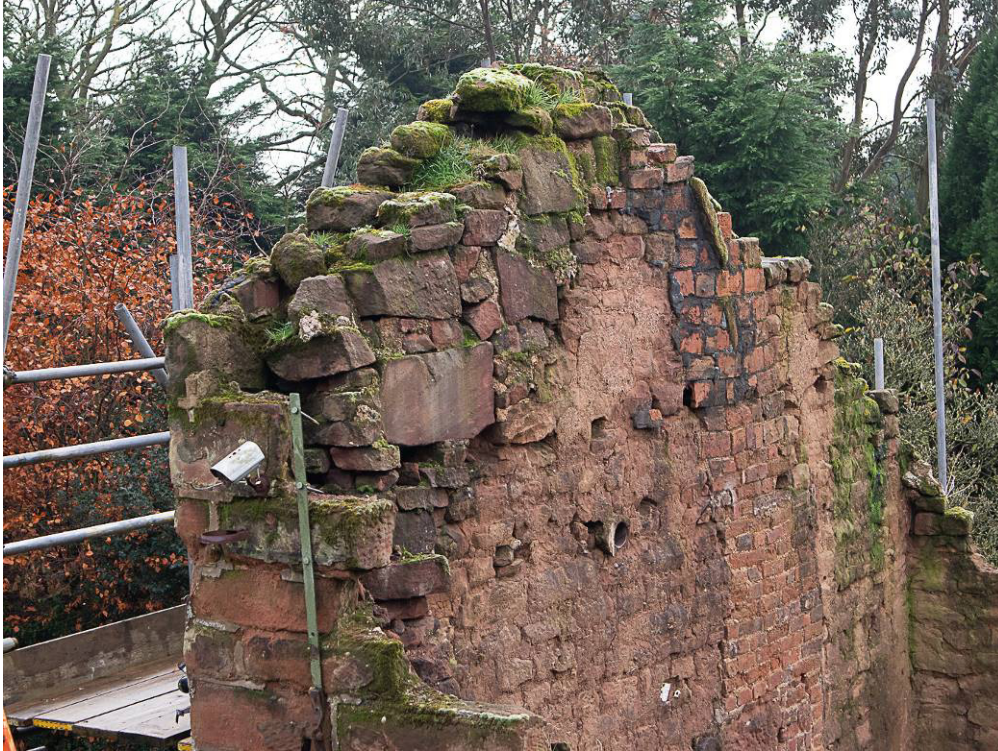
**Photograph 3**

View looking onto the internal face of the East elevation of the original building showing the extent of the loss of roof and wall fabric. This closer inspection confirms the need to disassemble and rebuild the gable pike and the masonry below the eaves corner. The chimney shaft has had the inner face rebuilt. It appears to be poorly bonded. Localised rebuilding and new ties will be required to ensure stability of this wall.

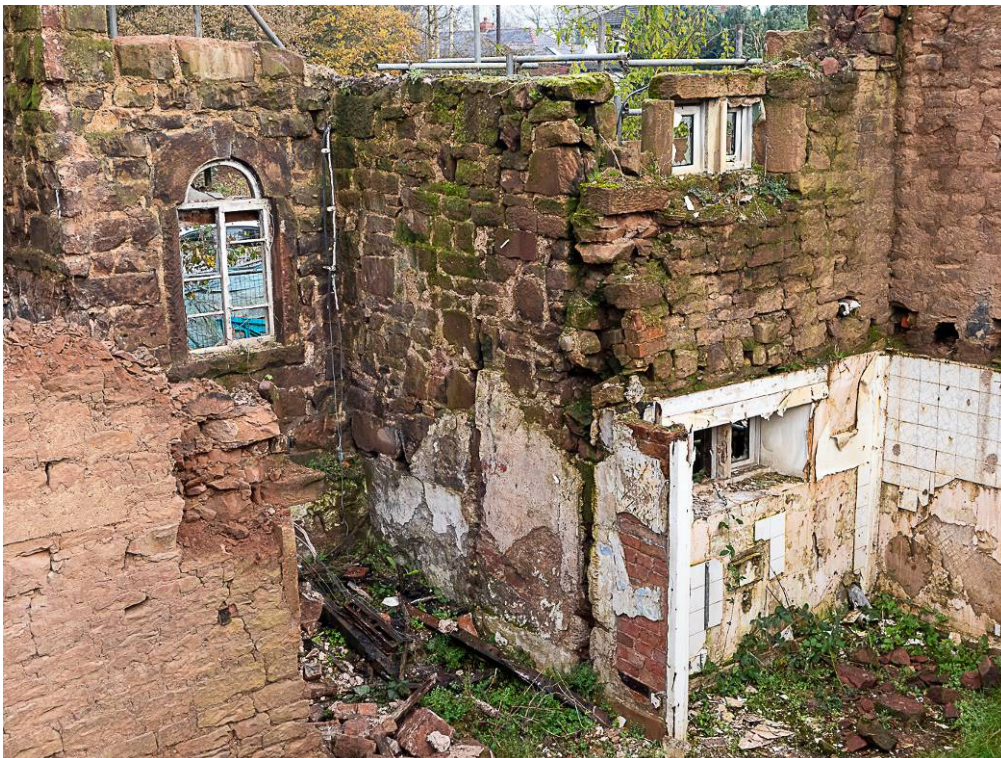
**Photograph 4**

View looking onto the internal corner of the north return and the east elevation. The short wall (RHS of this photo) was the original house's rear elevation. This wall has been severed when the 1<sup>st</sup> phase extension was constructed. The junction of the two walls has a wide open joint which will need local rebuilding.

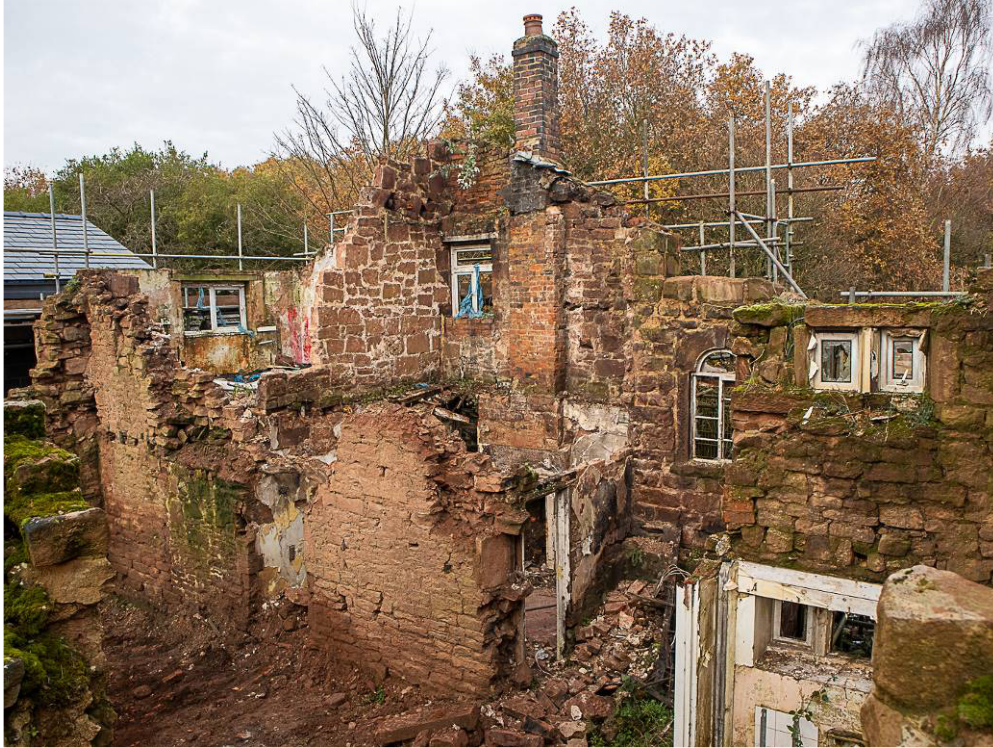
**Photograph 5**

View looking onto the internal corner of the north and west elevations. The spine wall is in the foreground. Note the lean on the chimney stack and poor condition of the spine wall.

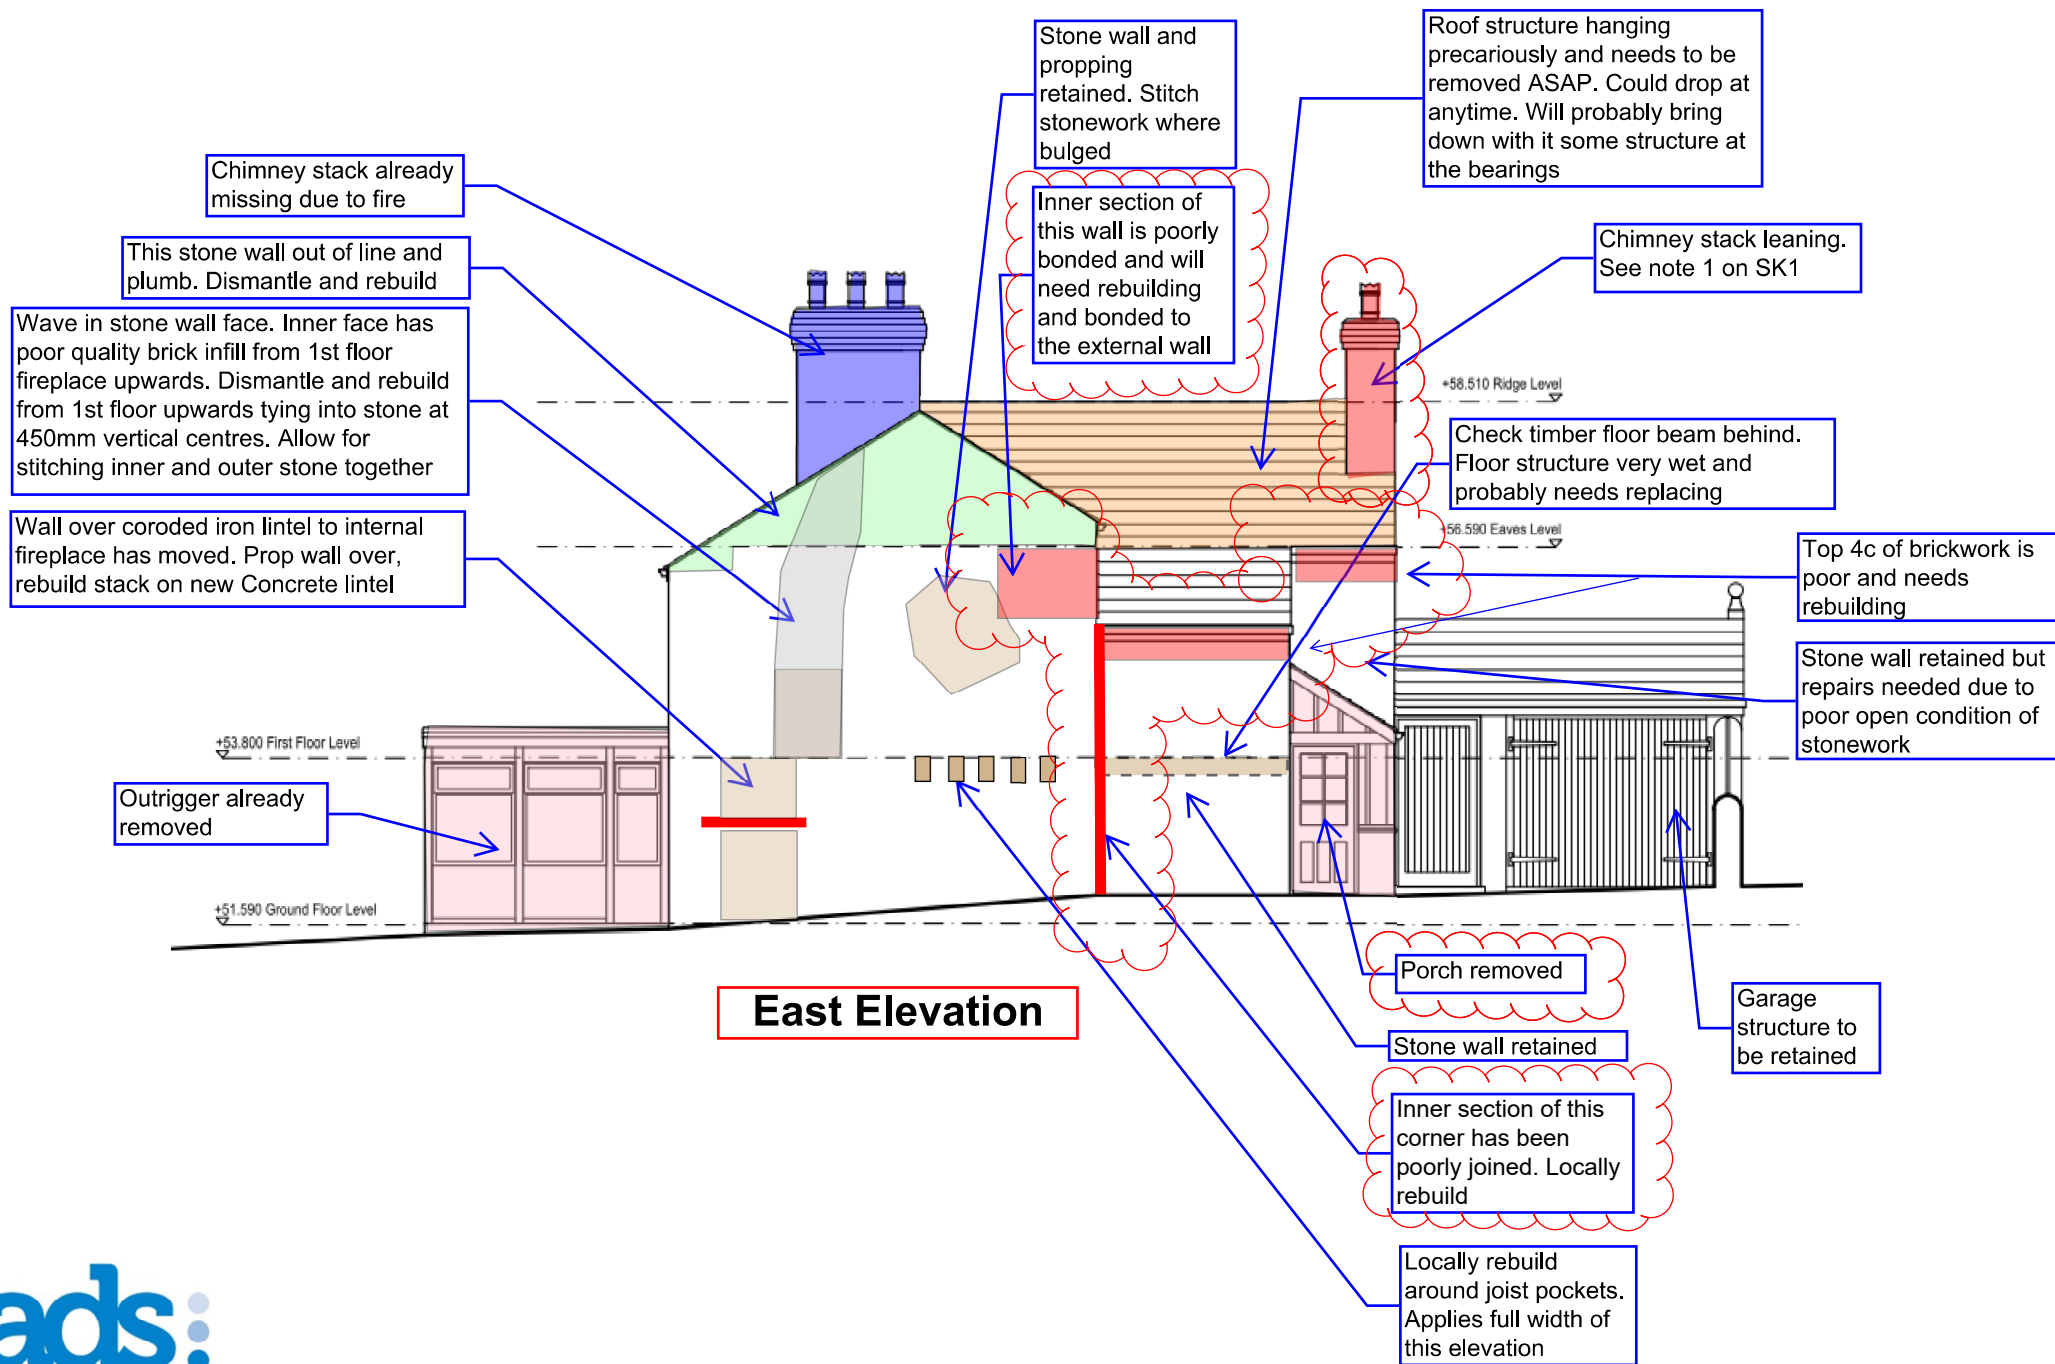
SK 3 Details of extent of further stone removal and repairs required

- a) The full extent of the distortion of the gable pike is visible and confirms that reconstruction is necessary.
- b) The brickwork immediately below the wall plates to the rear extension is loose and the mortar weathered. The loose masonry needs rebuilding.
