## **STRUCTURAL ENGINEERS REPORT**

Pex Hill  
Cronton  
WA8 5QW

9137-ADS-XX-XX-RP-S-001

12<sup>th</sup> April 2024

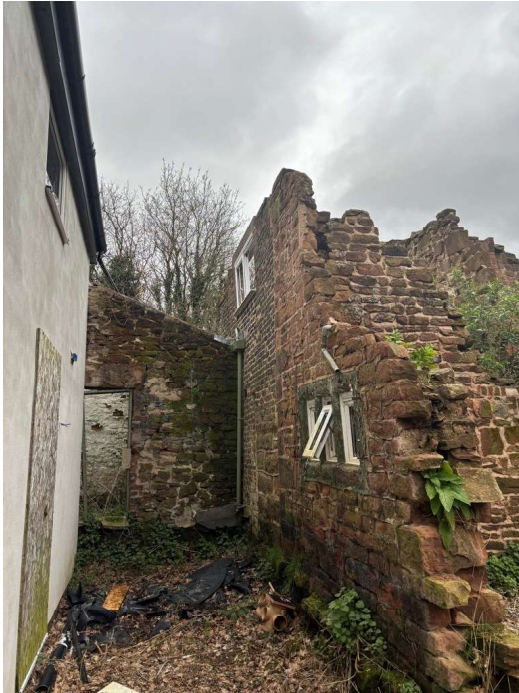
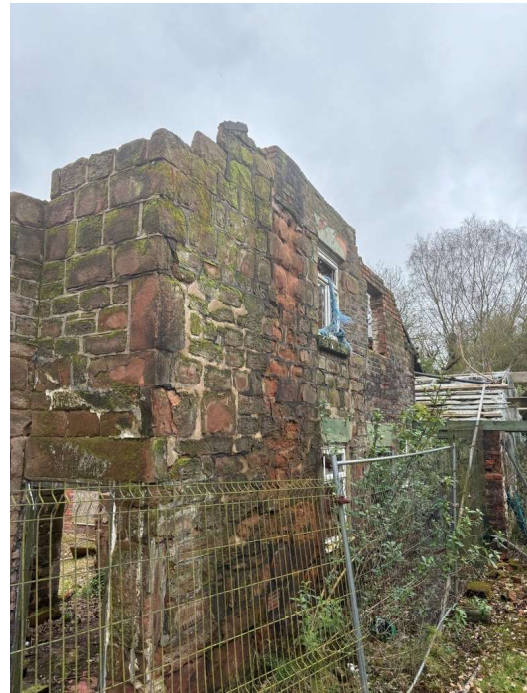
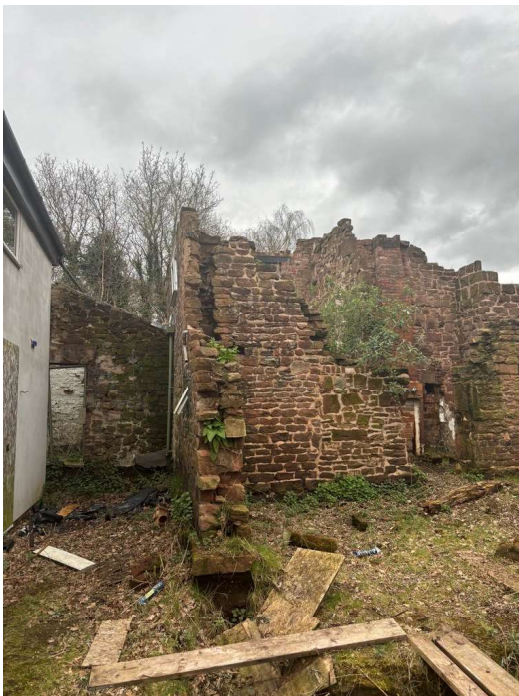
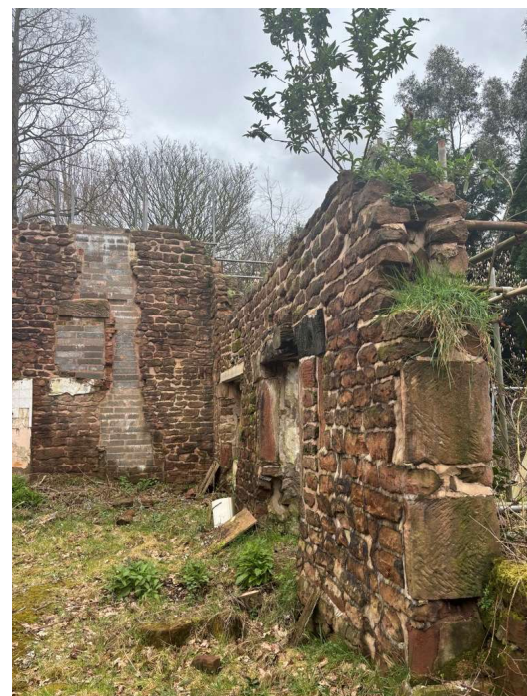
### 2024 PHOTOS

Since the 2016 report it is evident that the building has deteriorated further. On our recent inspection we noticed that the existing roof and ceiling structures which were previously present were no longer there. The ceiling structure, in particular, was providing head restraint and/or lateral restraint to the head of a large proportion of the remaining external walls. Since the lateral restraint has been removed, sections of first floors walls have since collapsed together with remaining window, window frames, cill, surrounds etc. In addition the majority of remaining walls have started to lean or tilt.

It is clear that the structural stability of the building has decreased since our first inspection and could be considered to be progressively worsening with some parts of the remaining building potentially now considered to fall under the classification of dangerous structures. We have marked up plans and elevations to illustrate the areas already perished and areas which would need to be taken down and rebuilt. Approx. 80% of the wall panels have either collapsed already or would require rebuilding, in addition to the entire roof and first floor structures. As such we see little benefit in attempting to dismantle/refurbish 20% of the remaining existing walls and would recommend that it is demolished and rebuilt following a successful planning application.

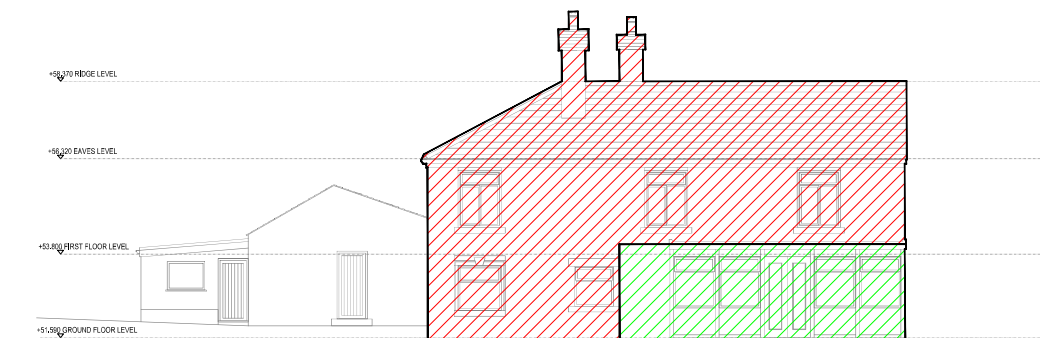
ELEVATION A-A

- COLLAPSED
- AREA OF STONE WALL TO BE TAKEN DOWN AND REBUILT

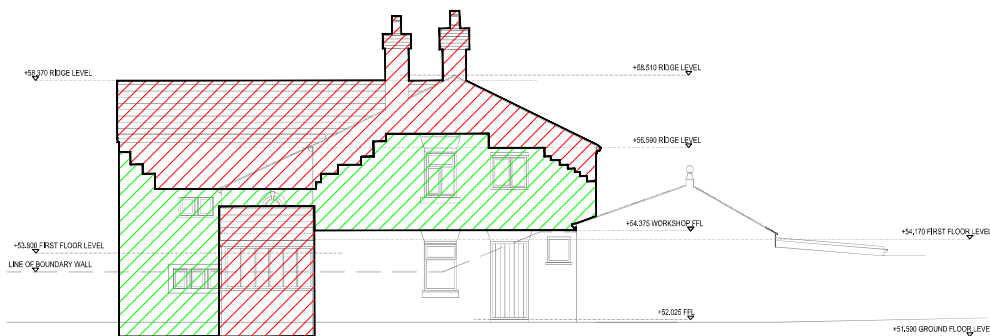
ELEVATION B-B

- COLLAPSED
- AREA OF STONE WALL TO BE TAKEN DOWN AND REBUILT
