# DAYTIME BAT SURVEY

## ECCLESTON HOUSE & ASPINALL HOUSE, PRESCOT, LIVERPOOL

JANUARY 2022

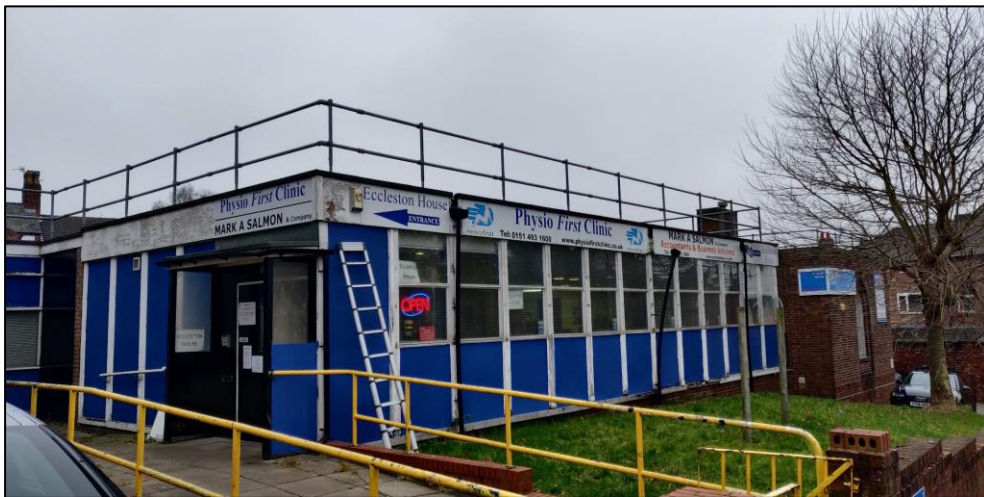
- 3.2 Eccleston House is a single-storey, steel-framed building, constructed from wooden panelling, which is moderately degraded with peeling paint and rotten wood found throughout the exterior. The windows and doors are all intact and flush to the external panels. The building has a flat, felted roof which is in good condition, with minimal damage to, or lifting of, the felt lining. While the outside of the building is generally well sealed, there are a number of air vents found on all sides (see Photograph 1). These gaps were inspected for droppings and an endoscope was used to probe internally for bat evidence. Due to lack of bat evidence and a large amount of built-up debris such as dust and spider webs, the ventilation gaps appear to be unused by bats.

*Photograph 1 showing the front elevation of the building*

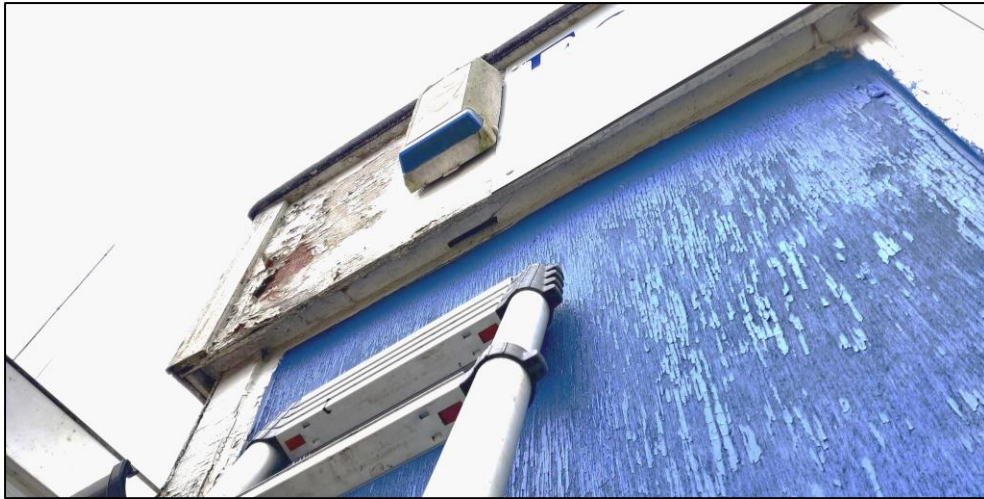
- 3.3 In places, a wooden lip/overhang exists (see Photographs 2 and 3). This was thoroughly inspected and found to be flush to the other panels and damp. No evidence of bat activity was found on the property exterior.

*Photograph 2 showing the side elevation*

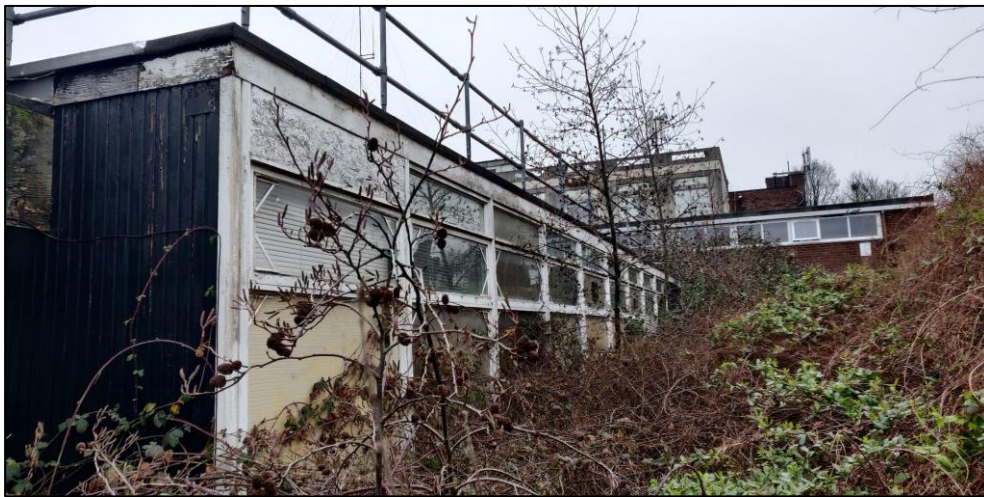
*Photograph 3 showing the rear of Eccleston House*

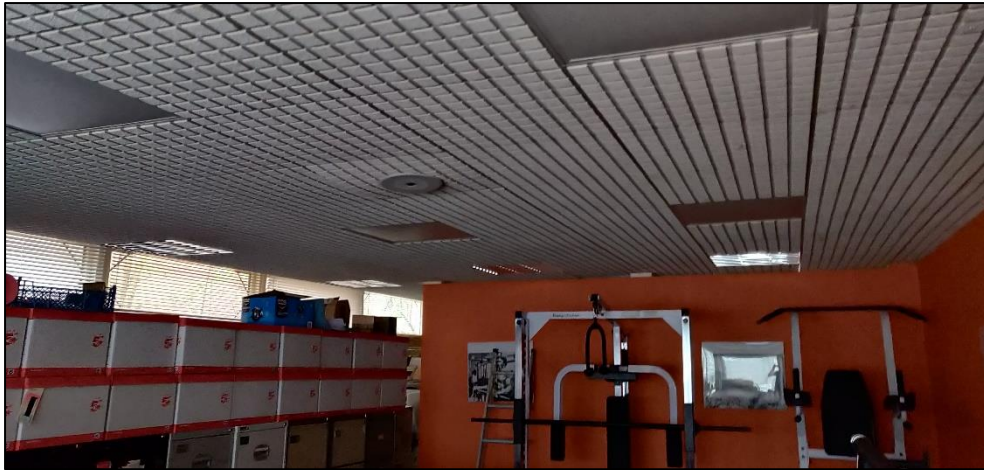
- 3.4 Internally, the building is divided into rooms, which are well lit and in use (see Photograph 4). A floating ceiling exists, which houses lighting, and this lies very close to the flat roof. No roof voids exist. Upon lifting a ceiling tile, no daylight was visible in the small gap. No evidence of bat activity was found within Eccleston House.

*Photograph 4 showing an internal room at Eccleston House*

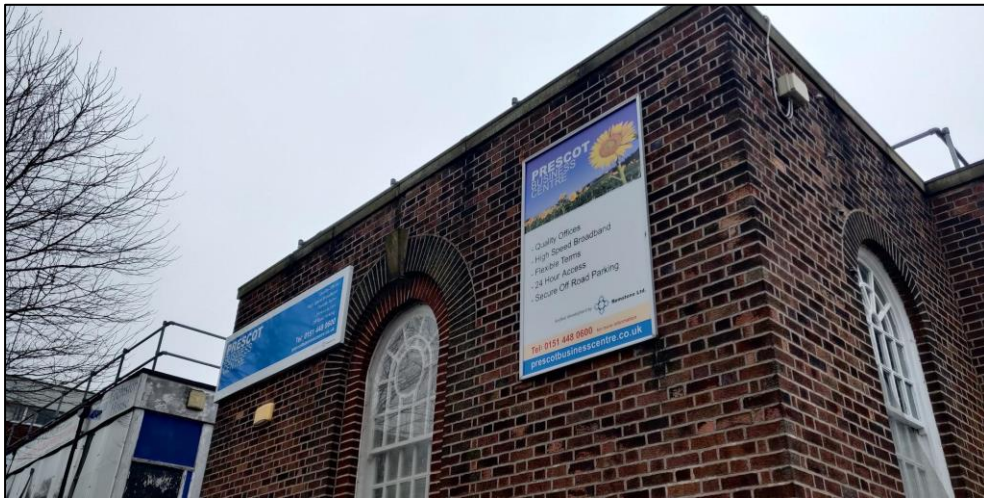
- 3.5 Aspinall House is a single-storey building constructed from brick (see Photograph 5). The external brickwork is in excellent condition, with no missing mortar or bricks. The windows are intact and the window and door frames are flush to the brickwork. It has a flat, felted roof which is in good condition (see Photograph 6). The stone lintels at the roof edges are intact. The building is well sealed, with no notable fissures or cracks leading to cavities and no evidence of bat activity was found externally.

*Photograph 5 showing Aspinall House*

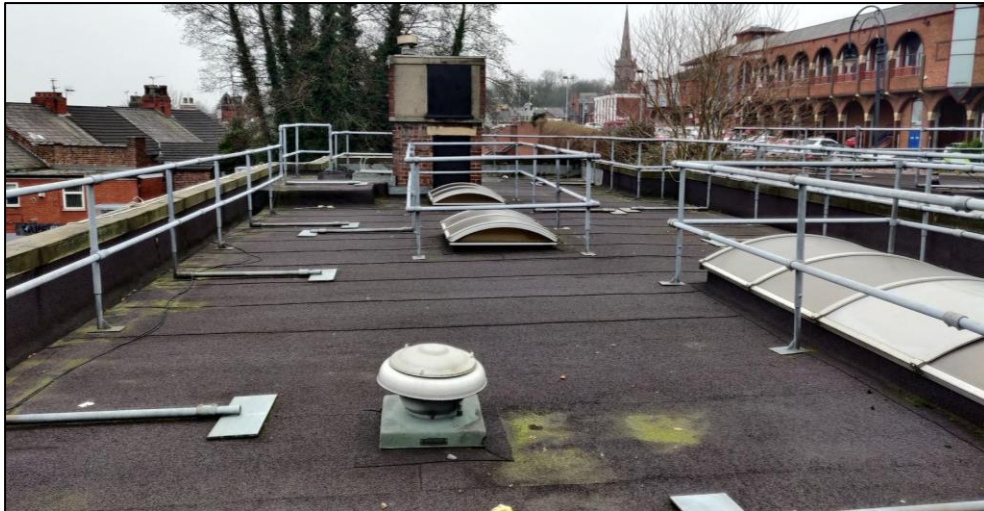
*Photograph 6 showing the roof of Aspinall House*

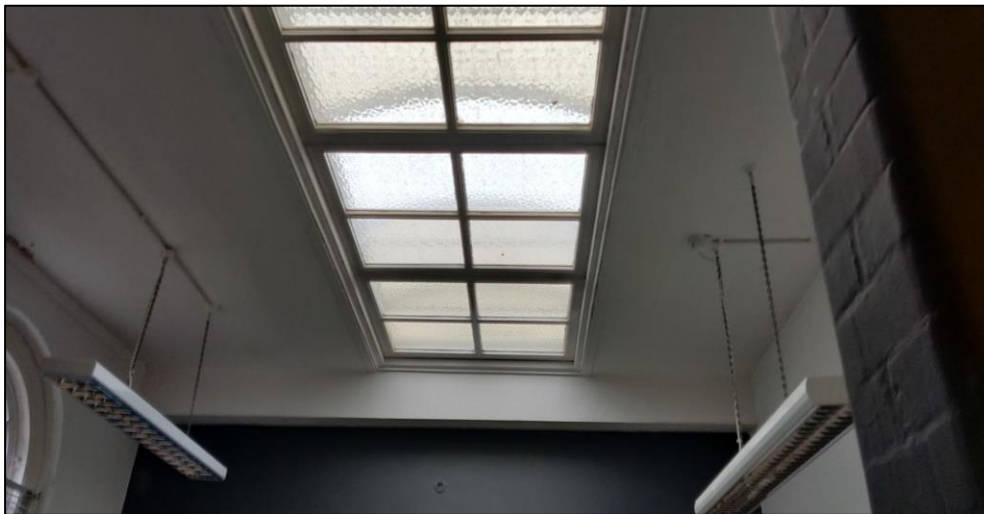
- 3.6 Inside, the building is divided into offices, with high ceilings and no roof voids (see Photograph 7). Skylights exist across the roof. The rooms are well lit and well sealed. Accessed externally is a boiler room that provides access to the roof. This room is partially open to the elements due to a grille on the door. Inside, it is well sealed with no bat roosting opportunities (see Photograph 8). No evidence of bat activity was found within Aspinall House.

*Photograph 7 showing part of the interior of Aspinall House*

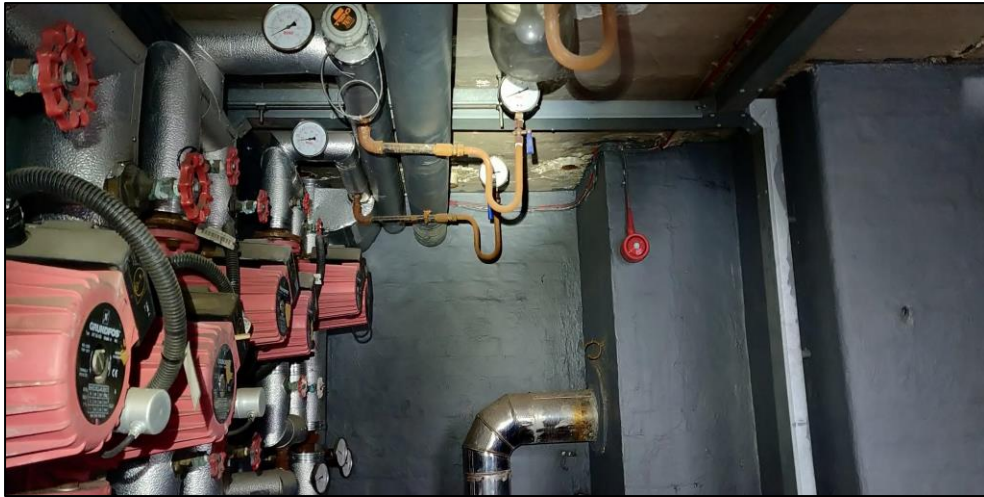
*Photograph 8 showing the interior of the boiler room*
