Picture Palace, Prescott  
for Purcell

Ground & First Floor Plans

Drawing No: X64/101    Rev: -    Scale: 1:200 @ A3    Date: July 2022

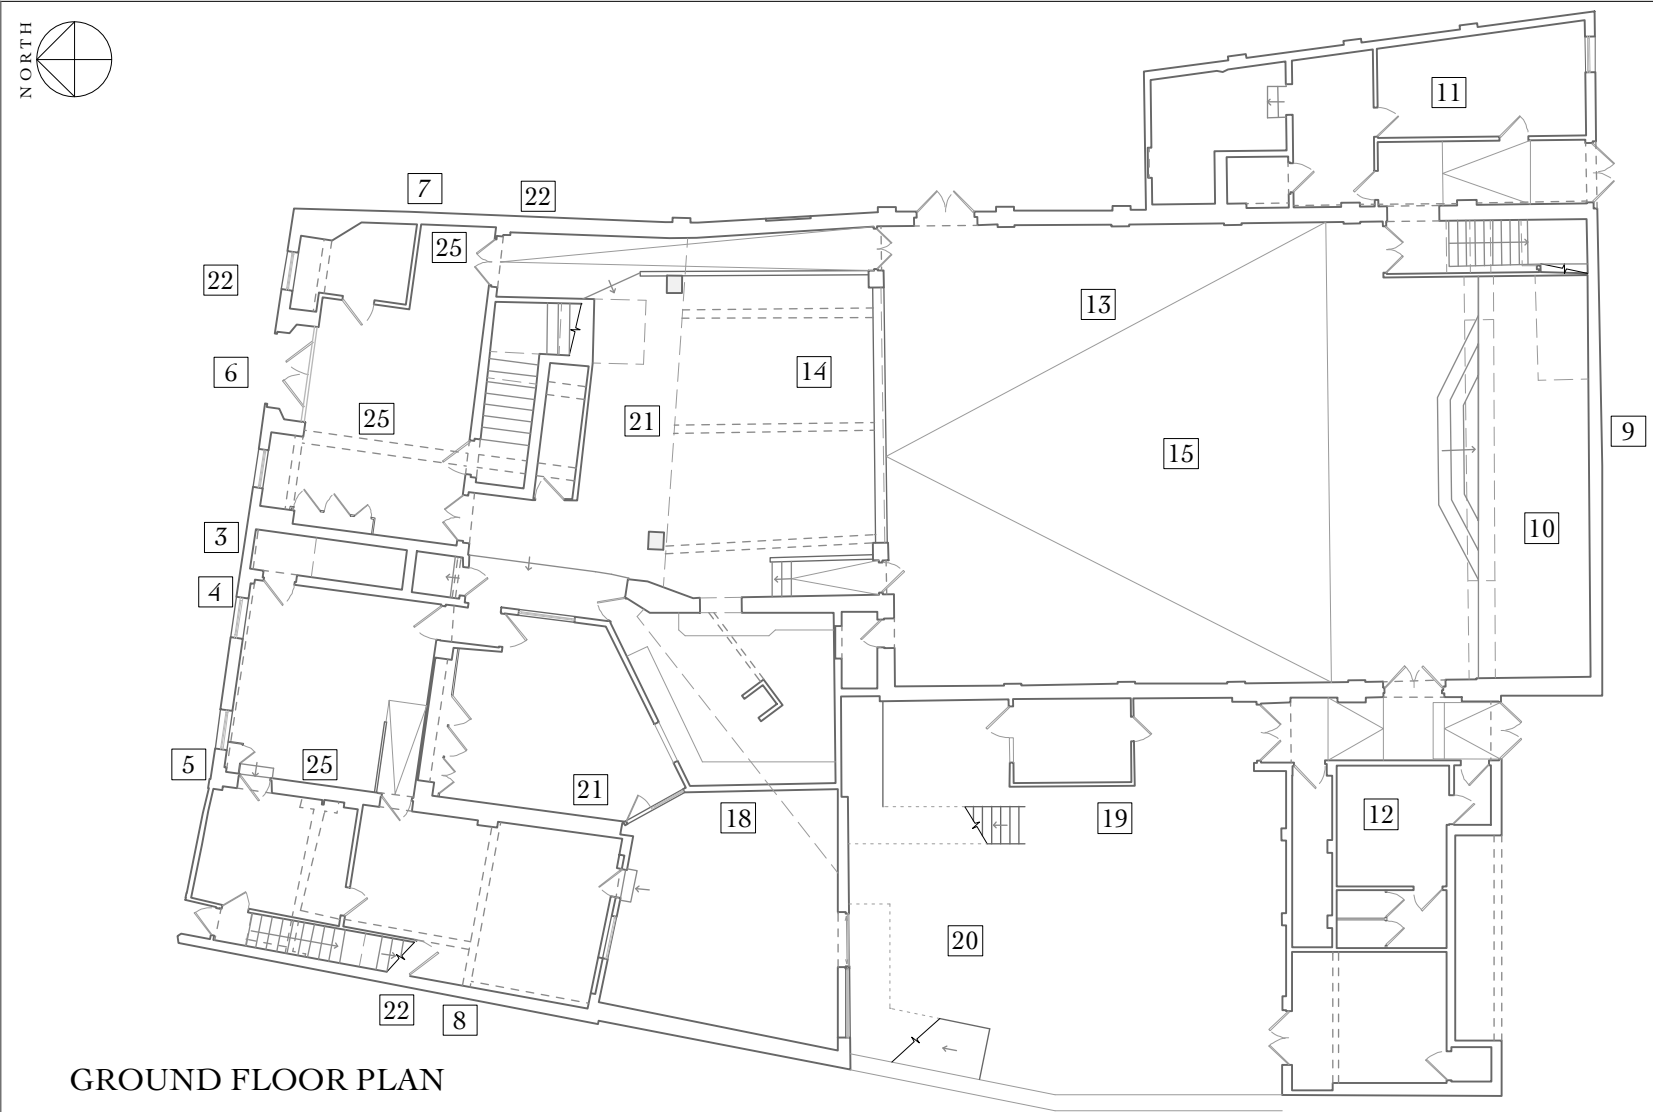
GROUND FLOOR PLAN

| Ref. | STRUCTURAL DEFECT |
|---|---|
| 1 | Displacement and vegetation growth to front elevation main parapet. Roots well established and initial vegetation clearance works superficial |
| 2 | Decay caused by prolonged water entry at the rear of the front elevation parapet – jack rafter feet ends and timber wall plate. |
| 3 | Vertical cracks visible in the high level cornice and the upper plain render, due to water entry and local areas of movement. |
| 4 | Vertical and diagonal cracking in the low level ashlar rendering, due to local movement and previous alterations to the entrance position. |
| 5 | The vertical joint between the right hand end building and the main building appears to have opened over time. The joint is wider at the top of the building elevation than at the bottom. May suggest some long term rotation. However, this is not visibly internally suggesting it is longstanding and potentially non-active. |
| 6 | Cracks generally in the front elevation onto Kemble Street. These are most likely a material issue, rather than being indicative of structural movement. (cement based render and wet clay bricks behind), |
| 7 | Same for left hand side gable elevation |
| 8 | Same for right hand side gable elevation |
| 9 | The external rear wall to the auditorium has distorted probably due to a lack of adequate restraint at roof level and the internal arrangement of the roof structure above the stage area. Horizontal forces from an inclined ceiling structure. |
| 10 | There is a large baptism plunge pool within the raised stage structure. |
| 11 | Water penetration through the roof finishes of the north east single storey amenity block has resulted in extensive dry rot outbreak and damage to structural timber lintols. |
| 12 | Water penetration through the roof finishes of the south east single storey amenity block has resulted in extensive dry rot outbreak and damage to structural timber lintols. |
| 13 | There are service trenches within the sloped ground floor from the small basement mechanical plant to grilles at the edges of the auditorium aisles. The covers of which in places have decayed and collapsed. |
| 14 | At the rear of the auditorium the ground floor has been raised with a timber joist floor. This appears to be a relatively modern addition to increase the level space as part of the Church use of the building. |
| 15 | The existing vaulted ceiling is a fibrous plaster construction with lath and plaster and mouldings. |
| 16 | At the west end of the auditorium ceiling, at the junction with the external walls there are areas of prolonged water entry that have resulted in local areas of ceiling collapse. |
| 17 | There are also a couple of isolated areas of water penetration towards the central areas of the vaulted ceiling. |
| 18 | At the rear of the Georgian property there is a single storey extension. The once corrugated sheet roof (asbestos), remains and is concealed by the ceiling and over cladding in profiled pressed metal. |
| 19 | External to the south side of the auditorium there is a single storey lean to addition constructed in concrete blockwork with a felt roof. |
| 20 | At the rear there are steel ladders and steel accessways and stairs that relate to maintenance access and fire escapes. |
| 21 | At the junction between the Georgian property and the auditorium extension a structural steelwork frame was inserted as part of the extension to support the upper brick wall of the front residential building. |
| 22 | The render on the front and side gables of the building is trapping moisture in the brickwork. Driving any moisture from failed flashings and water goods into the building. This is resulting in damage to internal plaster finishes and embedded timber such as timber lintols over windows. |
| 23 | Where water entry has been extensive there is evidence of local areas of decay to the floorboards and the bearing ends of floor joists. |
| 24 | Water entry due to failed flashings is also apparent at roof level in isolated areas. |
| 25 | Ground floor to first floor chimney breast missing in 3No locations. |
