| Ref. | STRUCTURAL DEFECT |

Picture Palace, Prescot  
for Purcell

Second Floor & Roof Plans

Drawing No: X64/102    Rev: -    Scale: 1:200 @ A3    Date: July 2022

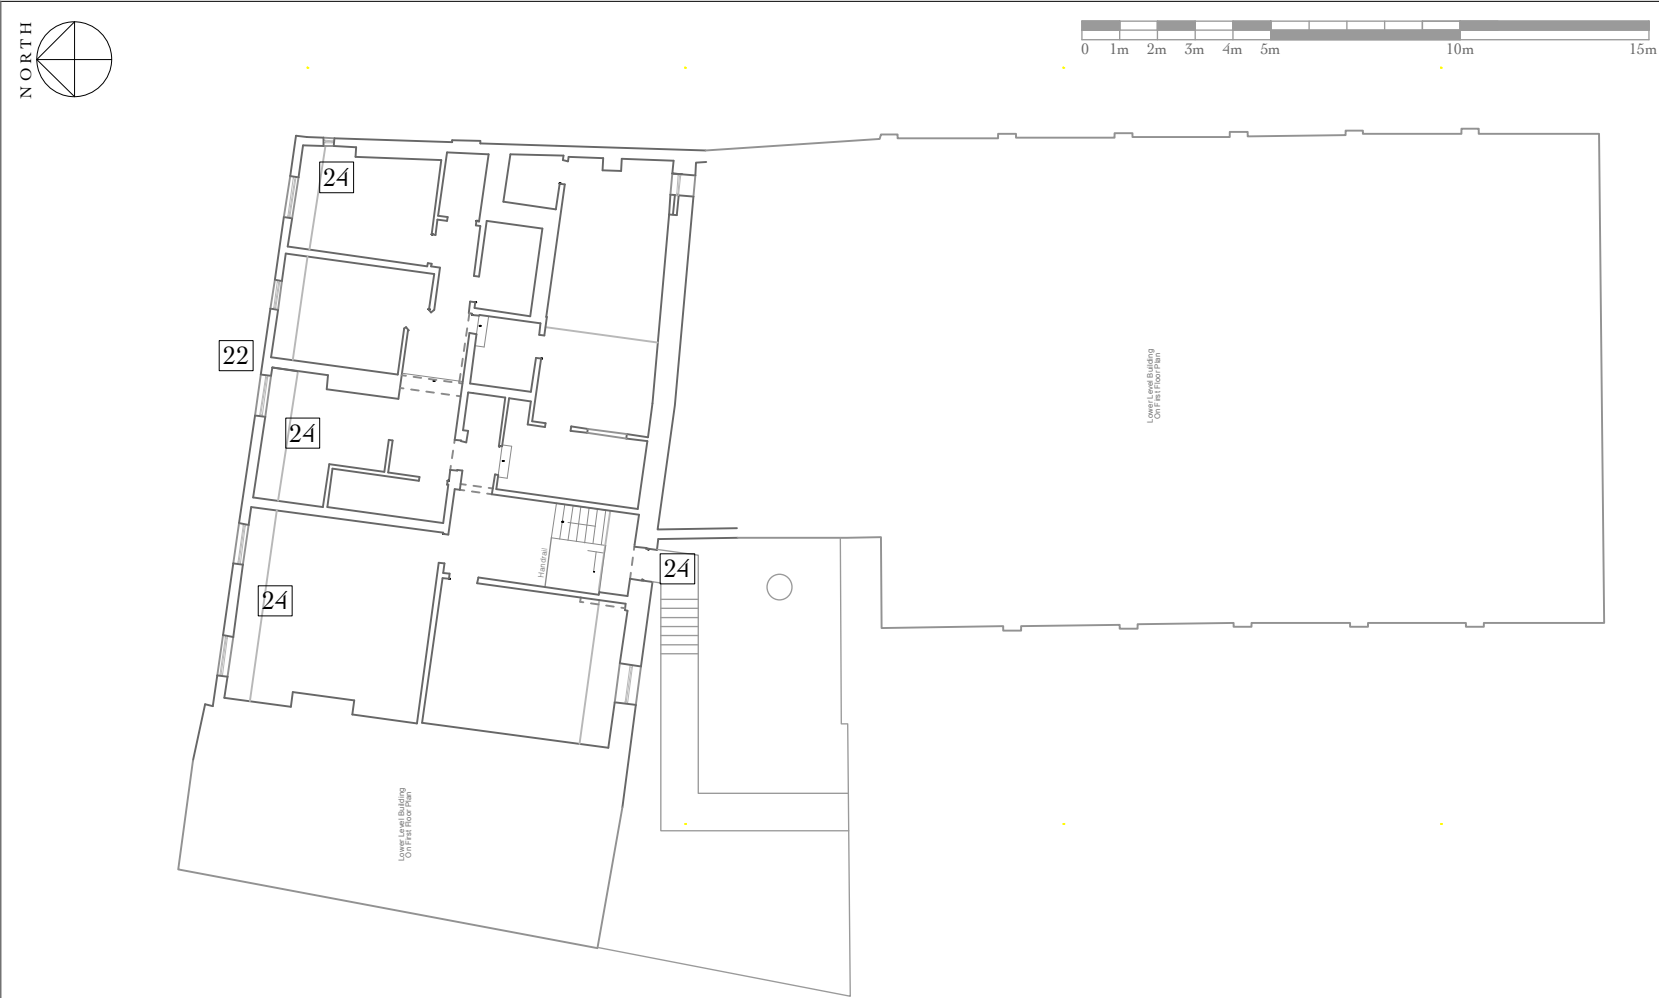
SECOND FLOOR PLAN

| Ref. | STRUCTURAL DEFECT |
|---|---|
| 18 | At the rear of the Georgian property there is a single storey extension. The once corrugated sheet roof (asbestos), remains and is concealed by the ceiling and over cladding in profiled pressed metal. |
| 19 | External to the south side of the auditorium there is a single storey lean to addition constructed in concrete blockwork with a felt roof. |
| 20 | At the rear there are steel ladders and steel accessways and stairs that relate to maintenance access and fire escapes. |
| GEORGIAN PROPERTIES | |
| 22 | The render on the front and side gables of the building is trapping moisture in the brickwork. Driving any moisture from failed flashings and water goods into the building. This is resulting in damage to internal plaster finishes and embedded timber such as timber lintols over windows. |
| 23 | Where water entry has been extensive there is evidence of local areas of decay to the floorboards and the bearing ends of floor joists. |
| 24 | Water entry due to failed flashings is also apparent at roof level in isolated areas. |
| 25 | Ground floor to first floor chimney breast missing in 3No locations. |

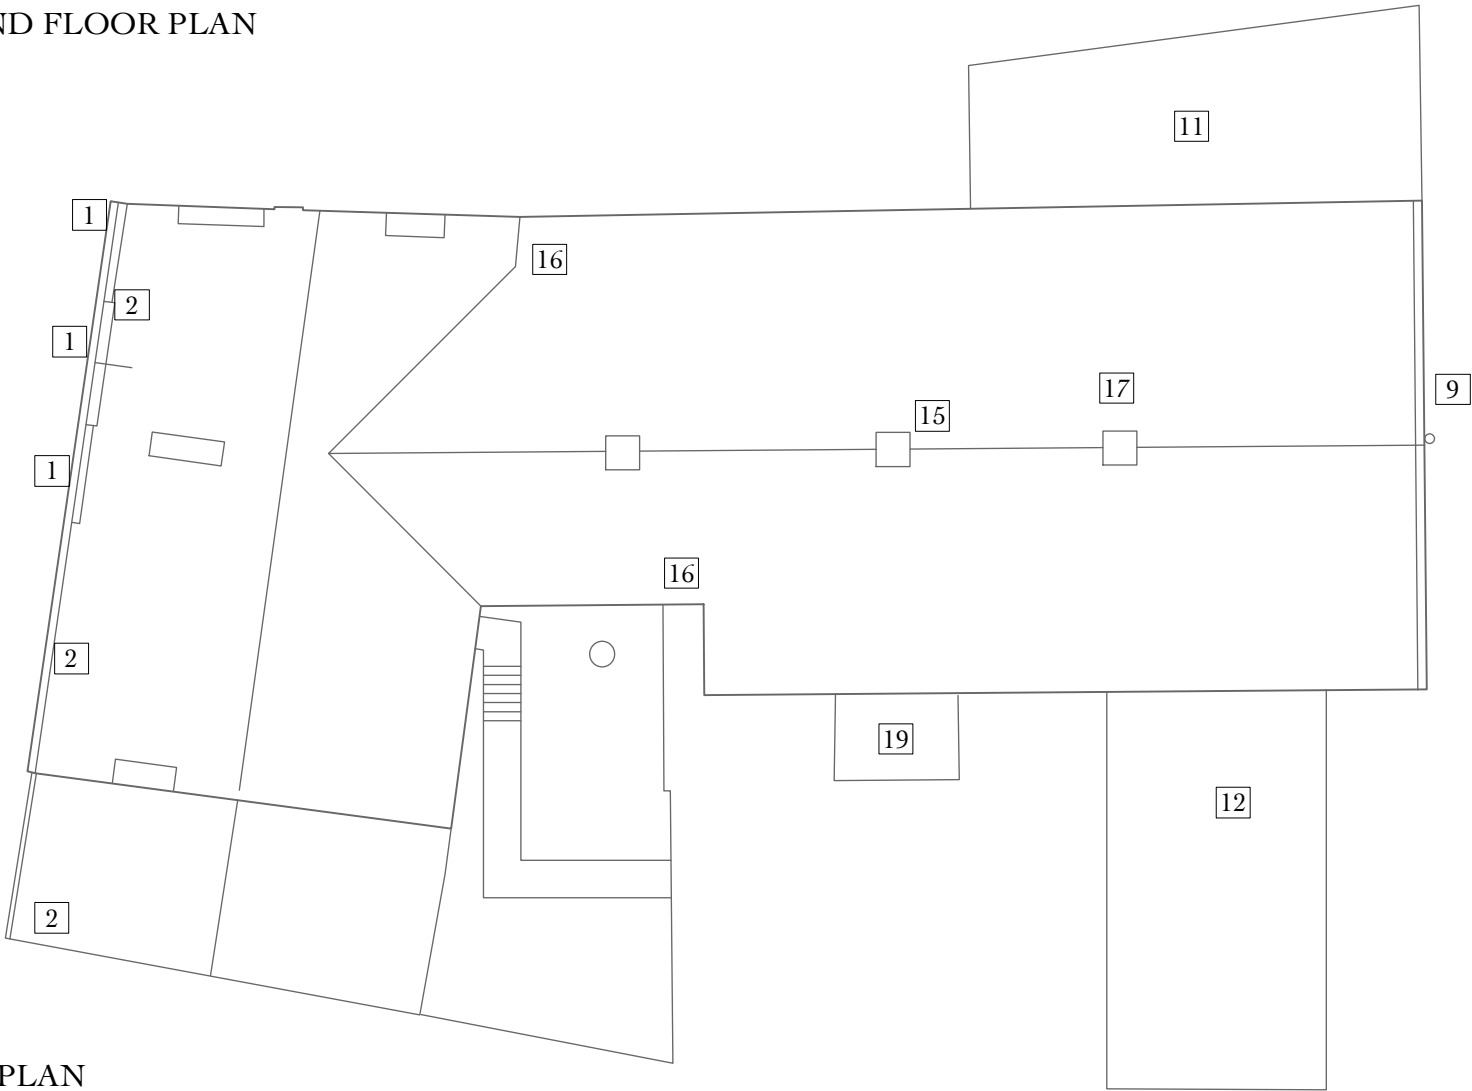
ROOF PLAN

| Ref. | STRUCTURAL DEFECT |
|---|---|
| 1 | Displacement and vegetation growth to front elevation main parapet. Roots well established and initial vegetation clearance works superficial |
| 2 | Decay caused by prolonged water entry at the rear of the front elevation parapet – jack rafter feet ends and timber wall plate. |
| 16 | At the west end of the auditorium ceiling, at the junction with the external walls there are areas of prolonged water entry that have resulted in local areas of ceiling collapse. |
| 17 | There are also a couple of isolated areas of water penetration towards the central areas of the vaulted ceiling. |
