EXISTING DUTCH & STONE BARN & PIGGERY, FORMER COACH ROAD FARM, CUT LANE, KNOWSLEY, L33 3AQ

STRUCTURAL APPRAISAL OF EXISTING BARN & PIGGERY FOR CONVERSION TO LIVING ACCOMMODATION

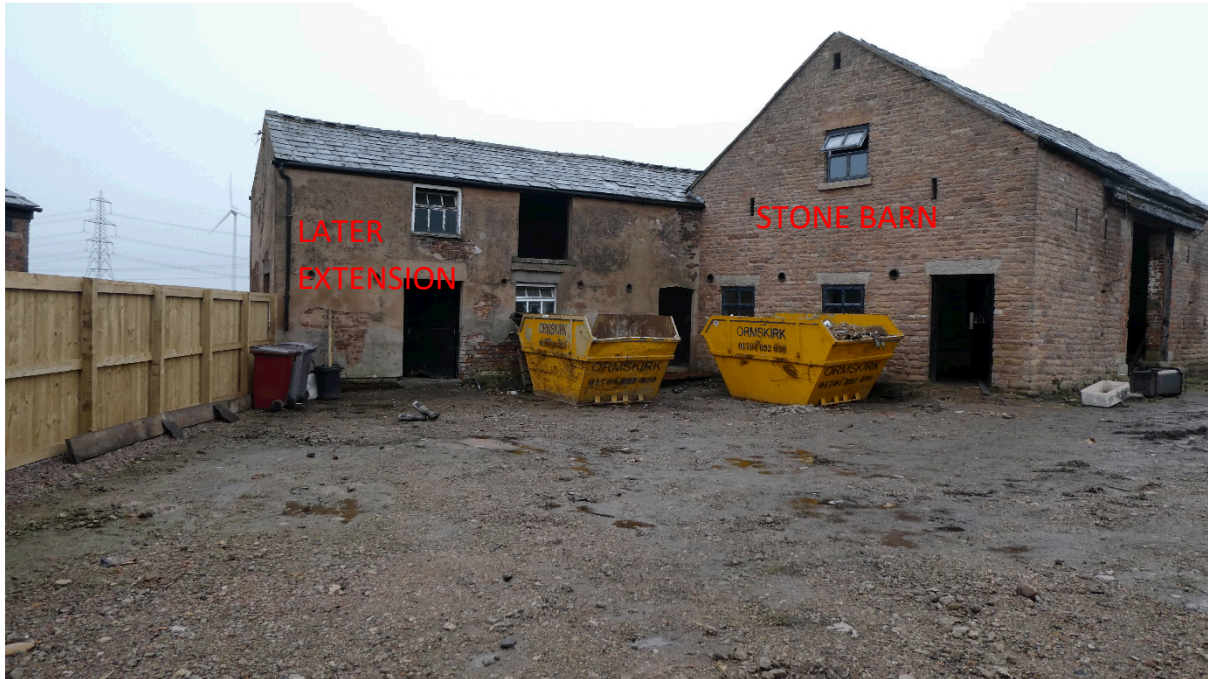
#### 2.1.1 Original Stone Barn

The barn has been standing since 1759 and overall there is little sign of any differential settlement or deflection'

The walls are constructed of stone ranging in thickness from 350mm to 400mm thick.

The foundations are of stone thickened out below ground level.

The roof is constructed entirely of exposed timber members with a slate roof.

The ground floors are of concrete which may overlay the original floors, with the upper floors being constructed of open timber flooring.

There are signs of woodwork attack to some of the timbers and further investigations and repairs would be required.

The existing roof timbers will require further investigation as to the extent of any damage caused by wood worm attack, and any necessary repairs be carried out.

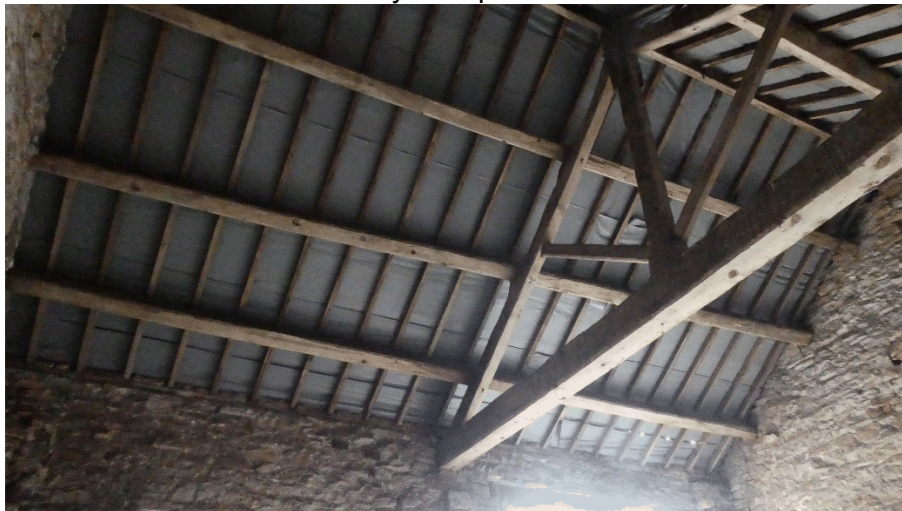
There is a King Post Truss Rafter in the centre of the main barn area.

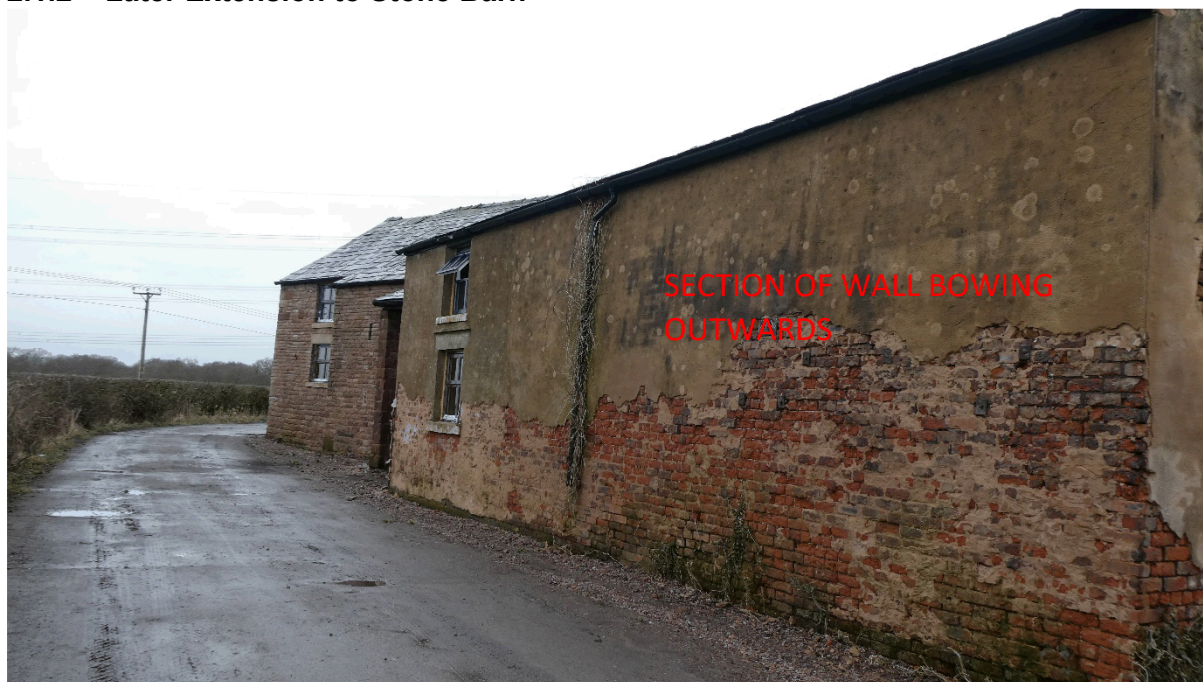
### 2.1.2 Later Extension to Stone Barn

Built later prior to 1840 the extension shows some signs of movement and settlement, in particular the side elevation to Cut Lane is bowing outwards and requires to be rebuilt

The walls are constructed of 350mm thick brickwork rendered on the outside with a sand/cement render.

There are signs of woodwork attack to some of the timbers and further investigations and repairs would be required.

Approximately 1/3<sup>rd</sup> of the existing side elevation wall to Cut Lane has bowed outward and needs to be taken down, the foundations investigated and repaired as necessary, then the wall rebuilt and tied into the remaining structure.

Again the existing roof timbers will require further investigation as to the extent of any damage caused by wood worm attack, and any necessary repairs be carried out.

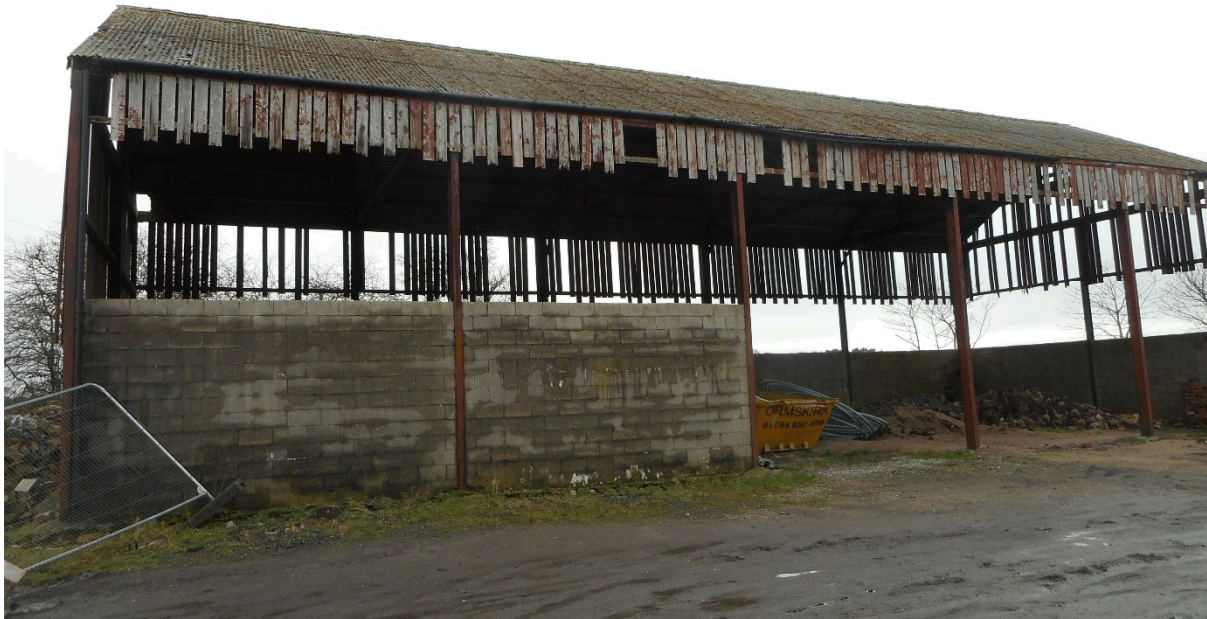
### 2.1.3 Dutch Barn

The building would appear to have been constructed within the mid-20th century and overall there are no signs of settlement or movement.

The roof is supported off 14No. 178 x 102 x 19kg universal beams, as columns, set in concrete around the external at an average of 4.6m centres. The beams show signs of rust due to lack of maintenance and would need to be treated and repainted

The corrugated roof sheets would appear to be of asbestos/cement and would require removal in a controlled manner(e.g. wetting down and 'Double Bagging') and taken to an appropriate waste disposal site.

The existing structure to the Dutch Barn will be retained as the principal structure and is capable of carrying the loads placed upon the columns and roof timbers. The existing steel columns require treatment and repainting.

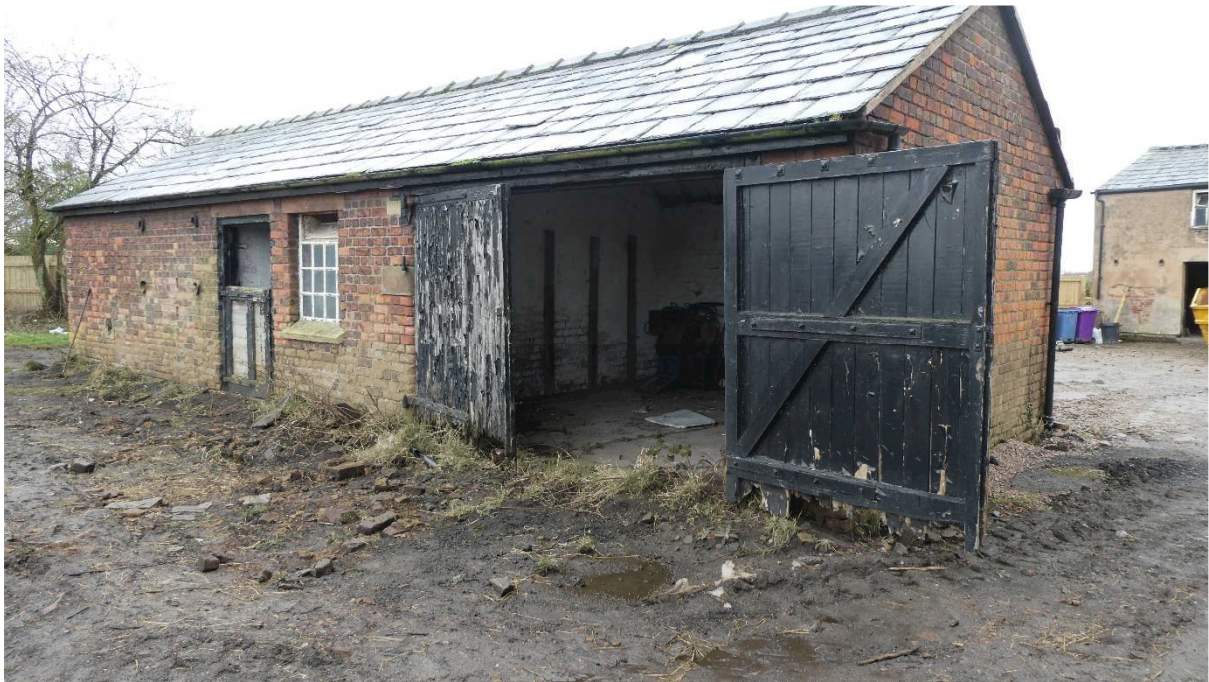
#### 2.1.4 Piggery

Overall there is little or no sign of movement or settlement, the brickwork being in good condition considering it's age.

The roof is a slate roof on timber t & g boards on timber purlins supported at the open end on steel posts.

The floor is a concrete slab of unknown thickness and shows no sign of damp or cracking.

The roof may require support from new rafters between the existing purlins to support any insulation layer proposed.
