**STRUCTURAL REPORT**

**THE BREWERY HOUSE  
NETHERLEY ROAD  
TARBOCK GREEN  
MERSEYSIDE  
L35 1QE**

**NEW START HOMES  
THE JOB BANK  
4 TUNNEL ROAD  
WAVERTREE  
LIVERPOOL  
L7 6QD**

**L1724/R01/revA**

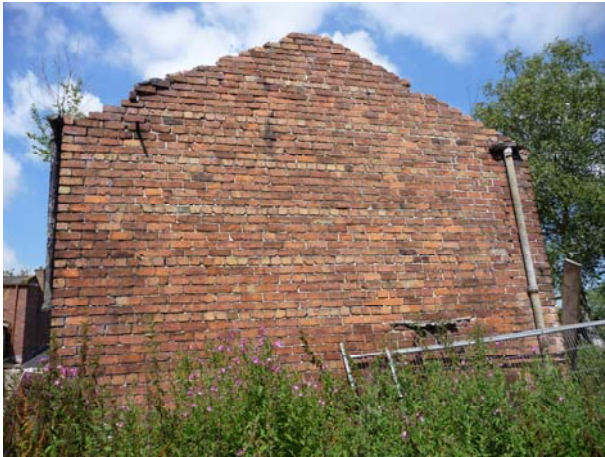
*Photograph 01*

This is constructed in English Garden Wall Bond loadbearing brickwork (*Photograph 01*). There is a header course every sixth course. The brickwork is badly weathered and the mortar joints deeply recessed. The wall is plumb up to eaves level but the triangular pike above the eaves leans inwards towards the building (*Photograph 02*). The top courses of brickwork along the verge are loose.

The North, East and West elevations should be demolished down to loft floor level and rebuilt. Approximately 50% of the existing brickwork will remain.

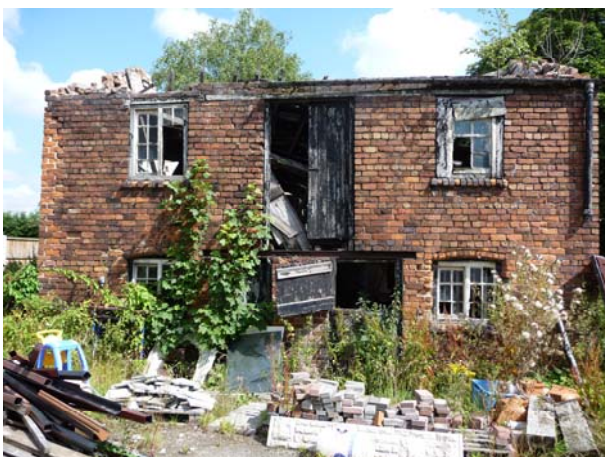
*Photograph 03*

This elevation is also constructed of English Garden Wall Bond (*Photograph 03*). All the brickwork is badly weathered and the joints deeply recessed. About 15% of the bricks are perished. There are two window openings to the loft level and two window openings to the ground level with a full height central door opening. There is a continuous timber wallplate at eaves level which acts as a lintel over the window and door openings (*Photograph 04*). There are two steel beams at loft floor level across the door opening (*Photographs 05 & 12*). These beams are exposed and rusted. The entire elevation leans outwards by 150mm above the ground floor window cill level (*Photograph 09*).

The South elevation which is presently unsafe should be demolished down to ground floor window cill level and rebuilt. Approximately 25% of the existing brickwork will remain.

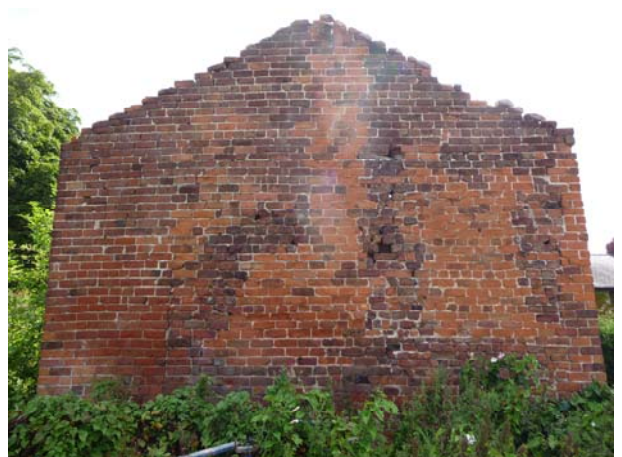
*Photograph 06*

This elevation is constructed in English Garden Wall Bond but approximately 50% of the wall has been 'patched in' with replacement brickwork (*Photograph 06*). Much of the original brickwork is perished and the mortar joints are deeply recessed. The wall is generally plumb up to eaves level although it does 'undulate' due to having been 'patched' several times. The brickwork pike above eaves level leans outwards by 75mm and the bricks are loose along the verge (*Photograph 07*).

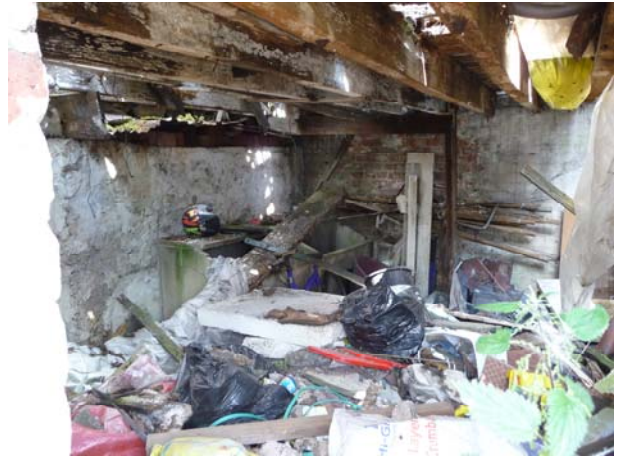
*Photograph 10*

collapsed roof (*Photograph 11*). The left hand half of the floor was still in place and supporting the dead load of the collapsed roof (*Photograph 10*).

I am of the opinion that any further collapse of the floor could result in collapse of much of the South elevation and is potentially dangerous.

Similarly the loft floor will require removal and replacing with a new suspended floor. New steel beams to support the loft floor will be required together with new lintels across the door and window openings.

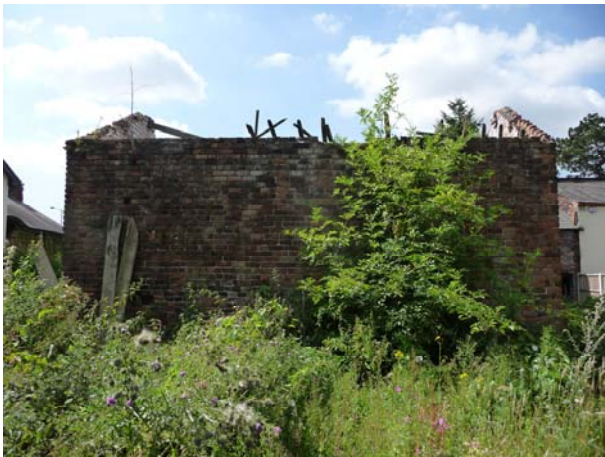
*Photograph 08*

This elevation is of similar construction to the other elevations (*Photograph 08*). Approximately 15% of the bricks are perished and the mortar joints are deeply recessed. The top half of the wall above loft floor level leans out by 75mm at the eaves.

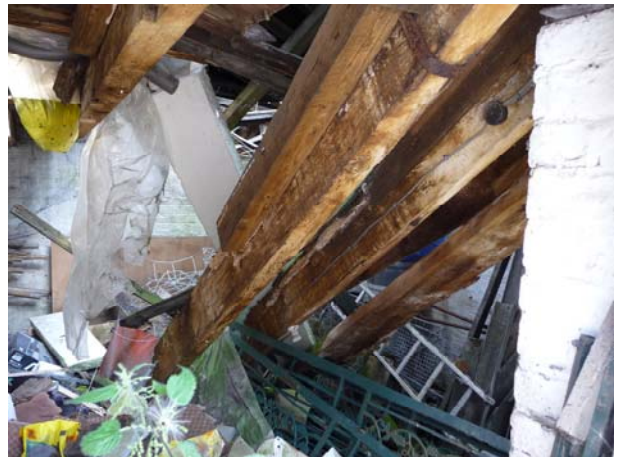
*Photograph 11*

This floor was constructed of timber joists spanning from the North to South elevations. Timber boarding formed the top surface of the floor. As viewed from the South through the window and door openings it was evident that the right hand half of the floor had collapsed, presumably unable to support the weight of the

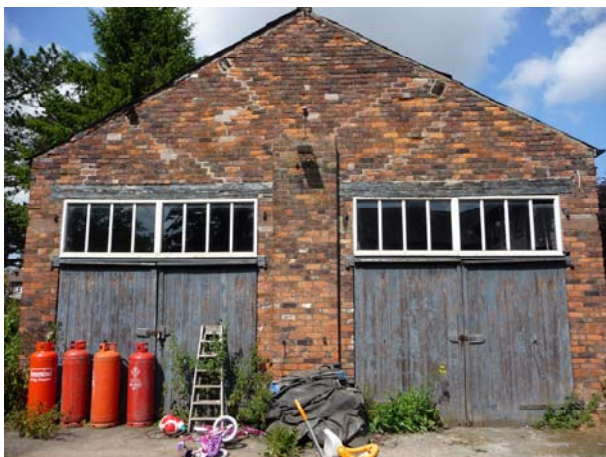
*Photograph 13*

This elevation has two large door openings with a brick pier between (*Photograph 13*). There are clerestory windows above the timber doors in each opening and there is a timber lintel above each of the door and window openings. These two lintels have deflected and this has caused diagonal cracking in the triangular panel of brickwork above (*Photographs 14 & 15*). This brickwork is laid in stretcher bond.

The North and South elevations may be left in place but should be raked out and repointed. The East elevation should be demolished down to the timber beam level above the two large openings. The beams should be replaced with steel beams or lintels and the pike of brickwork rebuilt including the top corner around the South elevation where it is cracked.

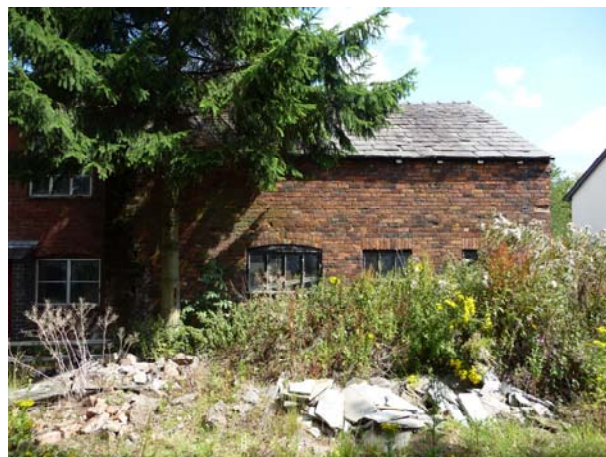
*Photograph 16*

This elevation was constructed in stretcher bond and has three window openings (*Photograph 16*). It was in a generally sound condition with the exception of a crack affecting the top four courses at the right hand end.

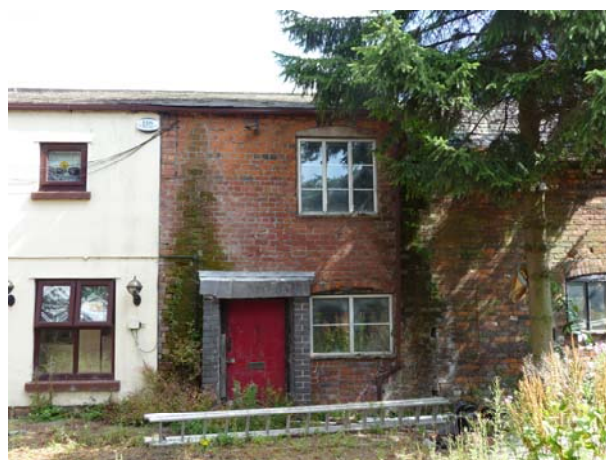
*Photograph 17*

There is a ground floor door opening which appeared to give access to the eastern wing of the house (*Photograph 17*). It has a small canopy over the door supported on brick piers. This construction is an 'add on' and not similar in style to the original. There are two window openings to the right of the door one to the ground floor and one to the first floor. The brickwork of this elevation is badly weathered and the mortar joints are deeply recessed. The brickwork between the link and the barn is block bonded and projects forward by 50mm (*Photograph 18*). The link wall extends above the barn roof and the purlin ends are exposed (*Photograph 19*).

Internally this is substantially derelict and should be cleared of all collapsed walls etc. If it is intended to have a first floor the existing floor should be removed and replaced. The existing South elevation should be raked out and repointed and the block bonding to the rear of the barn should be improved and possibly concealed by the addition of a bonded in brick pier.

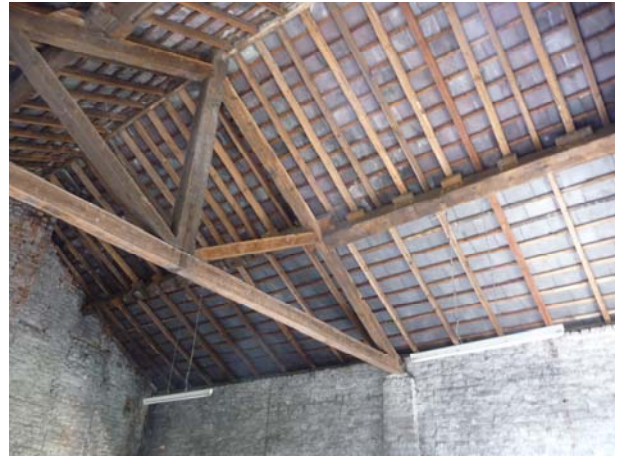
*Photograph 22*

There are stone slabs at the door entrances but elsewhere the floor appears to have an earth surface. The building contains a considerable amount of old belongings, furniture, toys, electrical appliances and general junk and rubbish (*Photograph 20*). There is no first floor and the underside of the roof can be seen (*Photograph 21*). There is a central roof truss spanning between the North and South elevations. There are two purlins, rafters and old slates on the Netherley Road elevation and this appears to be original. The Courtyard roof slope has been renewed with a single purlin and more widely spaced rafters supporting modern roof slates. The upper slope between the purlin and ridge has had additional rafters inserted to halve the spacing but these have not been inserted in the lower section between the purlin and the eaves (*Photograph 22*).

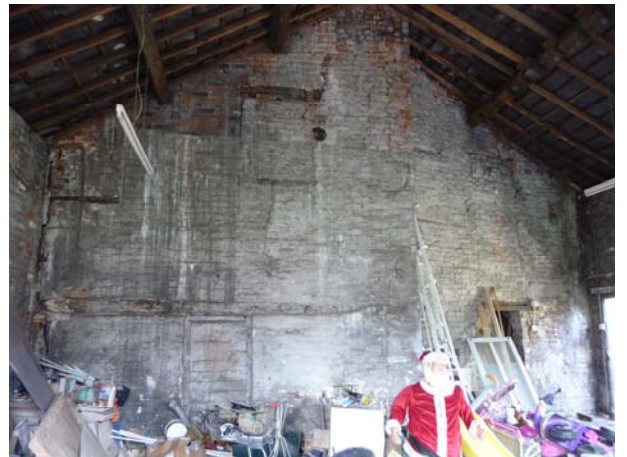
*Photograph 23*

The rear internal wall of the barn has had many former openings in it which have been infilled with brickwork and in some instances the old rotted timber lintels remain in place (*Photograph 23*). There are many vertical cracks in this wall which forms the division between the large barn and the small link building between the barn and the house.

The rotted timber lintels in the rear internal wall should be removed in small sections and brickwork bonded in. The method of repair of the cracks will depend on the final use but if left as it is steel crack tie rods should be bonded into raked out bed joints with epoxy resin mortar every sixth course across the cracks.

This is a common method of repair used in listed buildings and buildings in conservation areas. The epoxy resin mortar is restricted to every sixth bed joint for a length of 900mm central about the crack. It is recessed by 10mm brick from the face of the wall and is invisible when the wall is repointed.

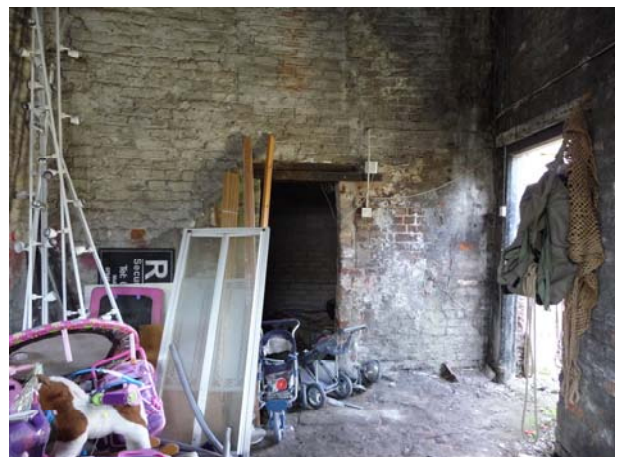
*Photograph 24*

Internally the link building was accessed through a door opening in the rear internal wall of the large barn (*Photograph 24*). An internal wall within the link appears to have collapsed and a partial concrete first floor is visible (*Photographs 25, 26, 27, 30, 31 & 32*). All of this was in a poor structural condition.
