# 34 Church St, Prescott

## Stage I Visual Structural Condition Appraisal

Curtins Ref: B074752

Project Address: 34 Church St, Prescott L34 3LA

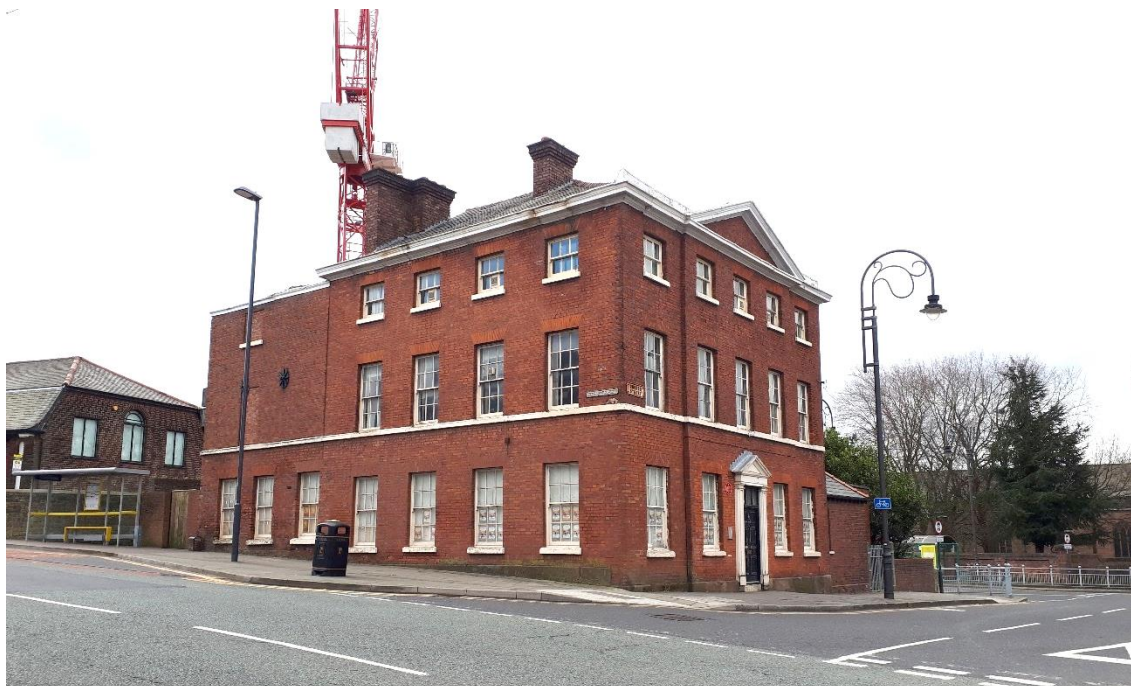
Figure 1: View of north and west elevations at intersection between High Street and Church Street

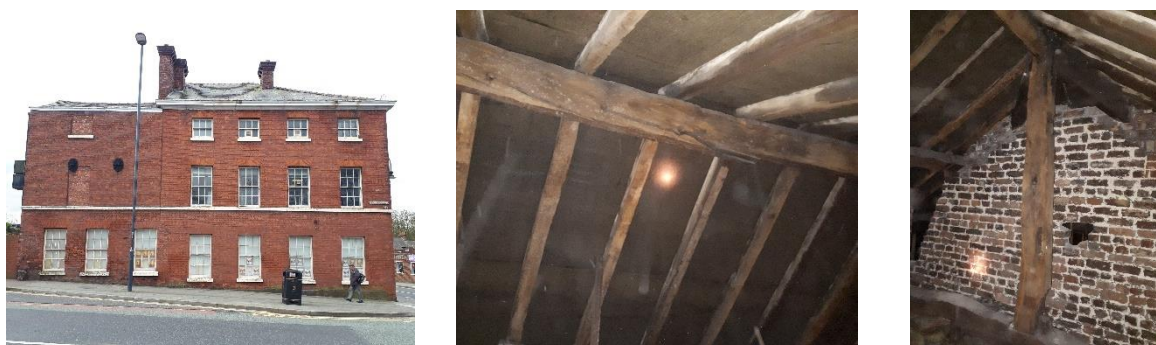
- 3.1 Both ridgelines sag between points of support. On the main roof of the building, the apex is a ridge purlin supported on the eastern masonry gable and on a timber prop supported by two masonry walls below. This purlin has a split through the lower (tension) side due to a combination of a pre-existing natural fault in the timber (a shake) which has been opened up over time by increased bending stress. This does not seem to be as a result of insufficient section size, but as a result of a pre-existing defect resulting in a localised weakening, and therefore in the sagging profile of the ridgeline and dished profile of the slope.

Figure 2: Sagging ridgelines (left), structural defect on ridge purlin (centre), and prop supporting hipped roof connection (right)

- 4.7 Localised structural repairs are required in the timber roof structure, including the splicing or replacement of the ridge purlin which has suffered a bending failure leading to deflection of the apex, and consequent down-the-slope thrust in the common rafters.

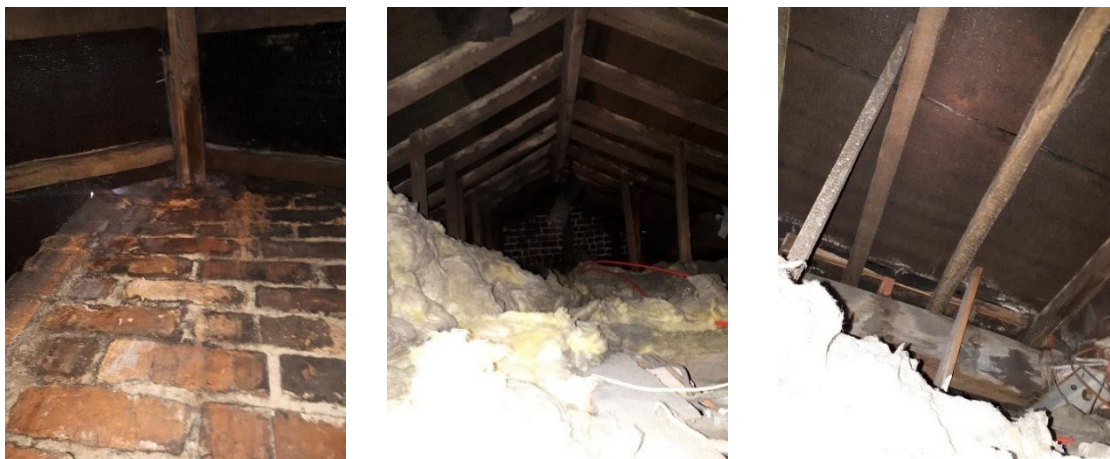
- 3.2 The apex of the roof on the east extension is a ridge board. In this configuration, the common rafters arch against the board as there is no vertical support at the apex, and thrust laterally down the slope to the purlins, which bend in the minor axis.
- 3.3 The easternmost gable peak exhibits an inward lean, which is a consequence of the inherent lack of vertical bracing within the roof (leading to racking of the vertical supports, in this case the masonry peak).
- 3.4 Other than the sagging ridgelines, the timbers in the roof seem to be in good condition, although some purlins and the props look to have been repurposed as they are not the right length and have been spliced at regular intervals (see DR-S-20006 in Appendix B).

Figure 3: Ridgeboard at bearing on main gable chimney with water ingress (left), view of ridgeboard and arching common rafters (centre), and areas of damp on south roof slope (right).

- 4.10 The eastern roof structure should be braced, and the leaning gable peak anchored into the roof structure.
- 4.11 The low-level extensions exhibit significant structural deterioration principally as an outworking of embedded ferrous lintel supports, which have corroded and jacked the overhead masonry upwards manifesting in unstable overhead masonry. This should be taken down and the ferrous lintels be removed and replaced with stainless prior to rebuilding.

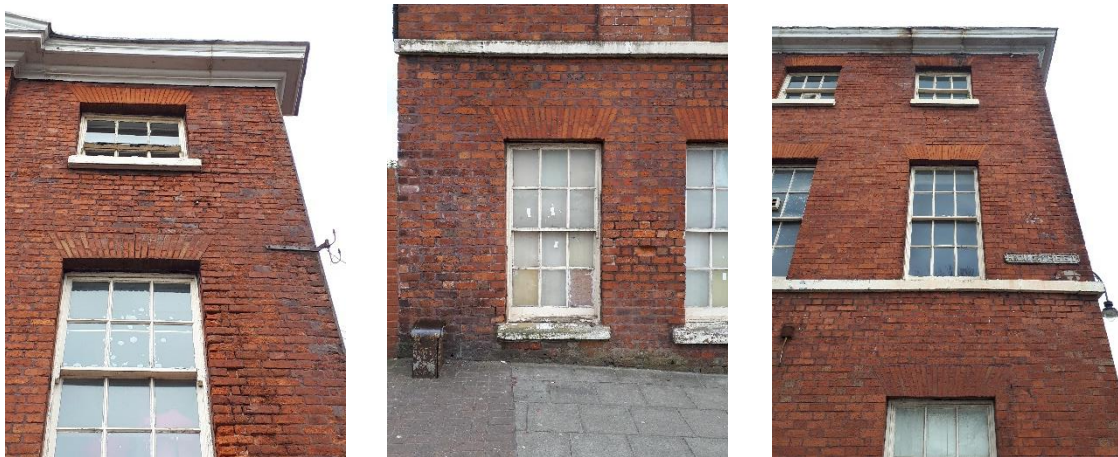
- 3.6 The perpendicular joints in the cornices of the main building indicate that these are stone blocks, and some of these have been damaged and displaced. This betrays the likelihood of embedded iron cramps. This should be further investigated. Any ferrous fixings should be located and removed before being replaced with stainless steel cramps.

- 3.10 The flat arches to the north & west main frontages exhibit structural activity and a history of remedial intervention. Some appear to have been replaced, possibly with a different structural composition. Others have slumped in the centre leading to deformed bed joint geometry in the masonry directly above. The probable cause of this being the sustained water ingress from overhead leading to disaggregation of the mortar and associated slump of the voussoirs until they re-lock together. All affected flat arches need to be slate pinned and micro grouted with a compatible lime grout to avoid further deterioration.

Figure 4: Instances of fabric repair required, some flat arches replaced, and displaced cornices.

- 4.3 The flat arches in the north and west elevations bear evidence of decay-induced deterioration, leading to slumping of the brick voussoir units and associated deformation in the wall overhead. The source of water ingress should be resolved, and the arches tightly pinned with saw-cut slate shims and micro-grouted to ensure full compaction of the mortar joints.

- 4.8 Fabric repair generally is recommended to the masonry skeleton, including removal of cement pointing and repointing with a compatible lime mortar to match the existing.

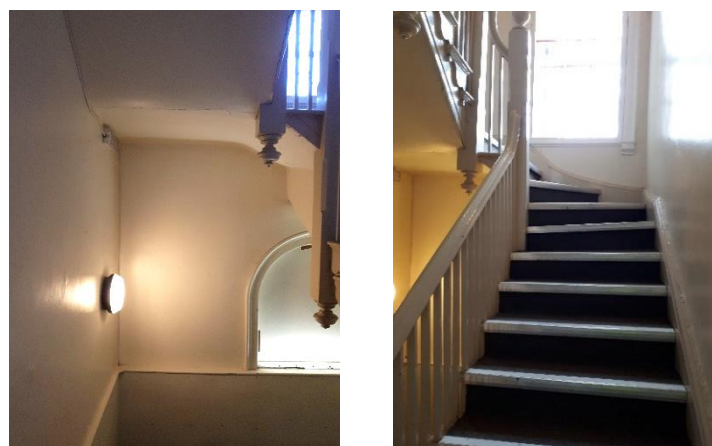
- 3.11 The internal stairs seem to slope in towards the stringer and deflect considerably underfoot. This seems to be due to insufficient support to the stringer which is exacerbated by the partial-height posts which are not continuous though the structure. Additional support should be considered at the stringer for any redevelopment.

Figure 5: Cranked stair due to insufficient support to the stringer.

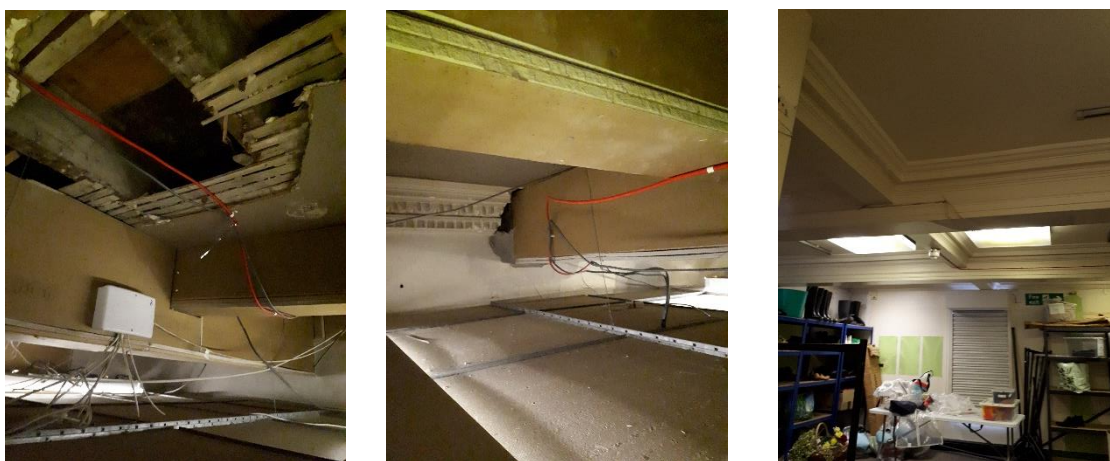
- 3.12 The floor structure has additional steel beams on each floor. As there was no significant sag or other deformations noted in the floor, and in the instances where the timber floor could be inspected no evidence of distress was observed, it seems that these steel beams have been added as a strengthening measure as opposed to a repair. If these were added at the time of conversion from a bank to a museum, this would correspond with increased floor loading and are therefore an appropriate intervention in the structural sense. The steel beams could potentially be removed if this was required and appropriate with the future reuse of the building. This would have to be further calculated and detailed prior to implementation.

Figure 6: Typical layering of floor structure in the strengthened state (left), additional beam breaking through moulding (centre), and original beams in the undisturbed state with moulding intact (right).

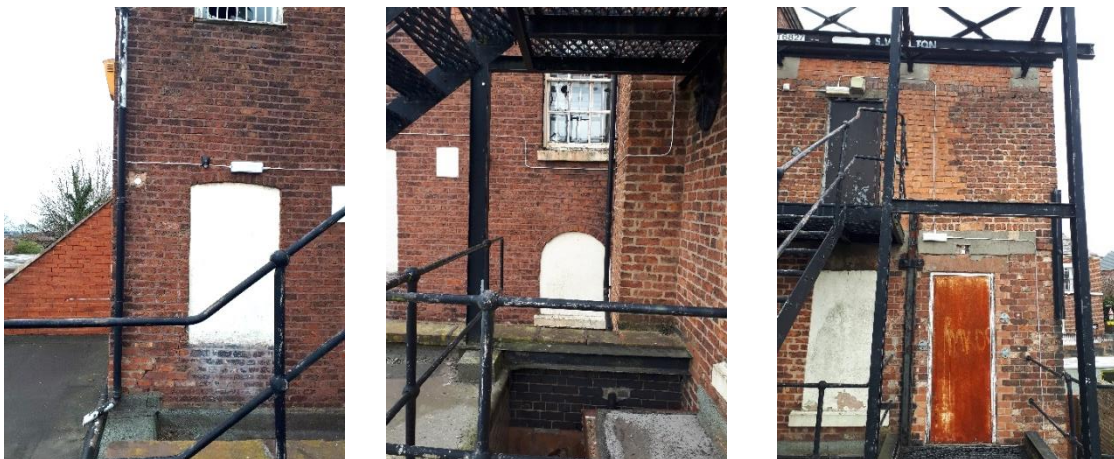
- 3.14 There seems to be some ground induced movement to the south face of the east extension. This is evidenced by the cranked geometry of the openings in the masonry skeleton, and bed joints at the interface with the main gable. Continued / active movement is indicated by the presence of cracking internally and externally (i.e. full-thickness) although the magnitude is typically small, i.e. hairline to 1mm in thickness.
- 3.15 The steel structure at this location looks to have been used as a craning structure (potentially to lift bank or museum items) into what was a larger opening at second floor level which has since been remodelled into a fire escape. The foundation of the steel structure might have undermined the existing foundations

of this face on the east extension (to be proved by intrusive investigations). The localised loading by this structure with inadequate foundations under the extension could be responsible for the differential settlement experienced at this location. Our recommendation for this area is that the masonry on this elevation of the east extension should be taken down and rebuilt on a competent foundation if it is to be reused for future refurbishment works.

Figure 7: Cranked bed-joints at interface with main gable (left and centre), and steel lifting structure with larger opening that has not been properly made good (right).

- 4.9 The eastern extension generally exhibits a poorer structural state compared with the main building core. A combination of crudely formed past alterations and apparently more rudimentary structural composition have manifested in structural deterioration, including significant differential settlement of the foundations at the position of the lifting frame. Structural intervention is recommended, which includes the rebuilding of the south wall on a new competent foundation.

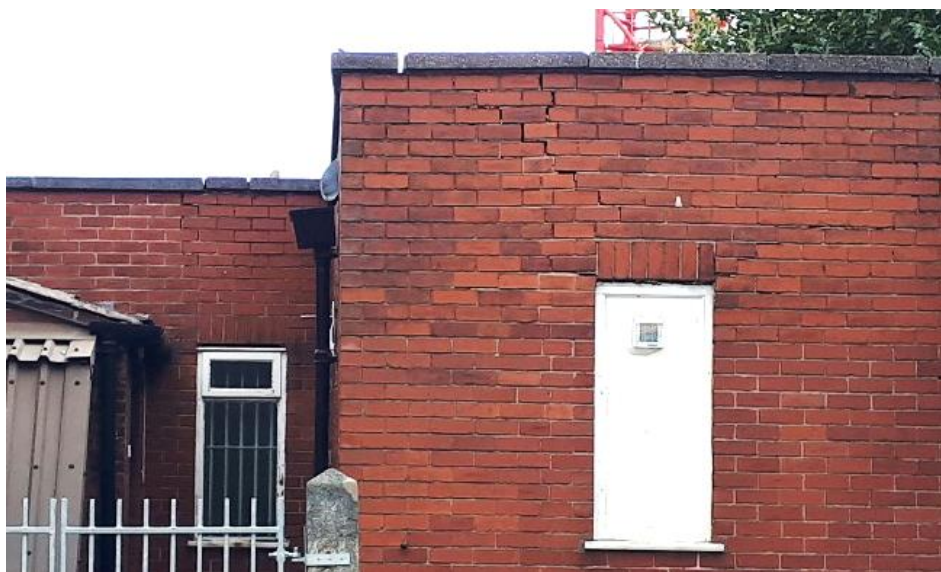
- 3.16 On the single storey extensions to the south, there are several instances of coarsely cracked and upwardly-deformed wallheads. This is typical of embedded steel that has corroded and is jacking up the surrounding masonry. The masonry will have to be taken down and rebuilt after the corroded steel has been removed.

Figure 8: Typical instance of cracking and open perpendicular joints in one-storey extensions to the south.

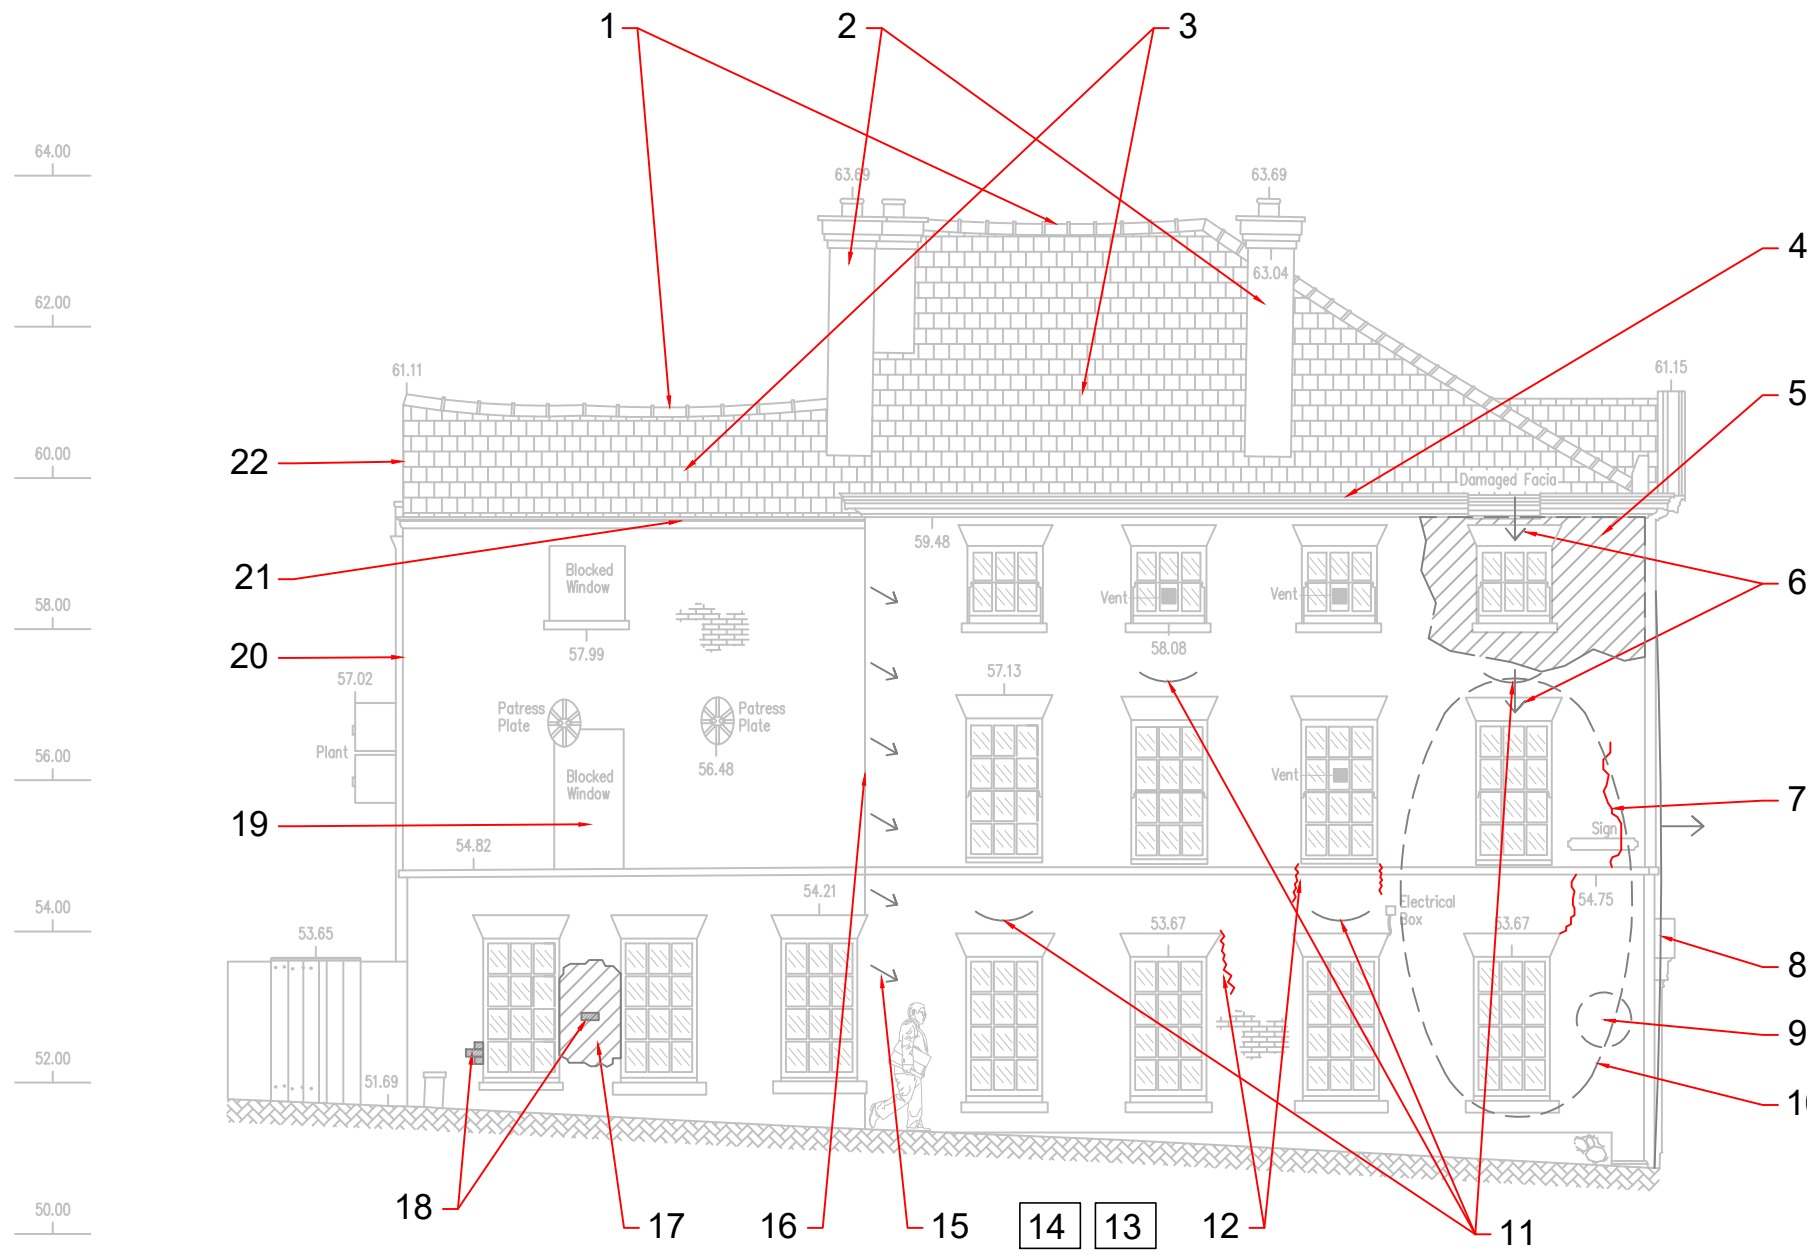
ELEVATION A  
SCALE 1:100

- A1 SAGGING RIDGELINE BETWEEN SUPPORTS ON BOTH ROOFS
- A2 CHIMNEYS RELATIVELY STRAIGHT AND NO SIGNIFICANT DAMAGE TO THE FABRIC AS OBSERVED FROM GROUND LEVEL. CLOSE QUARTERS INSPECTION RECOMMENDED.

- A3 DISHED ROOF SLOPES ACCORDING TO SAGGING RIDGELINE
- A4 EAVES LINE RELATIVELY STRAIGHT AND LEVEL BUT DAMAGED AND DECAYED FASCIA.
- A5 DOWNWARD MOVEMENT OF FLAT ARCHES BELOW PARTICULARLY DAMAGED FASCIA.

- A6 DAMP FABRIC IN THIS AREA
- A7 HAIRLINE CRACK AND SPLIT BRICKS TRACKING DOWN PAST THE STREET SIGN, ACROSS THE STRING COURSE AND DOWN TOWARDS THE GROUND FLOOR FLAT ARCH

- A11 SAG IN BEDJOINTS ABOVE THESE FLAT ARCHES
- A12 VERTICAL HAIRLINE CRACKS
- A13 GEOMETRY OF WINDOW OPENINGS OK
- A14 ALL FLAT ARCHES ON UPPER FLOORS OF ELEVATION A HAVE BEEN REPLACED

- A17 DECAYED MASONRY FABRIC. REBONDING OF CORNER AND DEEP-PACK REPOINT REQUIRED. EVIDENCE OF LIME MORTAR BELOW CEMENT
- A18 INDENT REPAIRS REQUIRED
- A19 DISTORTED GEOMETRY OF BLOCKED WINDOW OPENING

- A20 CORNER PLUMB AS VIEWED FROM THIS ELEVATION
- A21 FASCIA DAMAGED AT MIDPOINT AND DAMP FABRIC BELOW
- A22 GABLE PEAK LEANS INWARDS SLIGHTLY ca. 20mm OVER ITS HEIGHT

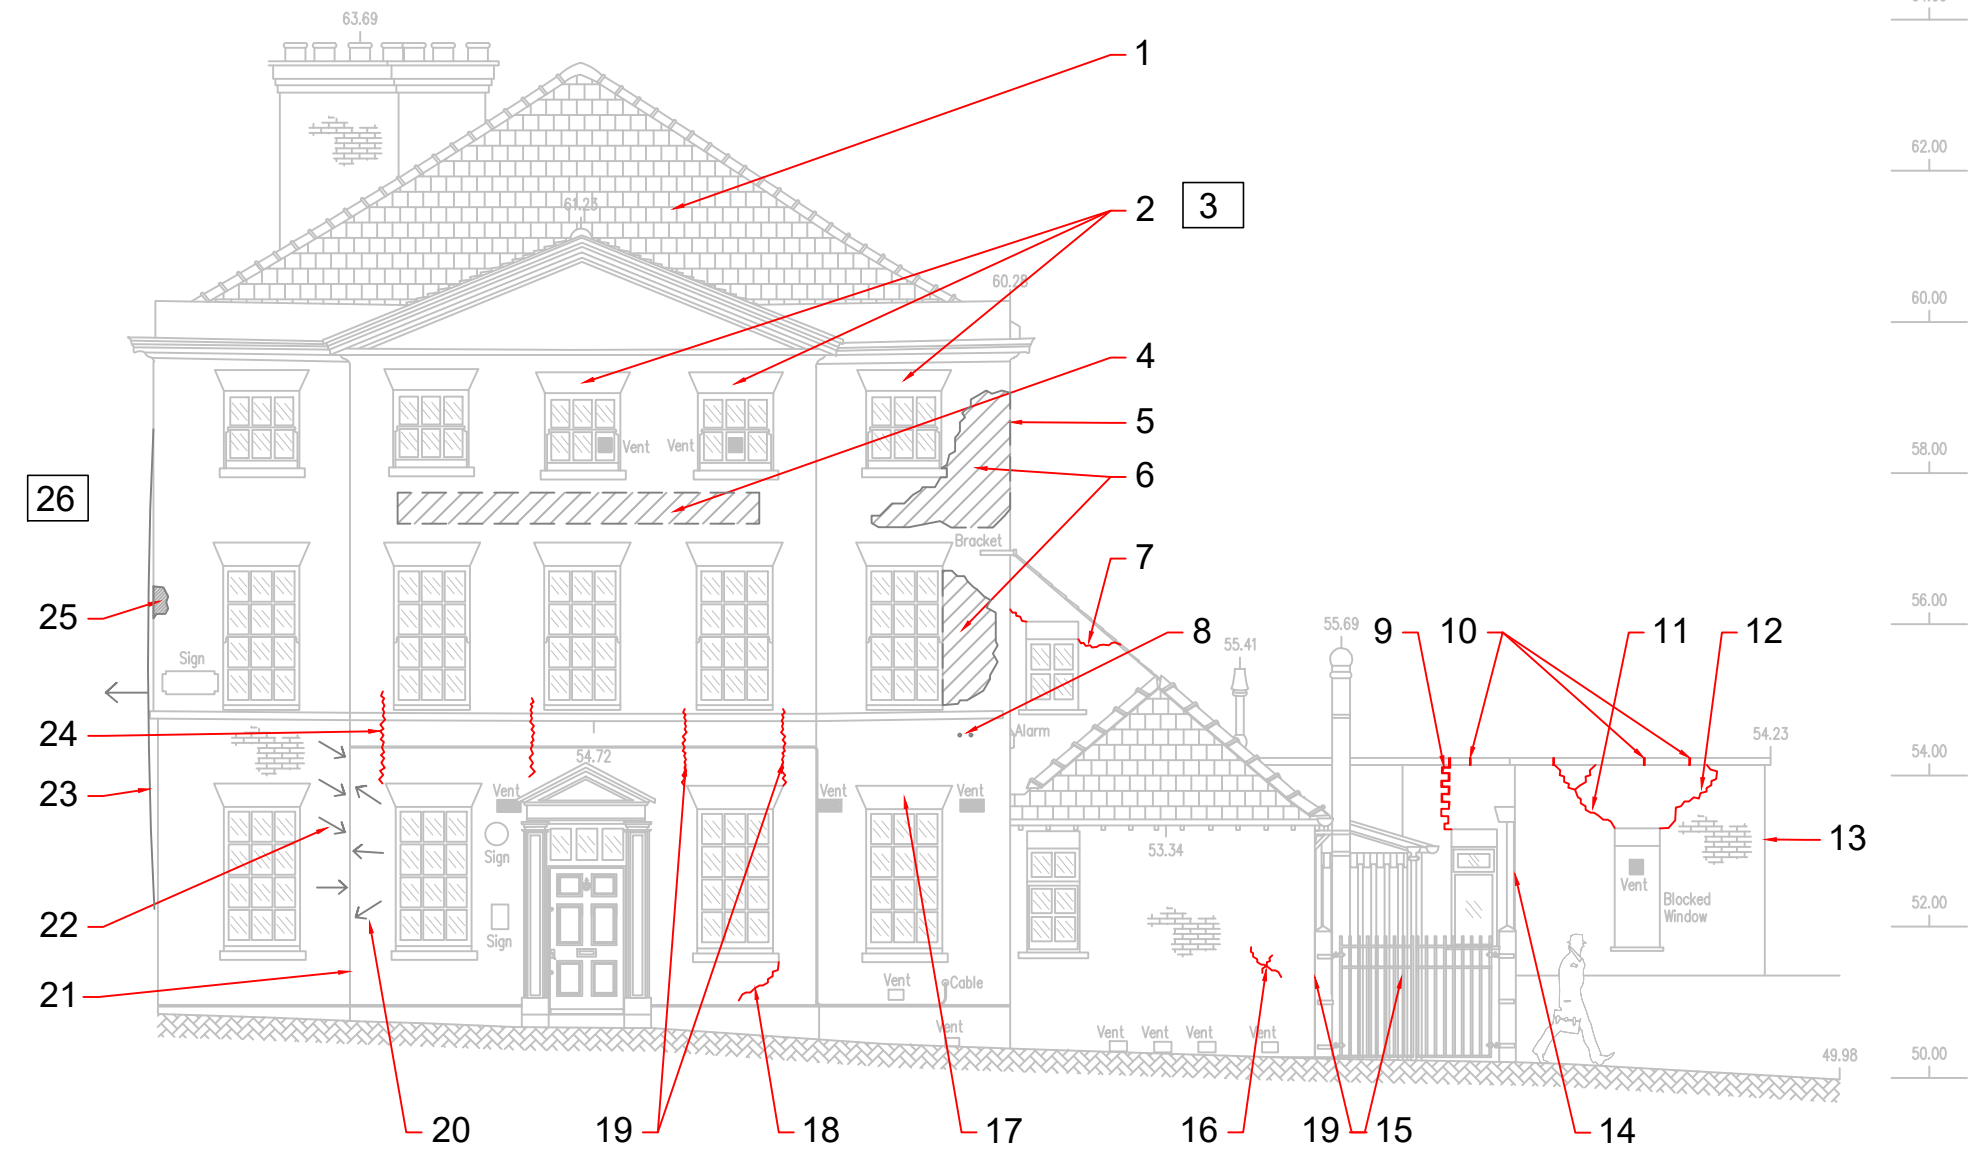
ELEVATION B  
SCALE 1:100

- B1 ROOF SLOPE NOT OBSERVED FROM THIS ELEVATION
- B2 NEW FLAT ARCHES (HAVE BEEN REPLACED AT SOME POINT)
- B3 ALL FLAT ARCHES REQUIRE SOME DEGREE OF PINNING AND DEEP PACK POINTING.

- B4 SEVERE MORTAR DECAY IN THIS AREA. DEEP PACK REPOINT AND SOME INDENT REPAIR REQUIRED
- B5 CORNER PLUMB
- B6 SEVERELY DECAYED MASONRY FABRIC INDENT REPAIRS REQUIRED

- B7 10mm CRACK BELOW FLAT ARCH
- B8 EMBEDDED METALWORK
- B9 CRACK INCREASING WITH HEIGHT TO 10mm AT COPING
- B10 OPEN PERPEND JOINTS IN COPING ca. 10-50mm

- B11 20mm DIAGONAL CRACK UP TO COPING. BRICKS LOCALLY DISPLACED IN THIS LOCATION
- B12 10mm DIAGONAL CRACK
- B13 CORNER PLUMB IN BOTH ORTHOGONAL DIRECTIONS

- B14 CORNER PLUMB
- B15 CORNER PLUMB
- B16 EMBEDDED METAL FIXINGS WITH HAIRLINE CRACKS IN MASONRY RADIATING FROM IT (CEMENT MORTAR)
- B17 FLAT ARCH HAS BEEN REPLACED AT SOME POINT. PRESTRESSED?

- B18 DIAGONAL HAIRLINE CRACK WITH SPLIT BRICKS FROM CORNER OF SILL
- B19 VERTICAL HAIRLINE CRACKS FROM EITHER SIDE OF FLAT ARCH
- B20 BEDJOINTS IN THIS SECTION TEND IN DIFFERENT DIRECTIONS AND BRICKS APPEAR TO HAVE BEEN REPLACED

- B24 VERTICAL HAIRLINE CRACK
- B25 INDENT REPAIR REQUIRED TO CORNER
- B26 LOCALISED PLASTIC REPAIRS WITH CEMENT MORTAR THROUGHOUT UPPER SECTION OF ELEVATION

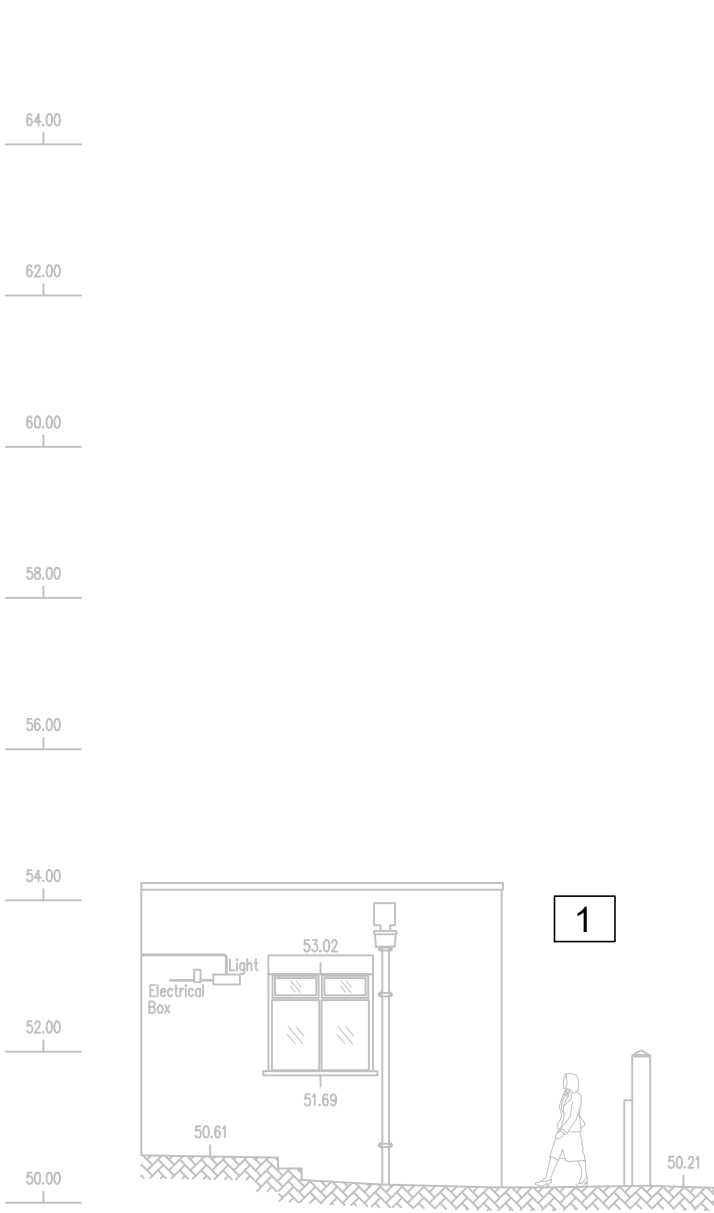
ELEVATION C  
SCALE 1:100

ELEVATION C  
C1 NO STRUCTURAL DEFECT OF NOTE TO THIS ELEVATION

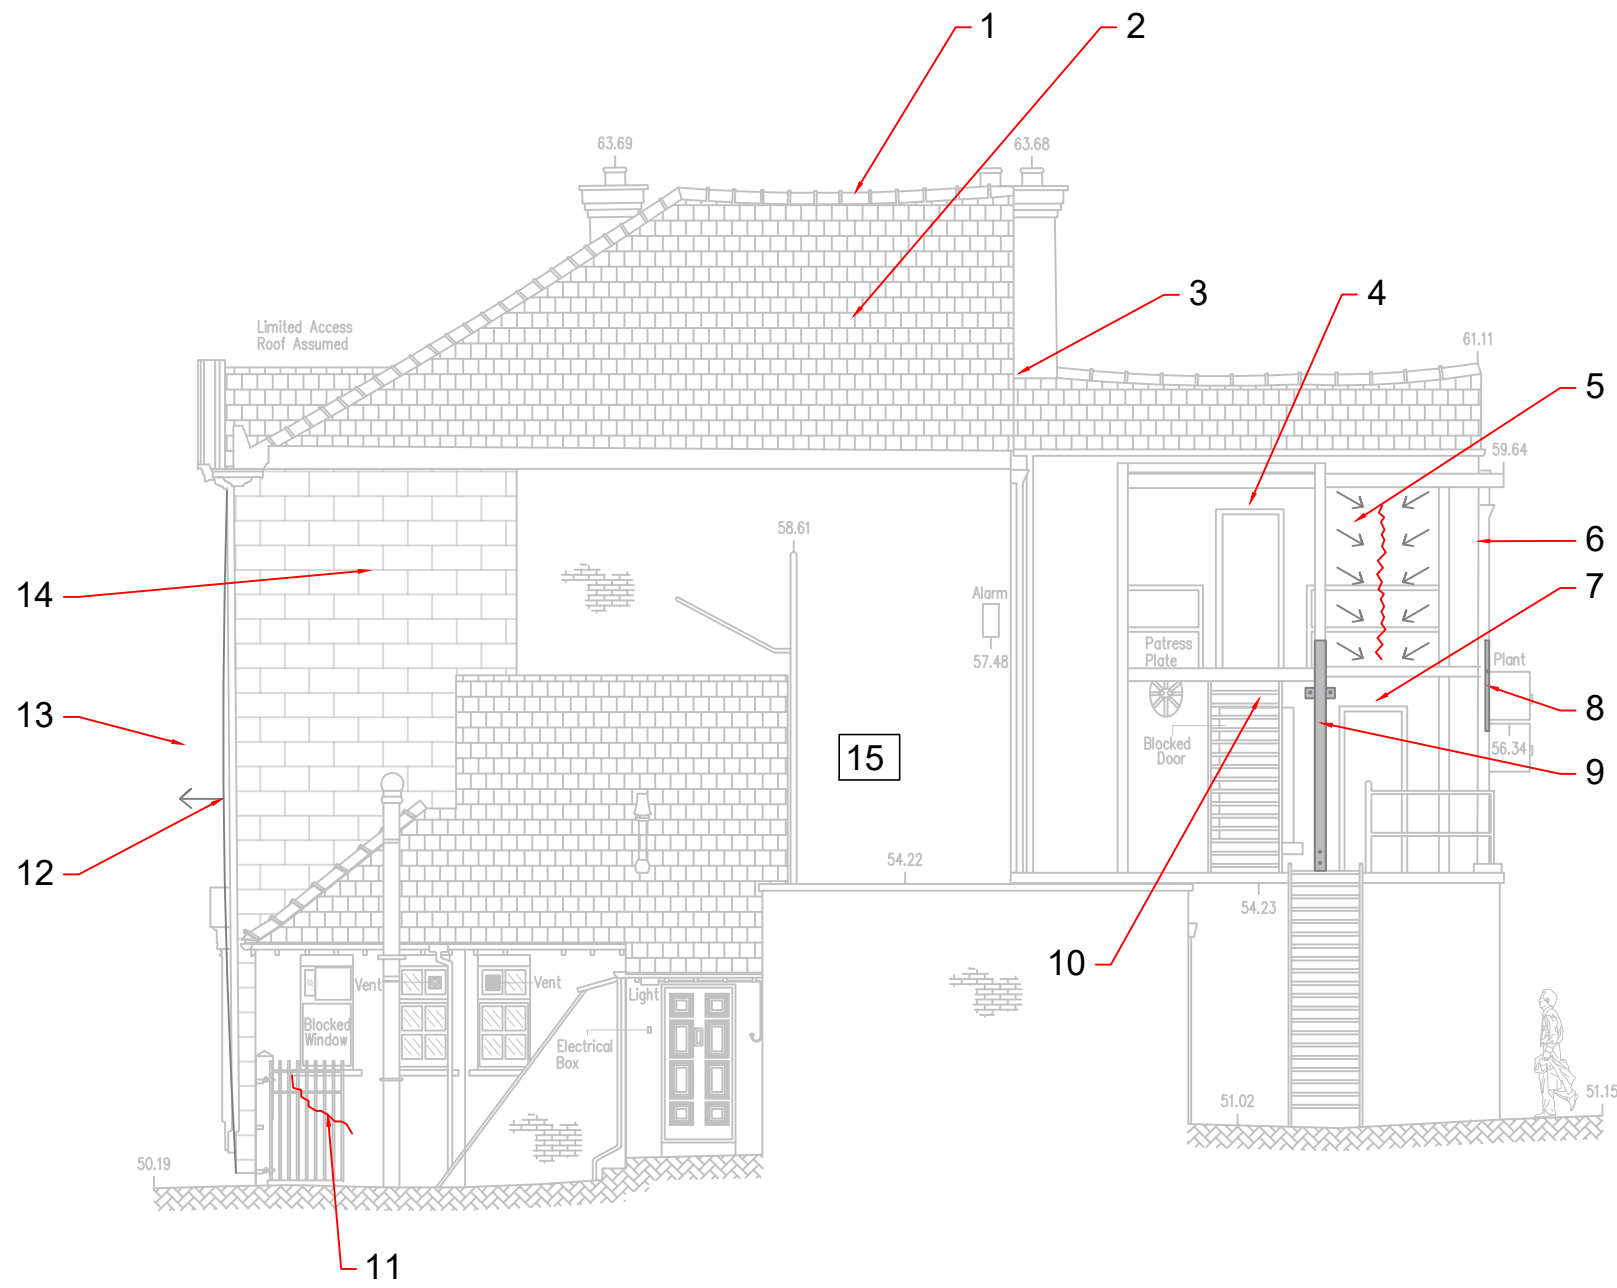
ELEVATION D  
SCALE 1:100

ELEVATION D  
D1 RIDGELINE AS PER ELEVATION A  
D2 SLOPE GENERALLY STRAIGHT ALTHOUGH SOME SLIPPED TILES  
D3 PROBABLE DAMP AT THIS INTERSECTION – CHECK IN ROOF SURVEY  
D4 CONCRETE LINTEL OVER EMERGENCY EXIT DOOR  
D5 BEDJOINTS LEAN IN / DOWN TO EITHER SIDE OF THE BOUNDARY BETWEEN OLD AND NEW. BRICKS HAVE BEEN REPLACED THIS SIDE  
D6 CORNER PLUMB  
D7 STONE LINTEL WITH TIMBER LINTEL ABOVE  
D8 STEEL BAR STRAPPING CORNER IN THIS LOCATION?  
D9 HEAVILY CORRODED STEEL BAR WITH BOLTS FOR TIE TO PATRESS PLATE ON ELEVATION A  
D10 DECAYED AND WEATHERED STONE LINTEL  
D11 5mm DIAGONAL CRACK FROM SILL OF BLOCKED WINDOW  
D12 SLIGHT OUTWARD BOW OF FRONT ELEVATION  
D13 ROOF SLOPE OK  
D14 LINED RENDER ON THIS SECTION  
D15 THIS SECTION OF ELEVATION NOT ACCESSIBLE DUE TO VEGETATION

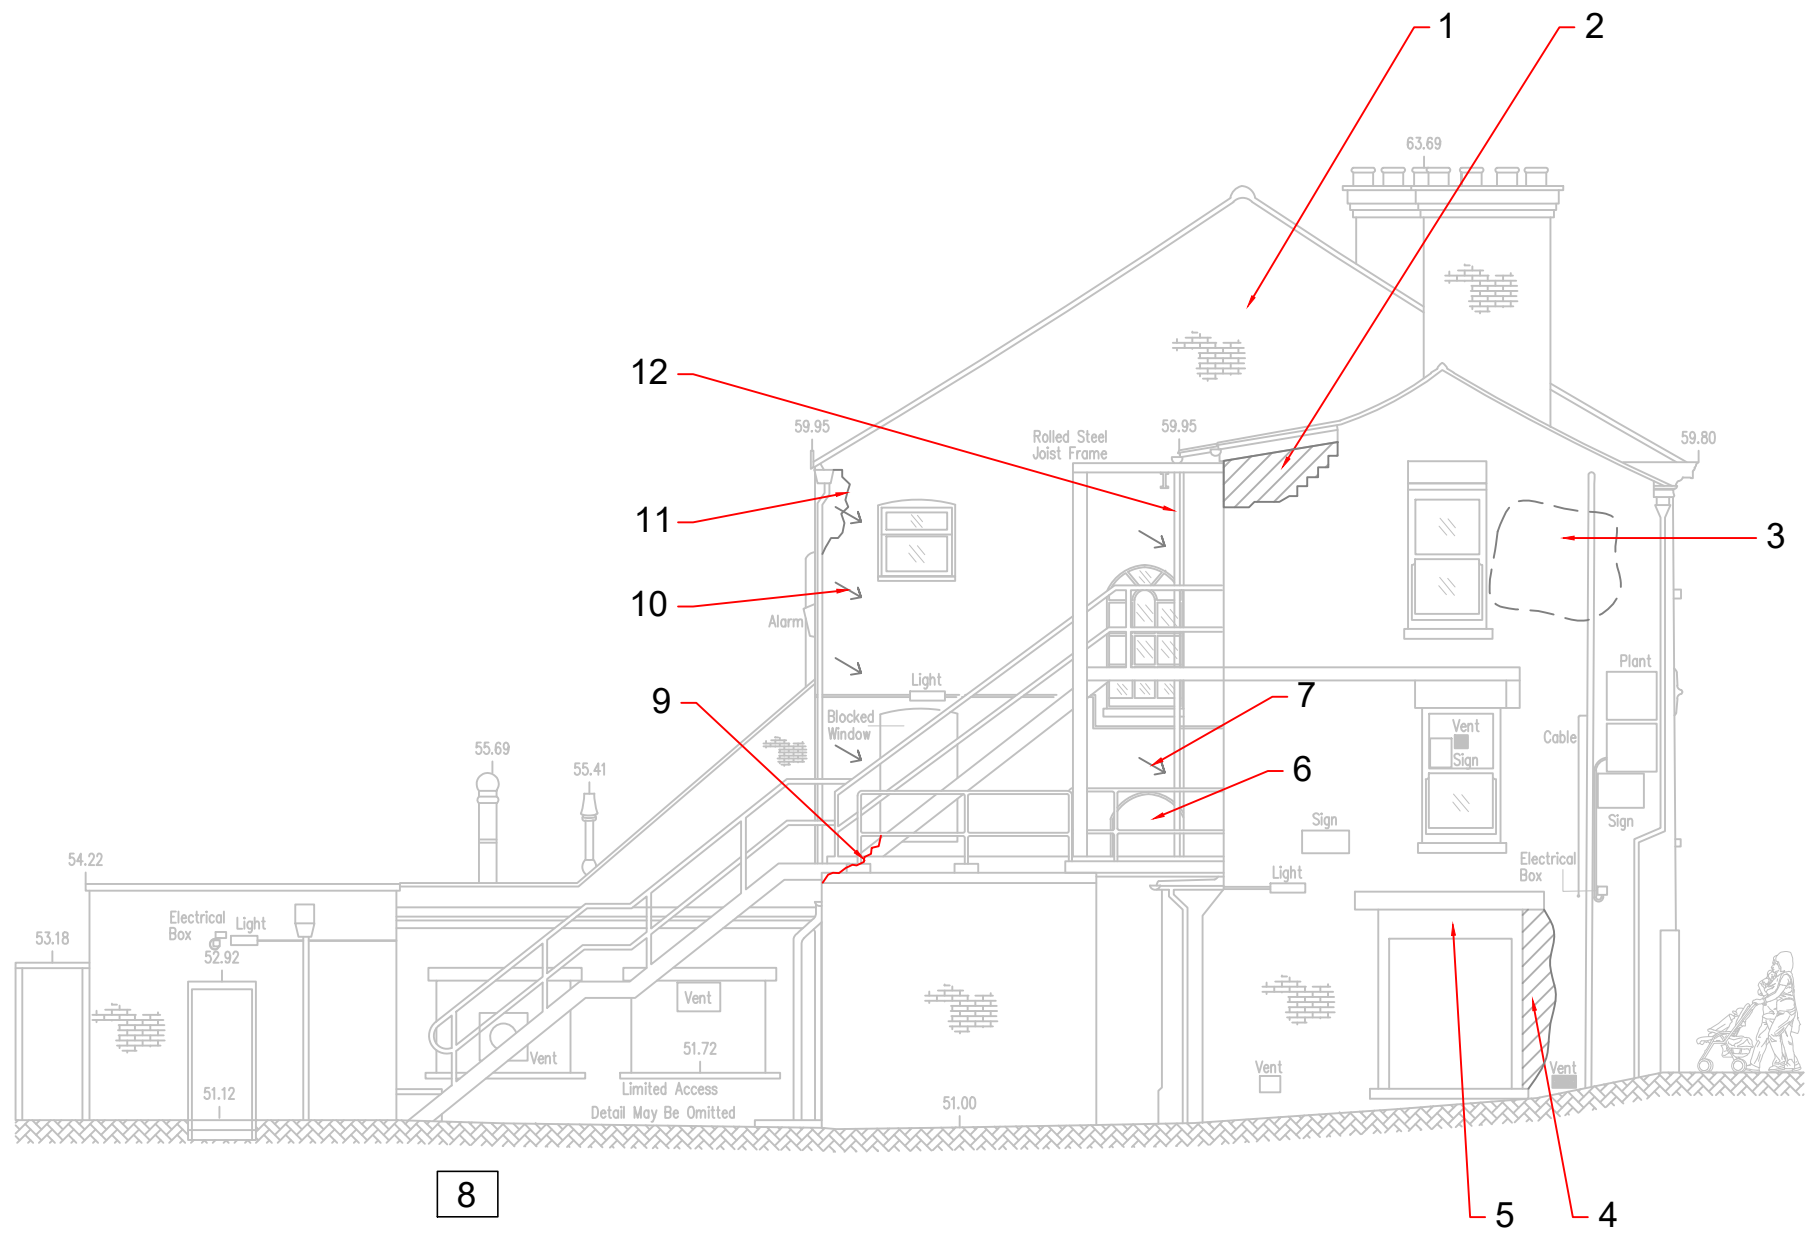
ELEVATION E  
SCALE 1:100

ELEVATION E  
E1 NO STRUCTURAL DEFECT OF NOTE TO GABLE PEAK AS OBSERVED FROM EMERGENCY STAIRS  
E2 BRICKS HAVE BEEN REPLACED BELOW CHANGE OF SLOPE IN ROOF  
E3 OUTWARD BULGE IN THIS LOCATION AND DAMP FABRIC IN GABLE PEAK ABOVE  
E4 JAMB OF OPENNING HAS BEEN REPLACED  
E5 TIMBER LINTEL COVERED BY FELT  
E6 DISTORTED ARCHED WINDOW  
E7 BEDJOINTS CRANK DOWN SIGNIFICANTLY, HAIRLINE CRACK FROM SILL TO ARCH  
E8 NO STRUCTURAL DEFECT OF NOTE TO SINGLE STOREY EXTENSIONS AT LOWER LEVEL  
E9 10mm DIAGONAL CRACK FROM SILL TO CORNER AT INTERFACE WITH FLAT ROOF  
E10 BEDJOINTS LEAN DOWN AT THIS INTERFACE  
E11 VERTICAL HAIRLINE CRACK ALONG THIS CORNER. BEDJOINTS TEND DOWN ALONG THIS CORNER  
E12 RAINWATER PIPE AT THIS LOCATION

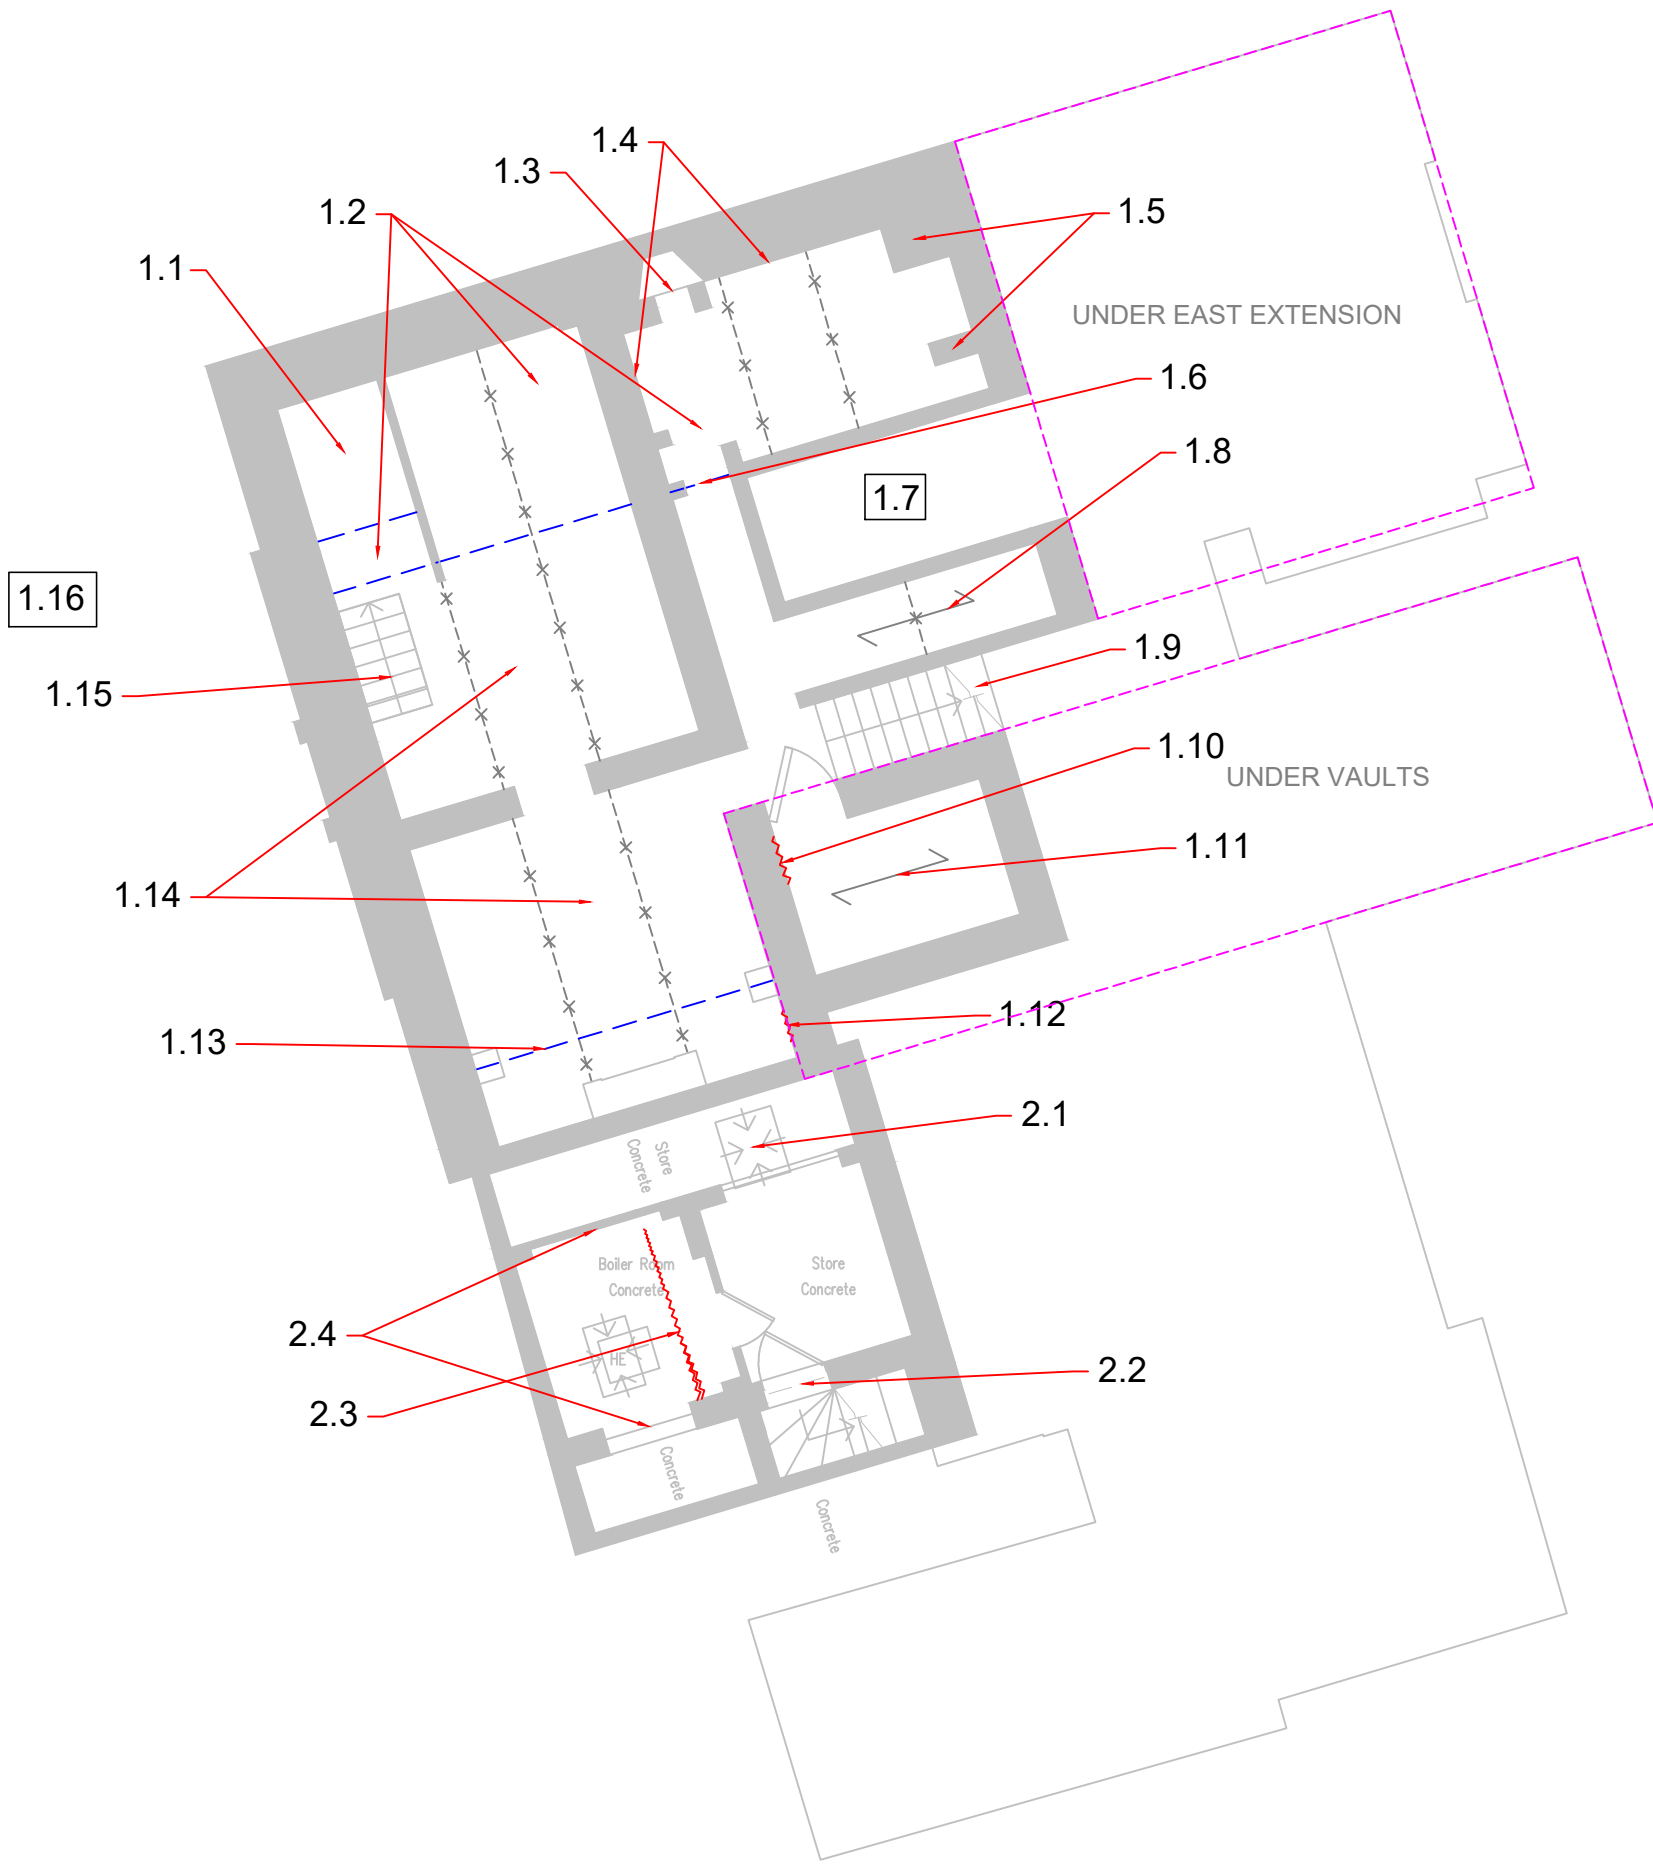
BASEMENT PLAN  
SCALE 1:100

- BA 1 BASEMENT 1 - NORTH  
BA 1.1 STEEL 'BEAM AND BLOCK'  
BA 1.2 SHUTTERED CONCRETE WITH BIG BRICK AGGREGATES  
BA 1.3 STEEL LINTEL  
BA 1.4 SOME SANDSTONE AND BIGGER BLOCKS OBSERVED IN BASEMENT WALL  
BA 1.5 BUTTRESSES TO RETAINING WALL?  
BA 1.6 STEEL BEAM CONTINUES THROUGH  
BA 1.7 NO ACCESS TO THIS SECTION  
BA 1.8 SPAN DIRECTION OF JOISTS ABOVE – SUSPENDED FLOOR CONFIRMED IN THIS AREA  
BA 1.9 STAIRCASE BLOCKED BY TRAPP DOOR ABOVE  
BA 1.10 5mm DIAGONAL CRACK ON FACE OF WALL  
BA 1.11 SPAN DIRECTION OF COMPACT FILLER JOIST FLOOR WITH THE STEEL JOISTS AT 200 C/C  
BA 1.12 HAIRLINE DIAGONAL CRACK ON THIS FACE  
BA 1.13 STOCKY STEEL BEAM  
BA 1.14 ASSUME SUSPENDED FLOOR ON THIS SECTION BUT NOT PROVEN AS COVERED BY FIRE PROTECTION – POSSIBLE ASBESTOS  
BA 1.15 HATCH WITH STAIRS DOWN TO BASEMENT  
BA 1.16 ACROW PROPS WITH TIMBER BEAMS ARE AN INAPPROPRIATE PERMANENT SUPPORT OF FLOORS ABOVE – A MORE PERMENANT SOLUTION SHOULD BE INVESTIGATED

- BA 2 BASEMENT 2 - SOUTH  
BA 2.1 PLINTH? WELL?  
BA 2.2 ARCHED ENTRANCE – NO STRUCTURAL DEFECT TO NOTE ON ARCH  
BA 2.3 50mm CRACK IN CEILING REDUCING TO HAIRLINE TOWARDS THE NORTH  
BA 2.4 DECAYING STEEL LINTELS
