# 34 Church St, Prescott

## Stage I Visual Structural Condition Appraisal

Curtins Ref: B074752

Project Address: 34 Church St, Prescott L34 3LA

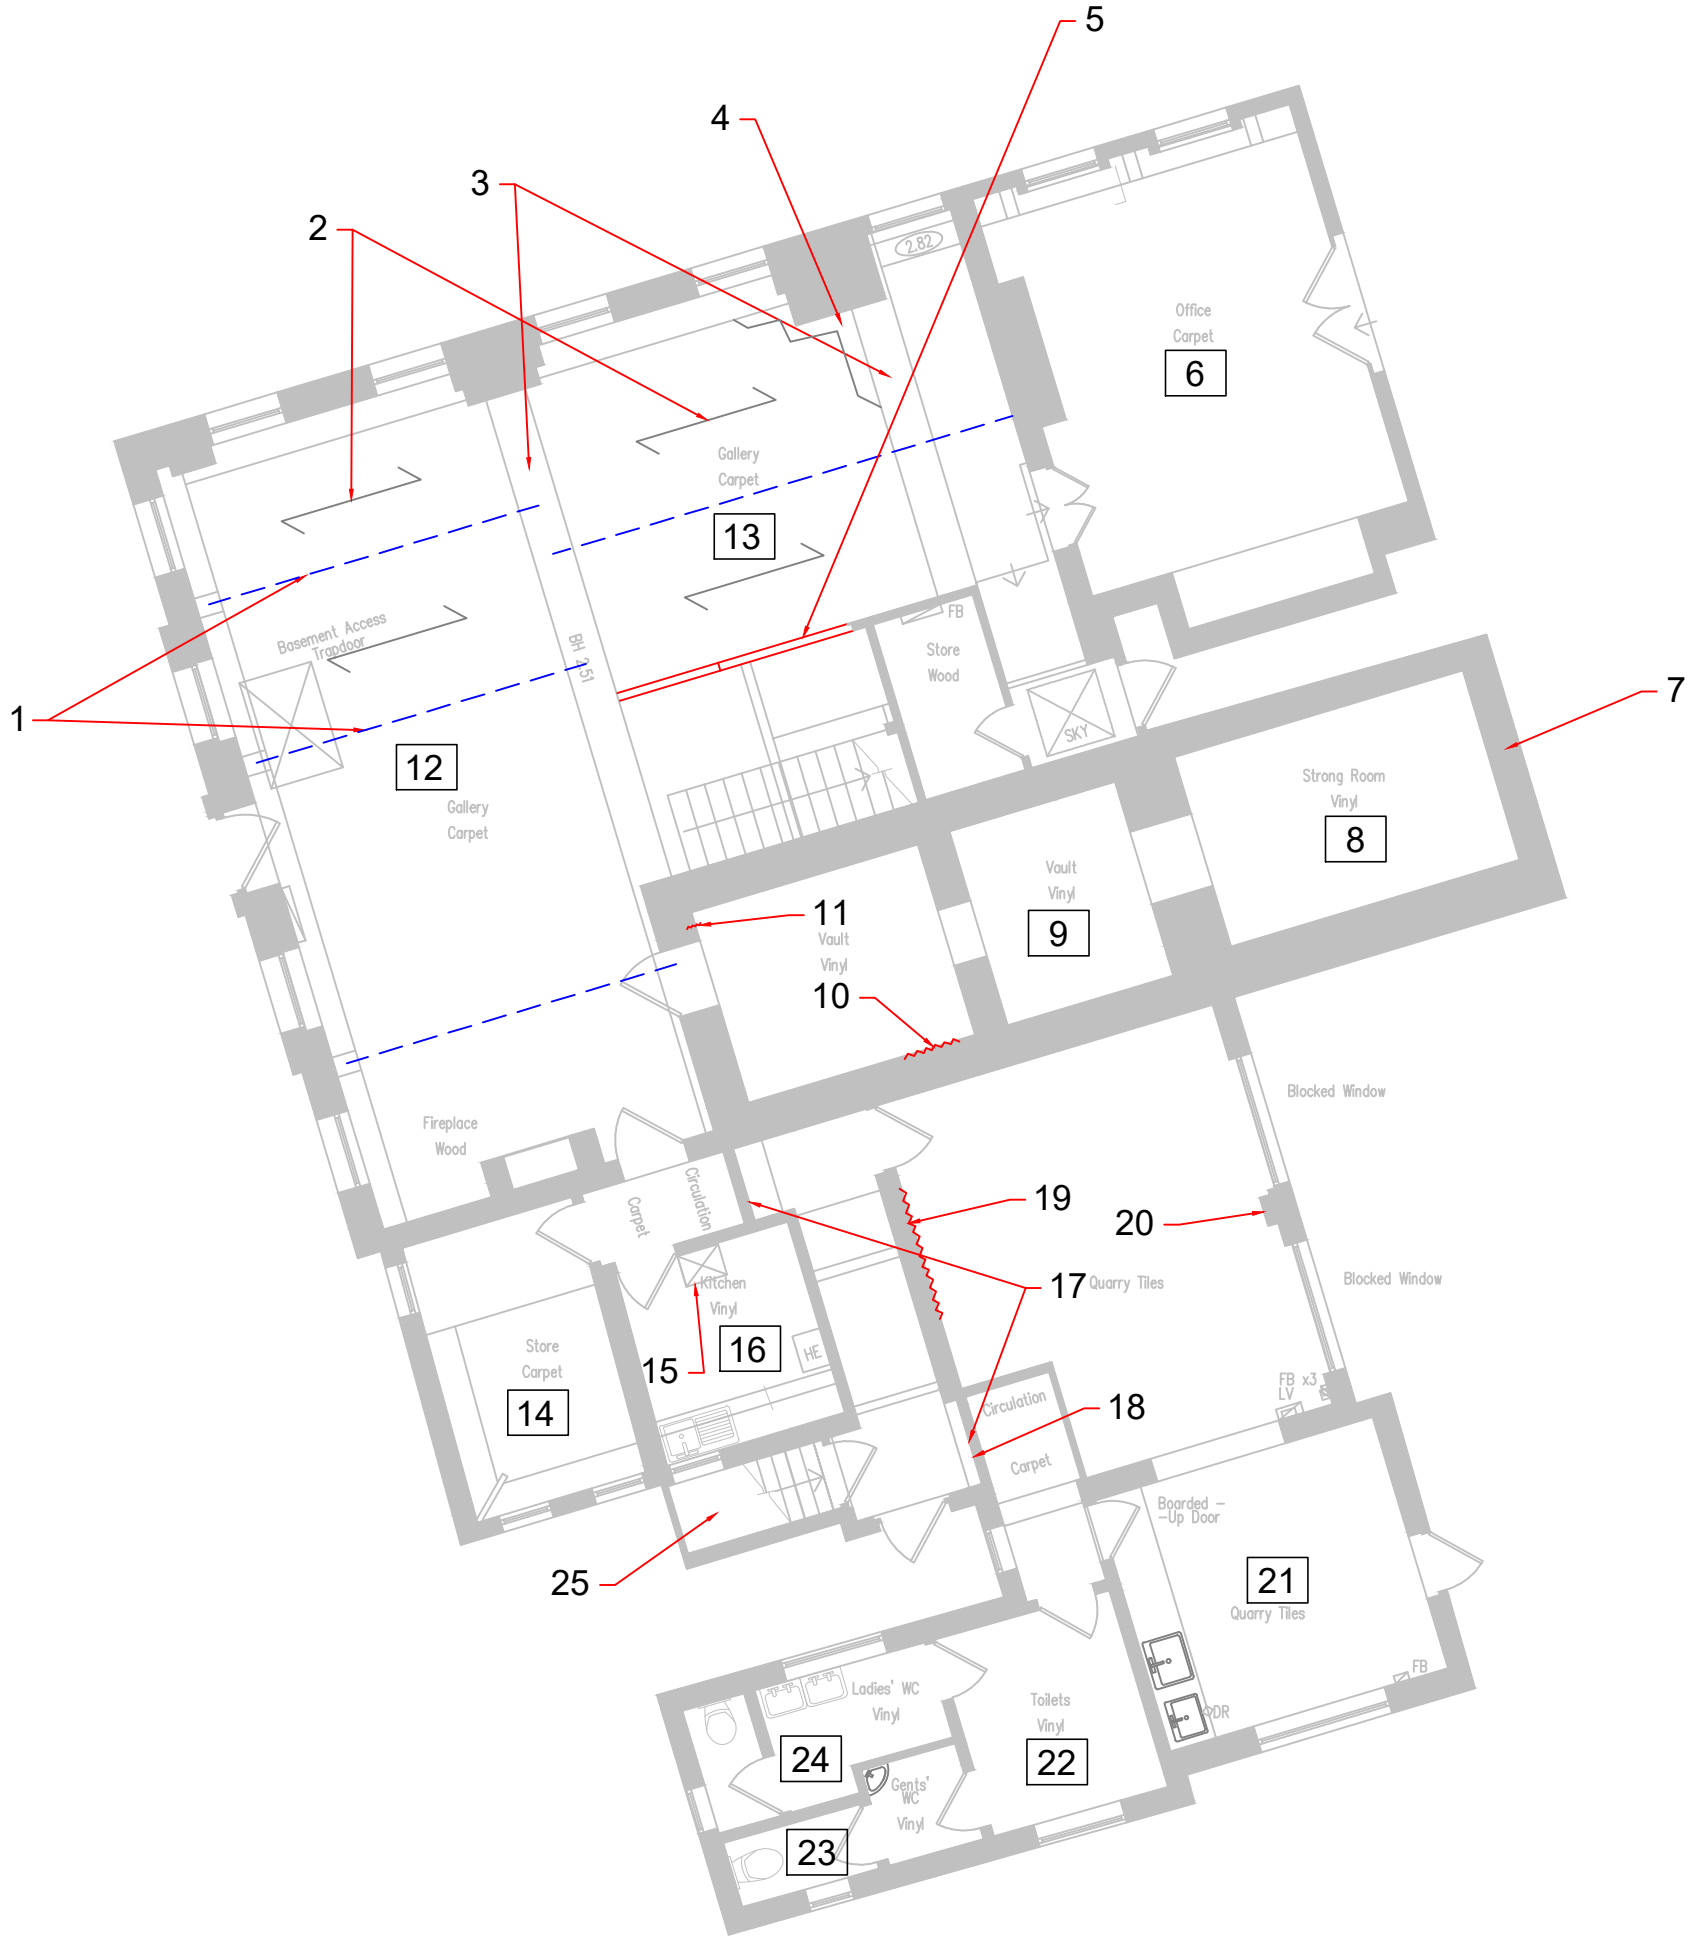
GROUND FLOOR PLAN  
SCALE 1:100

- GROUND FLOOR  
GF1 LAYOUT OF BEAMS SUPPORTING FLOOR ABOVE  
GF2 FLOOR JOIST DIRECTION AT FIRST FLOOR  
GF3 TRANSFER BEAMS ca 500mm DEEP?  
GF4 ORIGINAL MOULDINGS STILL PRESENT ABOVE SUSPENDED CEILING  
GF5 LOAD BEARING WALL ABOVE. PARTITION HAS BEEN REMOVED.  
GF6 NO ACCESS  
GF7 CONCRETE WALLS AROUND VAULTS  
GF8 NO STRUCTURAL DEFECT OF NOTE TO THIS VAULT  
GF9 NO STRUCTURAL DEFECT OF NOTE TO THIS VAULT  
GF10 MULTIPLE DIAGONAL HAIRLINE CRACKS IN THIS AREA  
GF11 VERTICAL HAIRLINE CRACK THROUGH FINISHES  
GF12 NO STRUCTURAL DEFECT OF NOTE TO FRONT ROOM  
GF13 NO STRUCTURAL DEFECT OF NOTE TO THIS ROOM  
GF14 NO STRUCTURAL DEFECT OF NOTE TO THIS ROOM  
GF15 LOFT HATCH – NO ACCESS  
GF16 NO STRUCTURAL DEFECT OF NOTE TO KITCHEN  
GF17 OPENINGS THROUGH HERE  
GF18 CRACKED LINTEL – INVESTIGATE  
GF19 HAIRLINE CRACKS IN FINISHES – INVESTIGATE. INTRUSIVE INVESTIGATION REQUIRED TO DETERMINE IF IT CONTINUES THROUGH SUBSTRATE

GF20 CRACKS IN FINISHES – EVIDENCE OF DAMP?  
GF21 NO STRUCTURAL DEFECT OF NOTE TO THIS ROOM  
GF22 NO STRUCTURAL DEFECT OF NOTE  
GF23 NO STRUCTURAL DEFECT OF NOTE ALTHOUGH VERY BAD SMELL  
GF24 NO STRUCTURAL DEFECT OF NOTE  
GF25 STAIRS TO BASEMENT 2  
GF26 ALL CORNERS TIGHT INTERNALLY

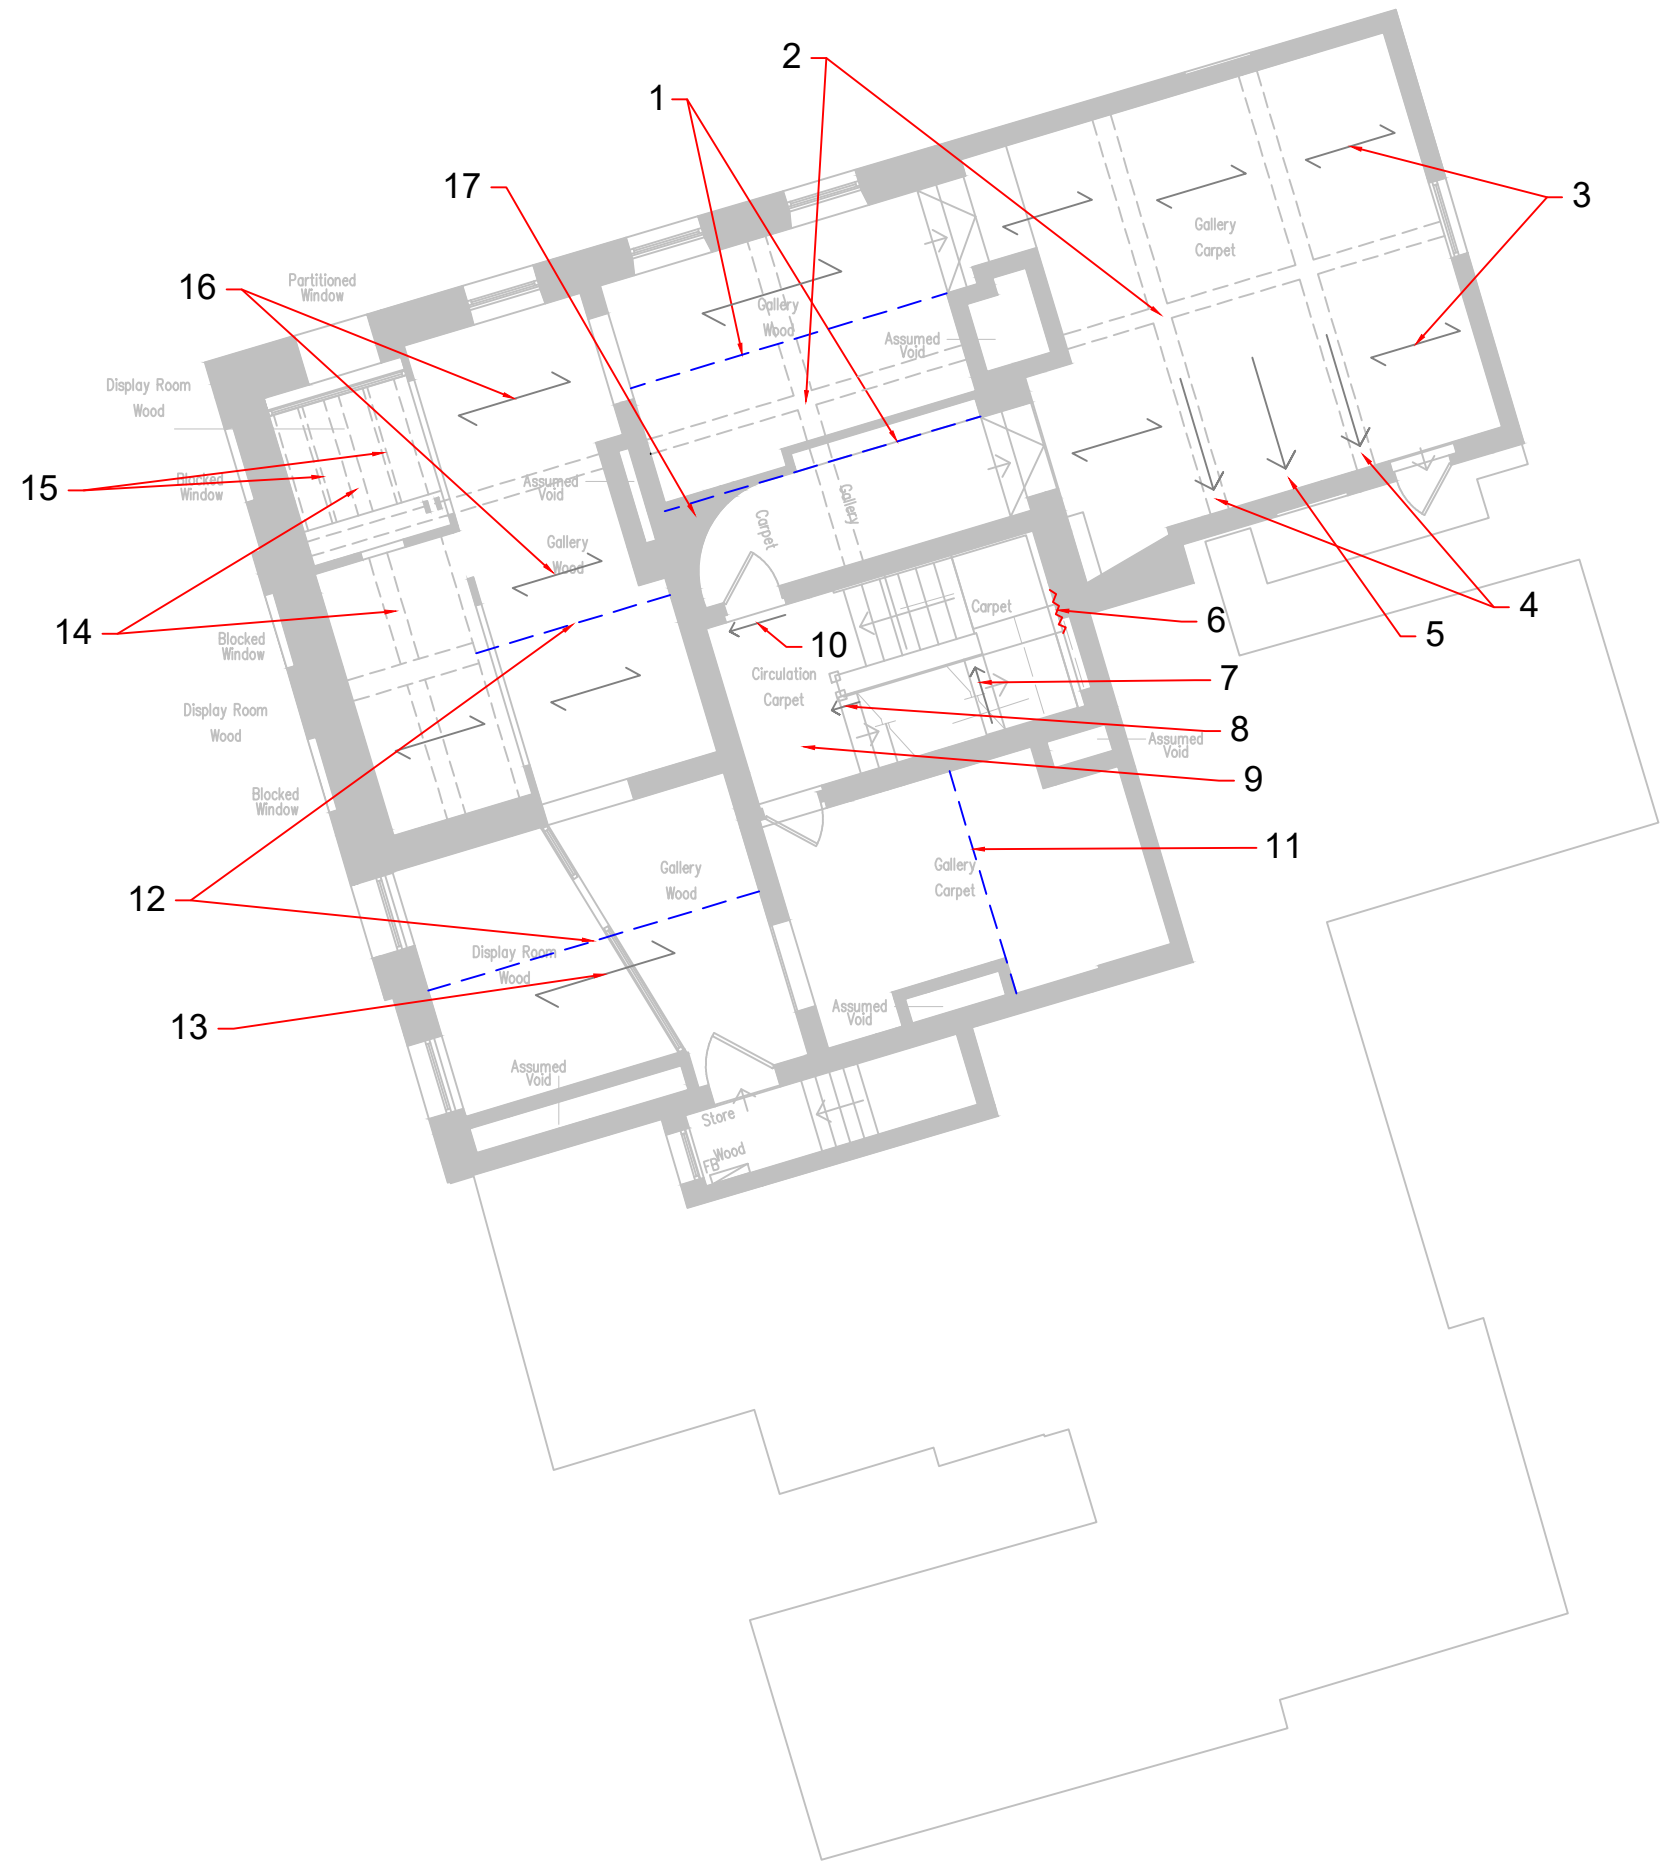
FIRST FLOOR PLAN  
SCALE 1:100

- FF6 SOME CRACKING FROM CEILING TO WINDOW
- FF7 POST LEANS OUT OF PLUMB
- FF8 STEPS LEAN DOWN – UNSUPPORTED BY POST BELOW
- FF9 SAG IN FLOOR BUT NOT BOUNCY

- FF13 DIRECTION OF FLOOR JOISTS AS SEEN FROM BELOW
- FF14 ENCASED STEEL BEAMS
- FF15 ADDITIONAL TIMBER JOISTS?
- FF16 DIRECTION OF FLOOR JOISTS AS SEEN FROM BELOW

- FF17 LATER PARTITION ADDED
- FF18 ALL CORNERS TIGHT INTERNALLY

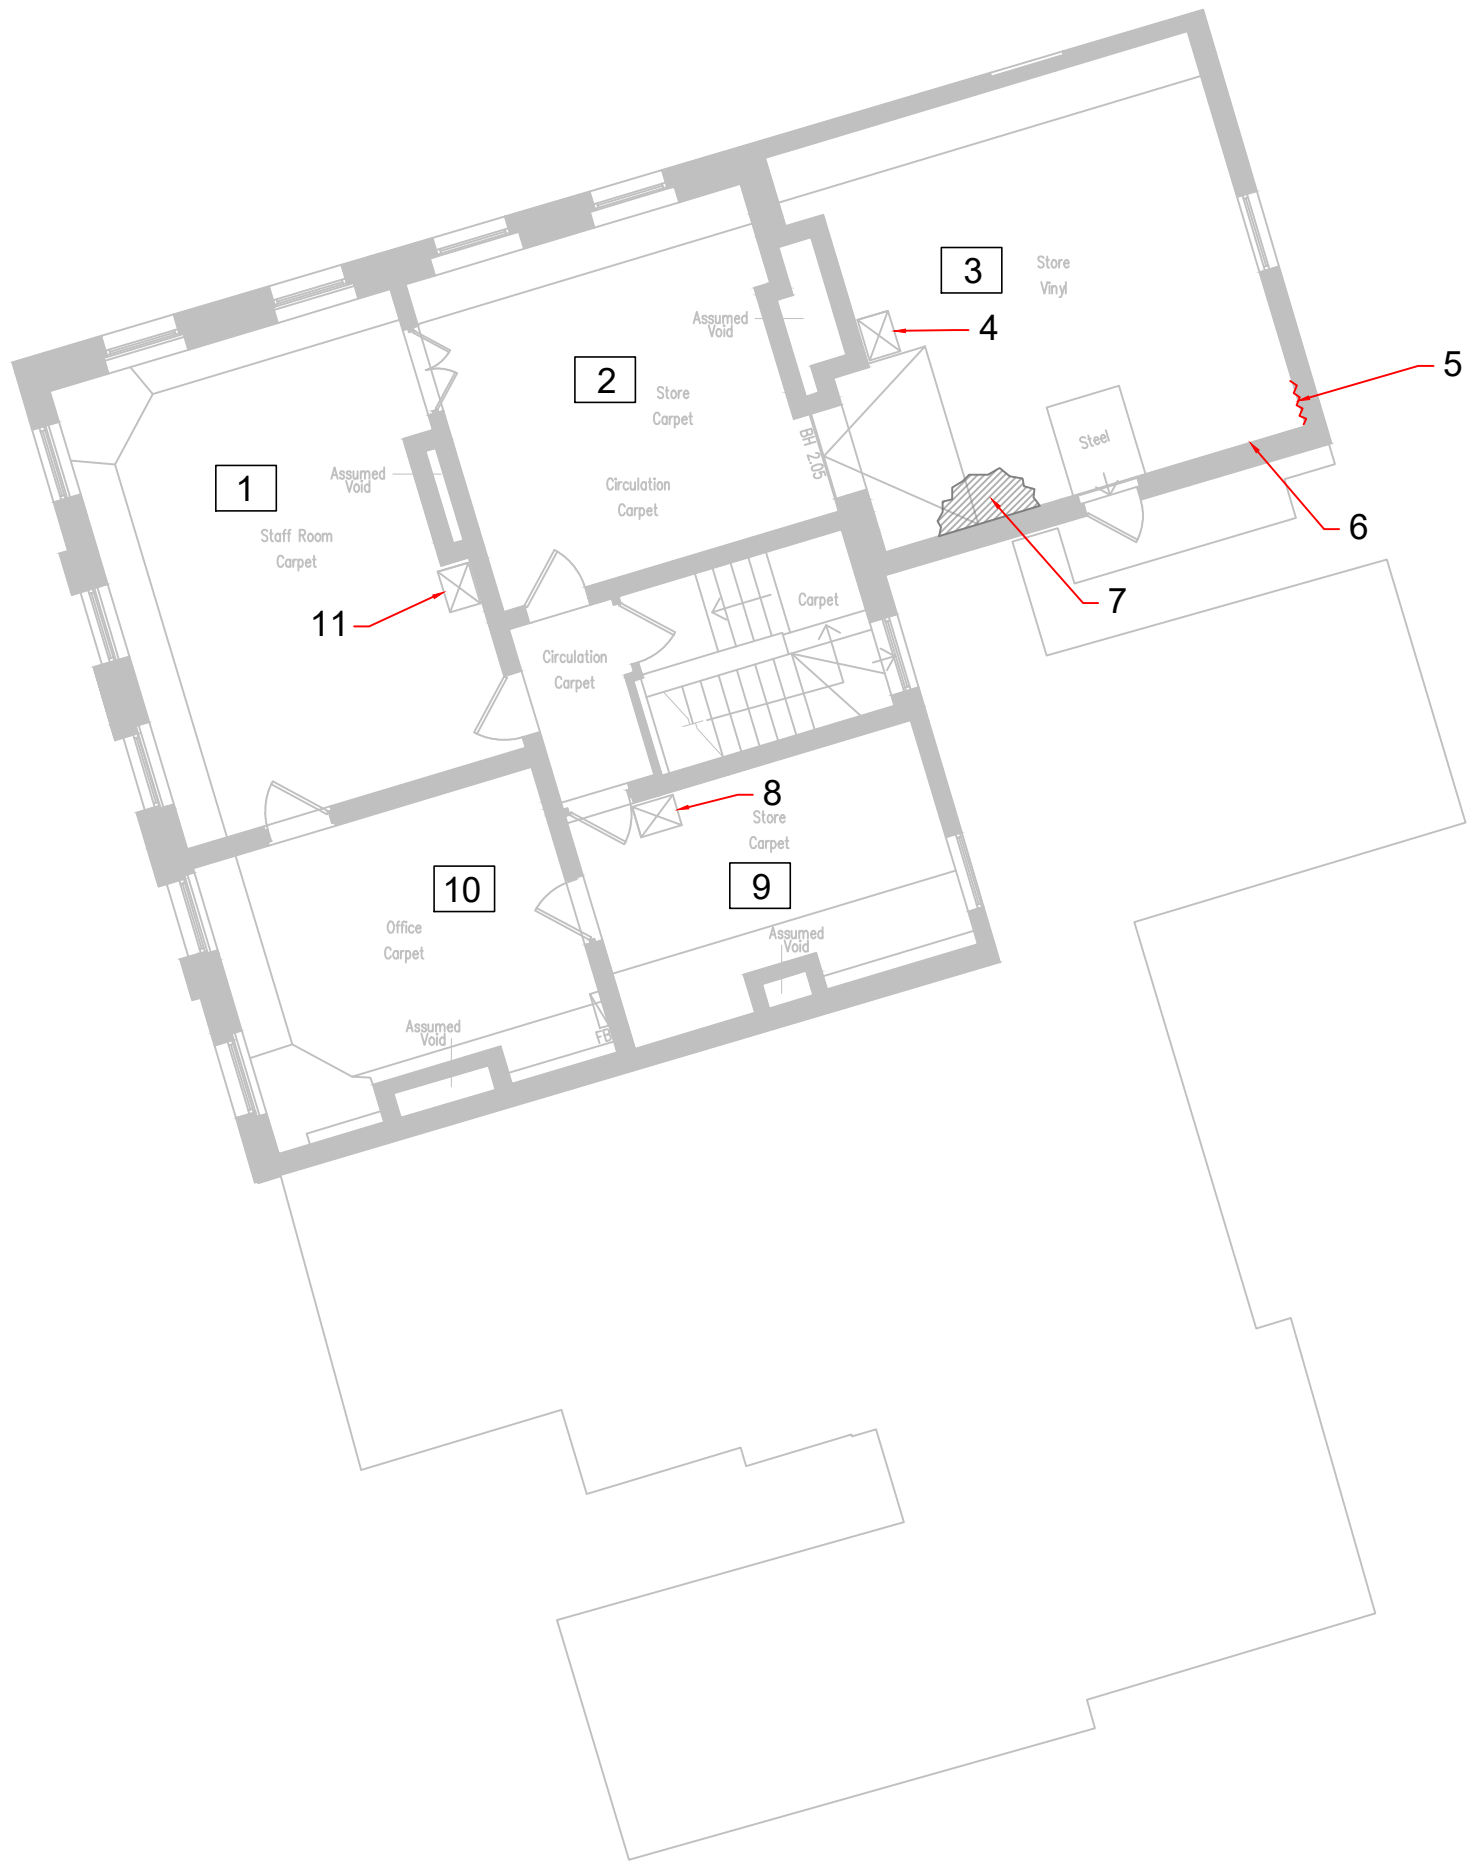
SECOND FLOOR PLAN  
SCALE 1:100

- SF1 NO STRUCTURAL DEFECT OF NOTE TO THIS ROOM
- SF2 NO STRUCTURAL DEFECT OF NOTE TO THIS ROOM
- SF3 NO STRUCTURAL DEFECT OF NOTE TO THIS ROOM
- SF4 LOFT HATCH
- SF5 DIAGONAL HAIRLINE CRACK IN TOP CORNER TRACKING DOWN TOWARDS ELEVATION D
- SF6 HAIRLINE CRACKS THROUGH FINISHES, WALLPAPER PEELING AS A RESULT OF DAMP
- SF7 DAMP CEILING – DISCOLOURATION AND LOCALISED SAG
- SF8 LOFT HATCH
- SF9 NO STRUCTURAL DEFECT OF NOTE TO THIS ROOM
- SF10 NO STRUCTURAL DEFECT OF NOTE TO THIS ROOM
- SF11 LOFT HATCH
- SF12 ALL CORNERS TIGHT INTERNALLY

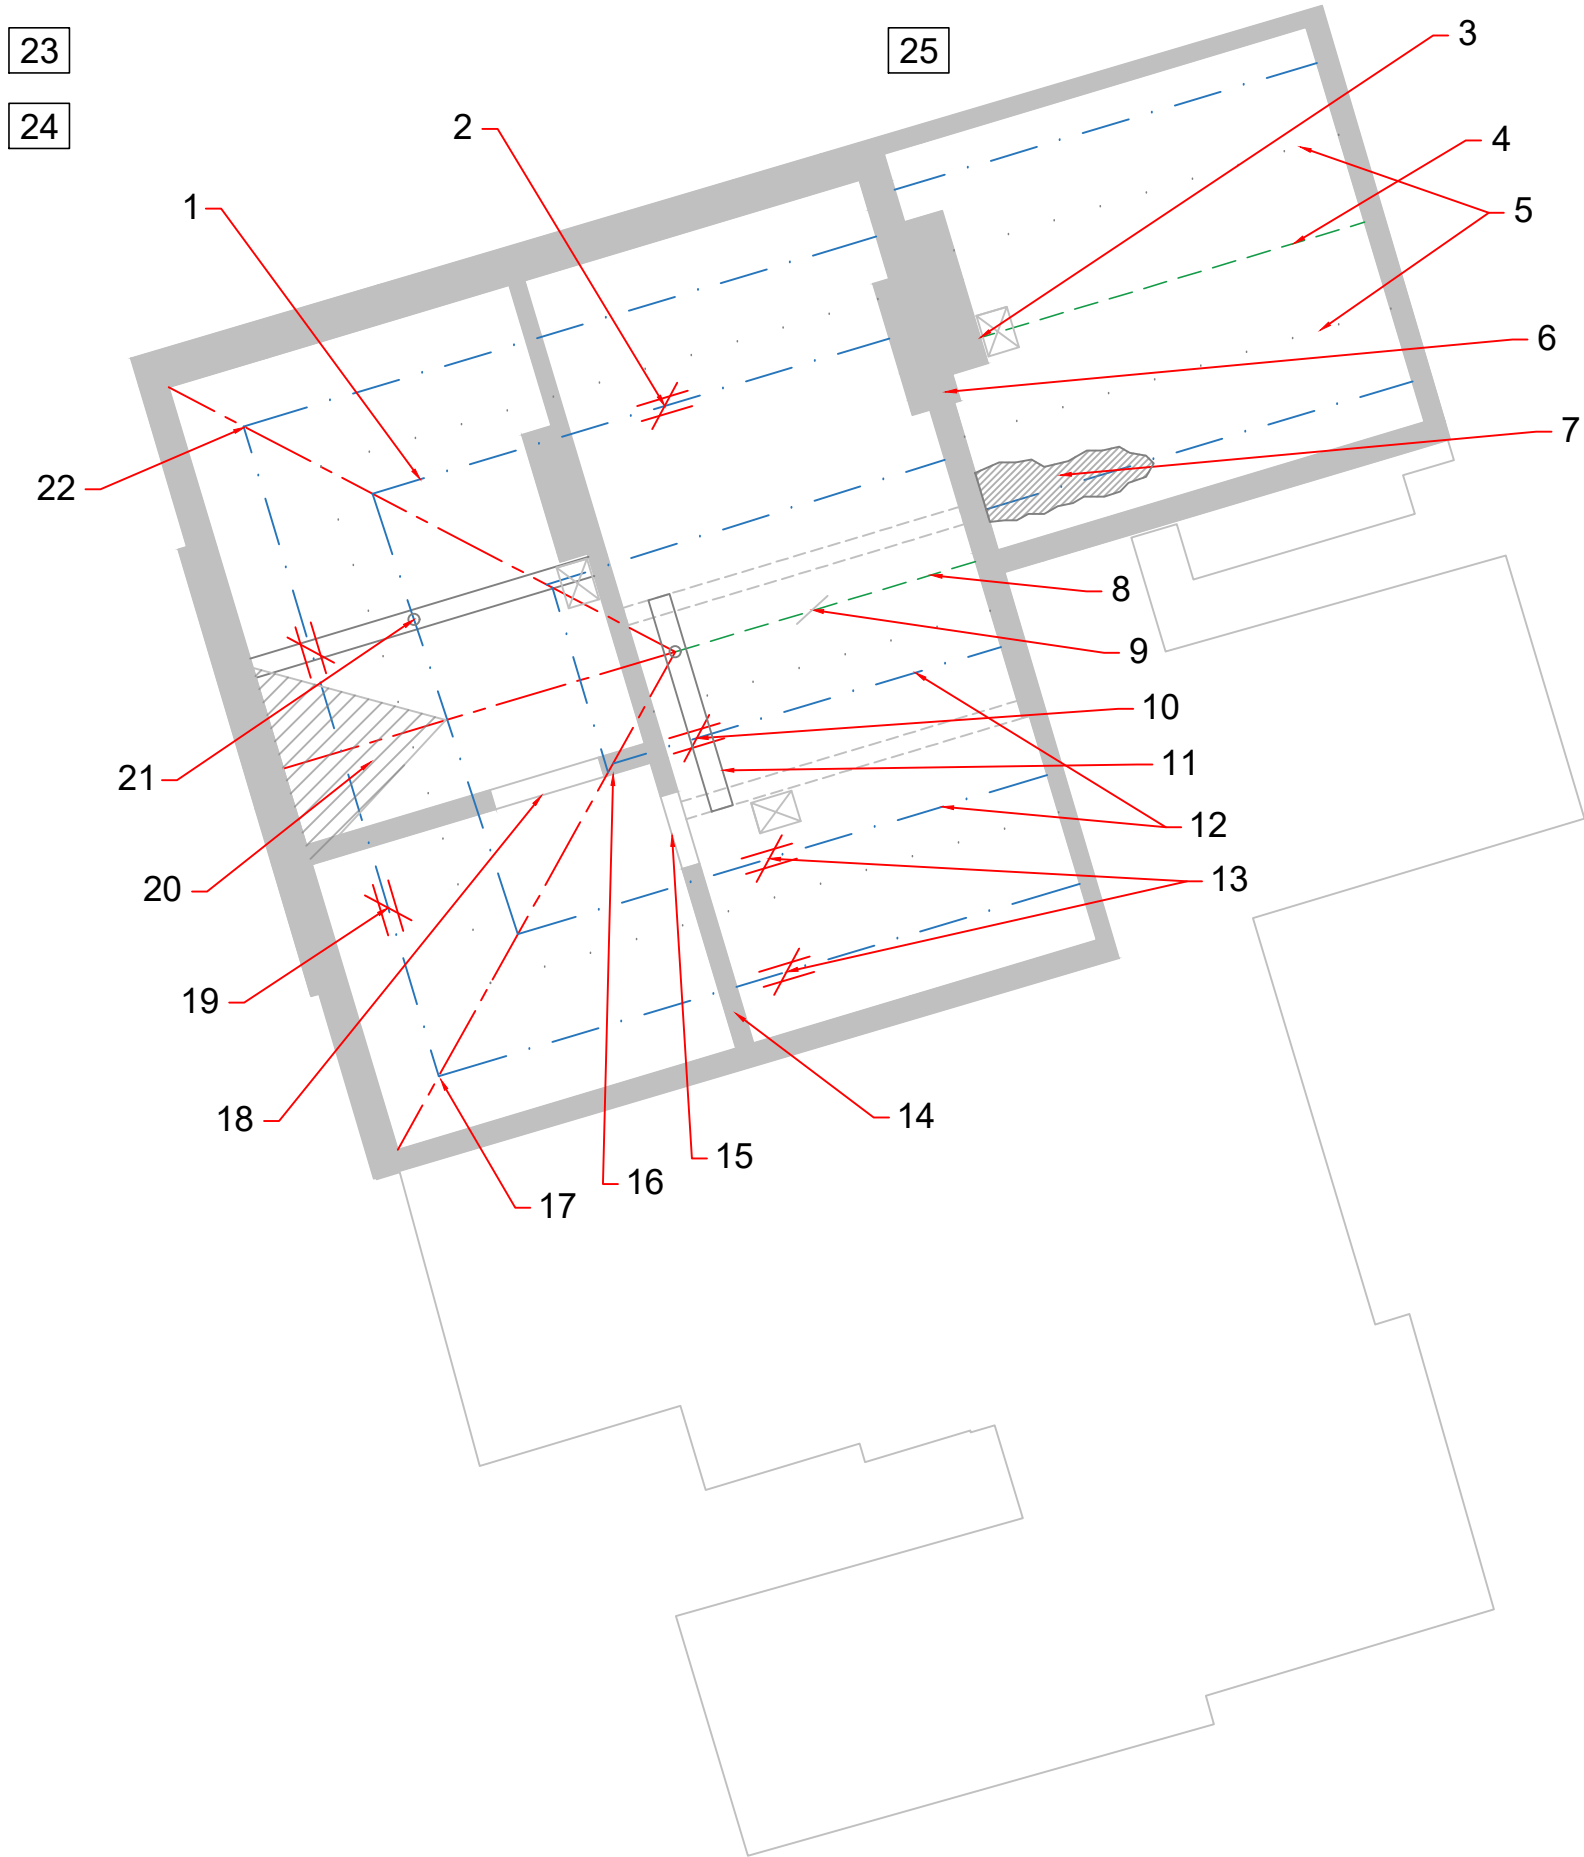
ROOF PLAN  
SCALE 1:100

- R4 RIDGEBOARD
- R5 COMMON RAFTERS PROPPED WITH SLENDER TIMBERS ALONG THIS LINE
- R6 LOOSE MASONRY UNDER CORBELLED CHIMNEY. REQUIRED PINNING / LOCAL REBUILDING AND DEEP PACK REPOINT

- R7 HOLES IN LINING AND DAMP END BEARING OF PURLIN
- R8 RIDGE PURLIN
- R9 BENDING FAILURE OF RIDGE PURLIN? CRACK ON TENSION SIDE THROUGH NATURAL FAULT LOCATION

- R12 COMMON RAFTERS TIGHTLY PACKED AGAINST PURLINS, FILLING ca. 100mm GAP BETWEEN THEM
- R13 SCARF JOINTS WITH LONG STEEL PLATE AND CLAMP
- R14 MASONRY GABLE OFFSET FRO HIPPED ROOF CONNECTION. LOCALISED REBUILDING REQUIRED AT GABLE PEAK TO INFILL MISSING MASONRY

- R22 PURLINS ATTACHED TO RAFTER (SEE PHOTOS)
- R23 TIMBERS IN GENERALLY GOOD CONDITION, SOME SEEM TO HAVE BEEN REUSED FROM ELSEWHERE AS IS CLEAR WHEN LOOKING AT THE PATTERN OF SPLICES JOINING SHORTER TIMBERS

- R24 SMALL TIMBER SECTIONS PROPPING COMMON RAFTERS IN ALL THE ACCESSED SPACE. SOME AT MORE REGULAR INTERVALS THAN OTHERS
- R25 SOME DECAY AND DAMP IN EASTERN EXTENSION
