## Tree Survey

Dan Bloomberg  
35 Bolton Hey, Huyton  
53.40791 -2.84937

Survey Date: 05/03/21

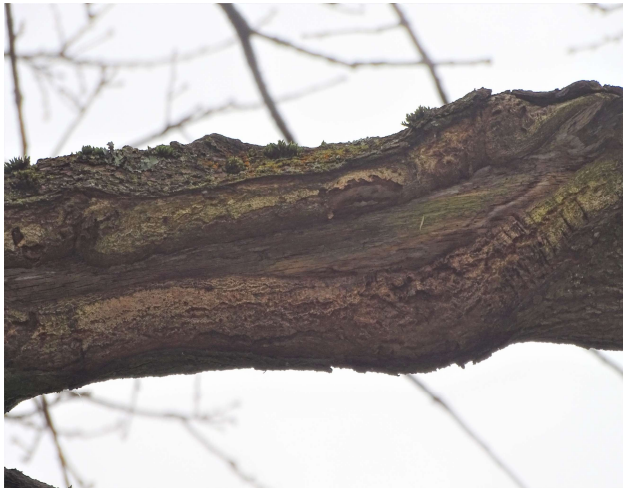
Example of Lesion
