Old Wood North, Whiston

Knowsley Metropolitan Borough Council

January 2022

## Technical Note – Old Wood North TWA

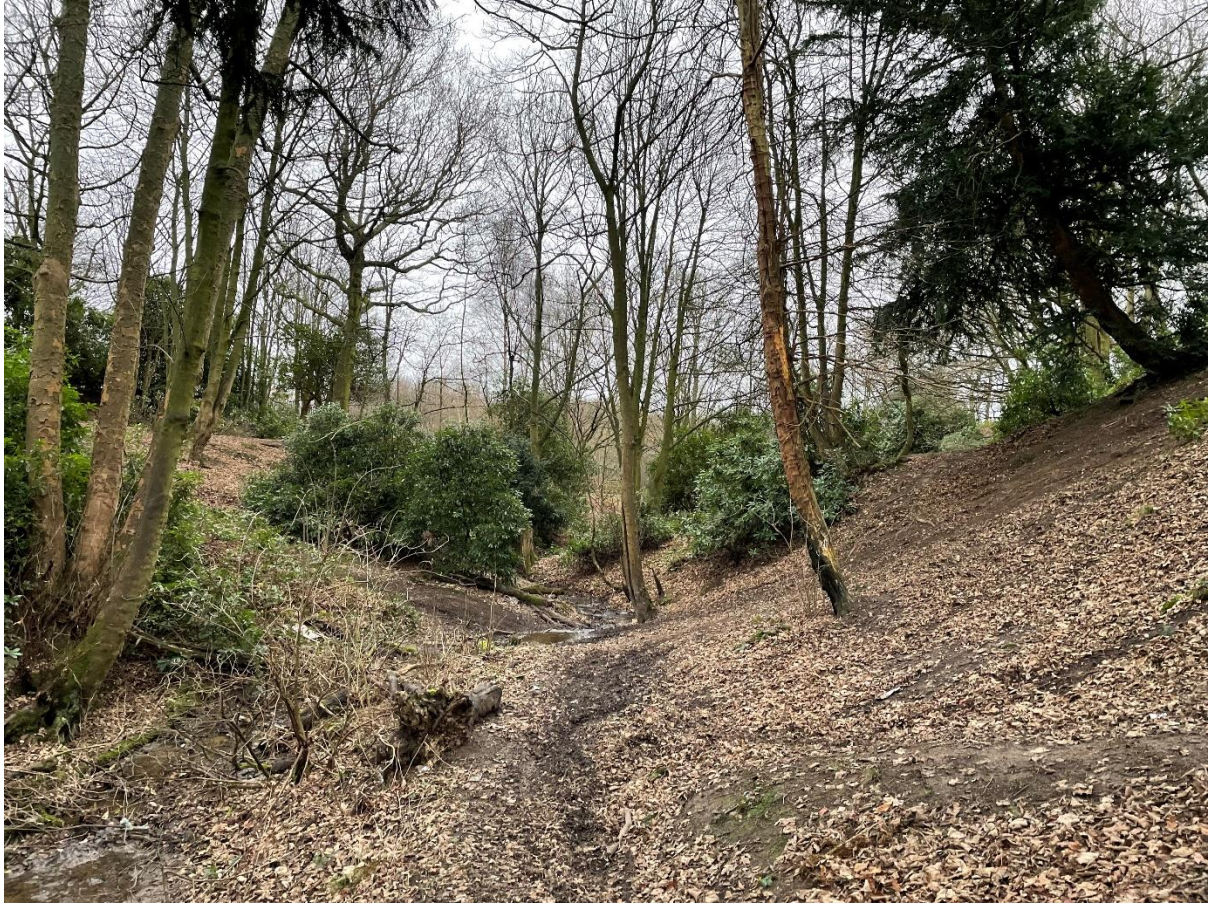
An image showing the watercourse in the foreground and dense Rhododendron clusters in the background.

Surrounding the watercourse within Old Wood are dense clusters of Rhododendron which could prevent access to the watercourse. Rhododendron is classified as an invasive woodland species and has been proven to have an overall negative effect on woodlands (Forestry Commission, 2022). The removal of the Rhododendron within a 10m buffer zone of the watercourse is recommended, this will allow for access to the watercourse and should improve the overall condition of the woodland (Ref: OldwoodRhod/TLP). These works are classed as exempt from a tree preservation and will not be included within the tree works application.

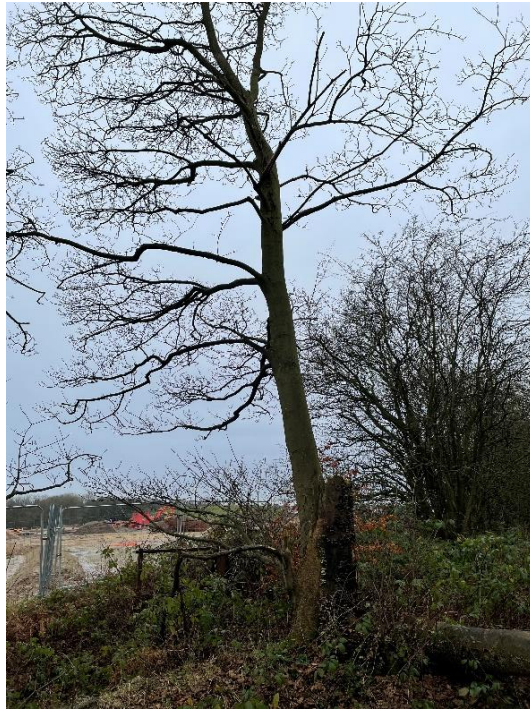
The client informed the author that access to the watercourse within the woodland will be from an area on the western side of the woodland (Ref: OldWood/TWA). To enable access to the watercourse, two trees need to be felled. T3, a twin stemmed Sycamore (*Acer pseudoplatanus*), upon inspection was found to have one failed stem that was hung up in an adjacent tree. At the base of the failed stem, there was Turkey Tail (*Versicolor trametes*) fungal fruiting bodies from the base to the location of the failure at 1m. It was estimated that the stem had failed some time ago due to the presence of flaking bark and fungal fruiting bodies, which are saprophytic and only feed off dead

wood. The remaining stem was in fair condition and the crown had minor deadwood (>50mm diameter) within but does require removal to enable access to the watercourse. It is considered that the loss of this tree will not have a detrimental impact to the woodland because of its overall condition.

An image showing T3.

| Tree No. | Species | Height (M) | Age | Condition Rating | Comments And Management Recommendations | Priority Rating |
|---|---|---|---|---|---|---|
| T3 | Sycamore | 15 | FM | Fair | Reasonable shape and form. Was twin stemmed, one stem has failed and is hung up in adjacent tree. Remaining stem has no major visible defects. <b>Clear fallen stem and fell remaining stem.</b> | 2 |

It is recommended that both trees are replaced on a 2:1 basis using tree species native to British woodlands.

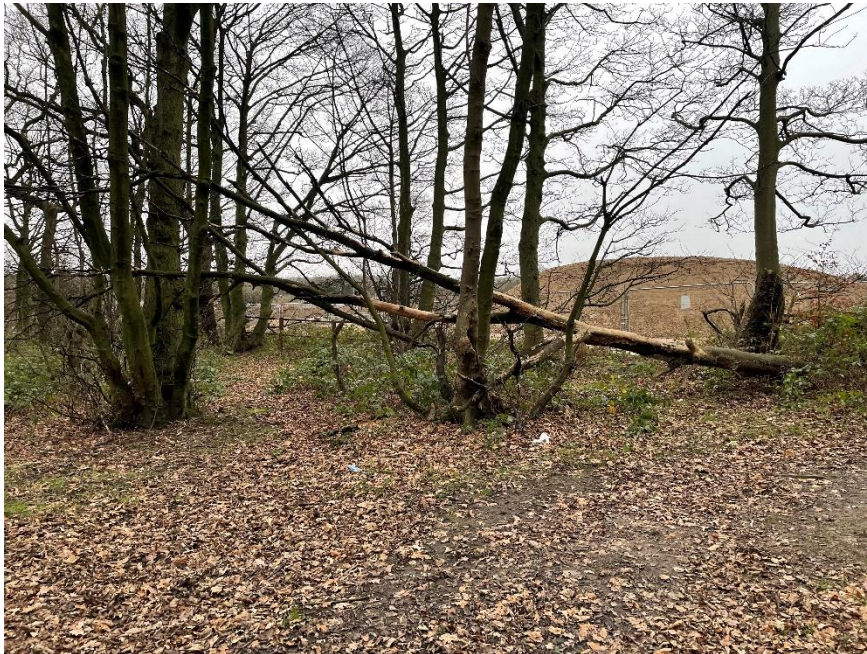
An image showing the fallen stem of T3.

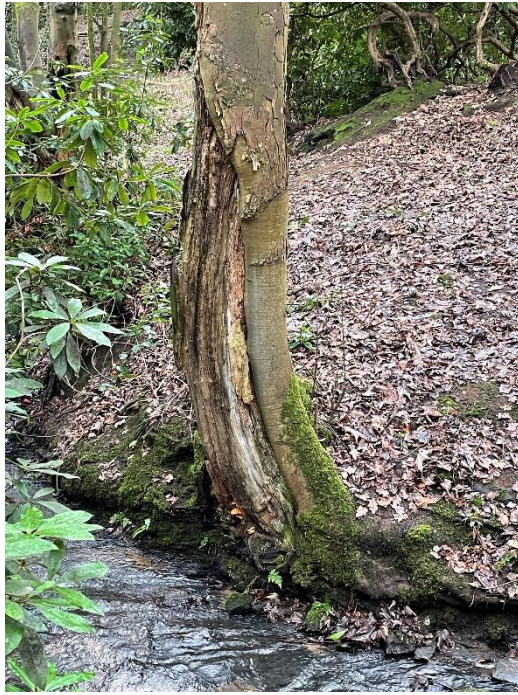
During the survey, several trees within the woodland were found to have varying levels of stem decay. These were T6, T7, T8 and T9. Because of the amount of decay within these trees, it is highly likely that they are structurally compromised and present a risk to the users of the woodland. Therefore, it is recommended that these trees are removed as soon as practicable to ensure the safety of the users of the woodland.

An image showing the decay on T7, a Sycamore.

| Tree No. | Species | Height (M) | Age | Condition Rating | Comments And Management Recommendations | Priority Rating |
|---|---|---|---|---|---|---|
| T7 | Sycamore | 18 | FM | Poor | Reasonable shape and form. Column of decay present from 0-2m, exposed wood has rot present with fungal fruiting bodies ( <i>Flammulina velutipes</i> ) present. Limited long-term value. <b>Fell.</b> | 2 |

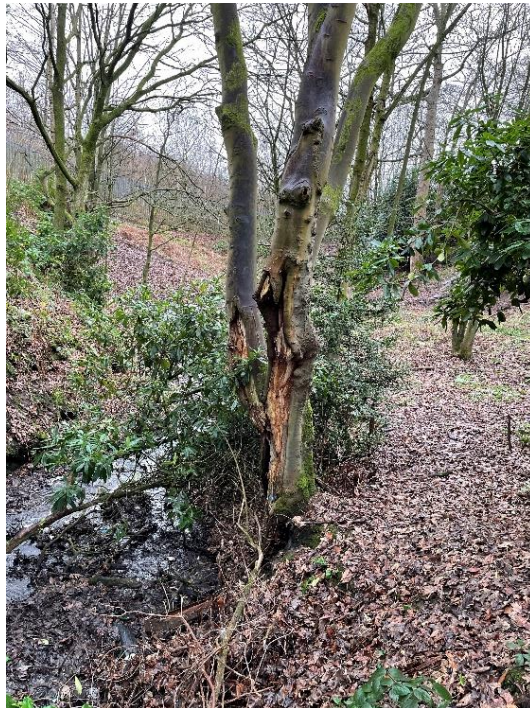
An image showing the decay on T9, a Sycamore.

| Tree No. | Species | Height (M) | Age | Condition Rating | Comments And Management Recommendations | Priority Rating |
|---|---|---|---|---|---|---|
| T9 | Sycamore | 18 | FM | Poor | Reasonable shape and form. Tri-stemmed. Extensive decay present at base of stems. Limited long-term value. <b>Fell.</b> | 2 |

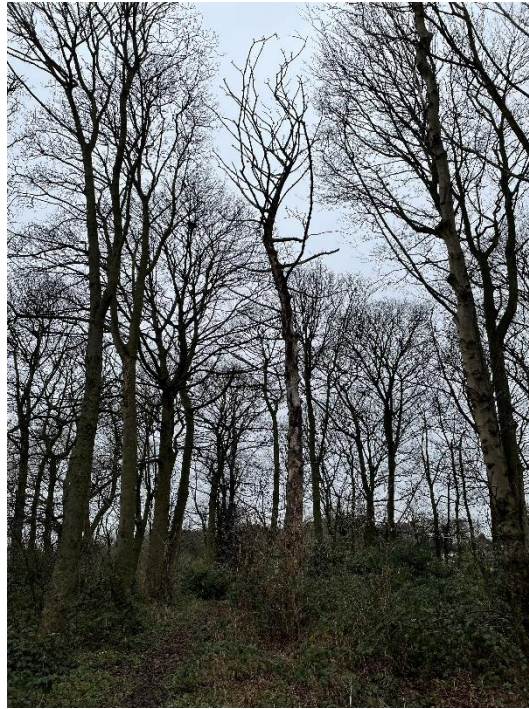
Upon inspection of T10, it was found to be dead. It is of the inspector's opinion that this tree has ecological value to the area and the main stem should remain to decay naturally. However, to ensure the safety of the tree's surroundings, the tree should be reduced to a standing dead stem with no branches or limbs remaining.

An image showing T10, a standing dead tree (centre).

| Tree No. | Species | Height (M) | Age | Condition Rating | Comments And Management Recommendations | Priority Rating |
|---|---|---|---|---|---|---|
| T10 | Standing Dead | 17 | D | Dead | Standing dead tree. Tree has some ecological value. <b>Reduce to monolith.</b> | 2 |

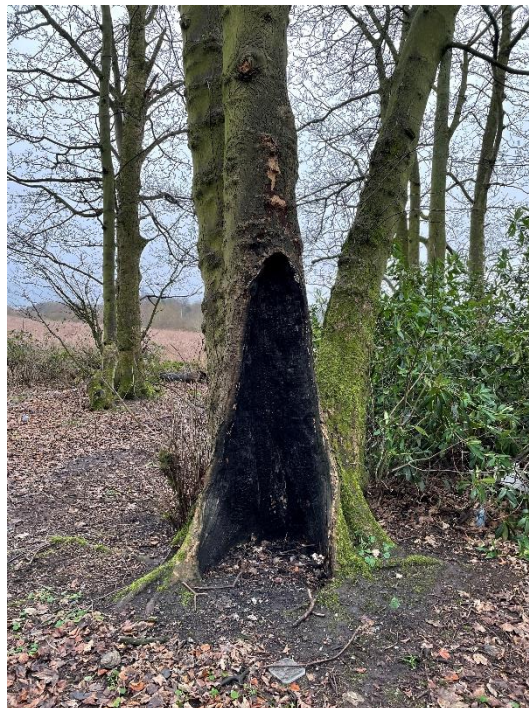
Upon inspection of T11, a multi-stemmed Sycamore (*Acer pseudoplatanus*), one of the stems was found to have partially hollowed from the base of the tree to 3m. The hollowed area had suffered from suspected fire damage and had some fungal fruiting bodies on the edge of the burnt area (*Bjerkandera adusta*), because of this the structural integrity of this stem is likely to be compromised and now presents a risk to the users of the woodland. It is recommended that this stem is removed as soon as practicable. The other stems were found to be in good condition and can remain, it is expected that the loss of one limb will not have a detrimental effect to the tree.

An image showing the fire damage on T11, a Sycamore.

| Tree No. | Species | Height (M) | Age | Condition Rating | Comments And Management Recommendations | Priority Rating |
|---|---|---|---|---|---|---|
| T11 | Sycamore | 18 | FM | Fair | Reasonable shape and form. Tri stemmed from base. One stem has extensive hollowing, hollowed area has evidence of fire damage. The other stem has no major visible defects. Minor deadwood in crown. <b>Fell fire damaged stem.</b> | 2 |
