# TIMBER & DAMP SURVEY

8-14 KEMBLE STREET  
PRESCOT

December 2022

**DEMAUS BUILDING DIAGNOSTICS Ltd**  
STAGBATCH FARM, LEOMINSTER, HEREFORDSHIRE HR6 9DA  
Tel. 01568 615662

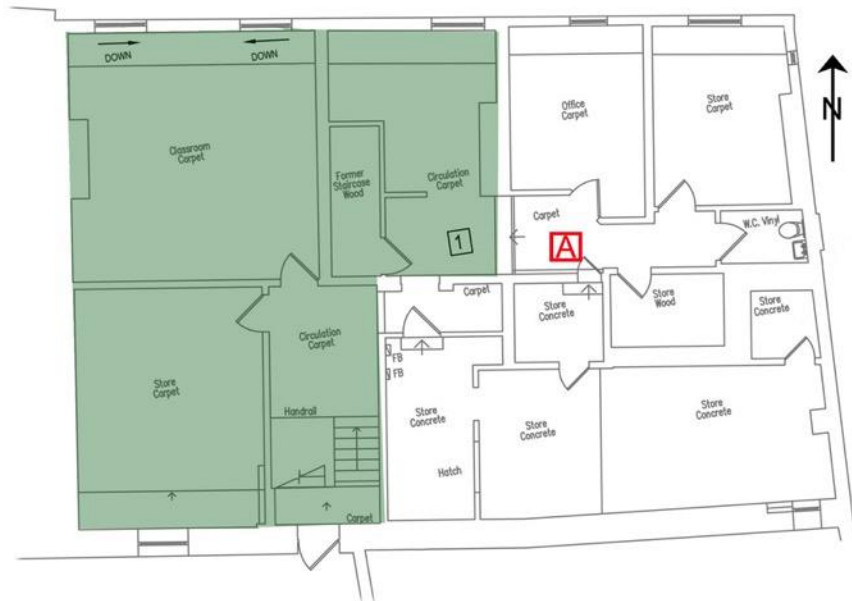
Figure 1. Front Building: Second Floor Plan

5.03 Debris covering the ceiling timbers prevented safe access to the area shown green in Figure 1. No significant degradation was identified in the structural roof timbers or ceiling timbers by visual inspection.

5.04 The relatively slender ceiling joists restricted access to other areas of the roof space, in particular the area around the parapet gutter on the north elevation and the purlins built into the east wall.

5.05 The parapet gutter has failed over a long period, and the presence of widespread fungal attack at lower levels in the wall below the parapet gutter would suggest that there is significant to severe degradation to all timbers within 900-1200 of the front (north) elevation.

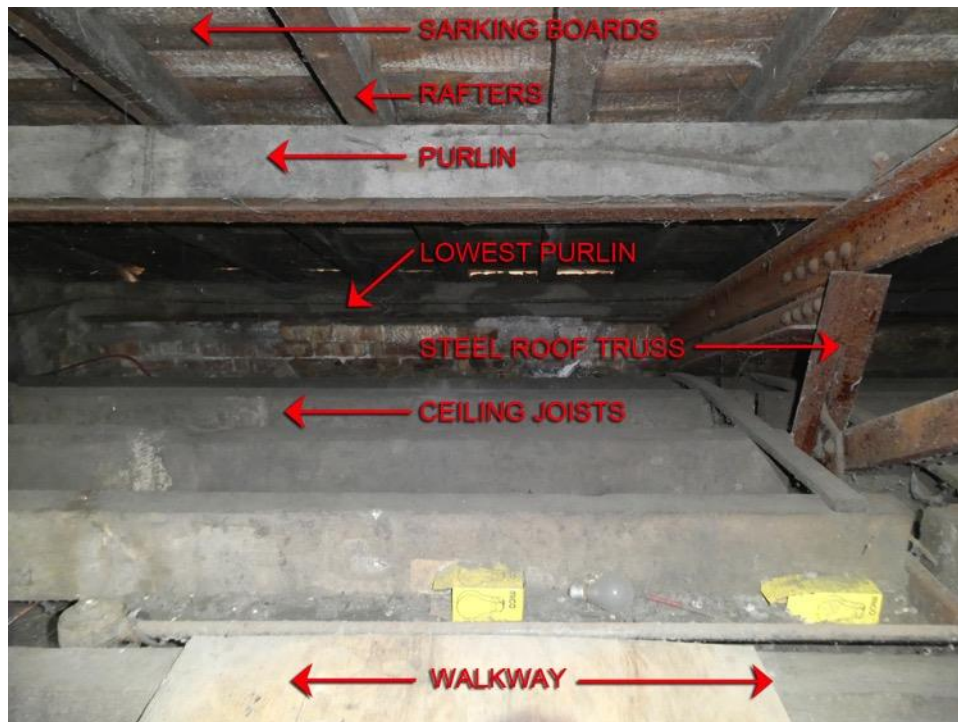
Figure 2. Main elements of roof structure.

- 5.23 The exact configuration of the structural elements at eaves level could not be determined, but it seems that the timber elements of the roof structure are

largely independent of the wall masonry, with the lowest purlin set close to the wall head, acting as a 'wall plate'. There may be a secondary plate bearing on the wall, but if present, it is not a significant structural element.

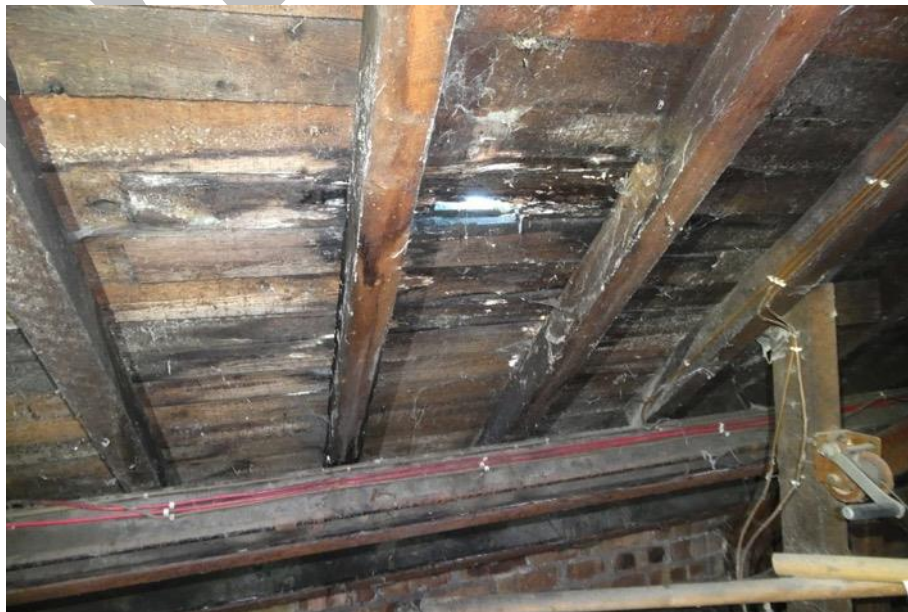
- 5.24 There is very localised fungal degradation around the ventilation cupola, and also where roof slates have slipped. Generally these have affected small areas of sarking board, which can easily be replaced locally.
- 5.25 Where fungal activity has spread to rafters, the weakened section can be easily partnered with a timber section fixed to one or both sides. See *Figure 3*

Figure 3. Localised decay of sarking boards.

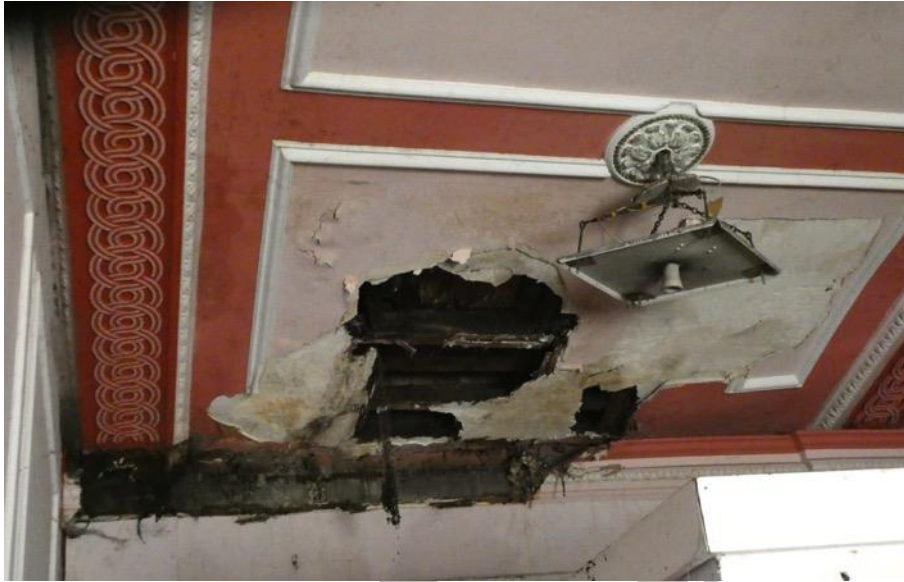
- 5.26 This leak due to slipped slates visible in Figure 3 has caused relatively little damage in the immediate area, but significantly more lower in the building where the water has accumulated and been absorbed by ceiling plaster etc. See *Figure 4*. Even here, necessary interventions are modest and straightforward. The affected ceiling joists will need to be partnered with new softwood elements fixed to one or both sides of the degraded joists, and probably spanning from truss to truss.

Figure 4. Damage to plaster ceiling caused by a roof failure directly above.

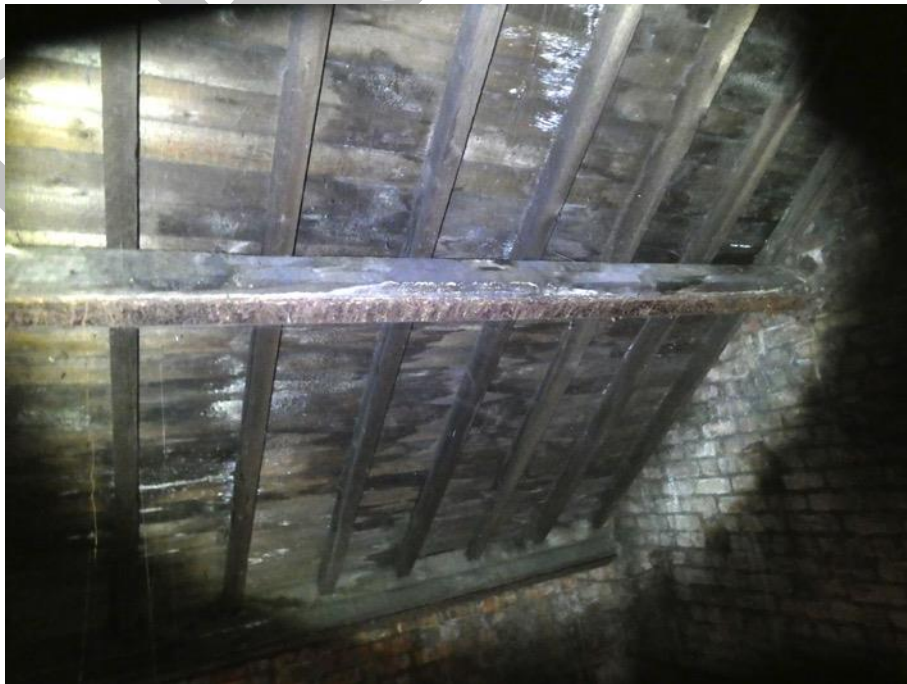
- 5.27 There is some fungal activity visible in the timber elements of the purlins in the south-most bay of the auditorium roof. See *Figure 5*. It is possible that water from a leak higher in the roof is collecting in the steel angle element of the purlin, allowing fungal activity to initiate and thrive on the timber section.

Figure 5. Fungal activity in purlin in south bay.

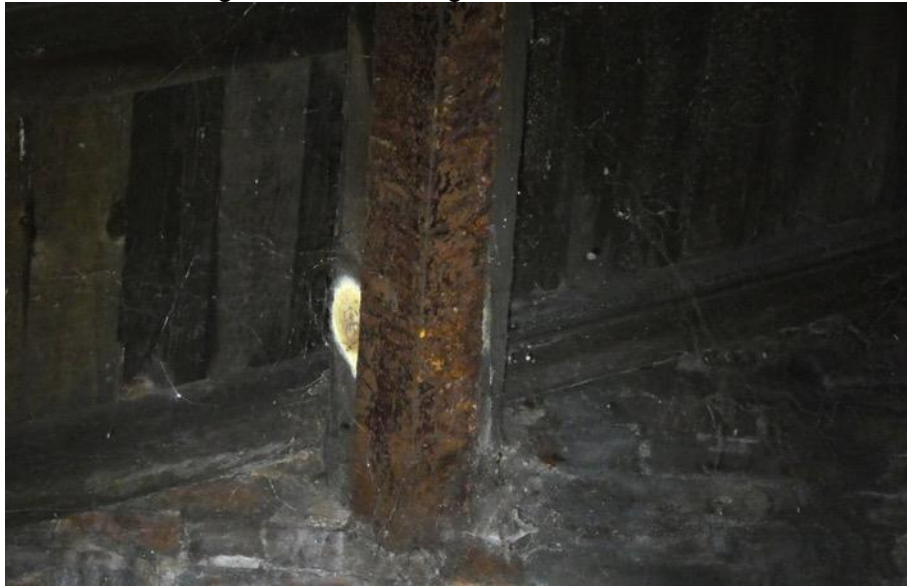
- 5.28 There is also evidence of fruiting body of a fungus (probably *Serpula lacrymans*) adjacent to the south gable wall. See Figure 6.

Figure 6. Fungal fruiting body on purlin

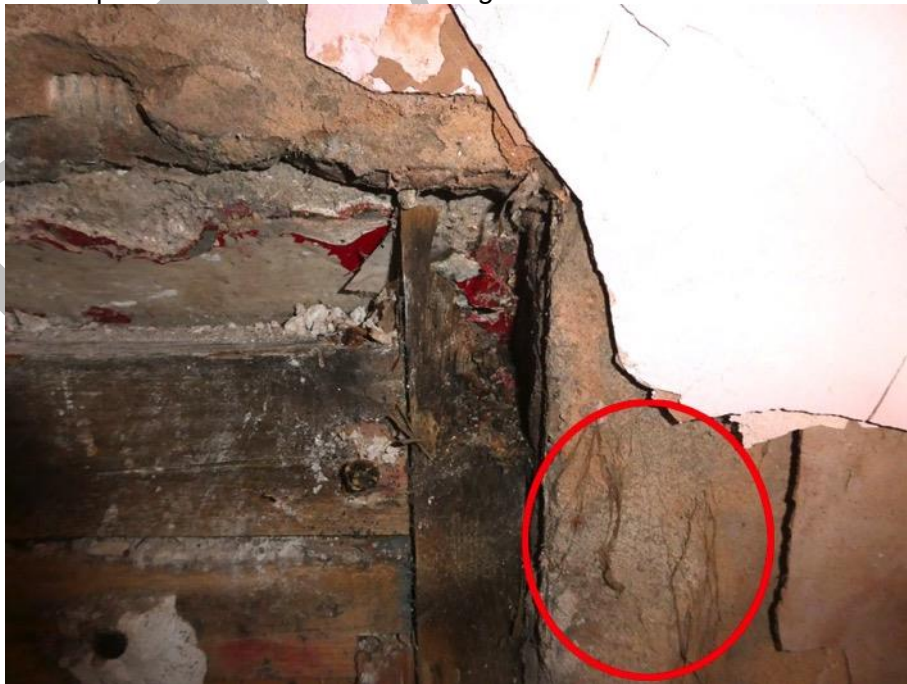
- 5.30 No structural elements could be identified within the main external walls of the auditorium. However, there is evidence of fungal strands growing between the internal plaster and the brickwork (circled), and there are non-structural timber elements to provide a food source. See Figure 7.

Figure 7. Mycelium growing on non-structural timbers and between plaster layers.

- 5.31 The timbers are probably later insertions used to infill recesses in the masonry walls.

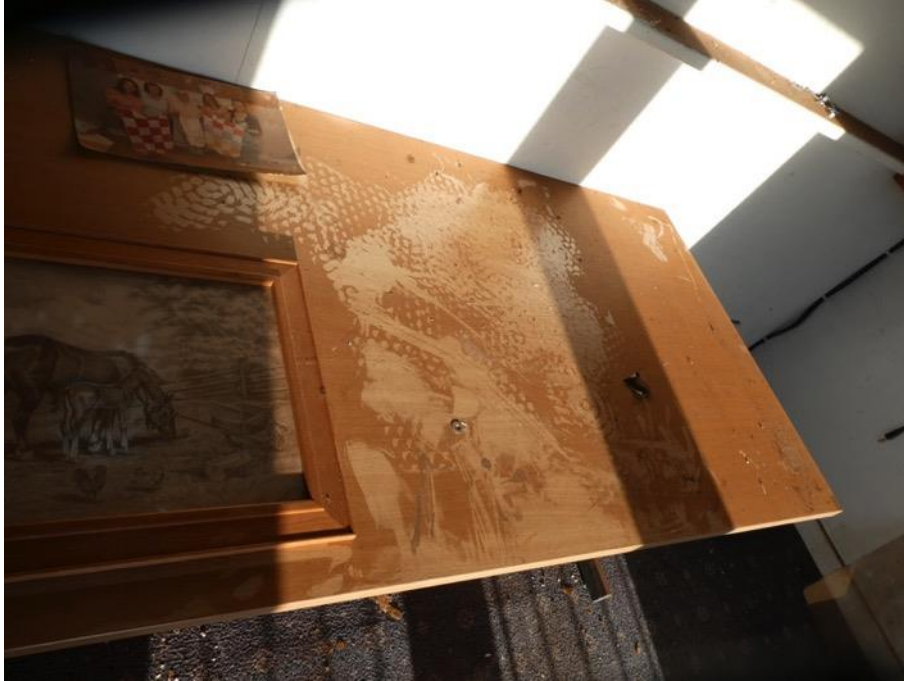
- 5.32 The plaster is almost certainly later and relatively impermeable. The walls generally are likely to be effectively saturated.
- 5.33 The south-most bay of the auditorium contains softwood doors and lintels etc. All accessible timbers built into, and/or in contact with the masonry walls are severely degraded by fungal attack. There are widespread fruiting bodies of *Serpula lacrymans* present, and all horizontal surfaces are liberally covered with fungal spores. See Figure 8

Figure 8. Spores of 'Dry rot' *Serpula lacrymans* covering all horizontal surfaces.
