**Taylor Wimpey (North West)**

**PROPOSED ACCESS ARRANGEMENTS  
FOX'S BANK LANE, WHISTON**

**STAGE 1/2 - ROAD SAFETY AUDIT  
JUNE 2023**

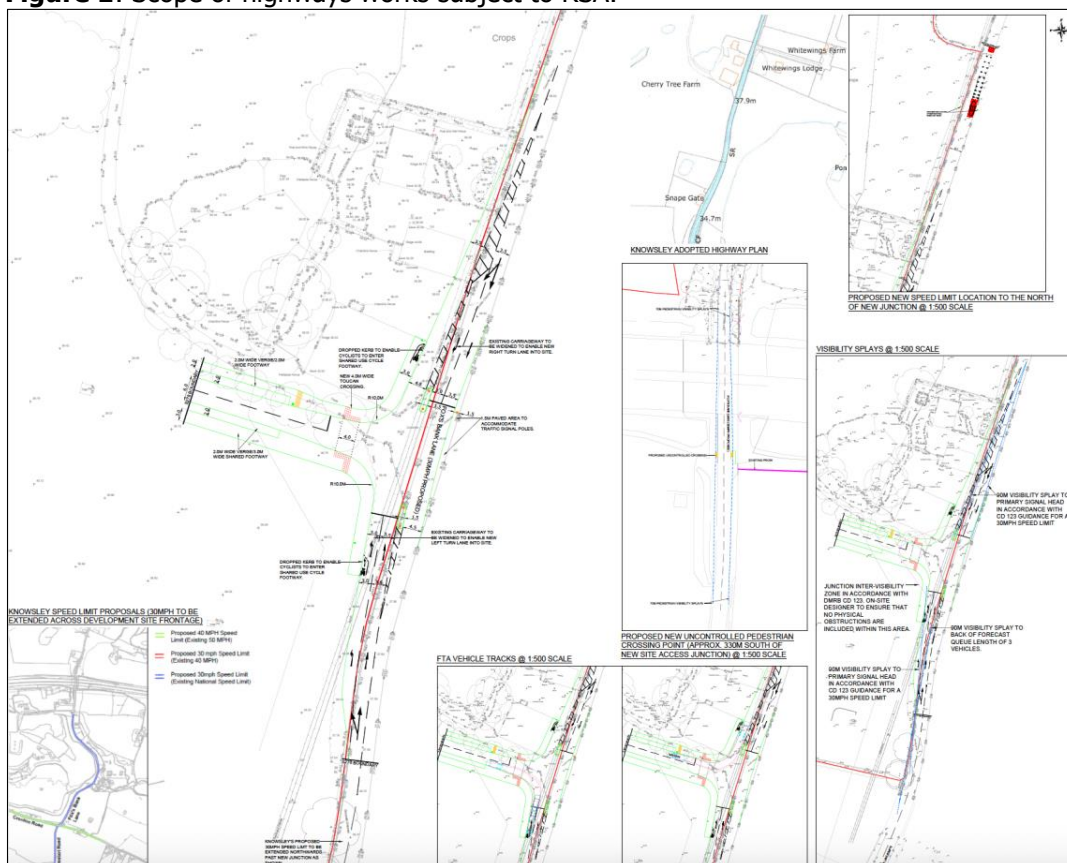
**Figure 1:** Scope of highways works subject to RSA.

1.10 The scope of the highways works subject to RSA are shown in **Figure 1**.

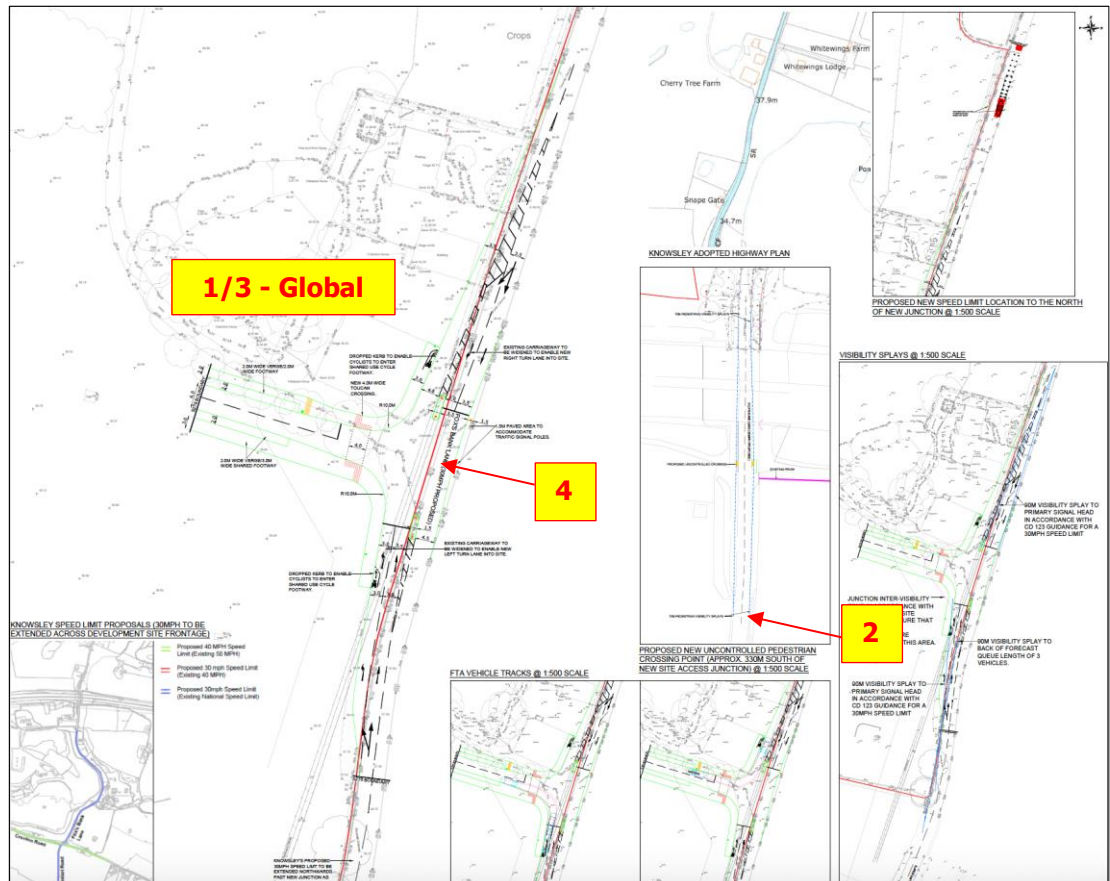
### Location of Identified Problems

**SUMMARY:** Proposed forward visibility splay to the signal heads may be insufficient resulting in an increased risk of drivers failing to stop on red potentially resulting in collisions.

- 2.1 The proposed forward visibility splays to the proposed signal heads on Fox's Bank Lane have been based on a 30mph speed limit. However, the audit team would note that based on observations made during the site visit, vehicle speeds on the approach to the proposed access, appeared to be excessive. The proposed forward visibility splays to the signal heads may therefore not be sufficient and potentially result in an increased risk drivers failing to stop on red potentially resulting in collisions.

**SUMMARY:** Proposed intervisibility splays to/from the proposed uncontrolled pedestrian crossing to the south of the site access may result in an increased risk of pedestrian/vehicle collisions.

- 2.3 As noted in Problem 1, vehicle speeds on Fox's Bank Lane appeared to be excessive. Excessive vehicle speeds on the approach to the proposed uncontrolled crossing could increase the risk pedestrian/vehicle collisions if sufficient inter-visibility splays to/from the crossing are not provided.

**SUMMARY:** No details provided with regard to the maintenance arrangements of the signals could potentially increase the risk of injuries to maintenance personnel.

- 2.6 No details have been provided with regard to the maintenance arrangements for the proposed signals. A lack of suitable maintenance facilities/area may increase the risk of injuries to maintenance personnel such as being struck by passing vehicles or slip/ trip falls if carrying or using equipment on uneven ground.

**SUMMARY:** Omission of lane guidance carriageway markings within the centre of the junction could result in head-on or loss of control type collisions.

- 2.8 There are no carriageway markings within the centre of the junction to advise drivers turning right into the site where they should wait if opposed by northbound traffic. This could result in vehicles waiting to turn right into the site, injudiciously entering the path of vehicles travelling northbound on Fox's Bank Lane which could result in head-on or loss of control type collisions should vehicles travelling northbound have to avoid a vehicle encroaching into the northbound lane.

- 2.2 It is recommended that vehicle speed surveys be undertaken post completion of the site access (prior to occupation of the site) and if vehicle speeds are excessive, it is recommended that additional speed reduction measures be provided.

- 2.5 It is recommended that vehicle speed surveys be undertaken post completion crossing and if vehicle speeds are excessive, it is recommended that additional speed reduction measures be provided on approach to the crossing.

- 2.7 It is recommended that suitable parking/layby provision should be provided for signals maintenance personnel.

- 2.9 It is recommended that lane guidance carriageway markings be provided to advise drivers where to wait if waiting to turn right into the site.
