## TREE RISK SURVEY REPORT

Mill View Care Home, 2 North Park Road, Kirkby, Liverpool L32 2DD

| Rainfords Reference | RA.TCS.297 |
| Survey Date | 24th April 2026 |

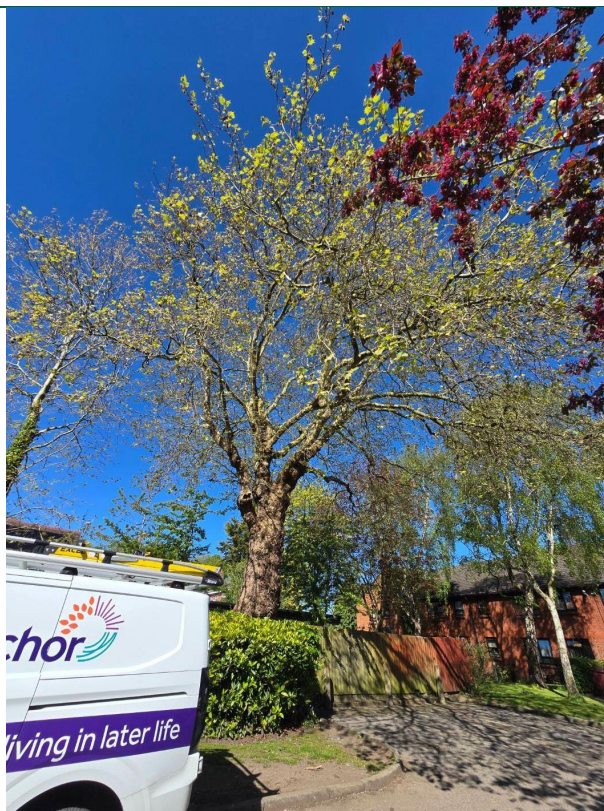
T3 is a mature tree that has been pollarded historically and has since developed a well-formed replacement canopy. A wound on a side limb has associated moderate cavity development, though this union does not carry significant structural loading at present. Small hung-up dead branches are present in the crown. The base of T3 is partially obscured by vegetation, which should be cleared at future visits.

Figure 3: T3 -- London plane; historical pollard with recovered canopy

| Tree ID | Common Name | Scientific Name | DBH (mm) | Ht (m) | Crown (m) | Life Stage | Physio. Cond. | Struct. Cond. | Overall Cond. | Comments | Recommendations | Work Priority | QTRA Risk No. | QTRA Category | Inspection Cycle | Last Inspection |
|---|---|---|---|---|---|---|---|---|---|---|---|---|---|---|---|---|
| 3 | London plane | <i>Platanus hispanica</i> x | 800 | 17 | 8 | M | Good | Good | Good | Looks to have been pollarded historically. Fully recovered canopy. Wound on side limb with moderate cavity, not holding significant weight. Base obscured by vegetation. Small hung-up dead branches. | Raise canopy to 6 m height; remove loose deadwood | Low | <1/1m | Broadly Acceptable | Low - 3 Years | 24/04/2026 |

| Tree Ref | Species | Work Required | Priority |
|---|---|---|---|
| T3 | London plane | Raise canopy to 6 m height; remove loose deadwood | Low |

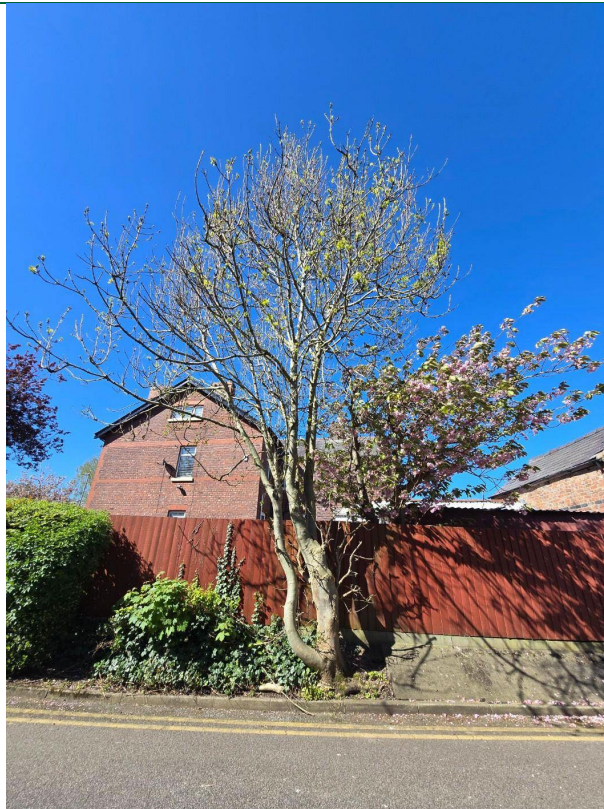
T10 (Tag 7433) is a common ash (*Fraxinus excelsior*) exhibiting Stage 2 ash dieback (*Hymenoscyphus fraxineus*). The tree occupies a constrained position adjacent to a kerb and fenceline, and given the progressive and irreversible nature of the disease and the tree's poor structural position. T13 (Tag 7436) is a second ash on this frontage, currently in good condition, but suppressed by adjacent conifers with low phototropic limbs encroaching into an adjacent garden.

Figure 4: T10 -- Common ash with Stage 2 ash dieback

T10, the Stage 2 ash with dieback, will continue to deteriorate. Ash dieback is a progressive disease with no viable treatment, and the tree's constrained position makes it unsuitable for long-term retention. Consent for felling should be included within the TPO application alongside T15 and T20.

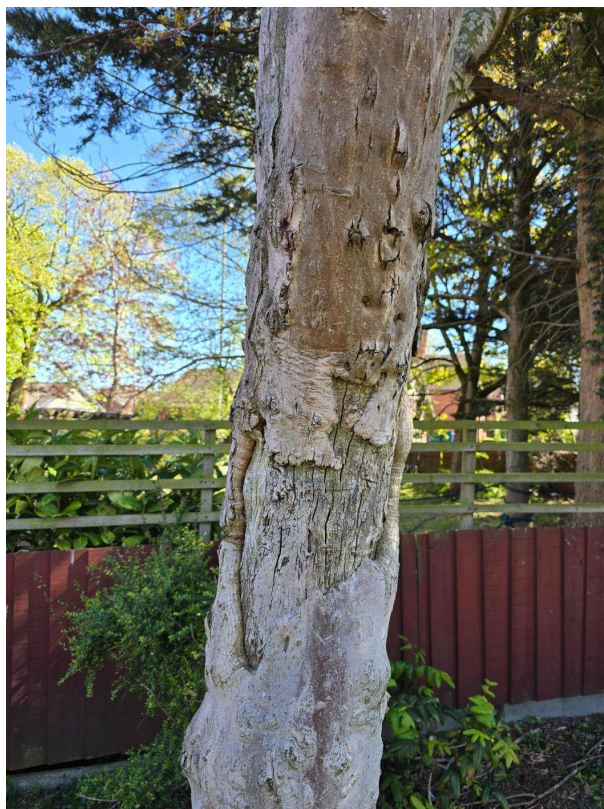
T11 (Tag 7434), a Norway maple (*Acer platanoides*), is significantly suppressed by adjacent conifers and is not considered a good specimen. Bark wounds are present at the main union with some woundwood development. The tree has previously been pruned clear of a sign but continues to re-encroach.

Figure 5: T11 -- Norway maple, suppressed with bark wounds at main union

| Tree ID | Common Name | Scientific Name | DBH (mm) | Ht (m) | Crown (m) | Life Stage | Physio. Cond. | Struct. Cond. | Overall Cond. | Comments | Recommendations | Work Priority | QTRA Risk No. | QTRA Category | Inspection Cycle | Last Inspection |
|---|---|---|---|---|---|---|---|---|---|---|---|---|---|---|---|---|
| 11 | Norway maple | <i>Acer platanoides</i> | 180 | 6 | 3 | SM | Fair | Fair | Fair | Suppressed by adjacent conifers. Has been reduced clear of sign before but still encroaching. Bark wounds under main union with good woundwood development; not a good specimen. Consider removal for good management. | Prune clear of sign by 2 m; consider removal and replacement | Low | <1/1m | Broadly Acceptable | Low - 3 Years | 24/04/2026 |

| Tree Ref | Species | Work Required | Priority |
|---|---|---|---|
| T11 | Norway maple | Prune clear of sign by 2 m; consider removal and replacement | Low |

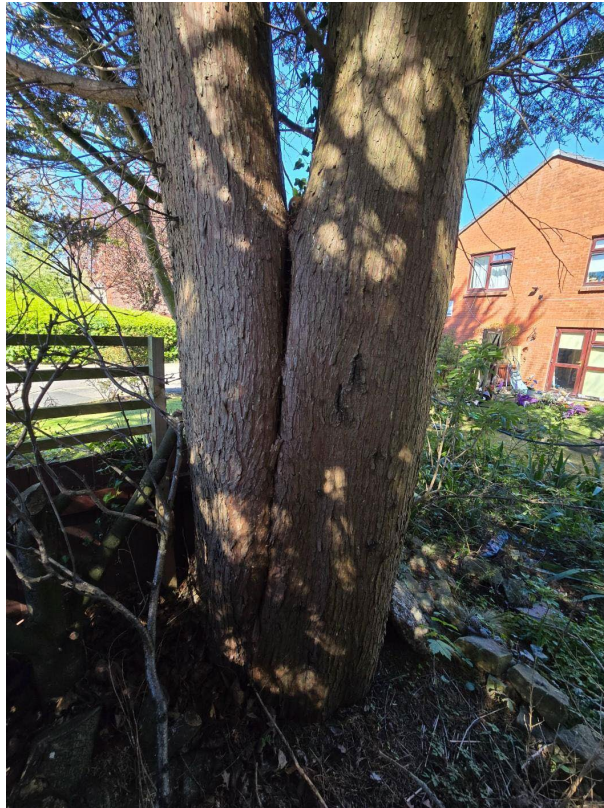
T12 is a mature Leyland cypress (*Cupressus x leylandii*) with a complex structural picture. The tree has an included main union with one side of the crown weighted towards an adjacent traffic light. A cobra cable brace is installed at approximately 8 m height but is not currently under significant tension; the brace should be checked at future inspections.

Figure 6: T12 -- Leyland cypress with included union and cobra cable brace

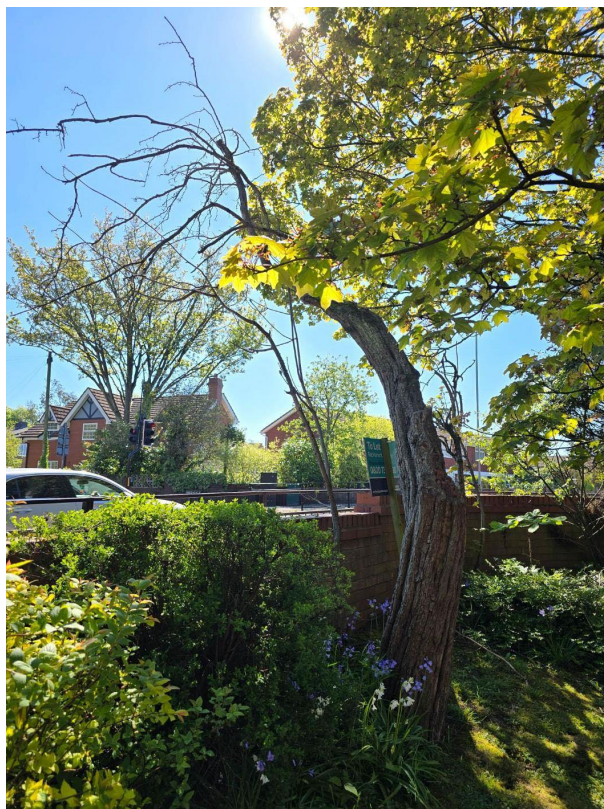
Figure 7: T15 -- Standing dead common hawthorn weighted over highway

The most pressing individual tree matter on the site is T15, the standing dead hawthorn on the east boundary, which is weighted over the public highway. While all recommended works have been allocated a Low priority in recognition of the overall risk profile under QTRA, T15 represents the most straightforward case for immediate action: a dead tree over a highway footpath requires removal irrespective of TPO status, and the necessary consent should be sought from Knowsley Metropolitan Borough Council without delay.

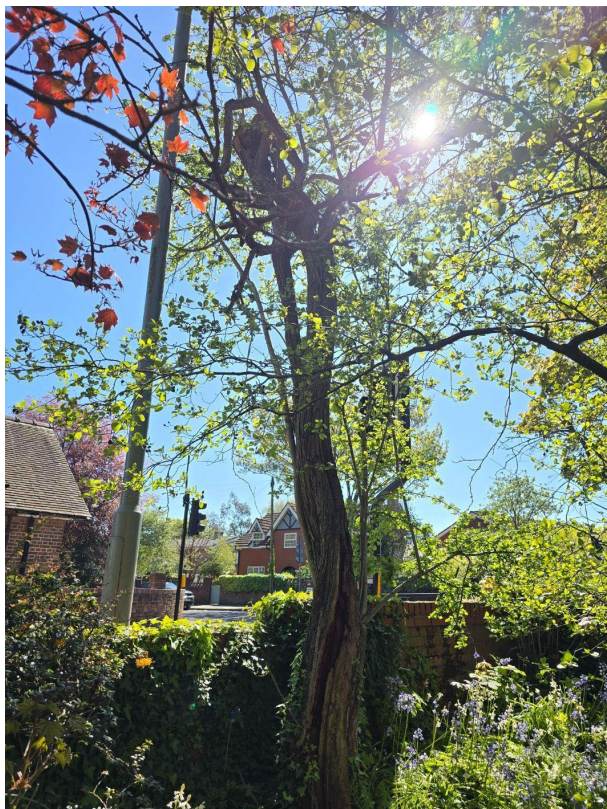
T17 (Tag 7440) is an over-mature common hawthorn (*Crataegus monogyna*) with stem decay typical of the species in late maturity. The tree is weighted over the highway footpath and has been reduced previously to manage decay and weight distribution; a further reduction of 2 m is recommended.

Figure 8: T17 -- Over-mature hawthorn with stem decay, weighted over footpath

| Tree ID | Common Name | Scientific Name | DBH (mm) | Ht (m) | Crown (m) | Life Stage | Physio. Cond. | Struct. Cond. | Overall Cond. | Comments | Recommendations | Work Priority | QTRA Risk No. | QTRA Category | Inspection Cycle | Last Inspection |
|---|---|---|---|---|---|---|---|---|---|---|---|---|---|---|---|---|
| 17 | Common hawthorn | <i>Crataegus monogyna</i> | 200 | 4 | 2 | OM | Good | Good | Good | Over-mature tree with stem decay typical for species, weighted over highway footpath. Has been reduced to manage decay and weight balance. | Further reduce by 2 m | Low | <1/1m | Broadly Acceptable | Low - 3 Years | 24/04/2026 |

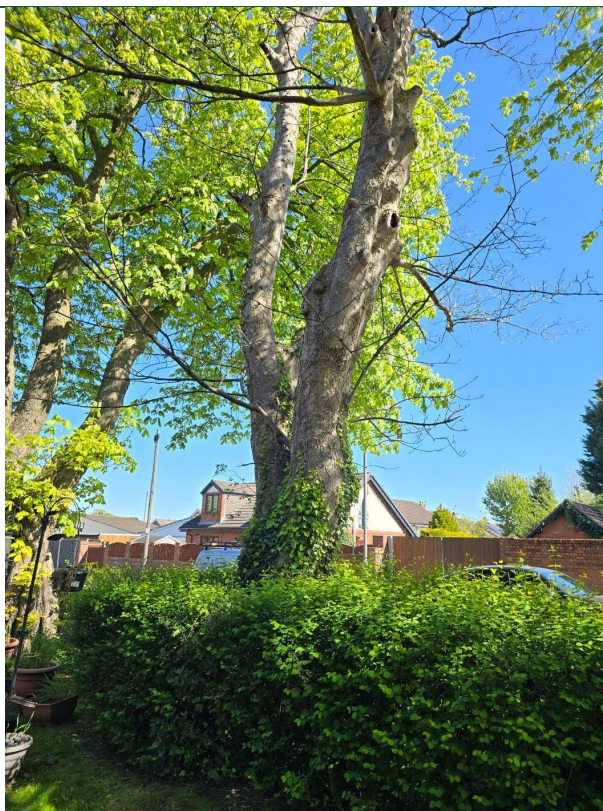
T20 (Tag 7443) is a mature sycamore (*Acer pseudoplatanus*) in declining condition. The upper canopy is dropping back and deadwood is increasing. Multiple pruning wounds throughout the stem are associated with developing cavities, and the base cannot be inspected due to obscuring vegetation. The tree is positioned over the highway.

Figure 9: T20 -- Declining sycamore with crown dieback and stem cavities

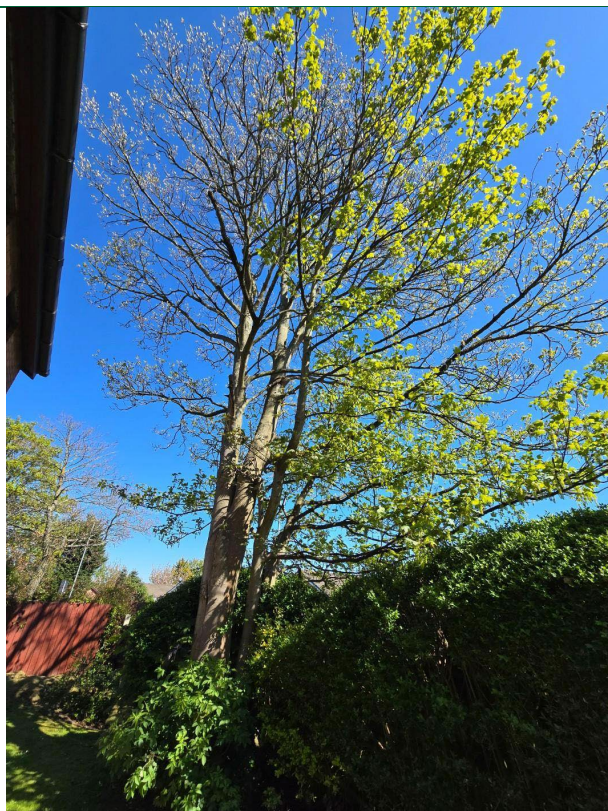
T25 and T26 are sycamores (*Acer pseudoplatanus*) adjacent to the highway footpath, with balanced canopies and bases obscured by ivy and hedgerow growth. T27 was observed to have low branches over the highway footpath. Of note, a natural brace at approximately 3 m height has resulted in an included union; this structural feature warrants monitoring at future inspections.

Figure 10: T27 -- Sycamore with included union at 3 m from natural brace

| Tree ID | Common Name | Scientific Name | DBH (mm) | Ht (m) | Crown (m) | Life Stage | Physio. Cond. | Struct. Cond. | Overall Cond. | Comments | Recommendations | Work Priority | QTRA Risk No. | QTRA Category | Inspection Cycle | Last Inspection |
|---|---|---|---|---|---|---|---|---|---|---|---|---|---|---|---|---|
| 27 | Sycamore | <i>Acer pseudoplatanus</i> | 412 | 14 | 6 | SM | Good | Good | Good | Balanced canopy with low branches over highway footpath. Natural brace has caused included union at 3 m height. Reasonable clearance from building. | Raise canopy to 3 m over footpath | Low | <1/1m | Broadly Acceptable | Low - 3 Years | 24/04/2026 |

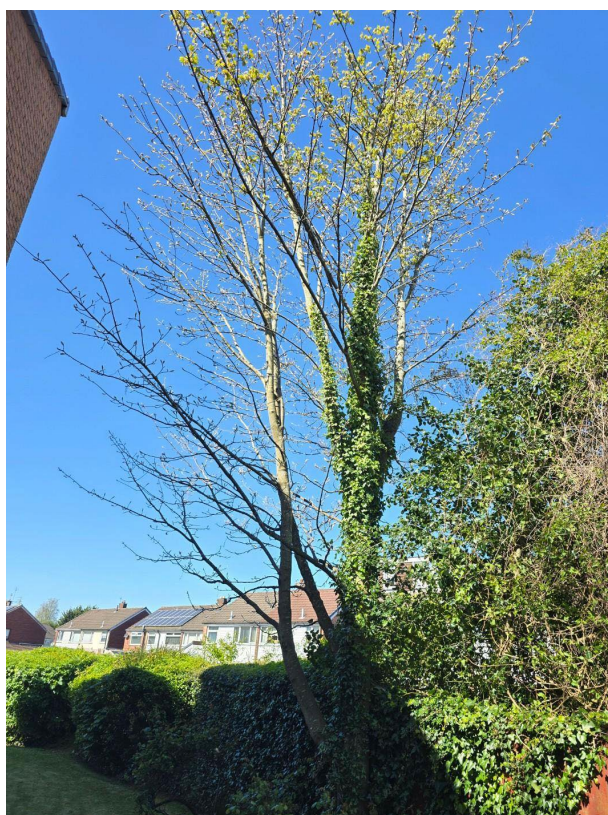
T28 is a young self-seeded sycamore (*Acer pseudoplatanus*) that has established against the fenceline. Removal is recommended as a matter of good management and to prevent fence damage.

Figure 11: T28 -- Self-seeded sycamore established against fenceline

| Tree ID | Common Name | Scientific Name | DBH (mm) | Ht (m) | Crown (m) | Life Stage | Physio. Cond. | Struct. Cond. | Overall Cond. | Comments | Recommendations | Work Priority | QTRA Risk No. | QTRA Category | Inspection Cycle | Last Inspection |
|---|---|---|---|---|---|---|---|---|---|---|---|---|---|---|---|---|
| 28 | Sycamore | <i>Acer pseudoplatanus</i> | 200 | 9 | 3 | Y | Good | Good | Good | Self-seeded tree established against fenceline. | Remove for good management and to prevent fence damage | Low | <1/1m | Broadly Acceptable | N/A | 24/04/2026 |

| Tree Ref | Species | Work Required | Priority |
|---|---|---|---|
| T28 | Sycamore | Remove for good management and to prevent fence damage | Low |

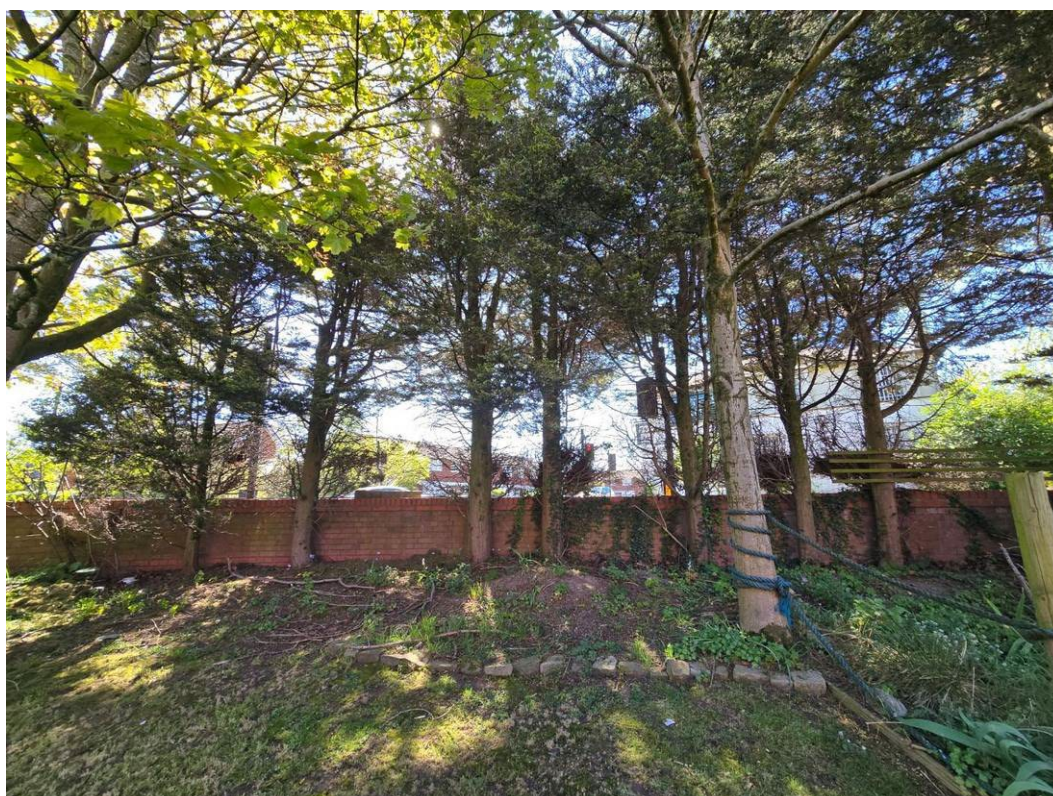
G01 is a group of Leyland cypress (*Cupressus x leylandii*) forming a hedgerow along part of the site boundary. The group is in overall good condition but is outgrowing its position, with encroachment into the highway. Cracks are forming in the wall adjacent to the hedgerow, which may be attributable to root or stem expansion and warrants monitoring.

Figure 12: G01 -- Leyland cypress hedgerow along site boundary

| Group ID | Group Type | Common Name(s) | Avg DBH (mm) | Height Range (m) | Life Stage | Overall Cond. | Est. Count | Comments | Recommendations | Work Priority | QTRA Risk No. | QTRA Category | Inspection Cycle | Last Inspection |
|---|---|---|---|---|---|---|---|---|---|---|---|---|---|---|
| G01 | Hedge | Leyland cypress (Cupressus x leylandii) | -- | 10 -- 17 m | SM | Good | -- | Group forming hedgerow along site boundary. Cracks forming in wall adjacent to trees. Outgrowing position with encroachment into highway. | Crown lift to 3 m over footpath removing dead areas; long-term removal and replacement recommended | Low | <1/1m | Broadly Acceptable | Low - 3 Years | 24/04/2026 |

Crown lifting to 3 m over the footpath with removal of dead areas within the canopy is recommended in the short term to address the highway encroachment. In the longer term, removal and replacement with a species better suited to the available space and boundary function is advisable to resolve the ongoing management burden and potential structural interaction with the wall.

| Tree Ref | Species | Work Required | Priority |
|---|---|---|---|
| G01 | Leyland cypress (group) | Crown lift to 3 m over footpath; remove dead areas; long-term removal recommended | Low |
