# Fox wood Garden Village, Whiston

## Treatment of boundary sycamore

| Project | Fox Wood Garden Village (Halsnead Park) | Purpose | To present the results of an inspection of an individual sycamore tree following boundary wall removal | | |
| 7137.09.001 | 1.0 | JGS | TDP | 09/07/2025 | |

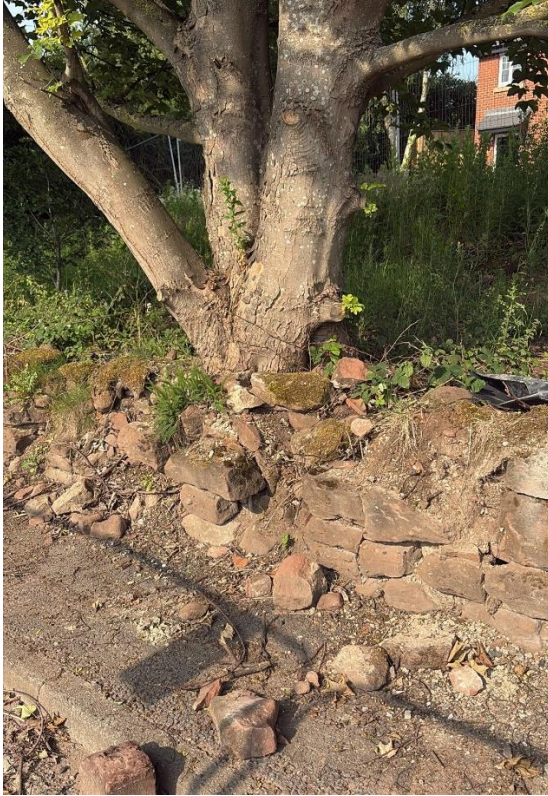
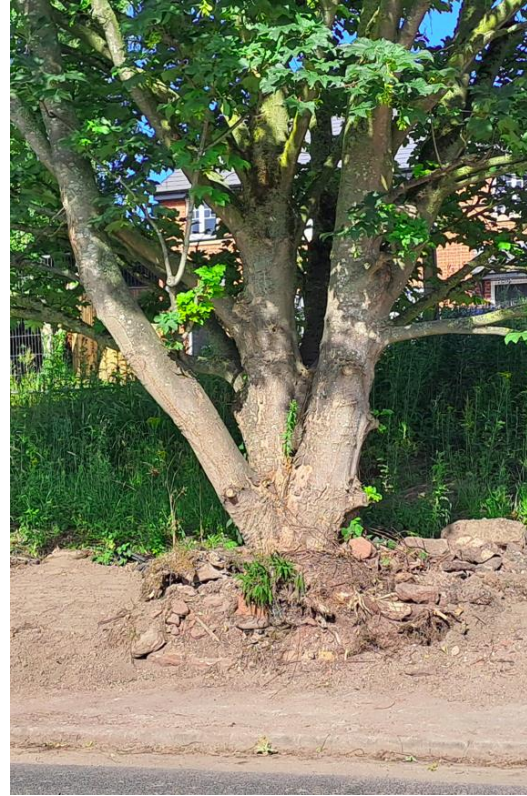
*Photos 1 and 2: Before and after the removal of old boundary wall*

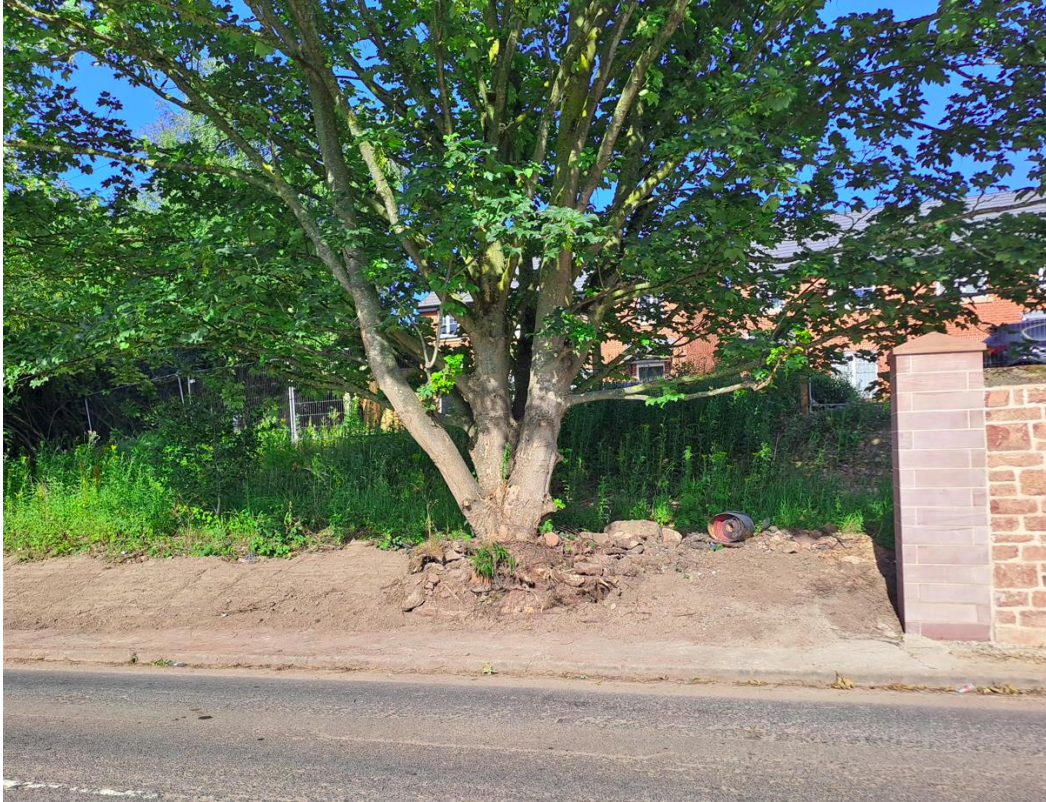
*Photo 3: View west following removal of old boundary wall (new wall right of frame)*

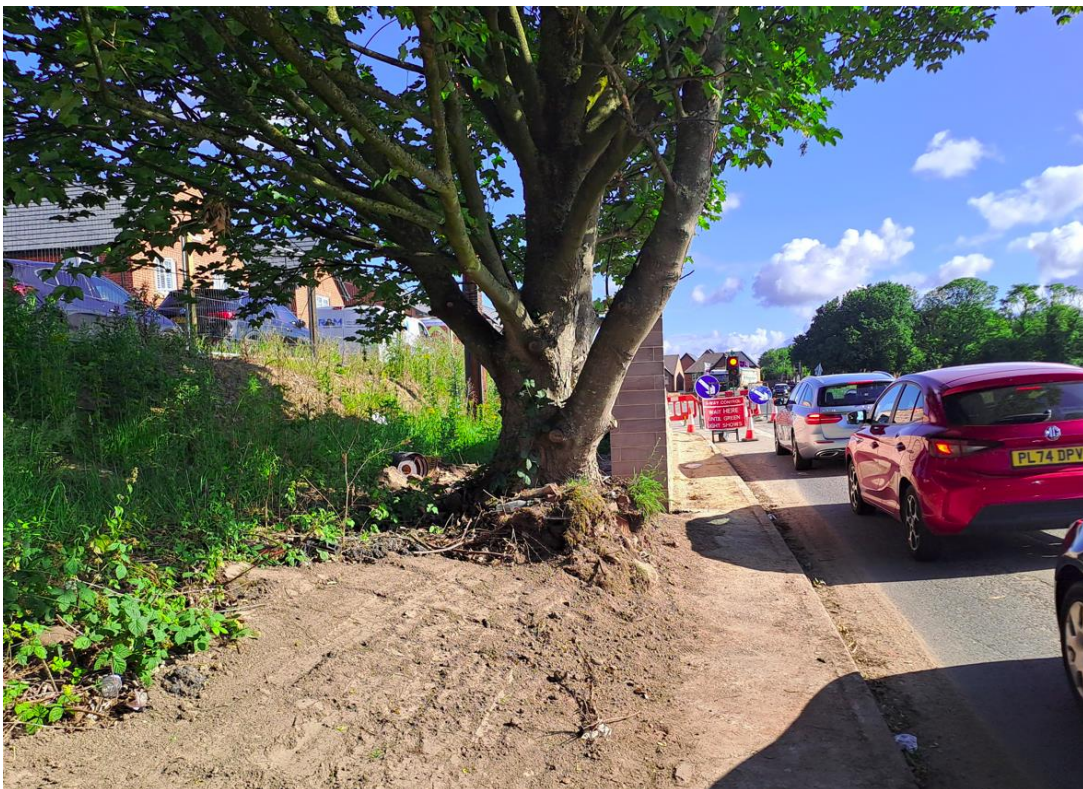
has established, resulting in tree root growth into soil filled voids in the wall and the exposure of these buttress and surface roots following the walls removal. Viewed from the east, north and south, the tree now sits on a small pedestal of earth and remnant stones that couldn't be removed due to root encirclement. The exact extent of excavation employed to remove any footings of the old wall is not known but is indicated by the extent of bare ground visible on Photo 4.

- 1.7 The position of the tree close to the site boundary and the fact that it's eastern root system is entwined with the remnants of the former wall preclude the installation of any substantial boundary treatment, including a new wall or hedge. This juxtaposition is shown in Photo 4. It demonstrates that it would not be possible to cultivate the ground to the east of the tree to allow for the establishment of a new hedge without further excavation and removal of tree roots that would effectively undermine the stem.

*Photo 4: View north of tree growing over development boundary*

- Removing the sycamore and grinding out main root ball prior to backfilling with good quality topsoil.
  - Cleansing of the soft ground to the west of the recent wall removal, removing debris and weed control.

- Planting of c. 20m of a mixed native species hedge between the new wall pillar to the retained section of stone wall in the south. This should be undertaken in late autumn/winter 2025.

- Planting of 2 field maple (*Acer campestre*) in the ground to the west of the hedge. These will recreate the green screen lost by the removal of the sycamore but avoid long-term interference with the power lines. New trees should be of extra-heavy standard nursery stock and be subject to ongoing maintenance for up to 5 years to ensure their establishment. They should be planted in late autumn/winter 2025.
