**Structural Appraisal**  
**of**  
**Boundary Wall**  
**at**  
**The Orchard, Huyton**

**Alderley Partnerships**

**Ref: B05**

**January 2025**

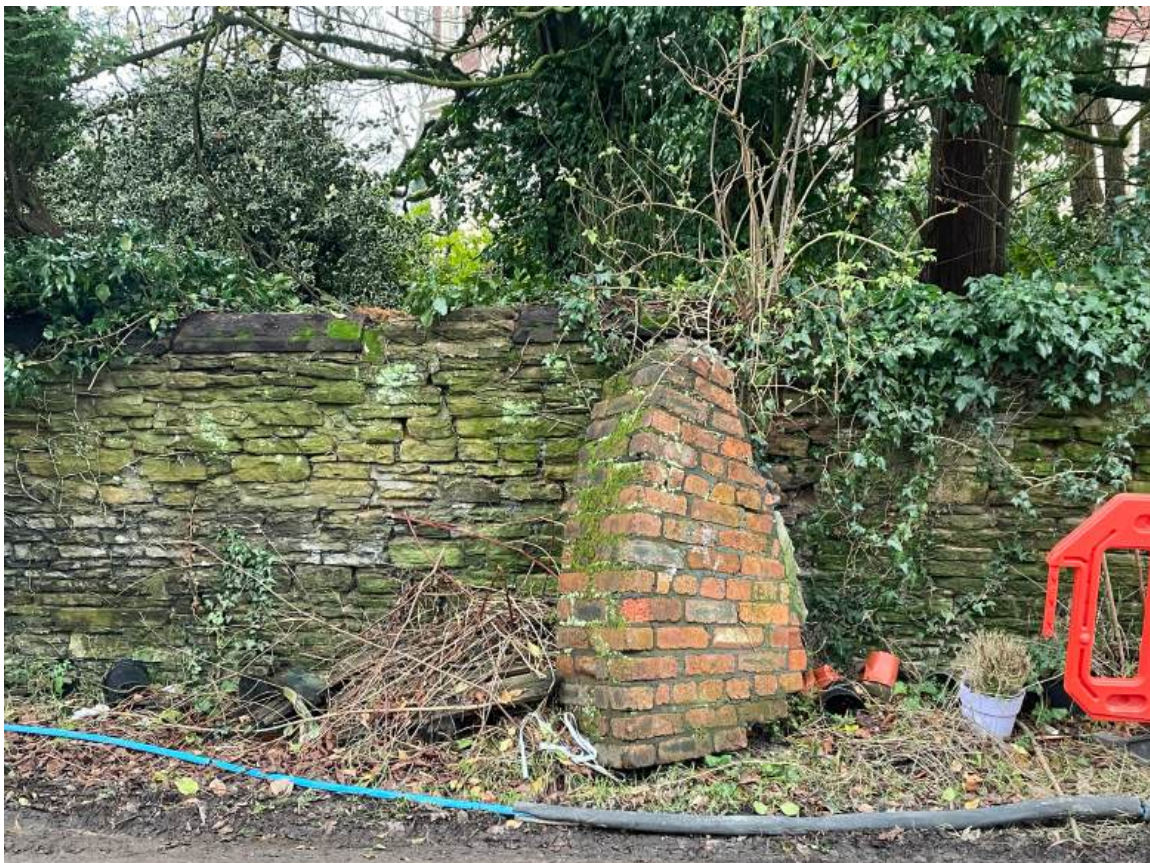
The length of wall under consideration is propped by five brick buttresses, one of which has been knocked over.

Photo 4: North Side of Wall - Broken Buttress

1. Remove ivy and plant growth from wall face and top.
2. Remove fallen buttress. Construct new buttress on concrete pad footing using the same bricks or new matching bricks and lime mortar.
3. Construct 2No new brick buttresses on concrete pad footings using matching bricks and lime mortar.
4. Take down two sections of wall, one at the west end abutting a building and one on the east corner of the gateway splay as shown on the drawing. Re-use stone with similar make-up if required. Use lime mortar.
5. Allow 5 linear metres of new coping stones bedded in lime mortar. Stones to be hand finished without any sawmarks visible.
6. Allow 3 square metres of patch repairs and making good.
7. Rebuild 8 linear metres of wall where fallen down, suggested to a height of 1.4metres rather than full height of 2.5 metres. Provide make-up matching stone. Use lime mortar.
