# WINDY ARBOR PLAYING FIELDS

## 2021 Boundary Wall Inspection Report

**PROJECT NO. 70057126**

**DATE: SEPTEMBER 2021**

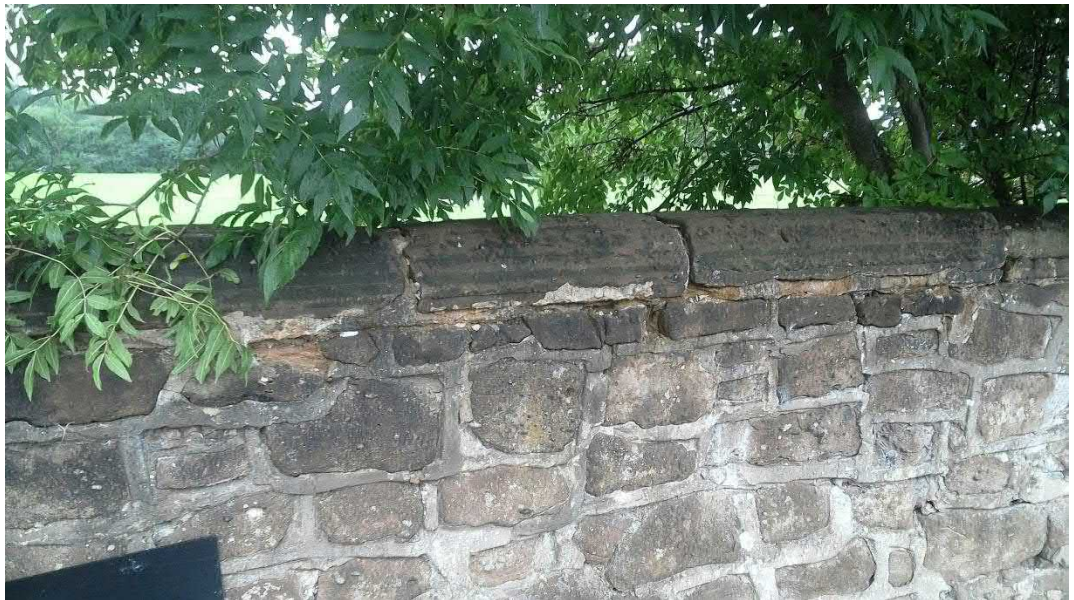
| Defect No: | 0003 | Elevation: | Roadside | Defect Chainage: | 7m |
| Defect Type: | Mortar Failure | | Severity: | Low | |

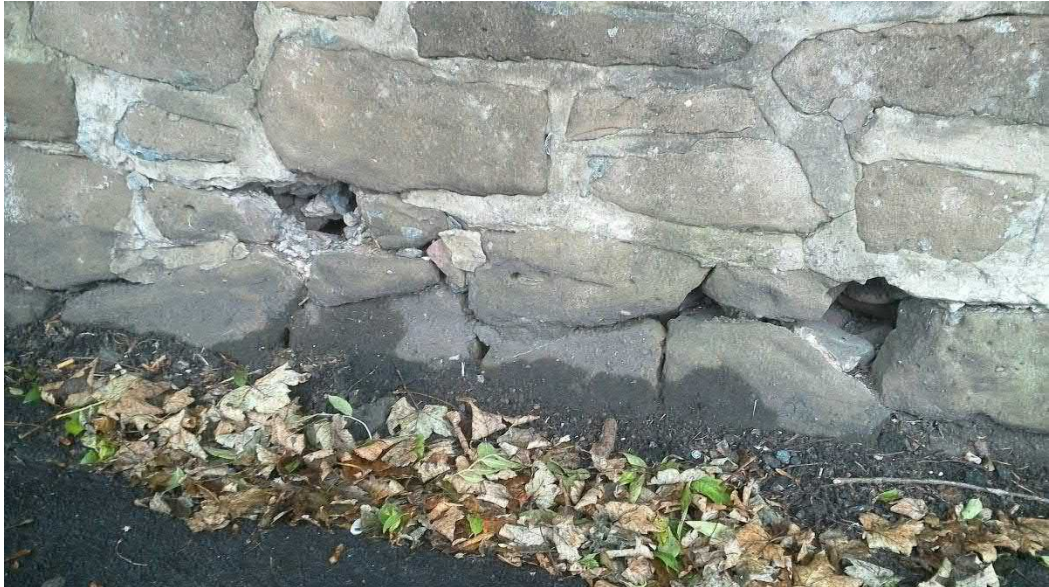
| Defect No: | 0006 | Elevation: | Roadside | Defect Chainage: | 17m |
| Defect Type: | Voids | | Severity: | Medium | |

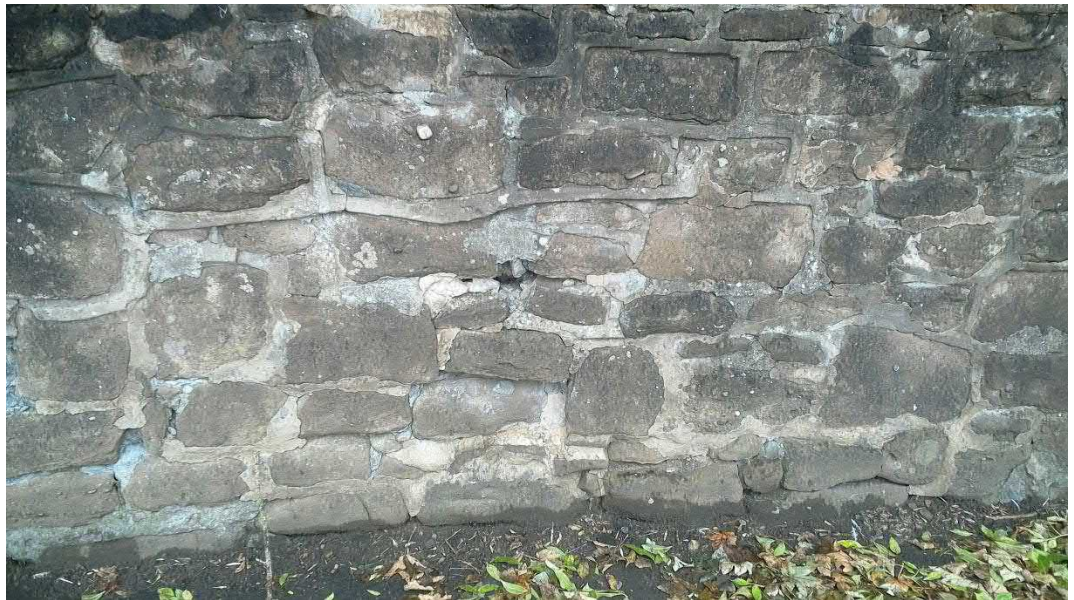
| Defect No: | 0009 | Elevation: | Roadside | Defect Chainage: | 35m |
| Defect Type: | Mortar Failure | | Severity: | Medium | |

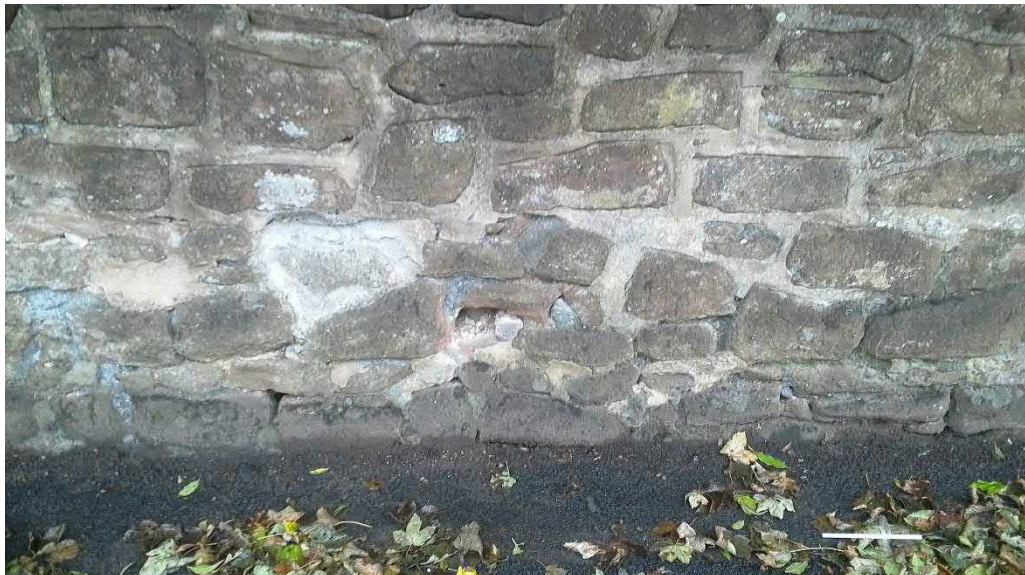
| Defect No: | 0012 | Elevation: | Roadside | Defect Chainage: | 53m |
| Defect Type: | Mortar Failure | | Severity: | Medium | |

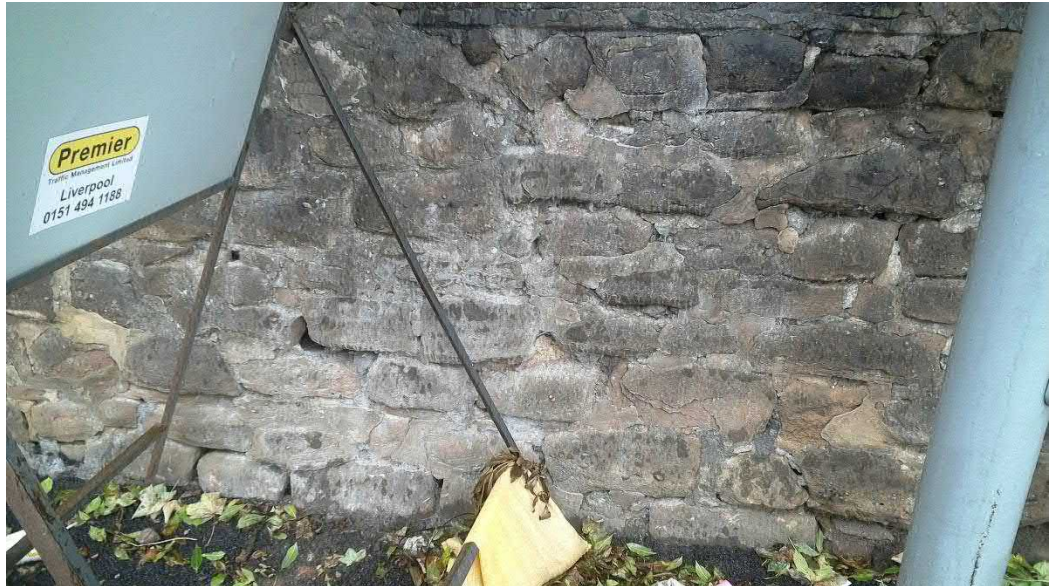
| Defect No: | 0013 | Elevation: | Roadside | Defect Chainage: | 64m |
| Defect Type: | Mortar Failure | | Severity: | Low | |

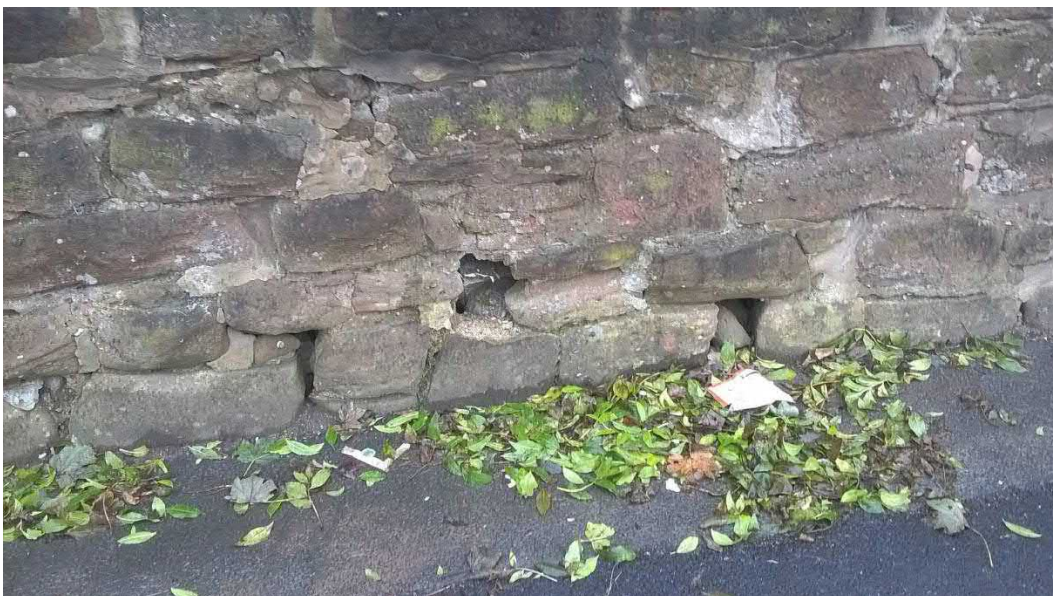
| Defect No: | 0014 | Elevation: | Roadside | Defect Chainage: | 74m |
| Defect Type: | Voids | | Severity: | Medium | |

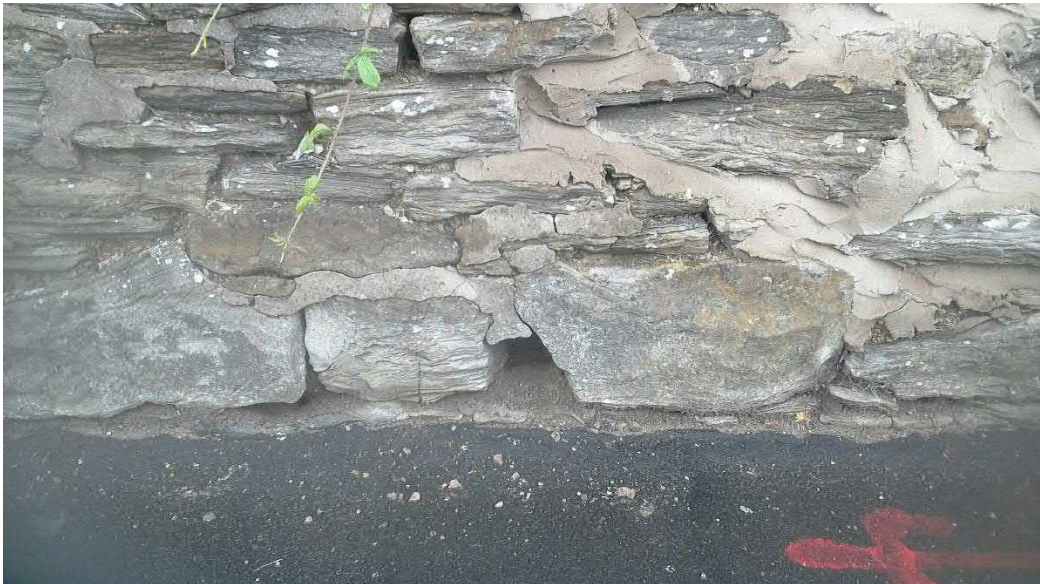
| Defect No: | 0020 | Elevation: | Roadside | Defect Chainage: | 182m |
| Defect Type: | Void | | Severity: | Medium | |

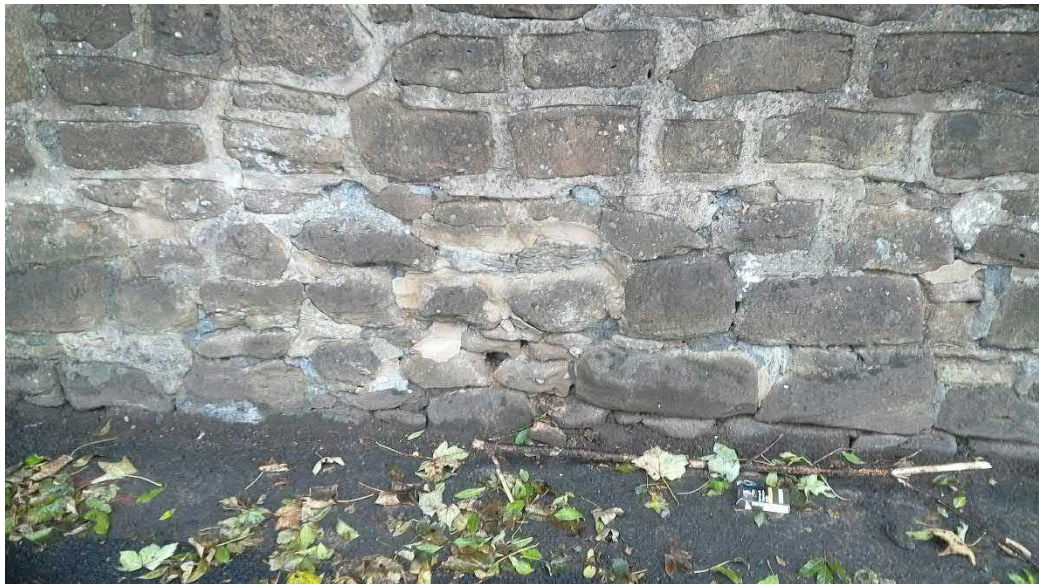
| Defect No: | 0023 | Elevation: | Roadside | Defect Chainage: | 207m |
| Defect Type: | Mortar Failure | | Severity: | Low | |

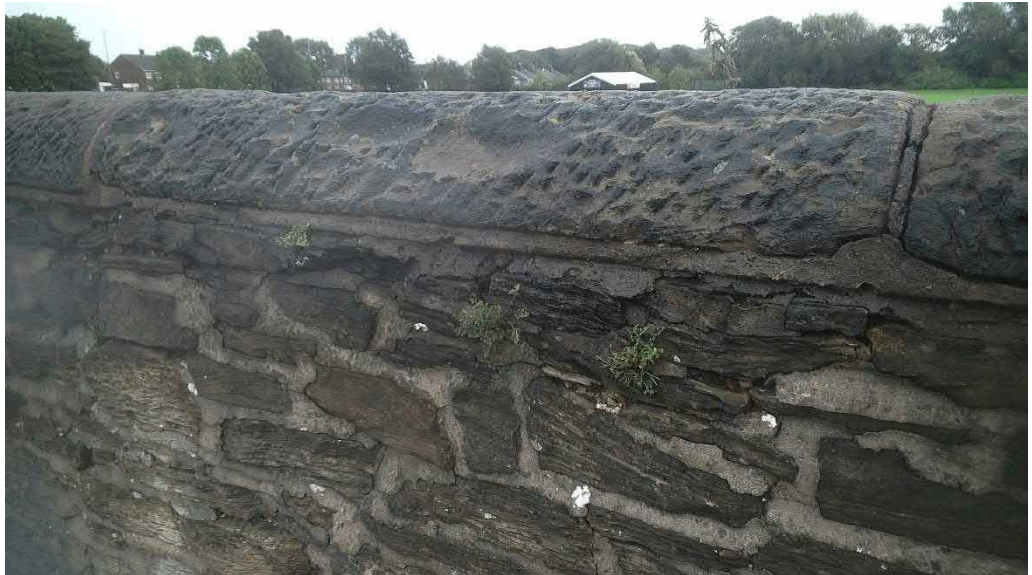
| Defect No: | 0029 | Elevation: | Roadside | Defect Chainage: | 233m |
| Defect Type: | Vegetation | | Severity: | Low | |

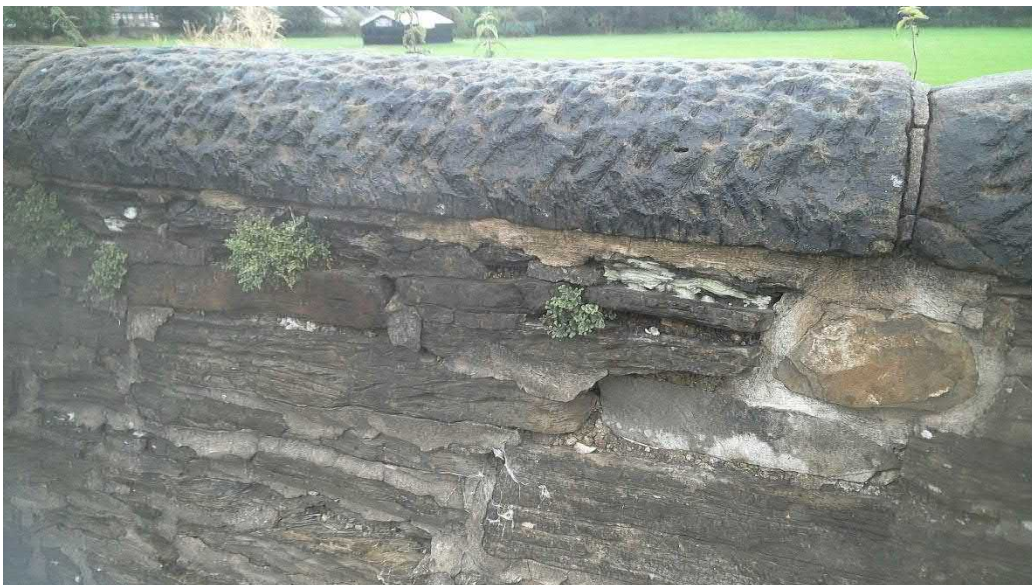
| Defect No: | 0030 | Elevation: | Roadside | Defect Chainage: | 238m |
| Defect Type: | Vegetation | | Severity: | Low | |

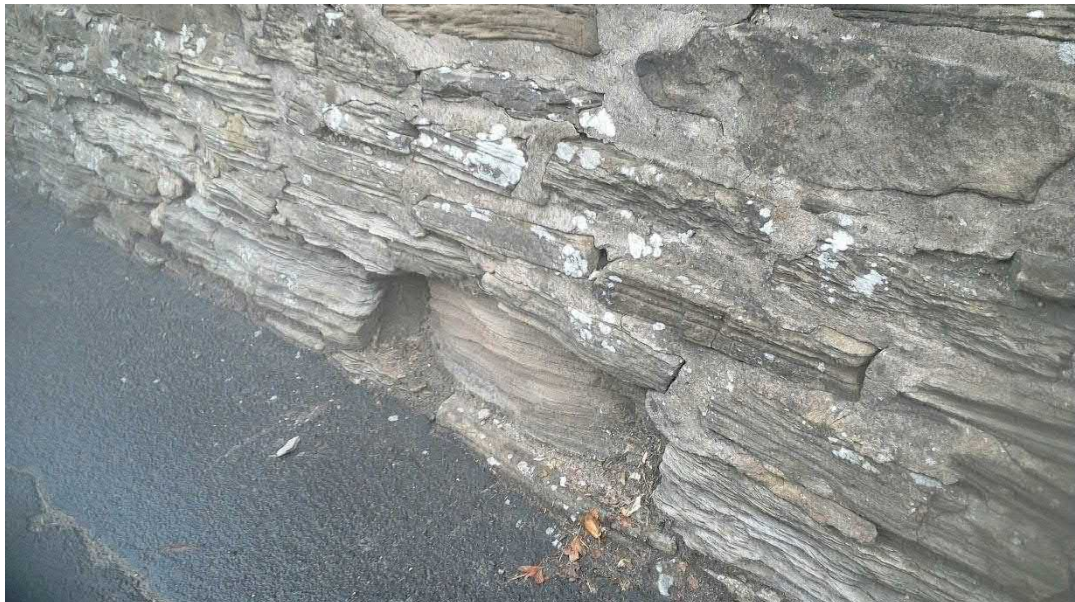
| Defect No: | 0031 | Elevation: | Roadside | Defect Chainage: | 240m |
| Defect Type: | Weathered Stone | | Severity: | Medium | |

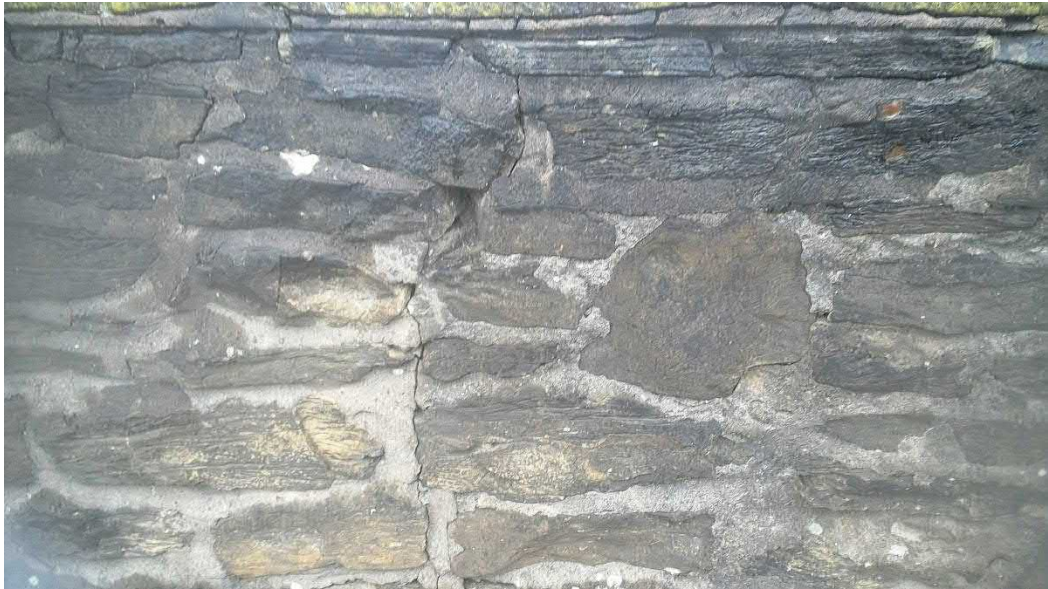
| Defect No: | 0037 | Elevation: | Roadside | Defect Chainage: | 262m |
| Defect Type: | Mortar Crack | | Severity: | Medium | |

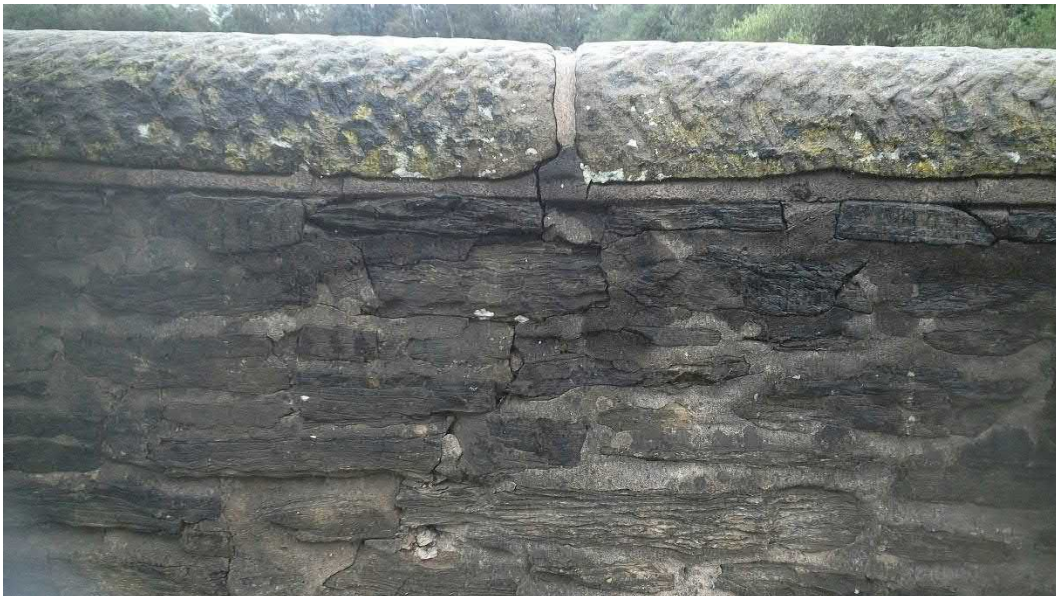
| Defect No: | 0038 | Elevation: | Roadside | Defect Chainage: | 265m |
| Defect Type: | Mortar Crack | | Severity: | Medium | |

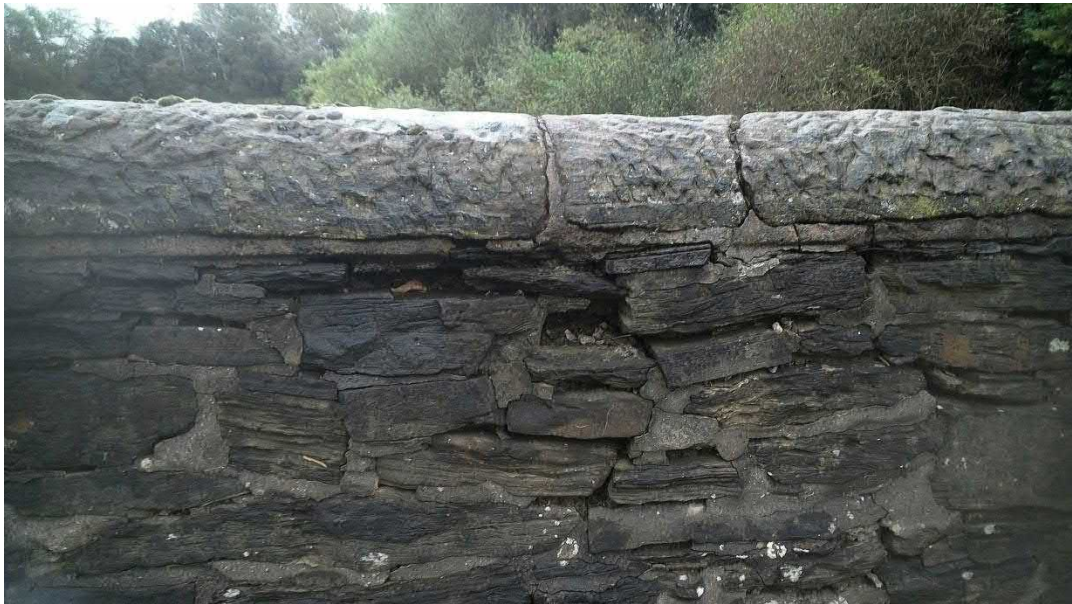
| Defect No: | 0040 | Elevation: | Roadside | Defect Chainage: | 274m |
| Defect Type: | Mortar Failure/ Cracked Cope | | Severity: | Low | |

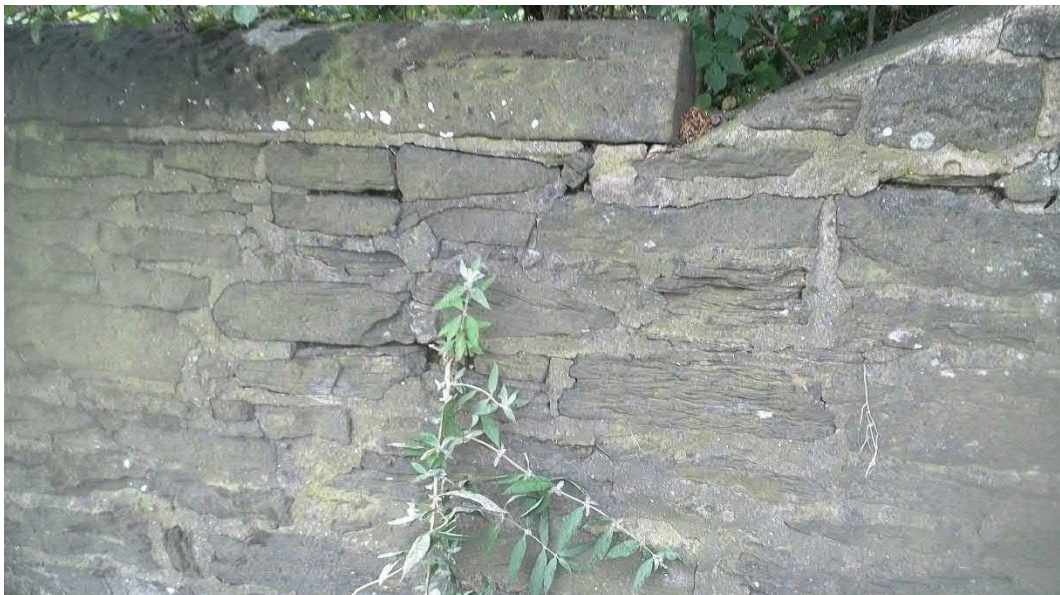
| Defect No: | 0042 | Elevation: | Roadside | Defect Chainage: | 286m |
| Defect Type: | Vegetation | | Severity: | Low | |

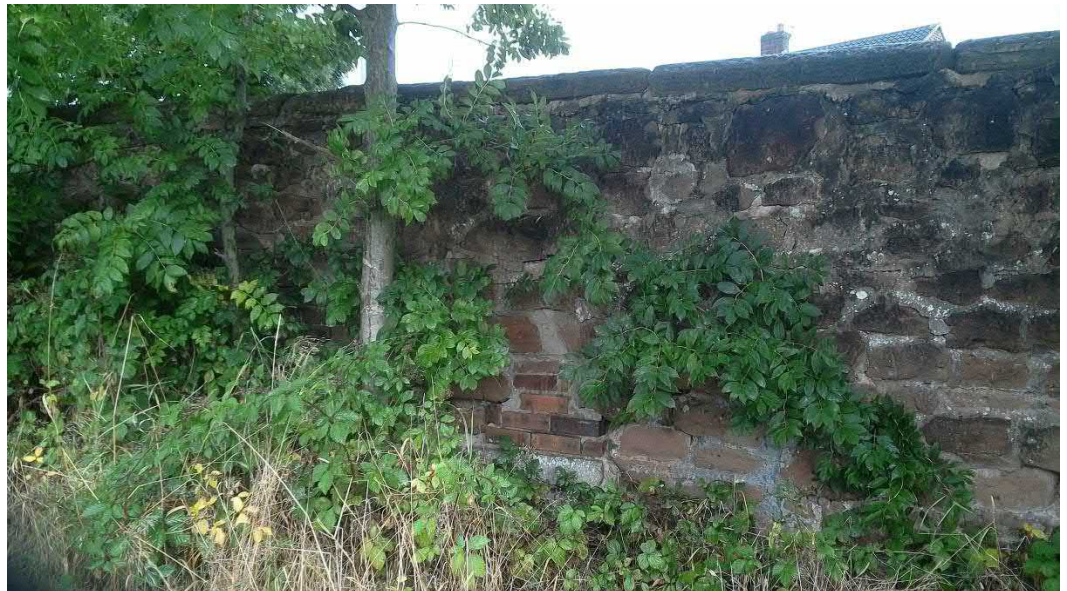
| Defect No: | 0047 | Elevation: | Parkside | Defect Chainage: | 26m |
| Defect Type: | Brickwork Repair | | Severity: | Low | |

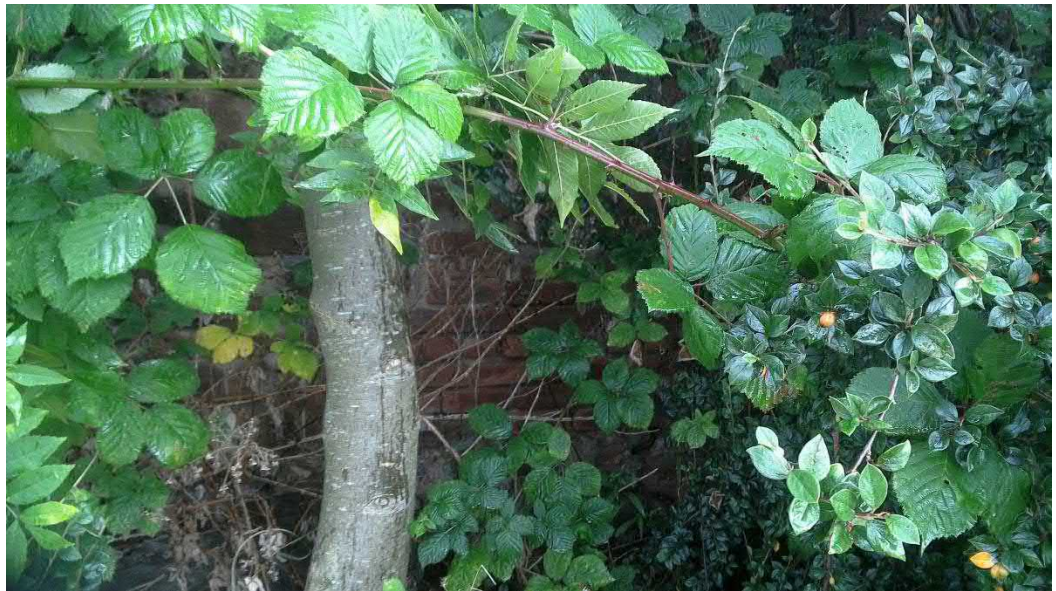
| Defect No: | 0049 | Elevation: | Parkside | Defect Chainage: | 42m |
| Defect Type: | Brickwork Repair | | Severity: | Low | |

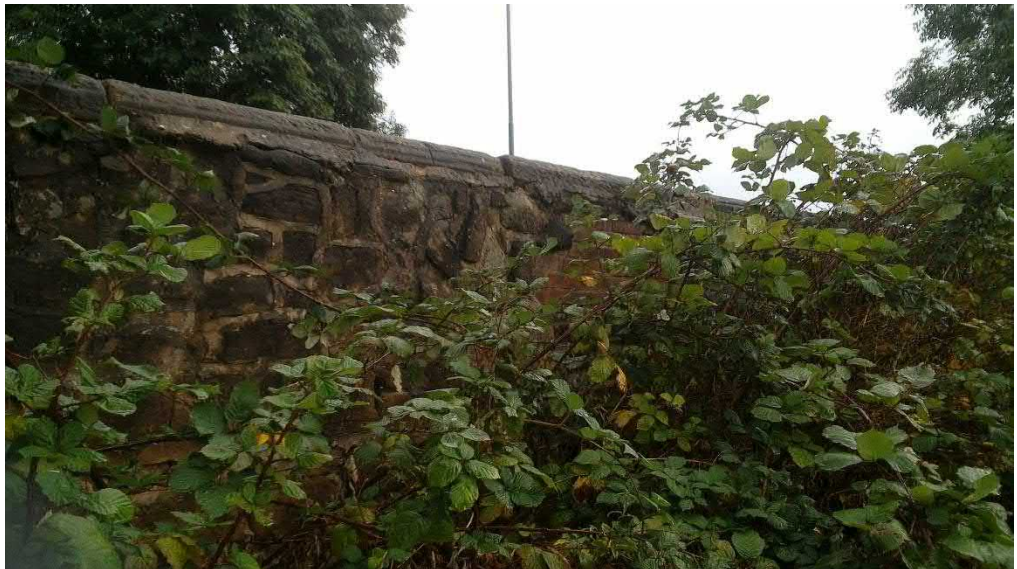
| Defect No: | 0050 | Elevation: | Parkside | Defect Chainage: | 48m |
| Defect Type: | Brickwork Repair | | Severity: | Low | |

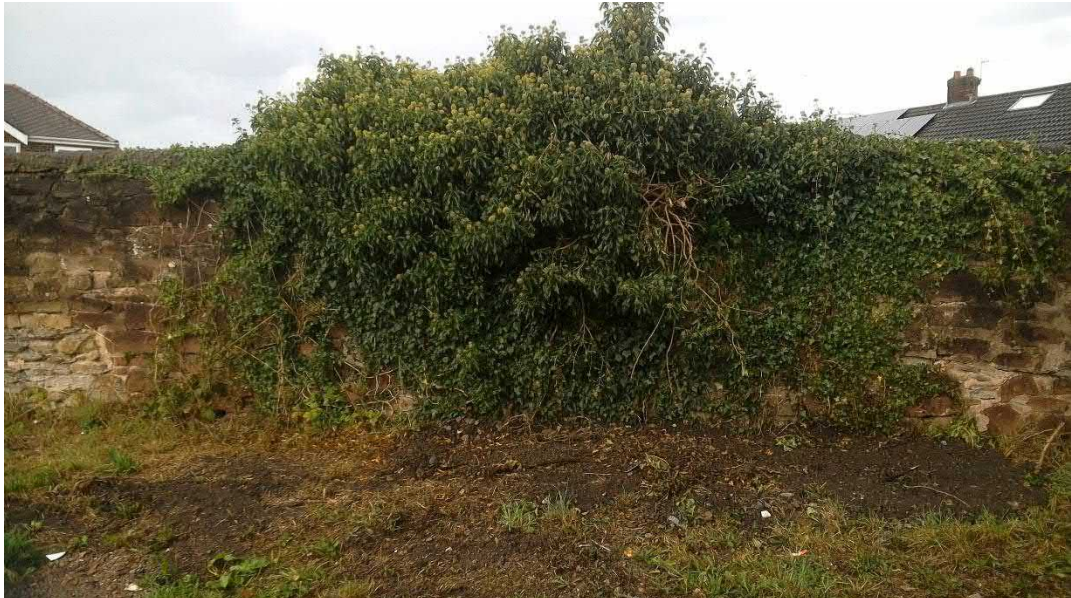
| Defect No: | 0054 | Elevation: | Parkside | Defect Chainage: | 116m |
| Defect Type: | Vegetation | | Severity: | Low | |

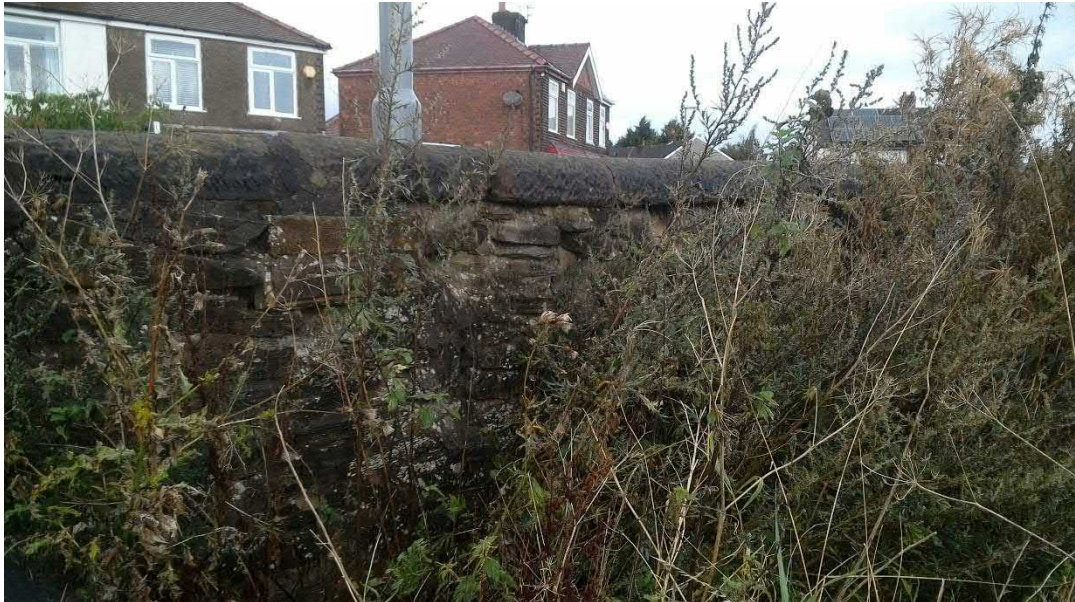
| Defect No: | 0059 | Elevation: | Parkside | Defect Chainage: | 199m |
| Defect Type: | Mortar Failure | | Severity: | Low | |

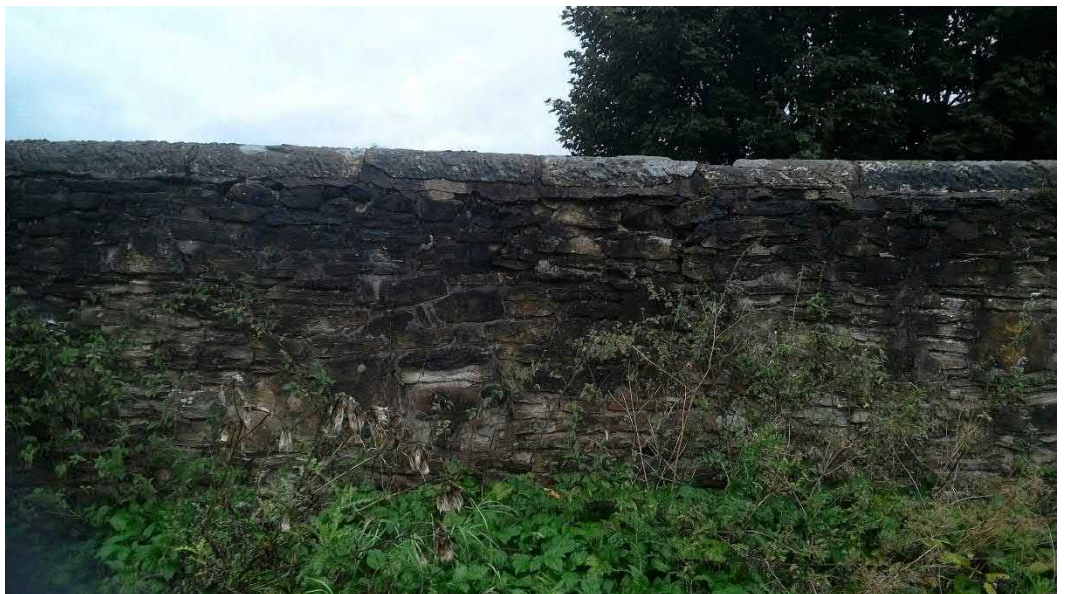
| Defect No: | 0066 | Elevation: | Parkside | Defect Chainage: | 270m |
| Defect Type: | Mortar Failure | | Severity: | Medium | |
