# WINDY ARBOR PLAYING FIELDS

## 2021 Boundary Wall Inspection Report

**PROJECT NO. 70057126**

**DATE: SEPTEMBER 2021**

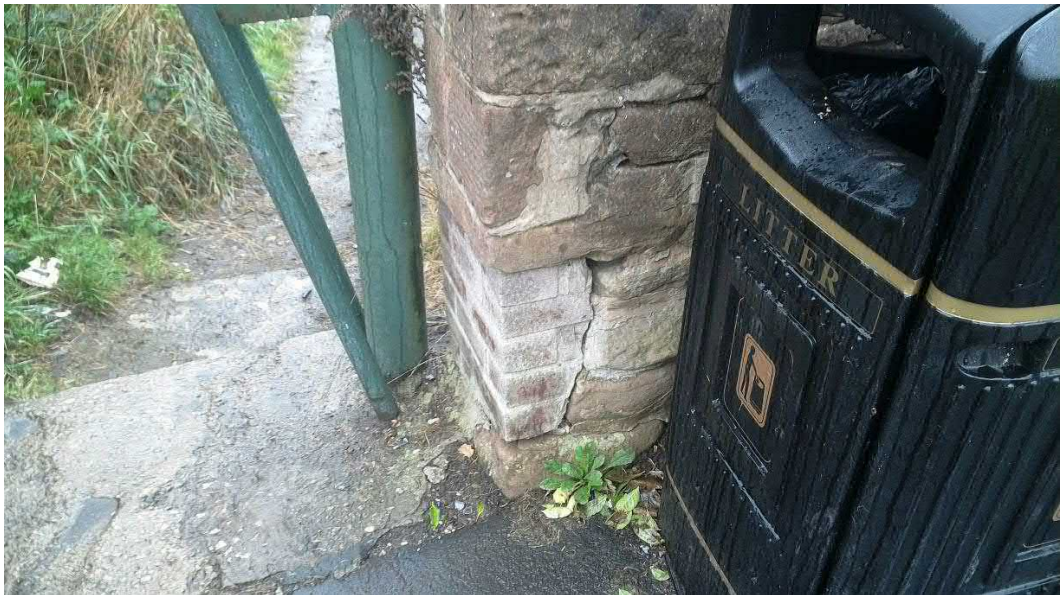
| Defect No: | 0001 | Elevation: | Roadside | Defect Chainage: | 0m |

| Defect Type: | Brickwork repair | | Severity: | Low | |

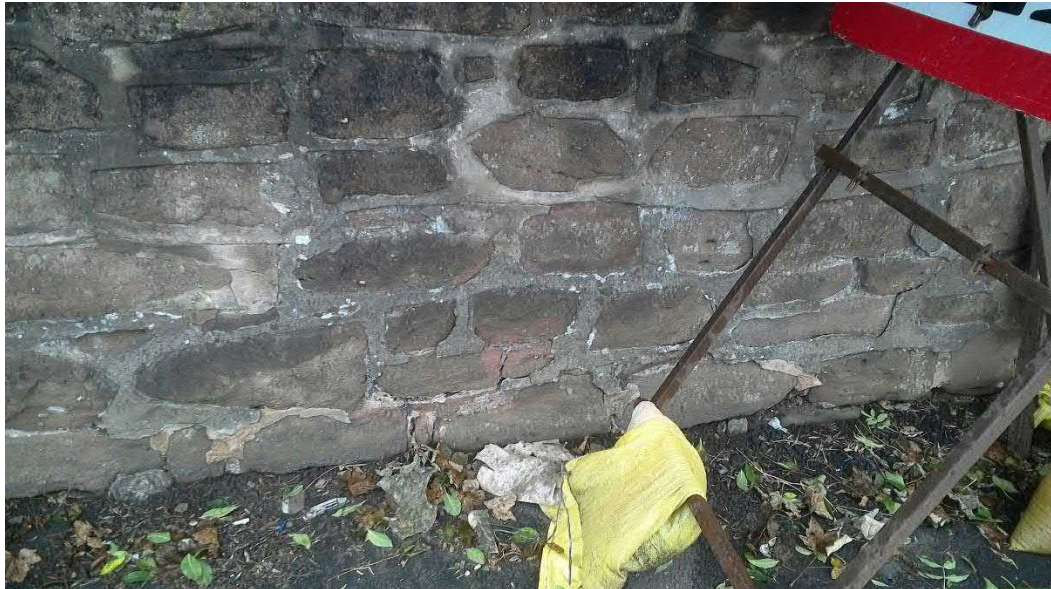
| Defect No: | 0002 | Elevation: | Roadside | Defect Chainage: | 5m |

| Defect Type: | Mortar Failure | | Severity: | Low | |

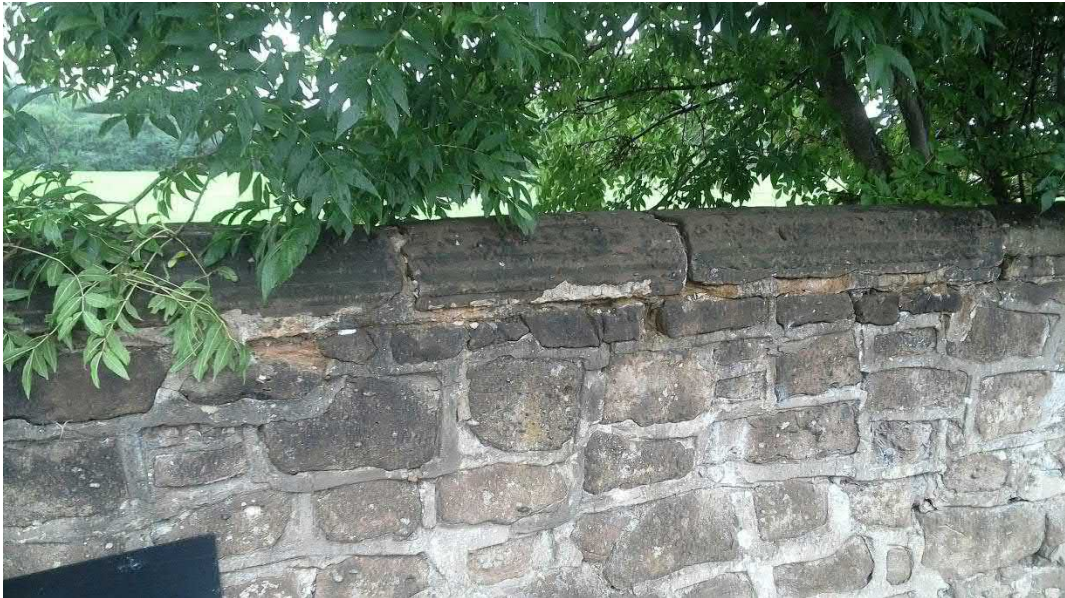
| Defect No: | 0003 | Elevation: | Roadside | Defect Chainage: | 7m |

| Defect Type: | Mortar Failure | | Severity: | Low | |

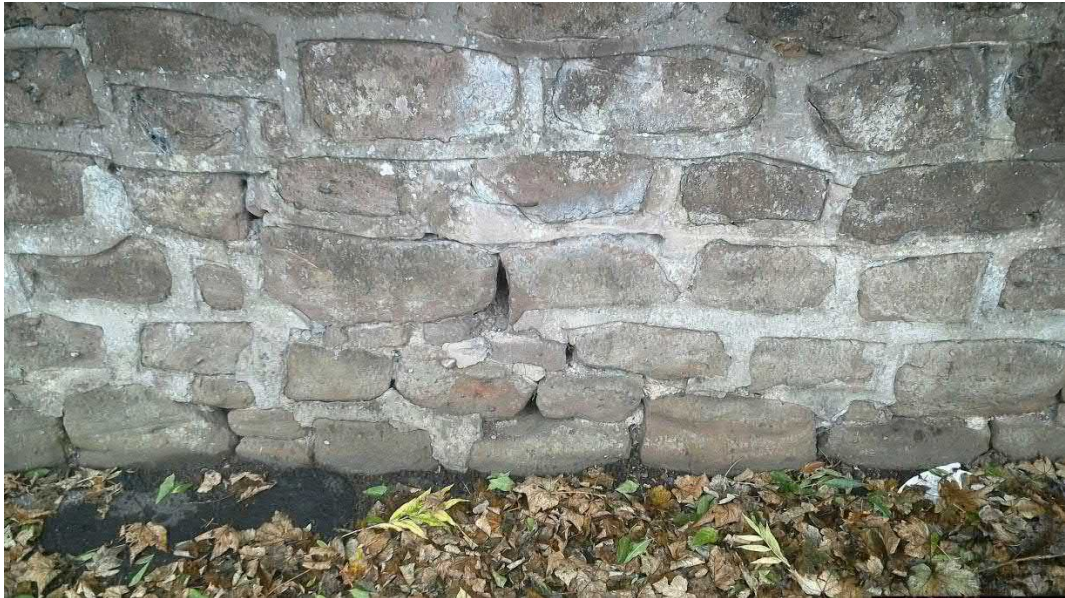
| Defect No: | 0004 | Elevation: | Roadside | Defect Chainage: | 10m |

| Defect Type: | Mortar Failure | | Severity: | Medium | |

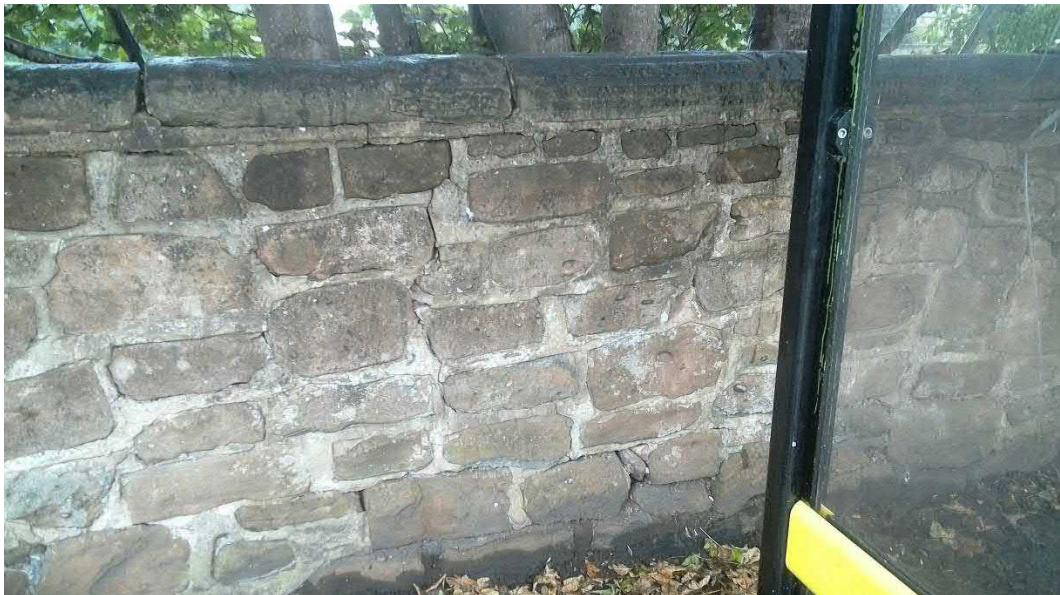
| Defect No: | 0005 | Elevation: | Roadside | Defect Chainage: | 15m |

| Defect Type: | Mortar Failure | | Severity: | Medium | |

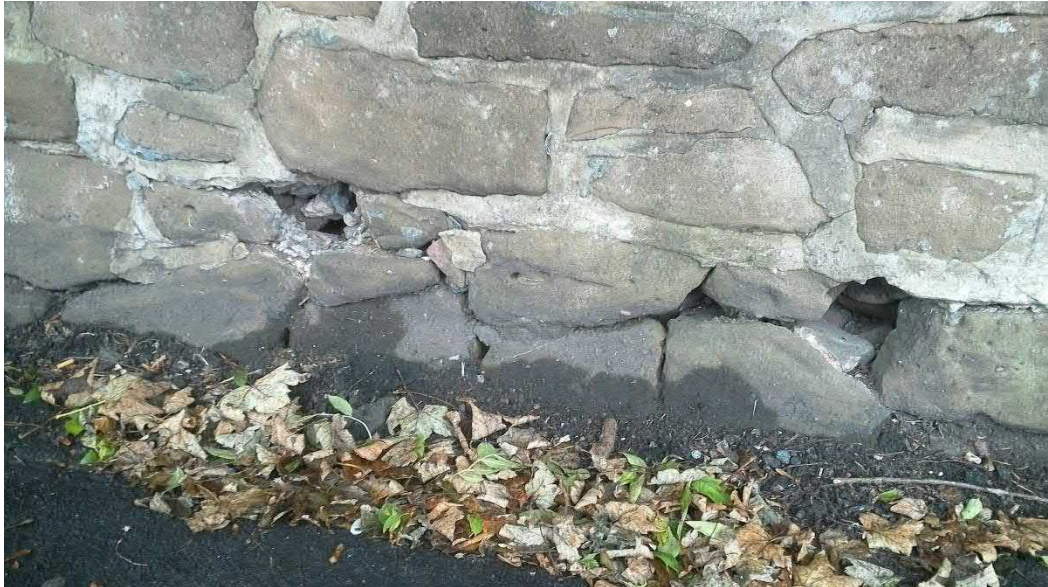
| Defect No: | 0006 | Elevation: | Roadside | Defect Chainage: | 17m |

| Defect Type: | Voids | | Severity: | Medium | |

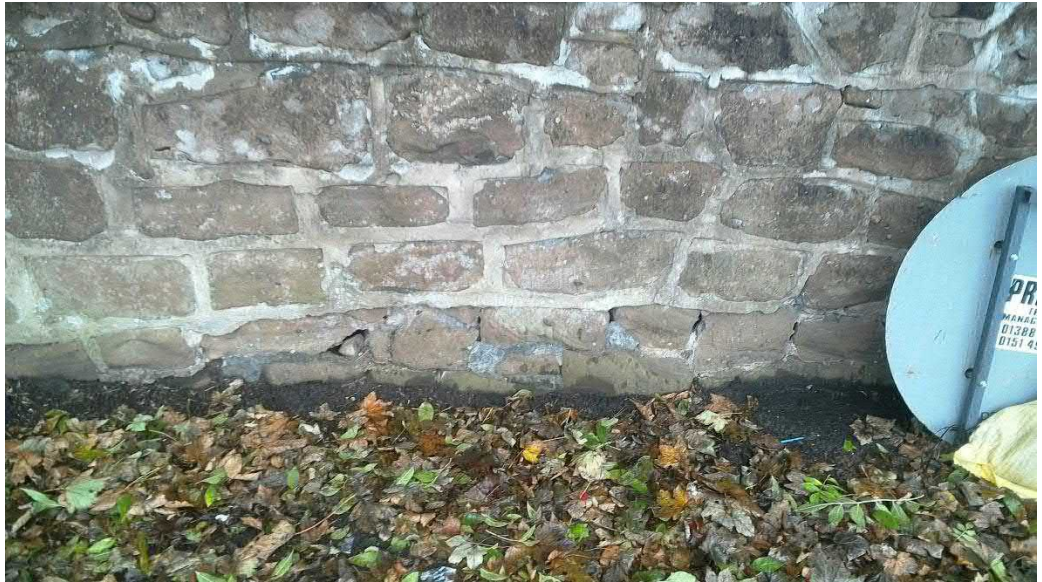
| Defect No: | 0007 | Elevation: | Roadside | Defect Chainage: | 22m |

| Defect Type: | Mortar Failure | | Severity: | Medium | |

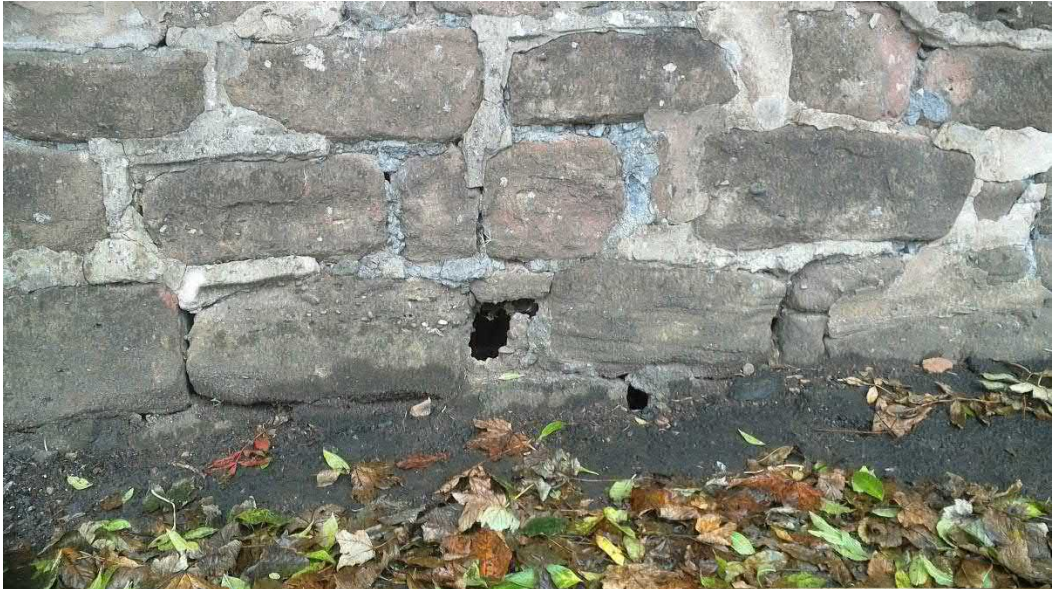
| Defect No: | 0008 | Elevation: | Roadside | Defect Chainage: | 29m |

| Defect Type: | Voids | | Severity: | Medium | |

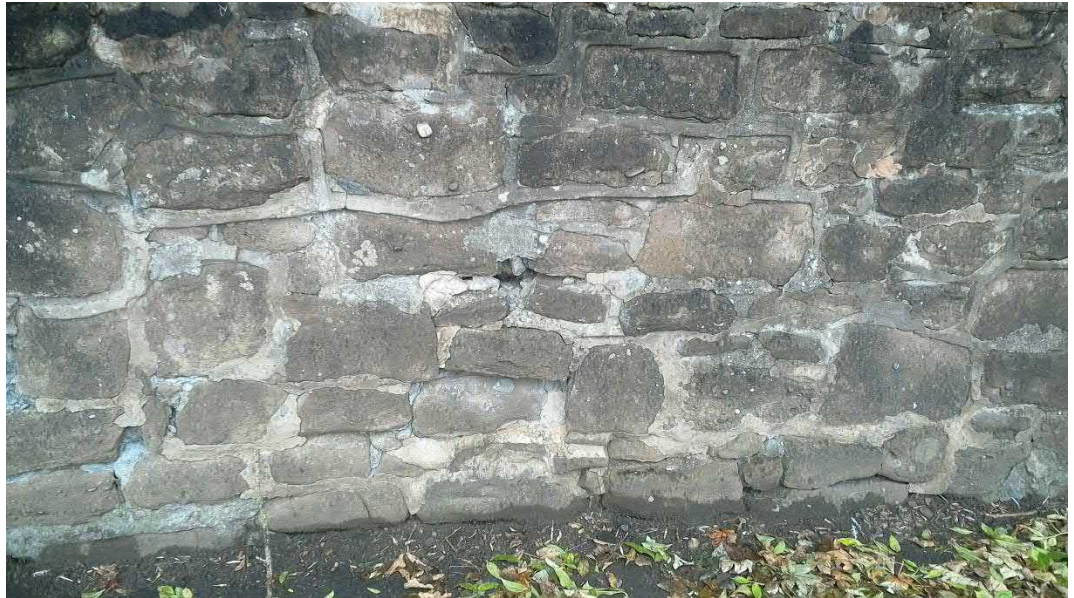
| Defect No: | 0009 | Elevation: | Roadside | Defect Chainage: | 35m |

| Defect Type: | Mortar Failure | | Severity: | Medium | |

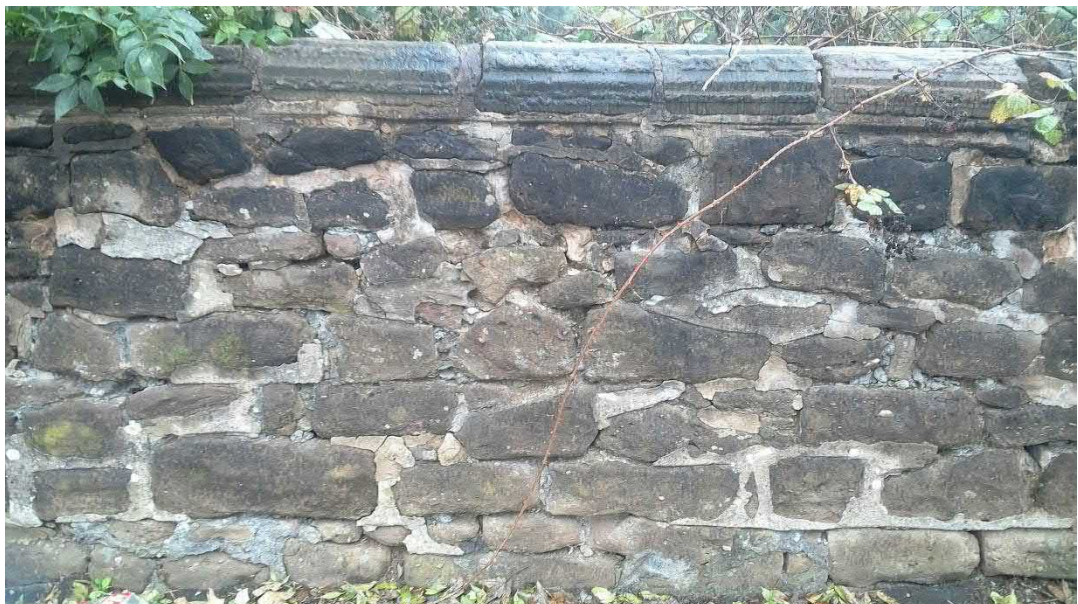
| Defect No: | 0010 | Elevation: | Roadside | Defect Chainage: | 40m |

| Defect Type: | Mortar Failure | | Severity: | Medium | |

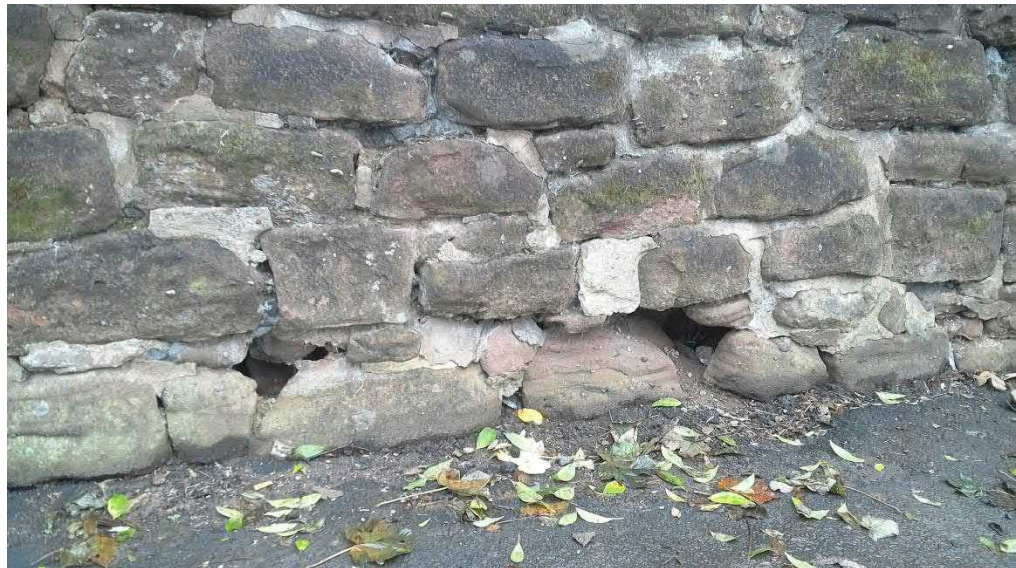
| Defect No: | 0011 | Elevation: | Roadside | Defect Chainage: | 46m |

| Defect Type: | Voids/ Weathered Stone | | Severity: | Medium | |

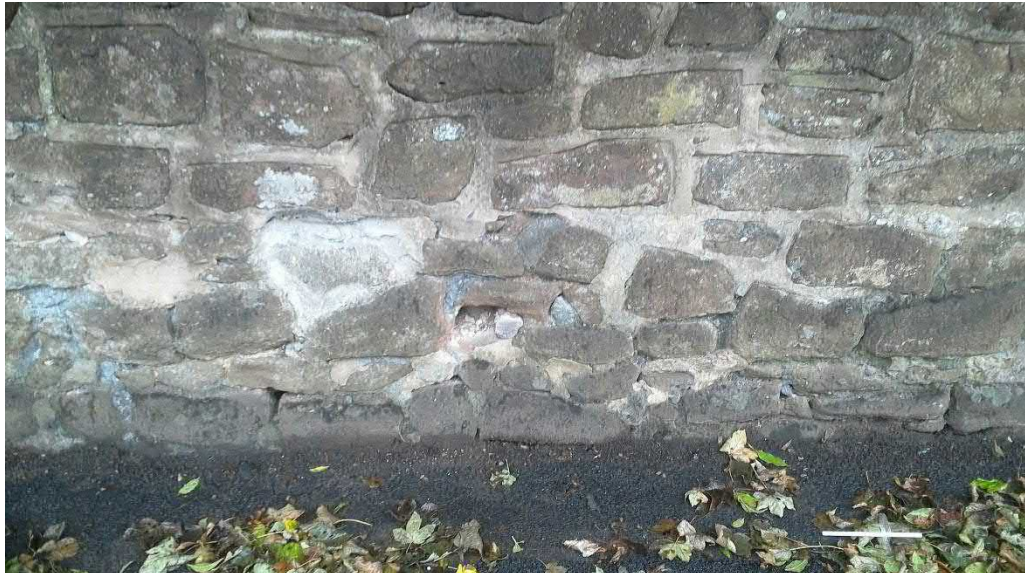
| Defect No: | 0012 | Elevation: | Roadside | Defect Chainage: | 53m |

| Defect Type: | Mortar Failure | | Severity: | Medium | |

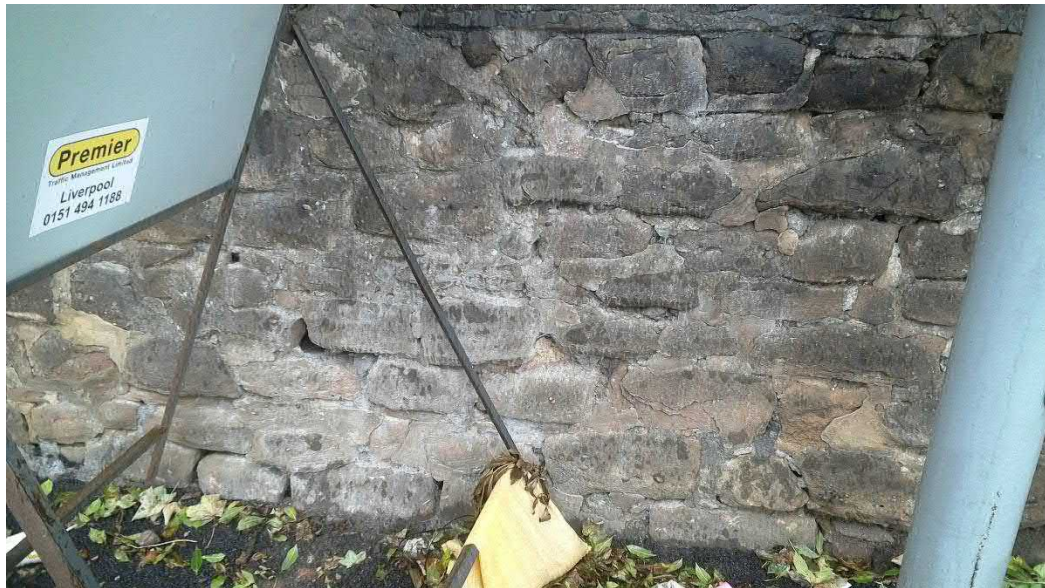
| Defect No: | 0013 | Elevation: | Roadside | Defect Chainage: | 64m |

| Defect Type: | Mortar Failure | | Severity: | Low | |

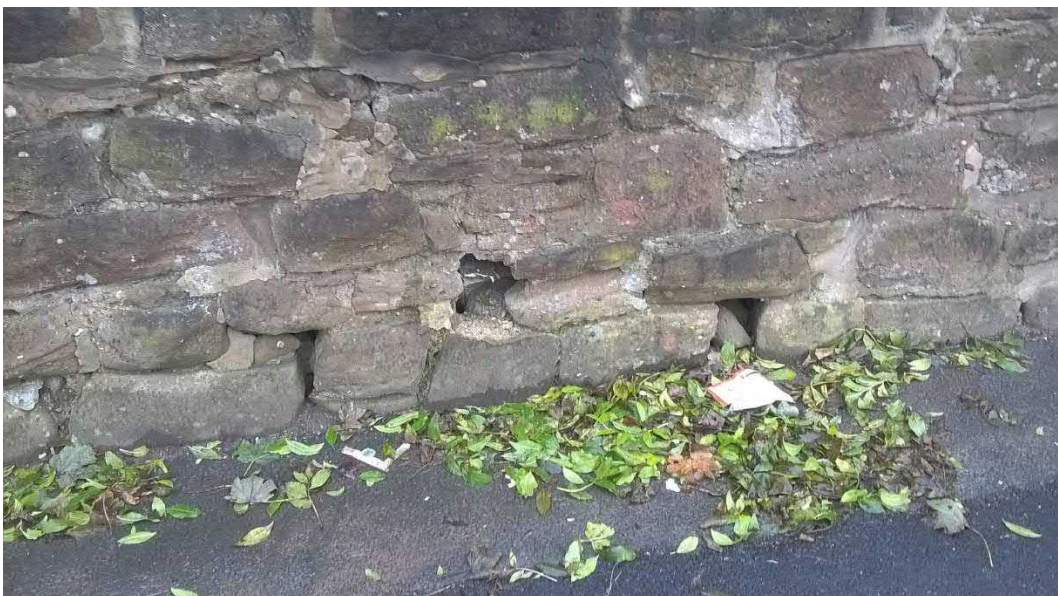
| Defect No: | 0014 | Elevation: | Roadside | Defect Chainage: | 74m |

| Defect Type: | Voids | | Severity: | Medium | |

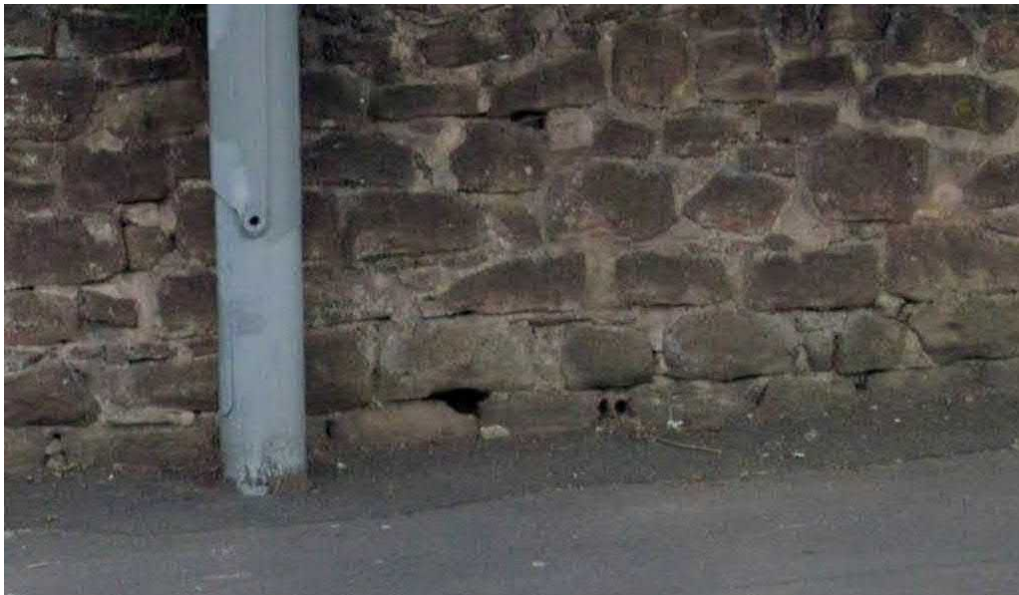
| Defect No: | 0015 | Elevation: | Roadside | Defect Chainage: | 95m |

| Defect Type: | Voids | | Severity: | Medium | |

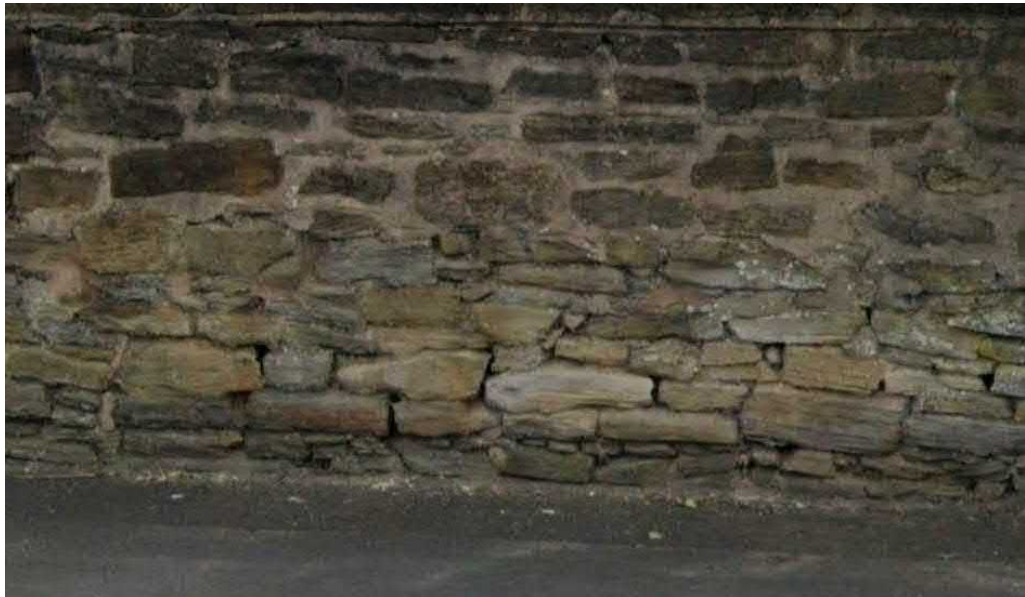
| Defect No: | 0016 | Elevation: | Roadside | Defect Chainage: | 102m |

| Defect Type: | Mortar Failure | | Severity: | Medium | |

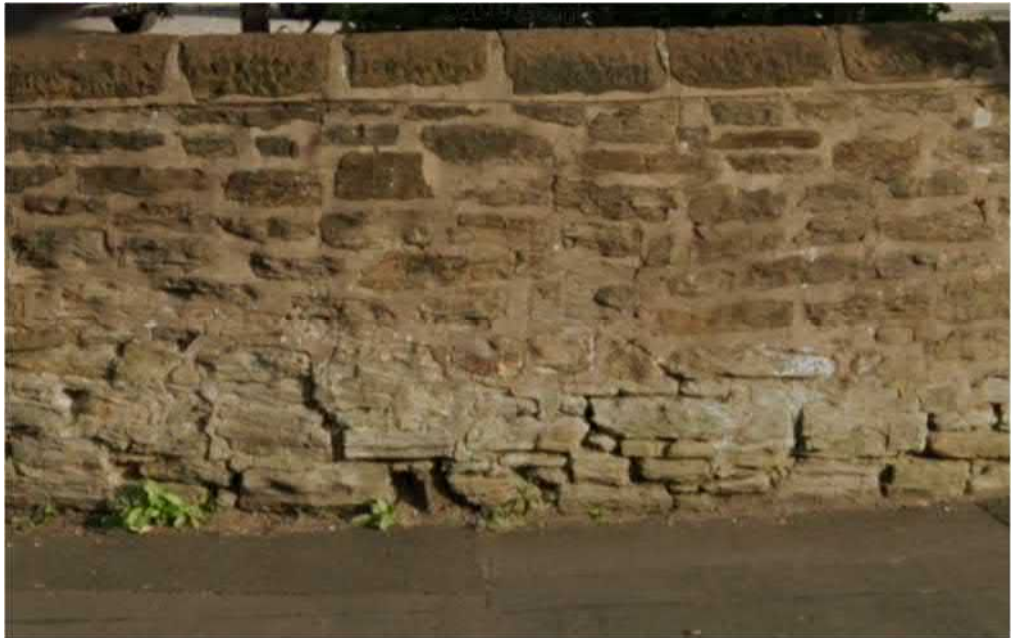
| Defect No: | 0017 | Elevation: | Roadside | Defect Chainage: | 115m |

| Defect Type: | Weathered Stone | | Severity: | Medium | |

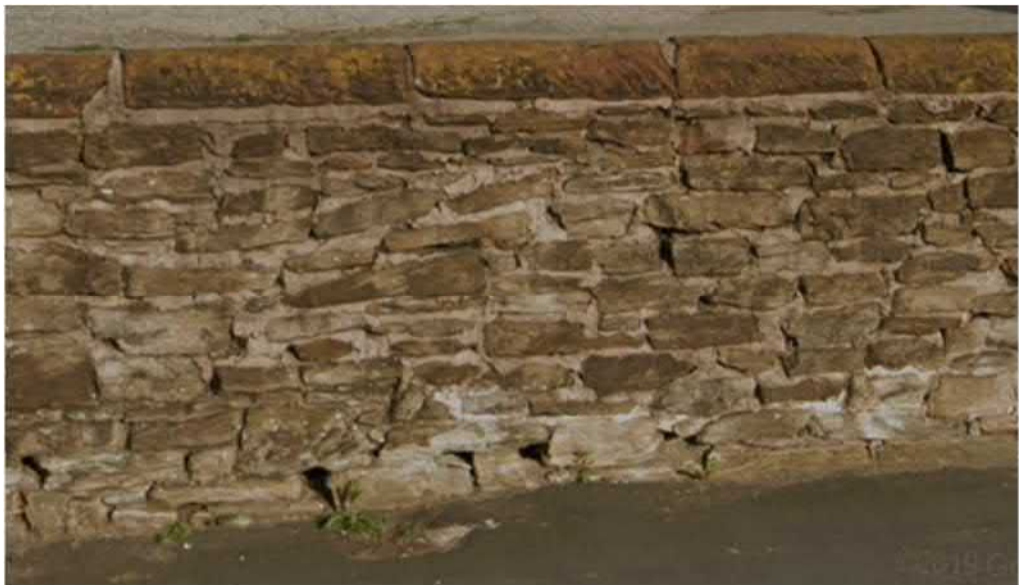
| Defect No: | 0018 | Elevation: | Roadside | Defect Chainage: | 130m |

| Defect Type: | Mortar Failure | | Severity: | Medium | |

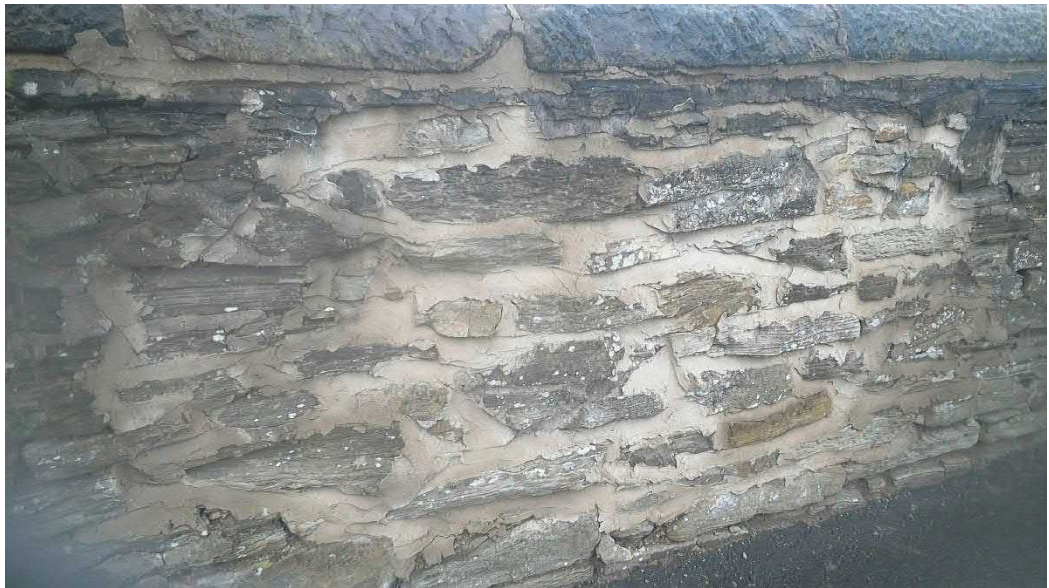
| Defect No: | 0019 | Elevation: | Roadside | Defect Chainage: | 177m |

| Defect Type: | Bow at re-pointing | | Severity: | Low | |

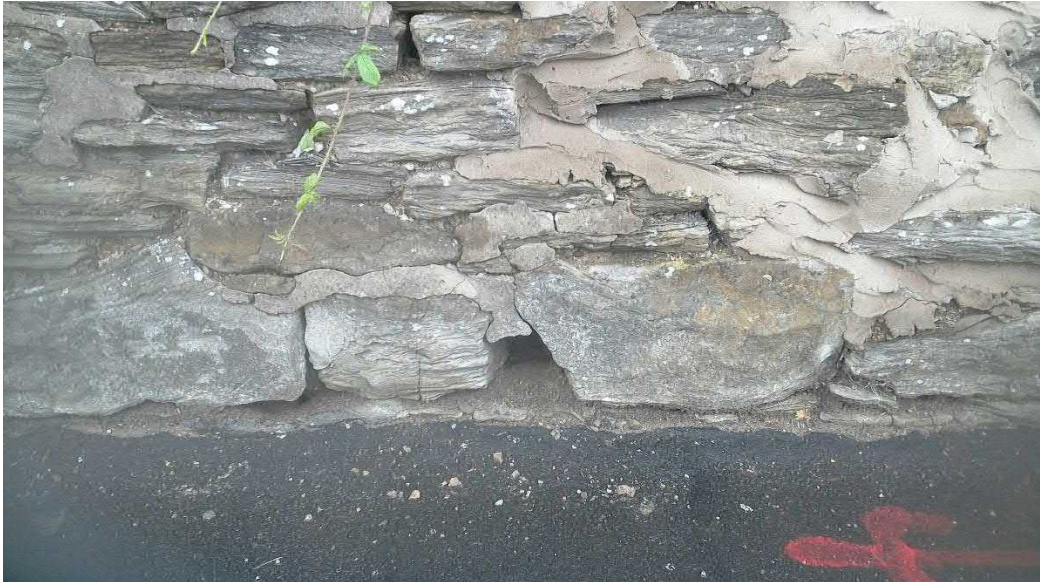
| Defect No: | 0020 | Elevation: | Roadside | Defect Chainage: | 182m |

| Defect Type: | Void | | Severity: | Medium | |

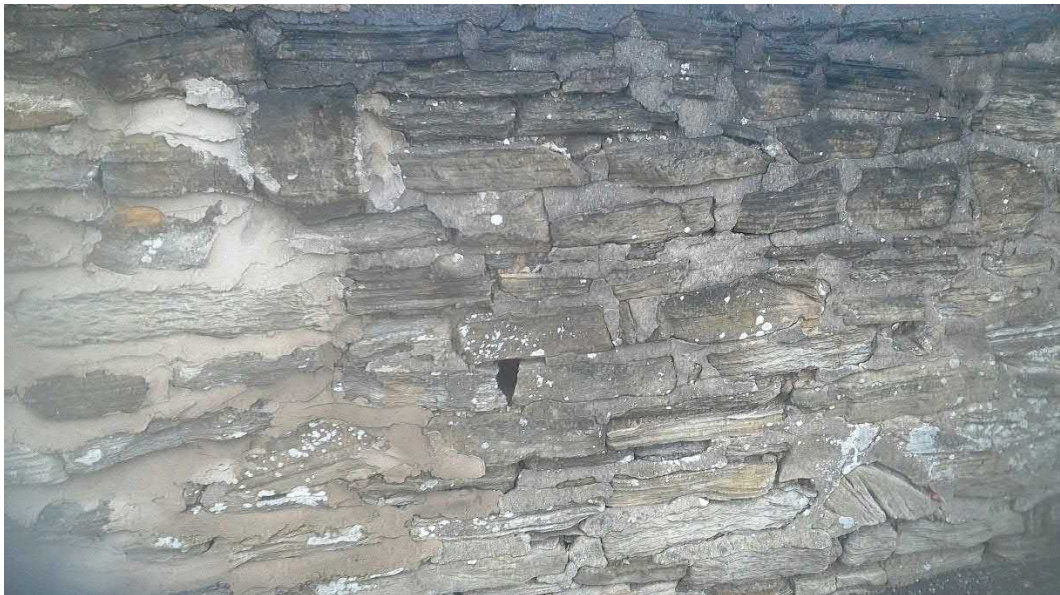
| Defect No: | 0021 | Elevation: | Roadside | Defect Chainage: | 197m |

| Defect Type: | Mortar Failure | | Severity: | Medium | |

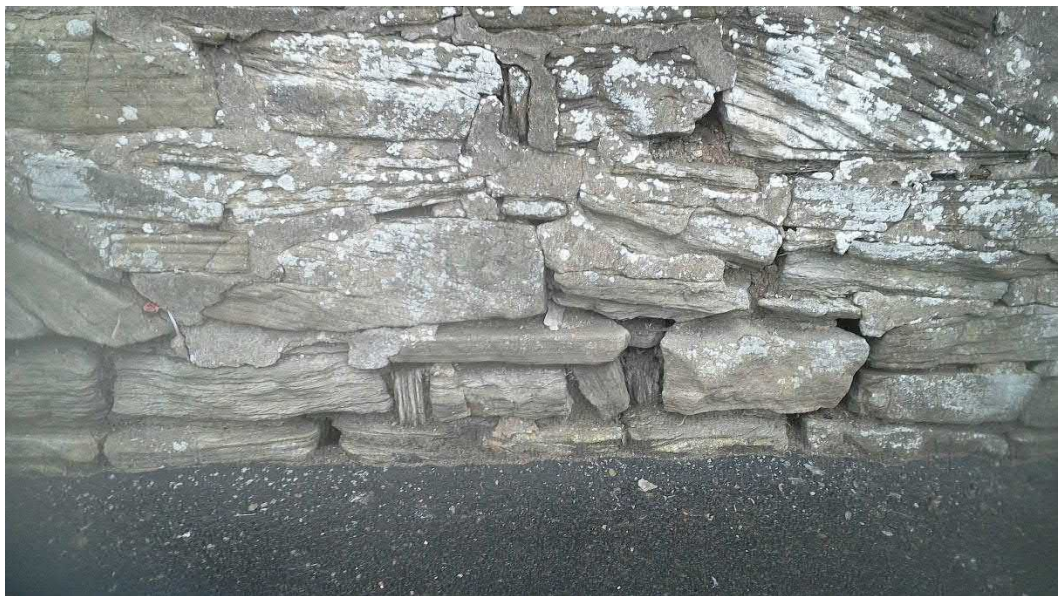
| Defect No: | 0022 | Elevation: | Roadside | Defect Chainage: | 204m |

| Defect Type: | Mortar Failure | | Severity: | Medium | |

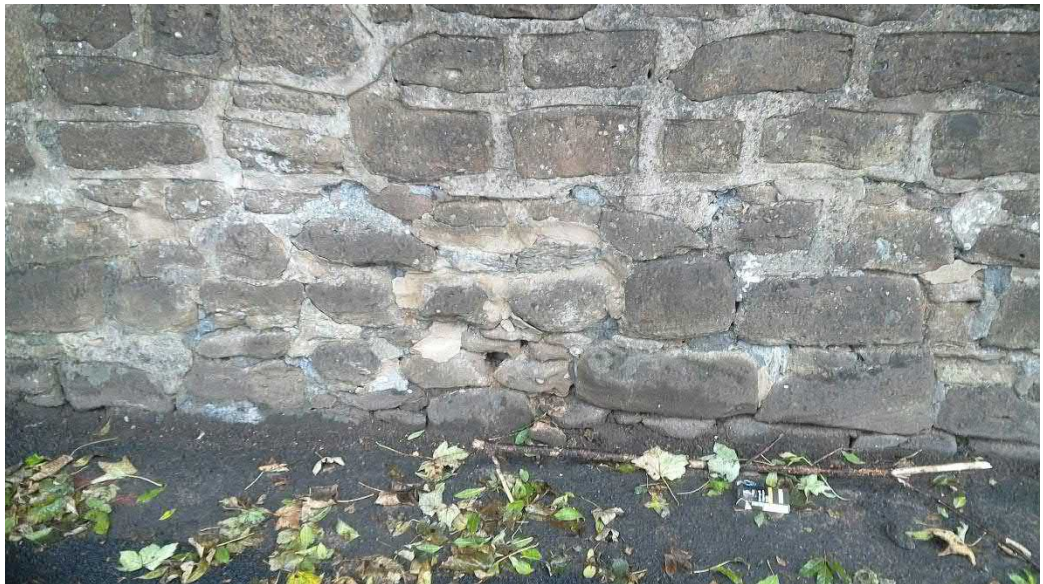
| Defect No: | 0023 | Elevation: | Roadside | Defect Chainage: | 207m |

| Defect Type: | Mortar Failure | | Severity: | Low | |

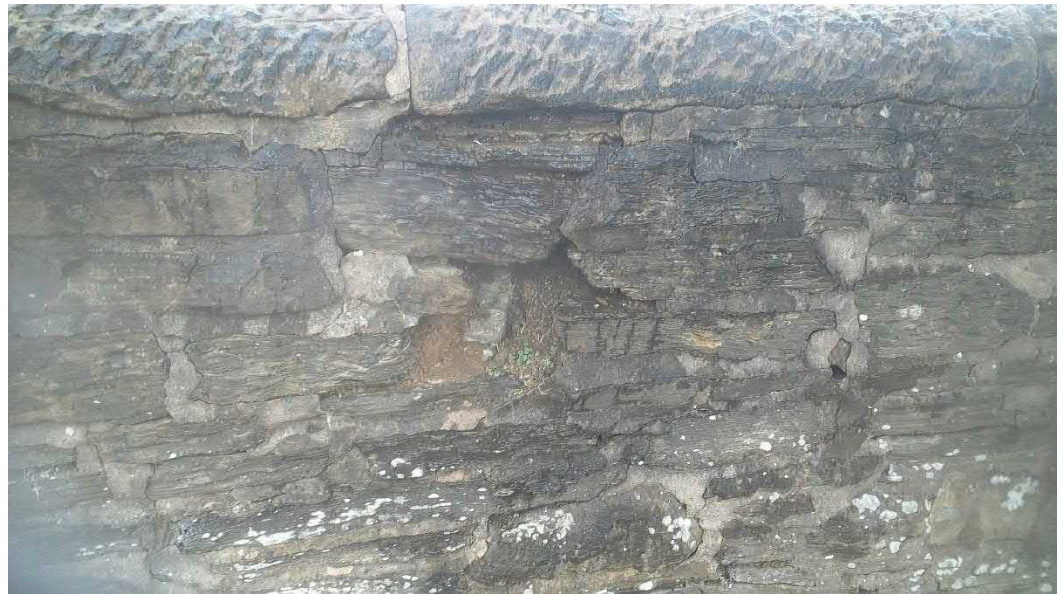
| Defect No: | 0024 | Elevation: | Roadside | Defect Chainage: | 211m |

| Defect Type: | Void | | Severity: | Medium | |

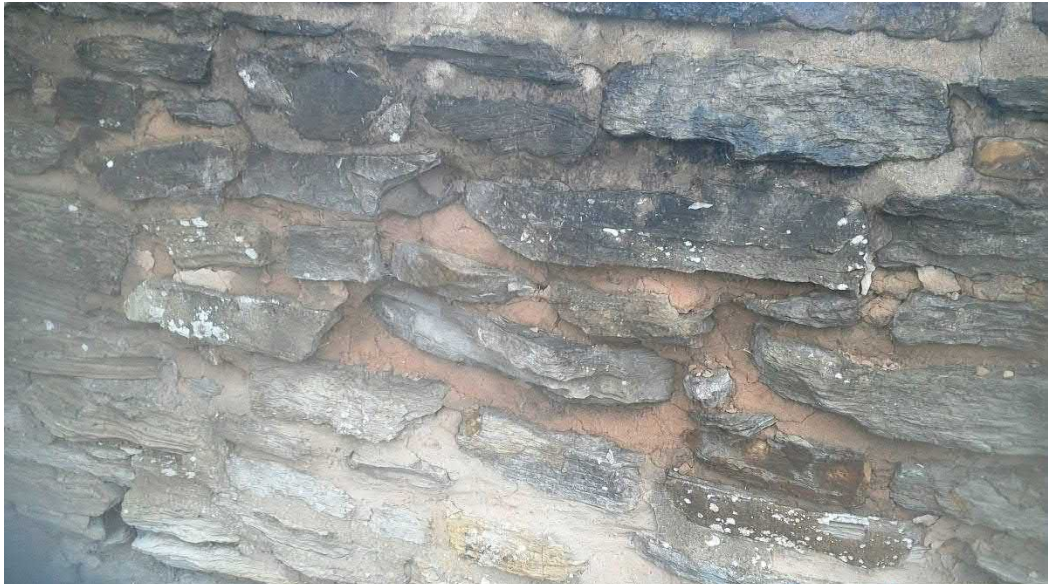
| Defect No: | 0025 | Elevation: | Roadside | Defect Chainage: | 216m |

| Defect Type: | Weathered Stone | | Severity: | Low | |

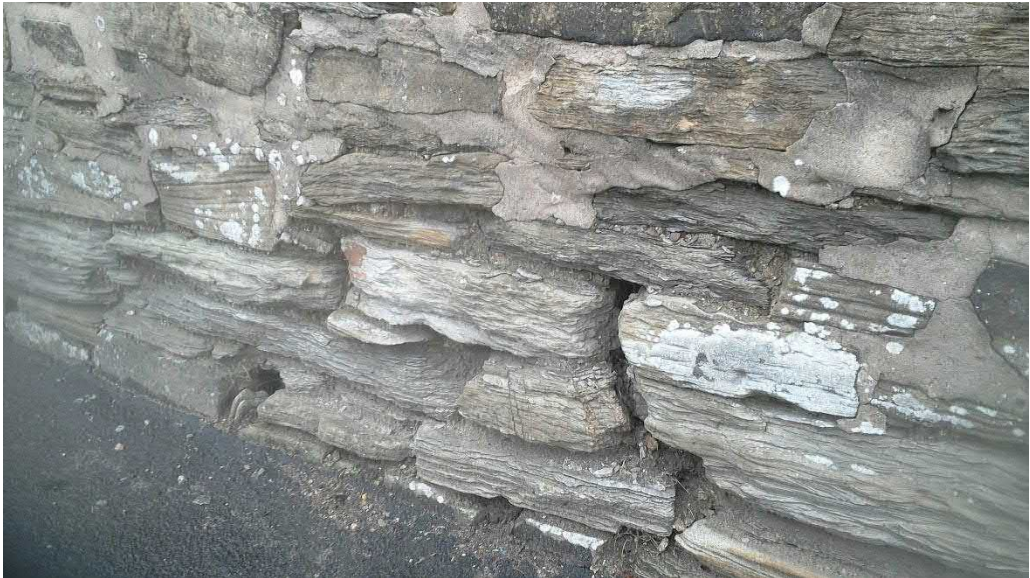
| Defect No: | 0026 | Elevation: | Roadside | Defect Chainage: | 220m |

| Defect Type: | Mortar/ Weathered Stone | | Severity: | Medium | |

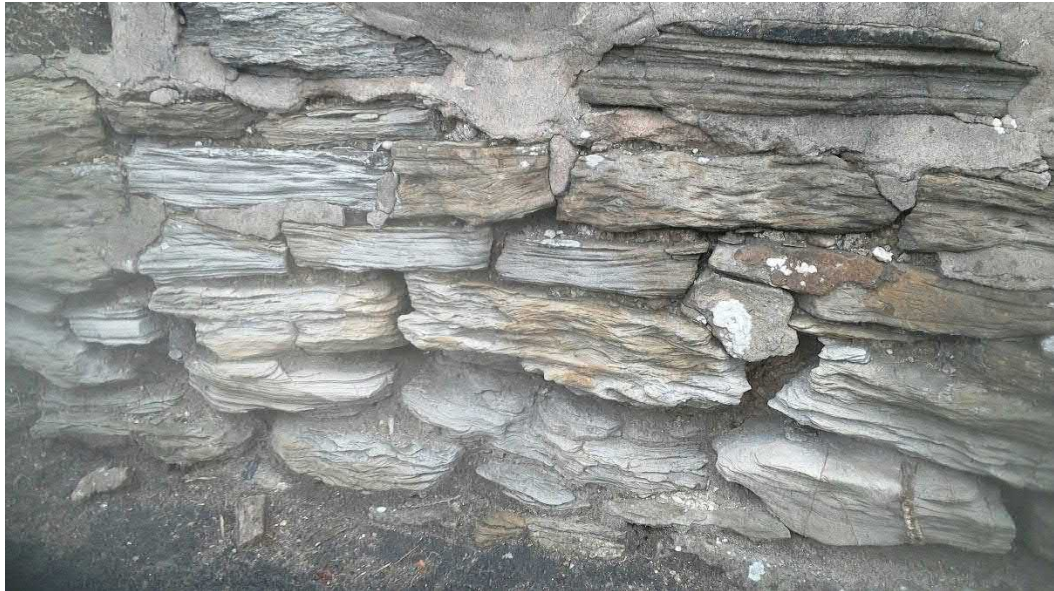
| Defect No: | 0027 | Elevation: | Roadside | Defect Chainage: | 226m |

The most significant defects observed are 2 areas of mortar loss and weathered stones on the roadside elevation at Windy Arbor Road (defects 27 and 34). A sizable void exists on the parkside elevation (defect 57) however this is located on the reduced height section of wall adjacent to the park entrance so is not considered as significant.

| Defect Type: | Mortar/ Weathered Stone | | Severity: | High | |

There were 59 defects identified on the other sections of the wall, due to their separation from the planned works on the car park it is not considered that these areas could be affected by (or affect) the works. It is suggested that consideration be given to localised repairs to the mortar and stone generally but particularly at the 2 defects rated as high priority.

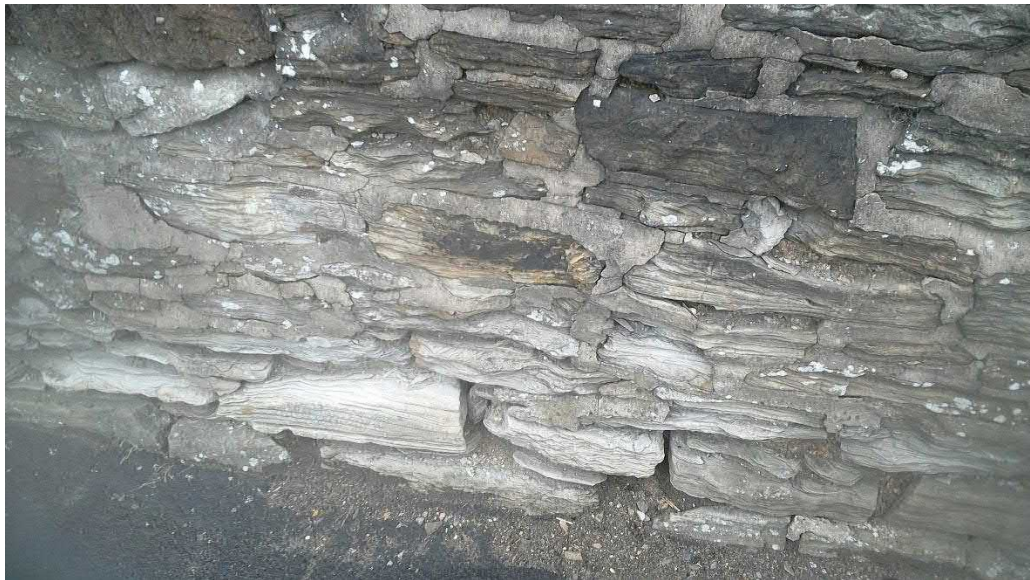
| Defect No: | 0028 | Elevation: | Roadside | Defect Chainage: | 230m |

| Defect Type: | Mortar Failure | | Severity: | Medium | |

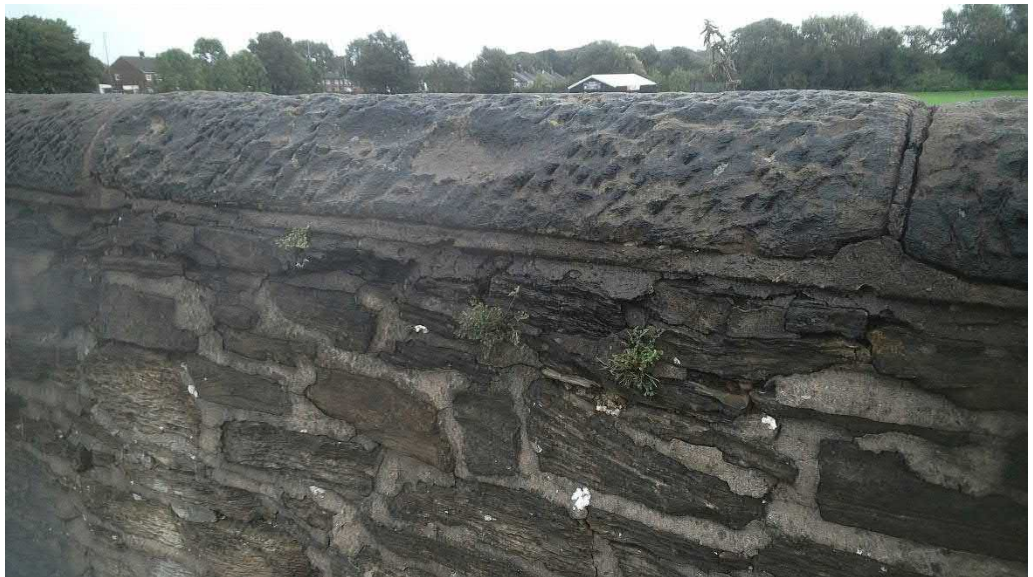
| Defect No: | 0029 | Elevation: | Roadside | Defect Chainage: | 233m |

| Defect Type: | Vegetation | | Severity: | Low | |

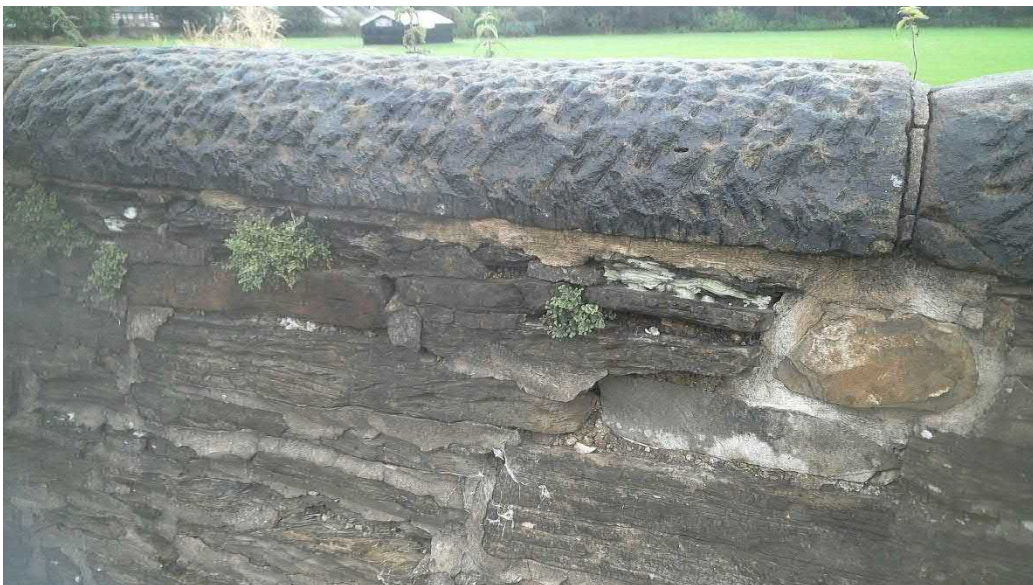
| Defect No: | 0030 | Elevation: | Roadside | Defect Chainage: | 238m |

| Defect Type: | Vegetation | | Severity: | Low | |

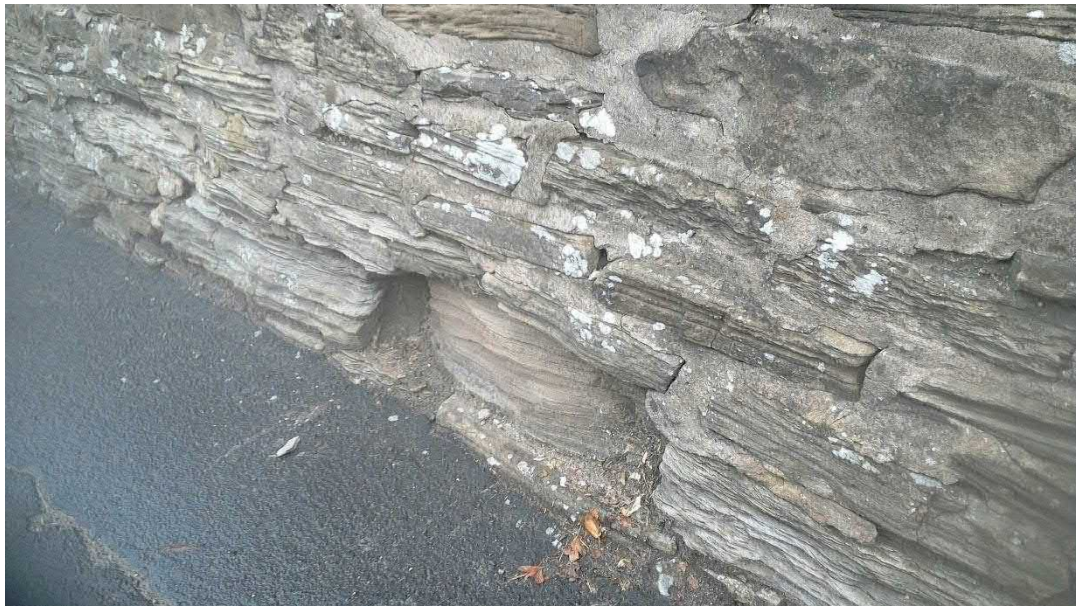
| Defect No: | 0031 | Elevation: | Roadside | Defect Chainage: | 240m |

| Defect Type: | Weathered Stone | | Severity: | Medium | |

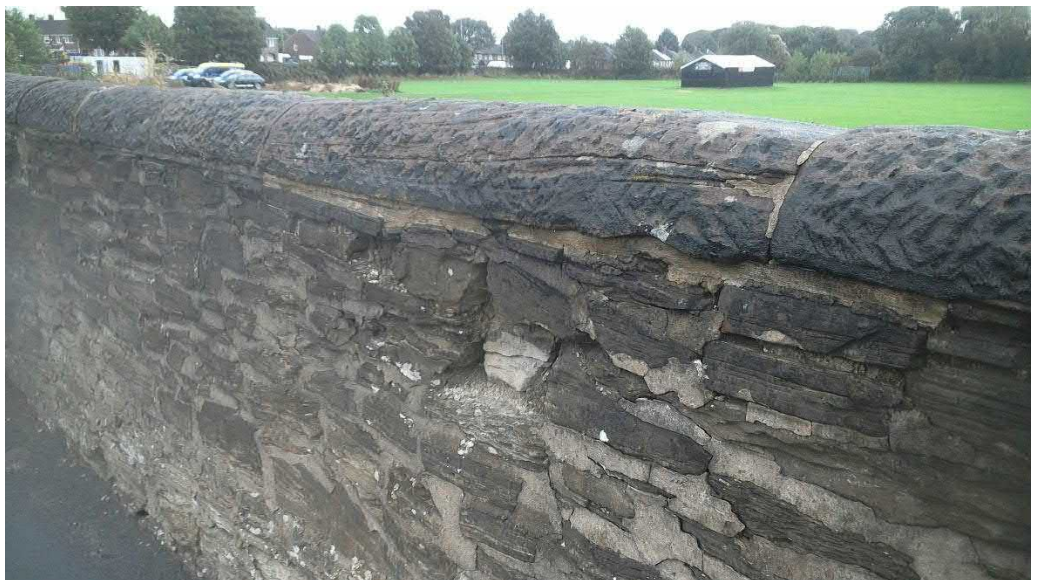
| Defect No: | 0032 | Elevation: | Roadside | Defect Chainage: | 243m |

| Defect Type: | Mortar Failure | | Severity: | Low | |

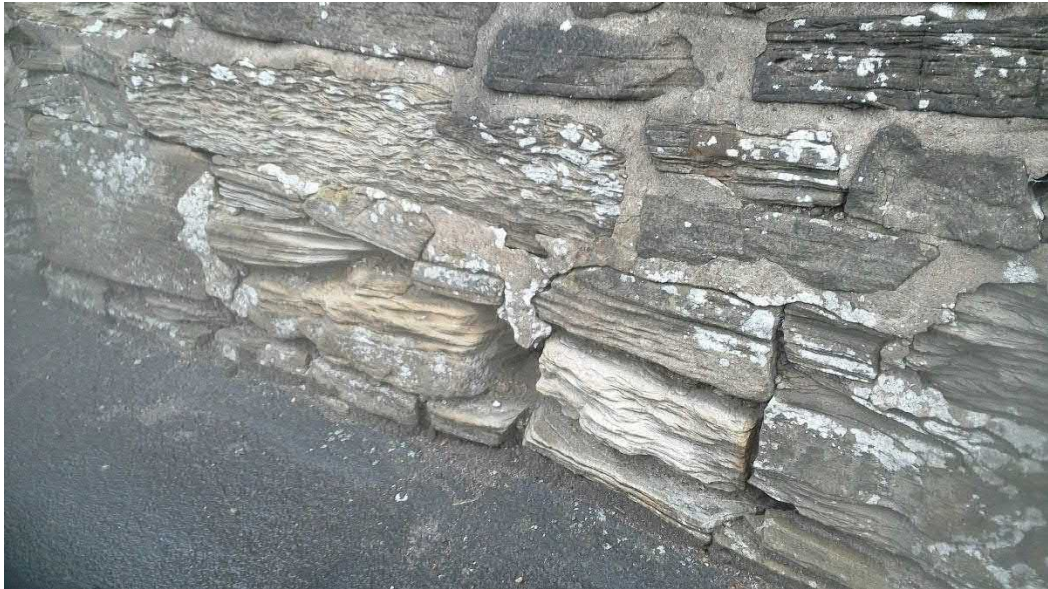
| Defect No: | 0033 | Elevation: | Roadside | Defect Chainage: | 245m |

| Defect Type: | Mortar Failure | | Severity: | Medium | |

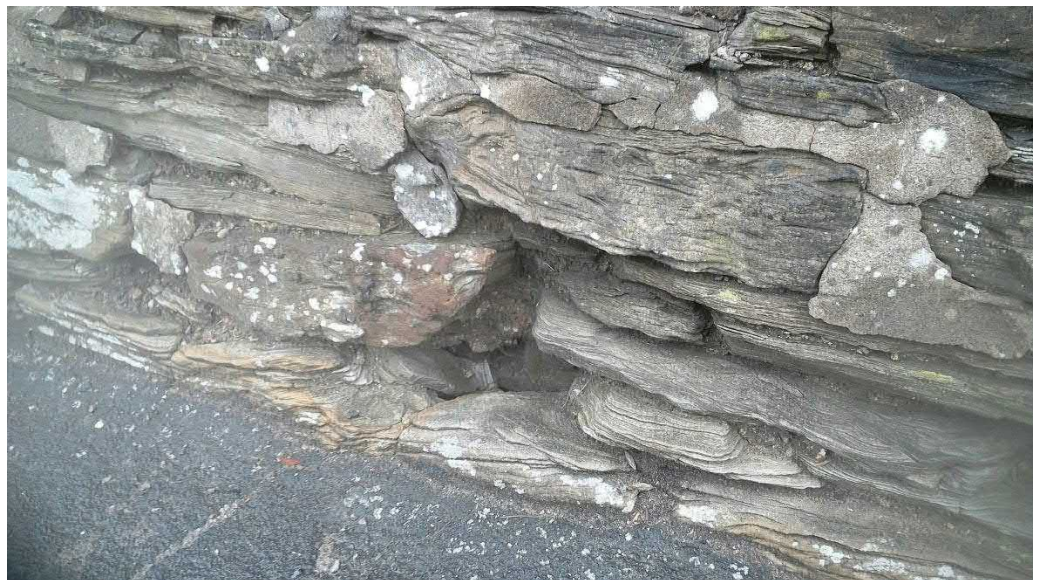
| Defect No: | 0034 | Elevation: | Roadside | Defect Chainage: | 251m |

| Defect Type: | Weathered Stone | | Severity: | High | |

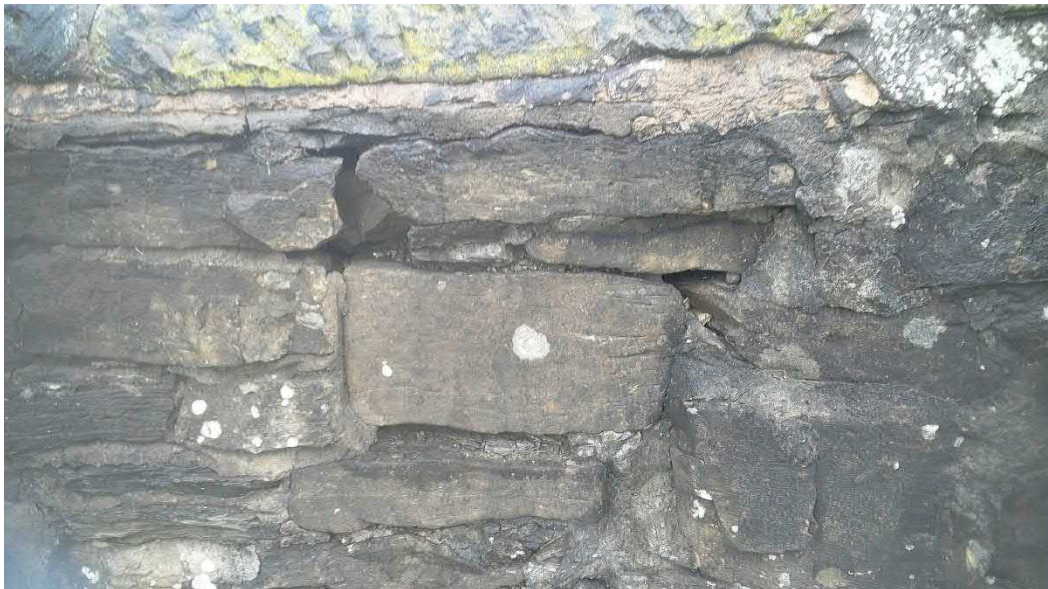
| Defect No: | 0036 | Elevation: | Roadside | Defect Chainage: | 258m |

| Defect Type: | Mortar Failure | | Severity: | Low | |
