# WINDY ARBOR PLAYING FIELDS

## 2021 Boundary Wall Inspection Report

**PROJECT NO. 70057126**

**DATE: SEPTEMBER 2021**

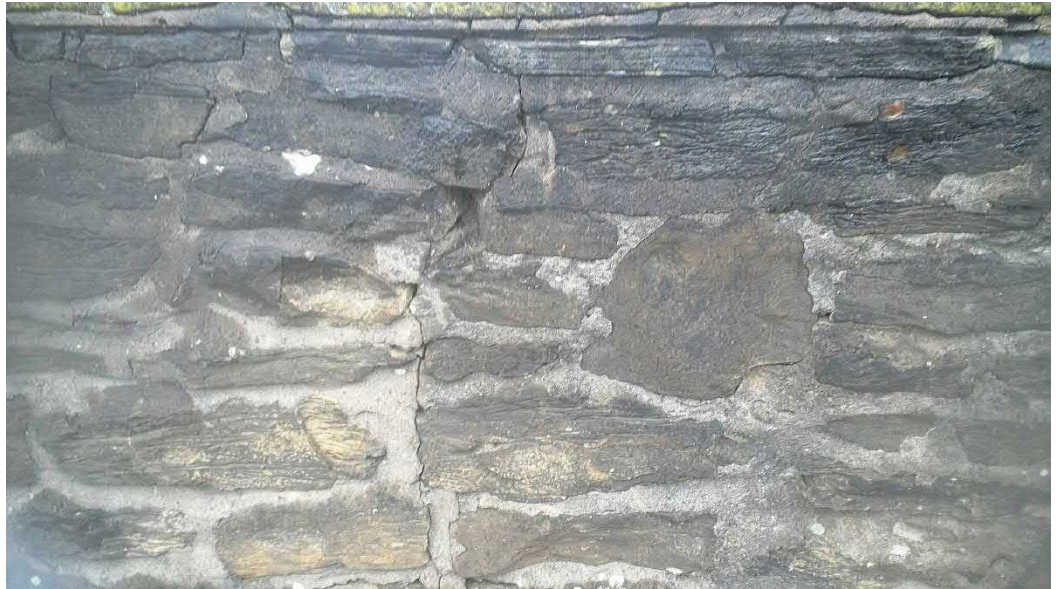
| Defect No: | 0037 | Elevation: | Roadside | Defect Chainage: | 262m |

| Defect Type: | Mortar Crack | | Severity: | Medium | |

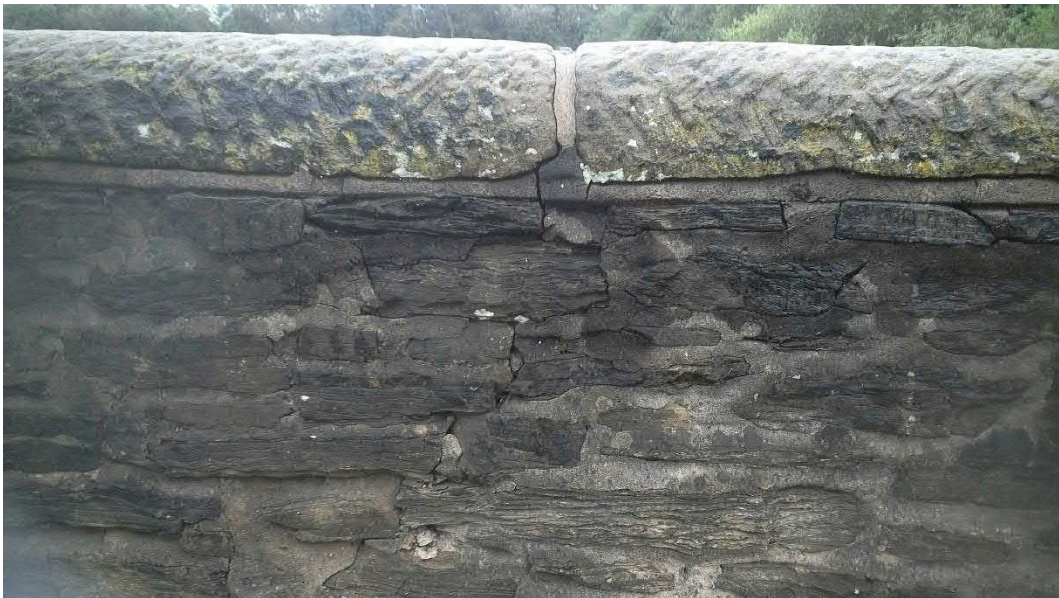
| Defect No: | 0038 | Elevation: | Roadside | Defect Chainage: | 265m |

| Defect Type: | Mortar Crack | | Severity: | Medium | |

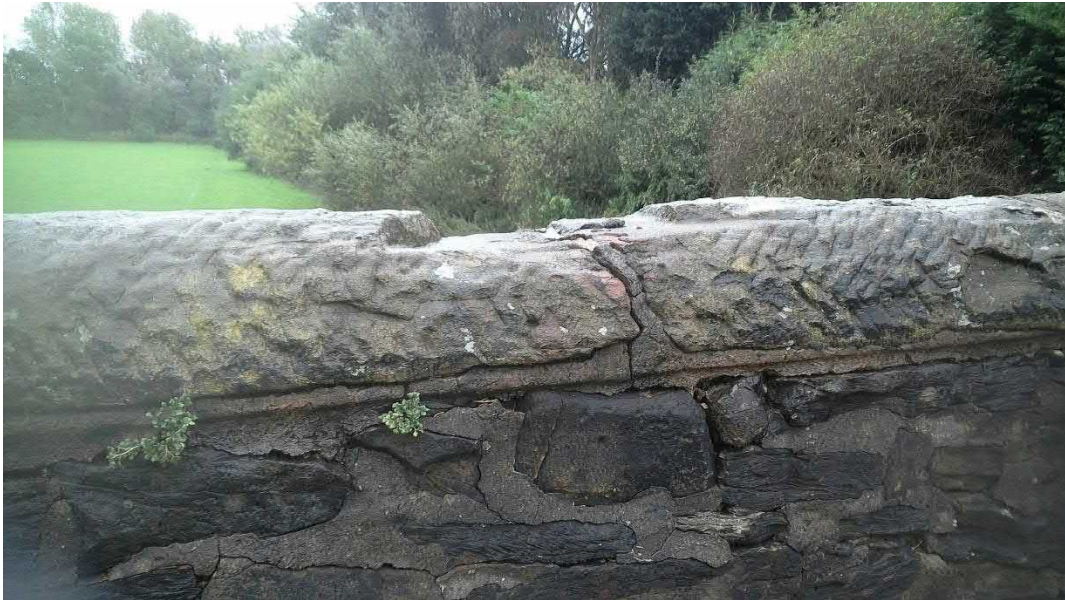
| Defect No: | 0039 | Elevation: | Roadside | Defect Chainage: | 270m |

| Defect Type: | Vegetation | | Severity: | Low | |

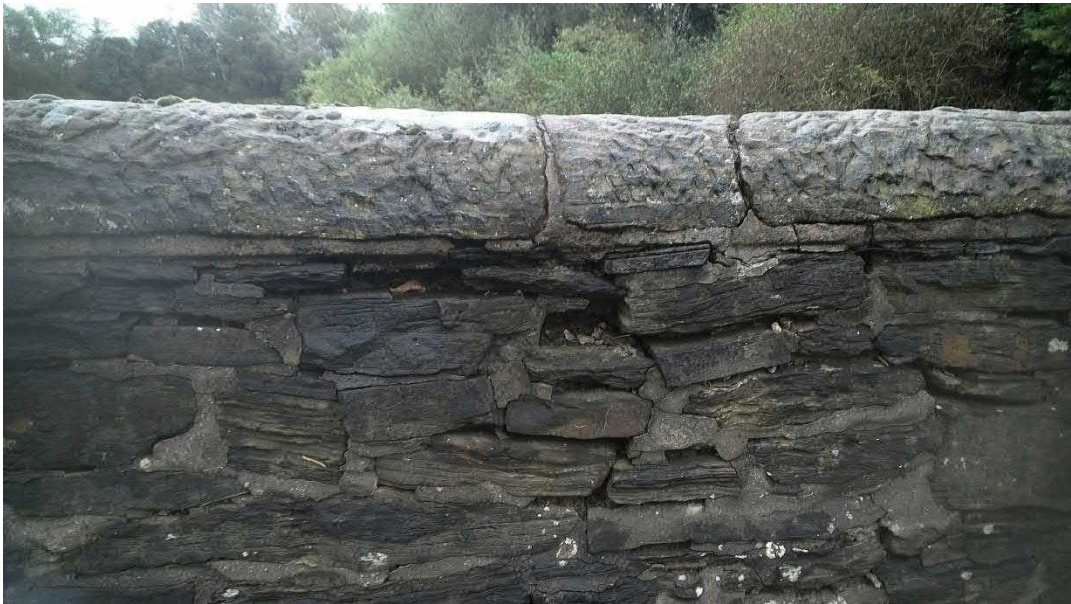
| Defect No: | 0040 | Elevation: | Roadside | Defect Chainage: | 274m |

| Defect Type: | Mortar Failure/ Cracked Cope | | Severity: | Low | |

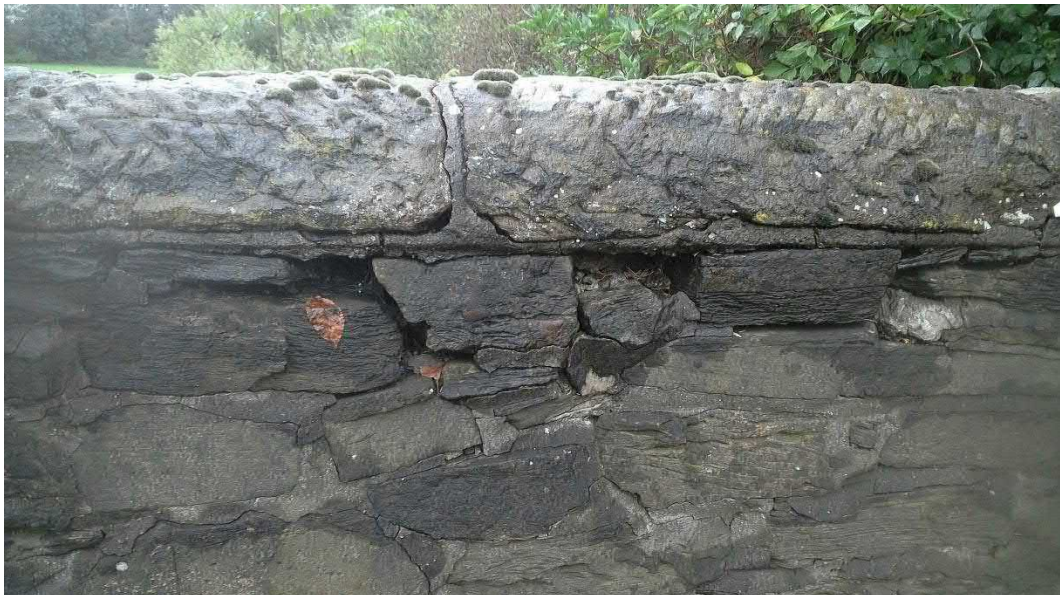
| Defect No: | 0041 | Elevation: | Roadside | Defect Chainage: | 280m |

| Defect Type: | Mortar Failure | | Severity: | Low | |

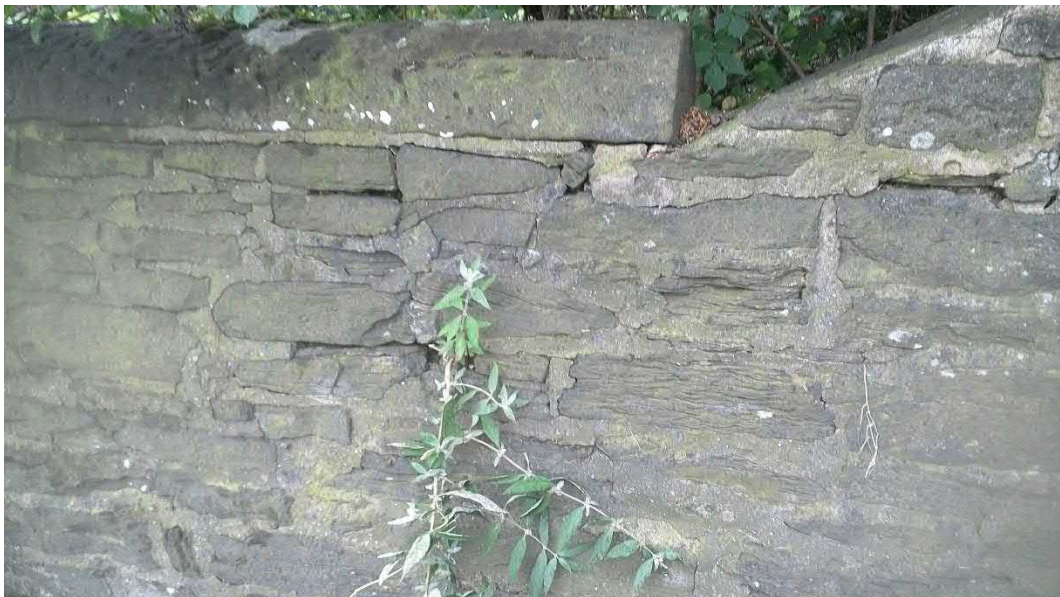
| Defect No: | 0042 | Elevation: | Roadside | Defect Chainage: | 286m |

| Defect Type: | Vegetation | | Severity: | Low | |

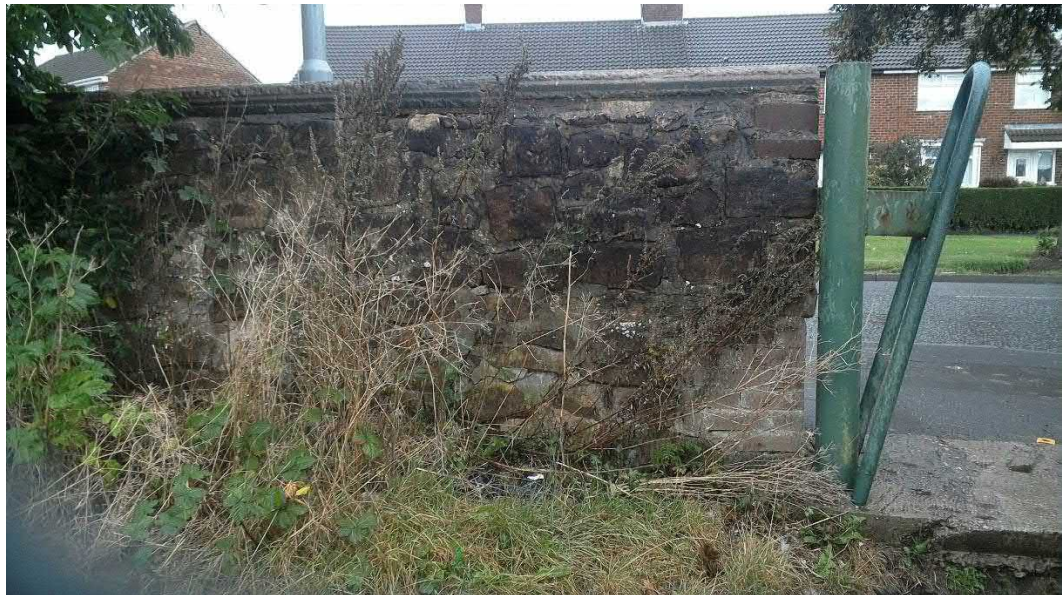
| Defect Type: | Brickwork Repair | | Severity: | Low | |

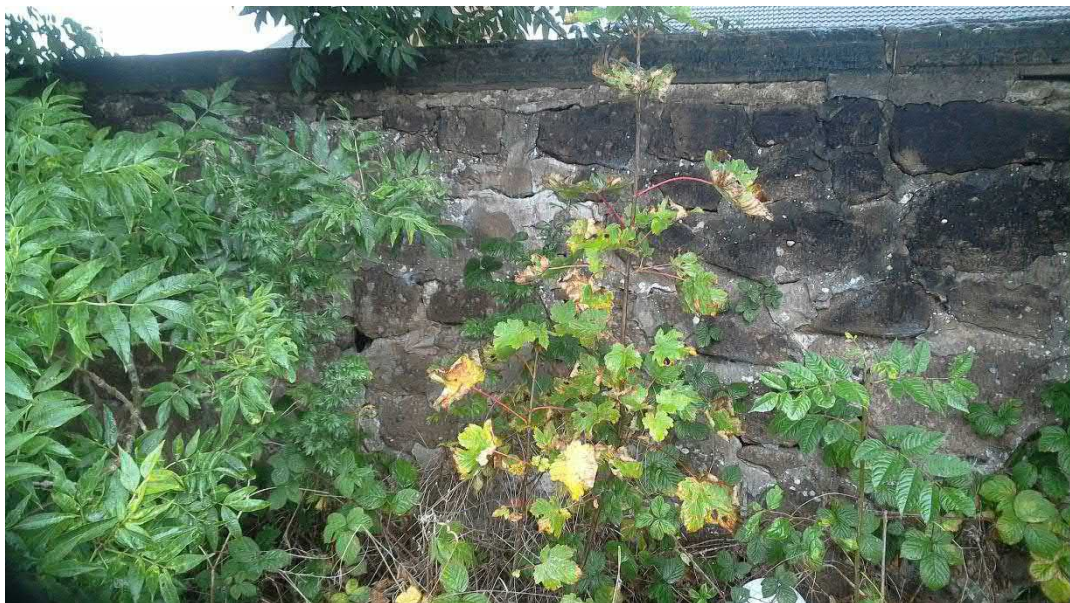
| Defect No: | 0044 | Elevation: | Parkside | Defect Chainage: | 12m |

| Defect Type: | Mortar Failure | | Severity: | Low | |

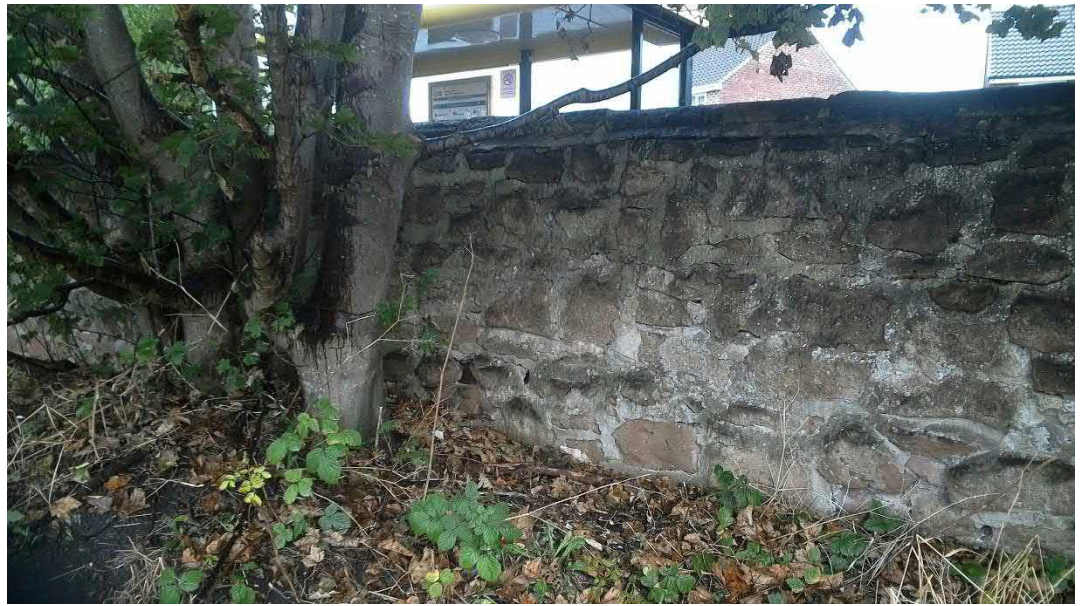
| Defect No: | 0045 | Elevation: | Parkside | Defect Chainage: | 14m |

| Defect Type: | Void | | Severity: | Medium | |

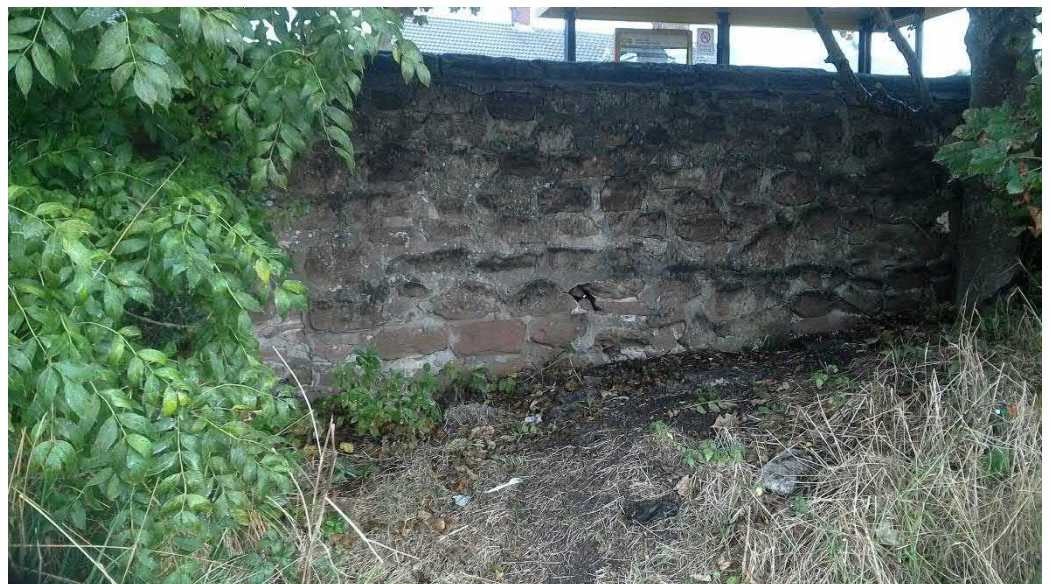
| Defect No: | 0046 | Elevation: | Parkside | Defect Chainage: | 17m |

| Defect Type: | Void | | Severity: | Medium | |

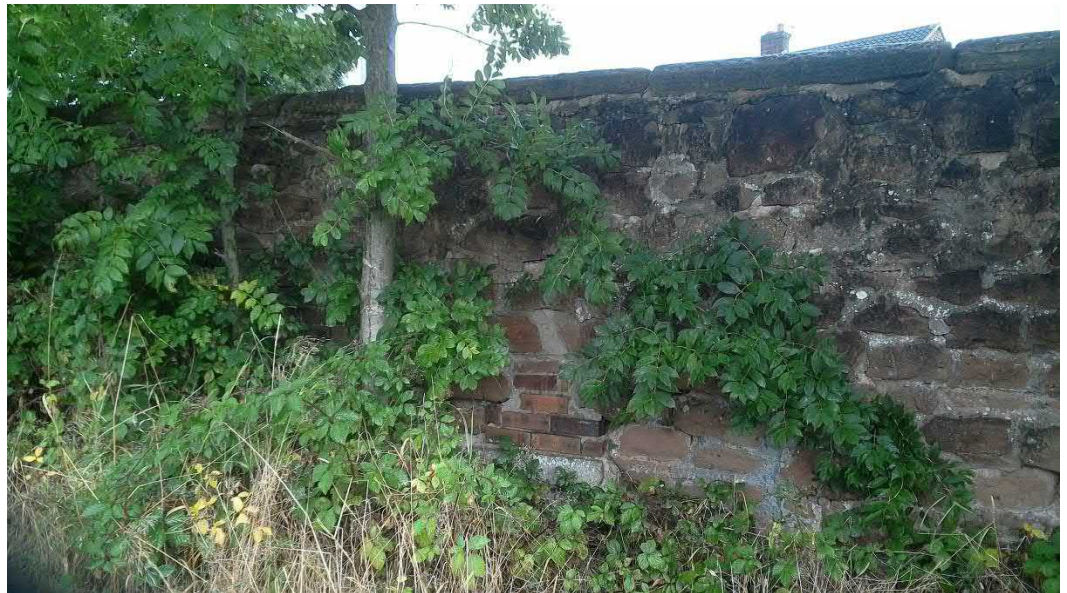
| Defect No: | 0047 | Elevation: | Parkside | Defect Chainage: | 26m |

| Defect Type: | Brickwork Repair | | Severity: | Low | |

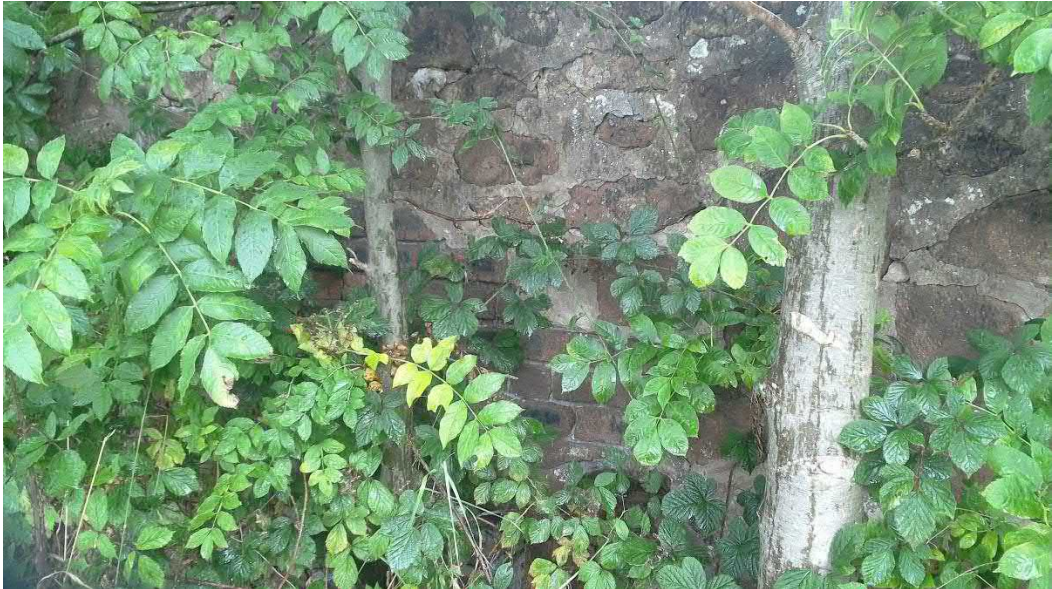
| Defect No: | 0048 | Elevation: | Parkside | Defect Chainage: | 35m |

| Defect Type: | Brickwork Repair | | Severity: | Low | |

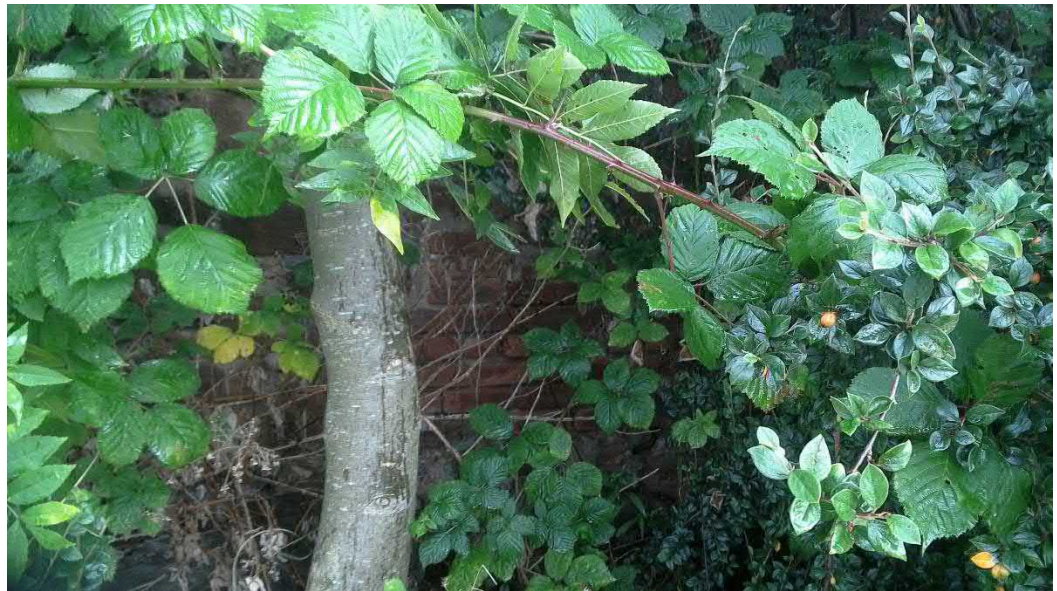
| Defect No: | 0049 | Elevation: | Parkside | Defect Chainage: | 42m |

| Defect Type: | Brickwork Repair | | Severity: | Low | |

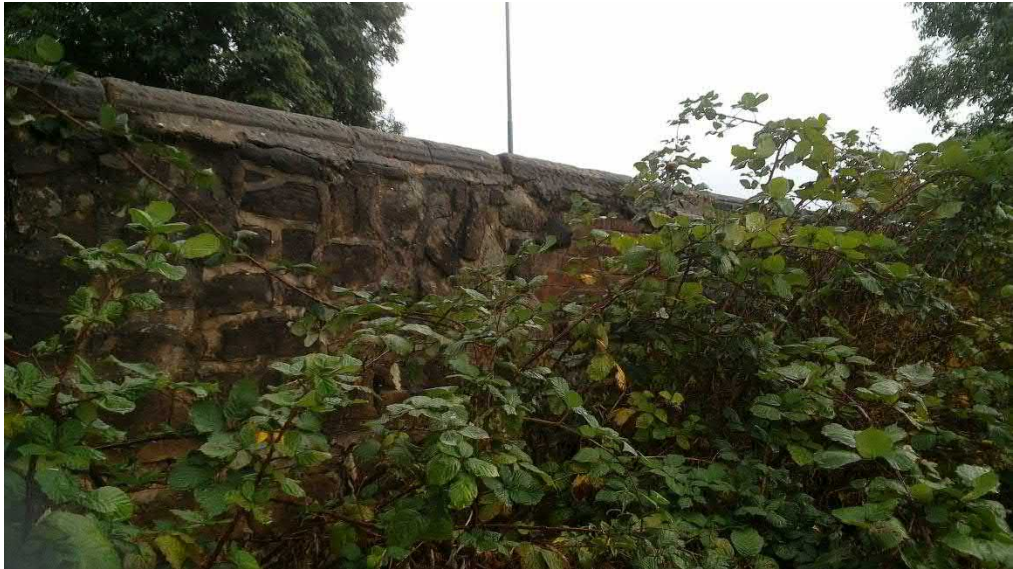
| Defect No: | 0050 | Elevation: | Parkside | Defect Chainage: | 48m |

| Defect Type: | Brickwork Repair | | Severity: | Low | |

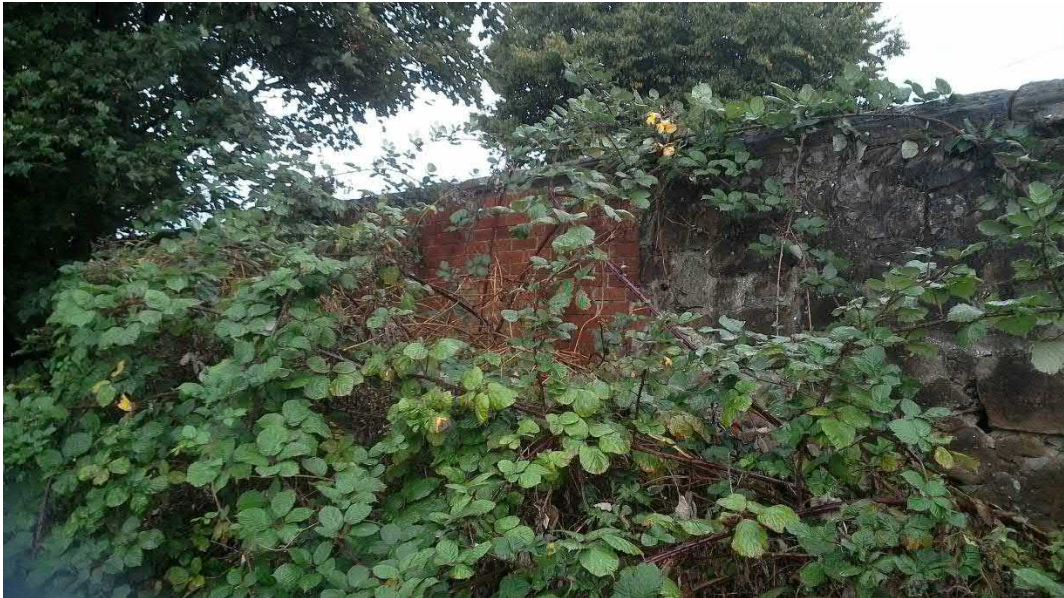
| Defect No: | 0051 | Elevation: | Parkside | Defect Chainage: | 56m |

| Defect Type: | Brickwork Repair | | Severity: | Low | |

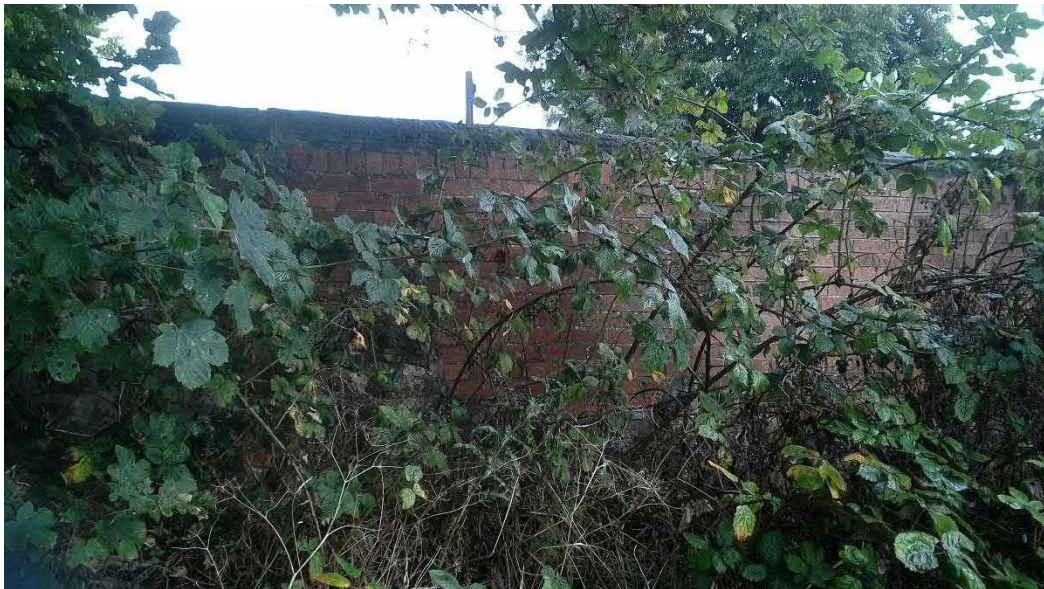
| Defect No: | 0052 | Elevation: | Parkside | Defect Chainage: | 62m |

| Defect Type: | Brickwork Repair | | Severity: | Low | |

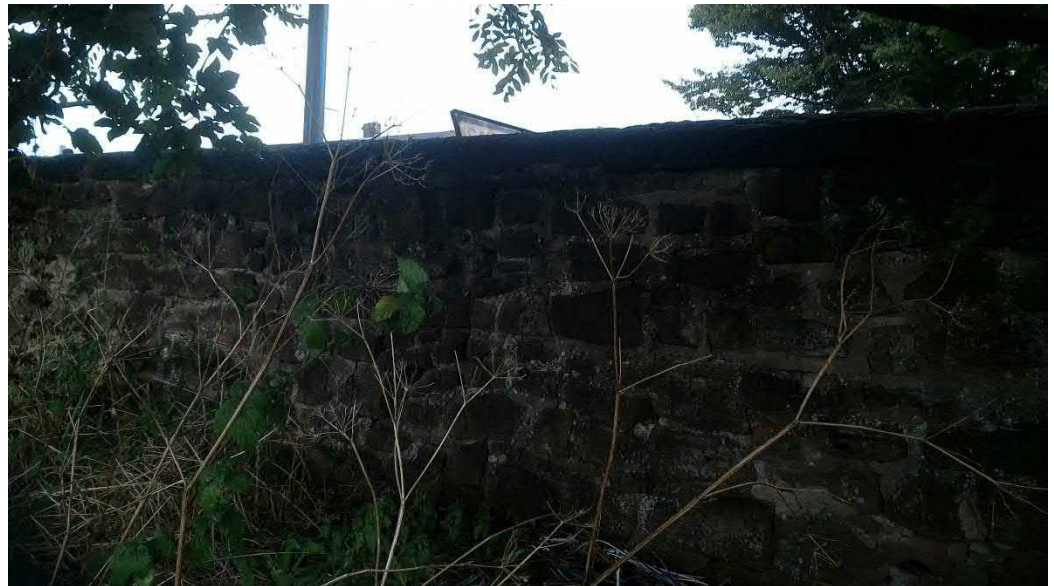
| Defect No: | 0053 | Elevation: | Parkside | Defect Chainage: | 65m |

| Defect Type: | Mortar Failure | | Severity: | Low | |

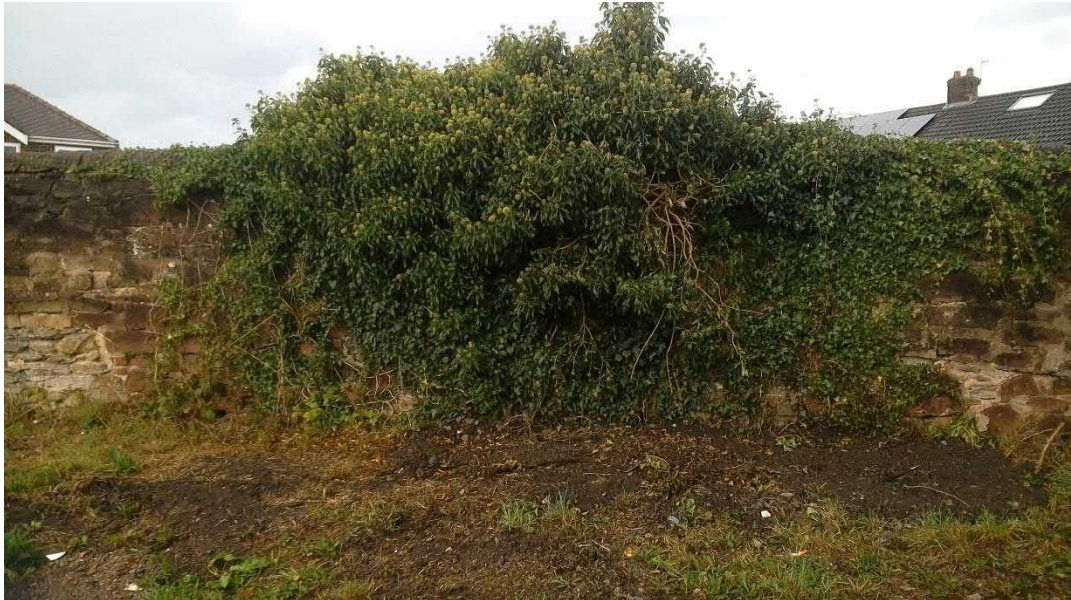
| Defect No: | 0054 | Elevation: | Parkside | Defect Chainage: | 116m |

| Defect Type: | Vegetation | | Severity: | Low | |

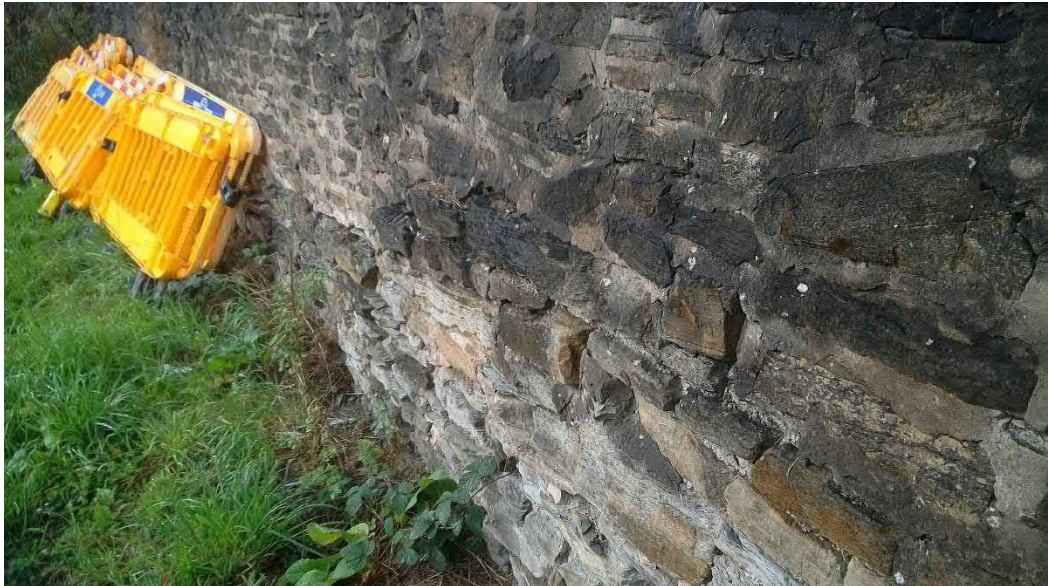
| Defect No: | 0055 | Elevation: | Parkside | Defect Chainage: | 120m |

| Defect Type: | Mortar Failure | | Severity: | Low | |

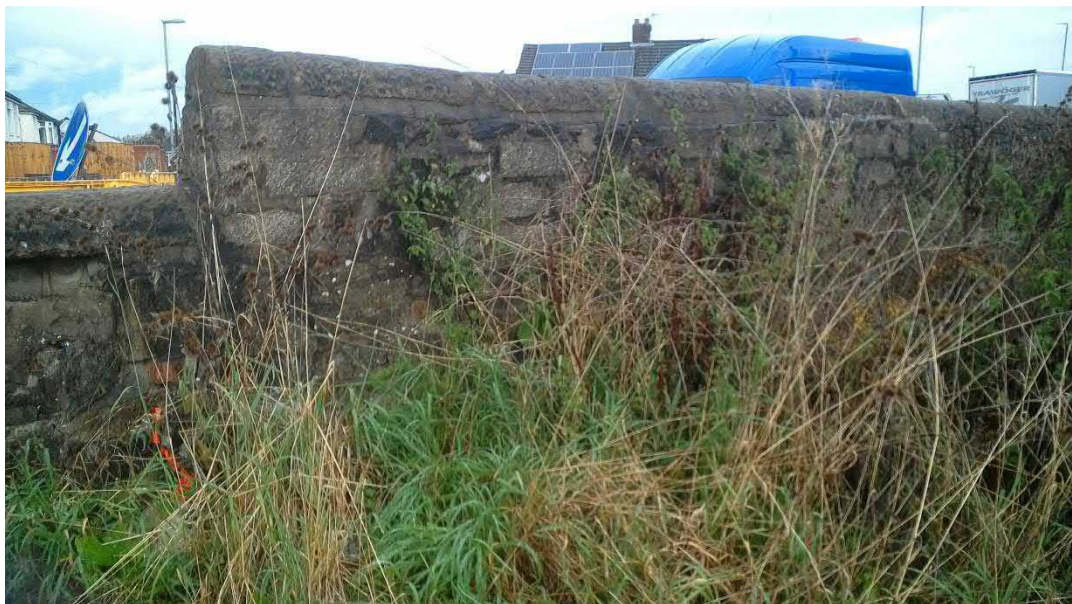
| Defect No: | 0056 | Elevation: | Parkside | Defect Chainage: | 136m |

| Defect Type: | Vegetation | | Severity: | Low | |

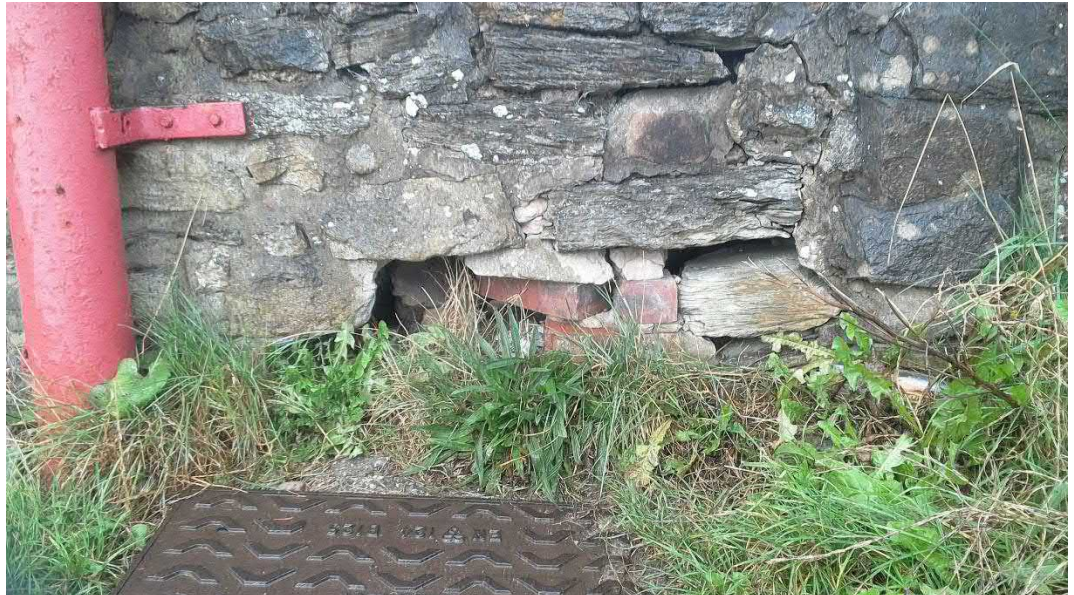
| Defect No: | 0057 | Elevation: | Parkside | Defect Chainage: | 144m |

The most significant defects observed are 2 areas of mortar loss and weathered stones on the roadside elevation at Windy Arbor Road (defects 27 and 34). A sizable void exists on the parkside elevation (defect 57) however this is located on the reduced height section of wall adjacent to the park entrance so is not considered as significant.

| Defect Type: | Void | | Severity: | Medium | |

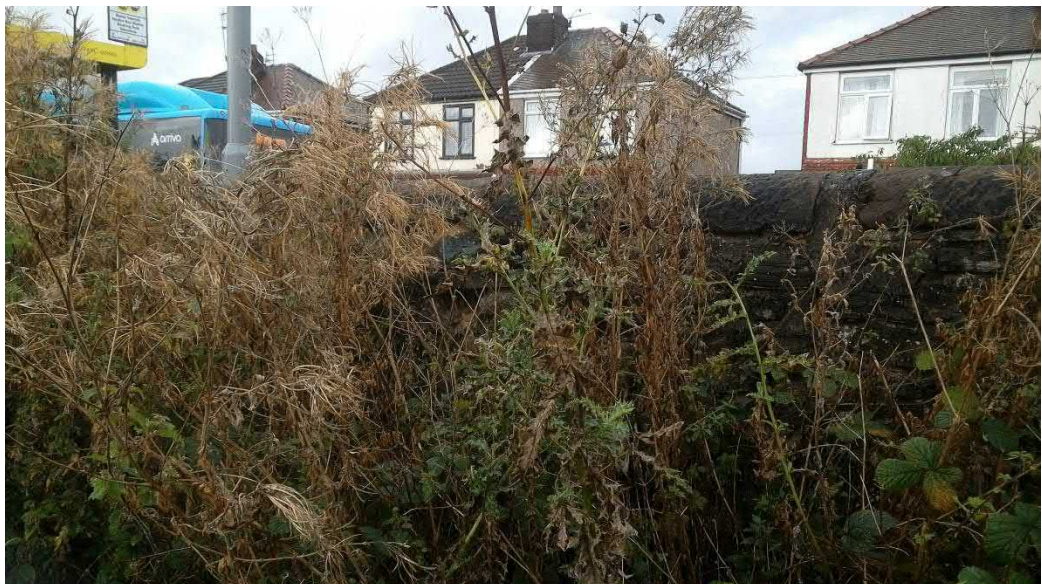
| Defect No: | 0058 | Elevation: | Parkside | Defect Chainage: | 167m |

| Defect Type: | Mortar Failure | | Severity: | Low | |

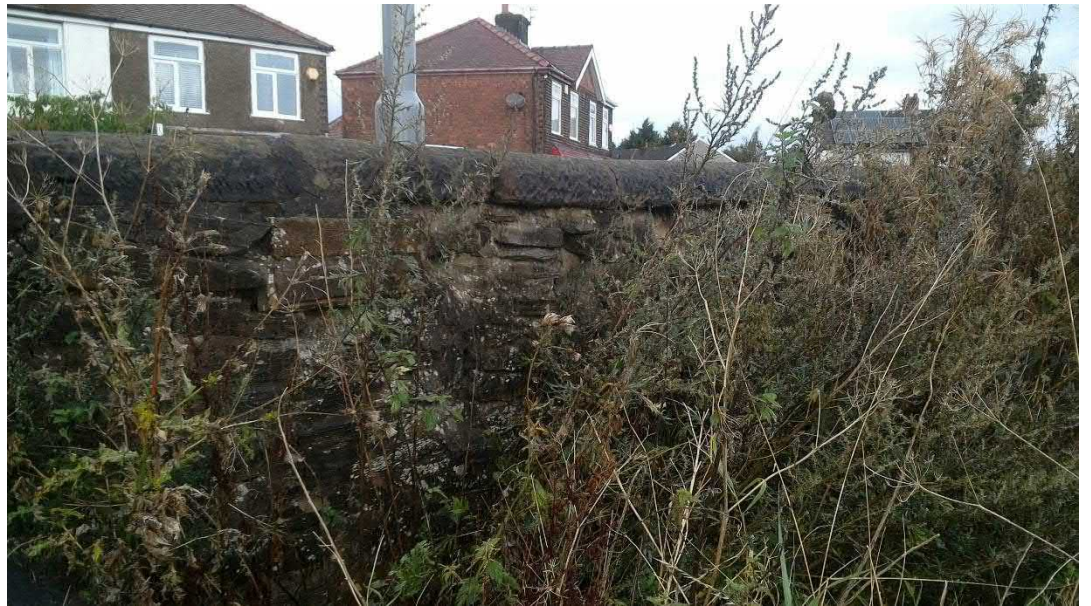
| Defect No: | 0059 | Elevation: | Parkside | Defect Chainage: | 199m |

| Defect Type: | Mortar Failure | | Severity: | Low | |

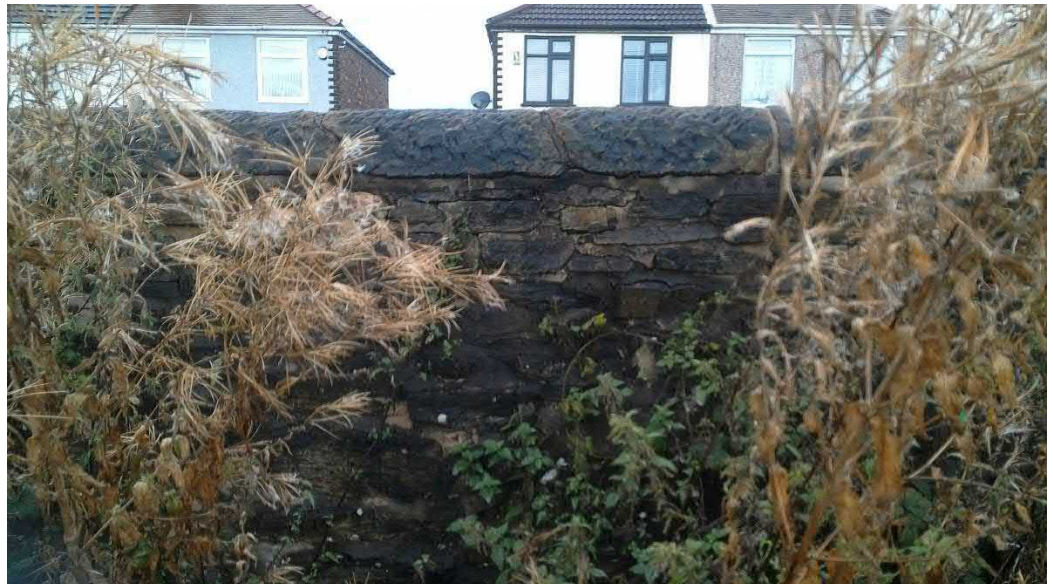
| Defect No: | 0060 | Elevation: | Parkside | Defect Chainage: | 208m |

| Defect Type: | Mortar Failure | | Severity: | Low | |

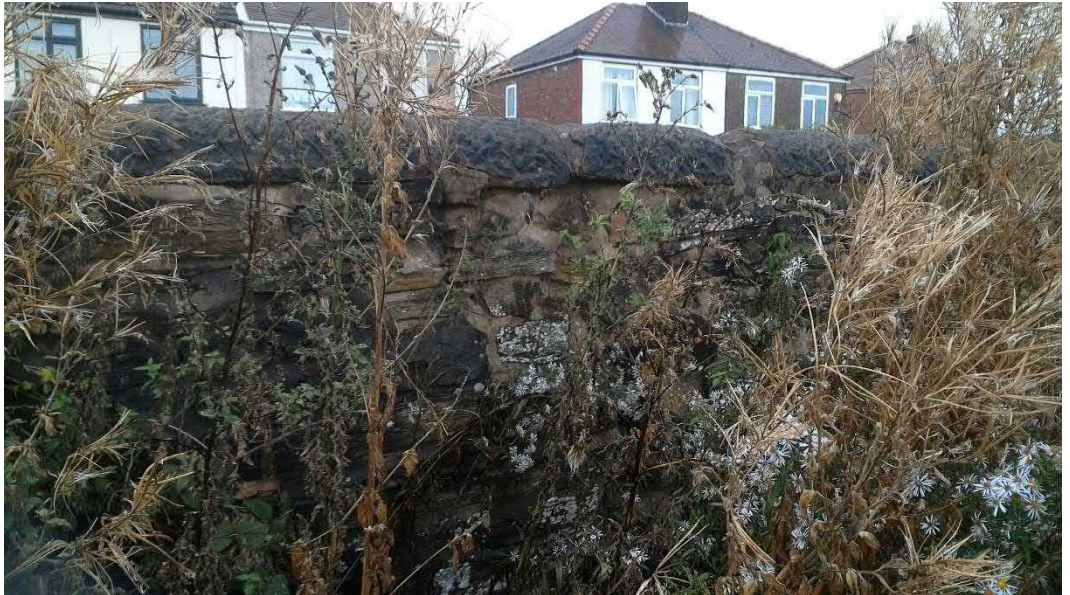
| Defect No: | 0061 | Elevation: | Parkside | Defect Chainage: | 217m |

| Defect Type: | Mortar Failure | | Severity: | Low | |

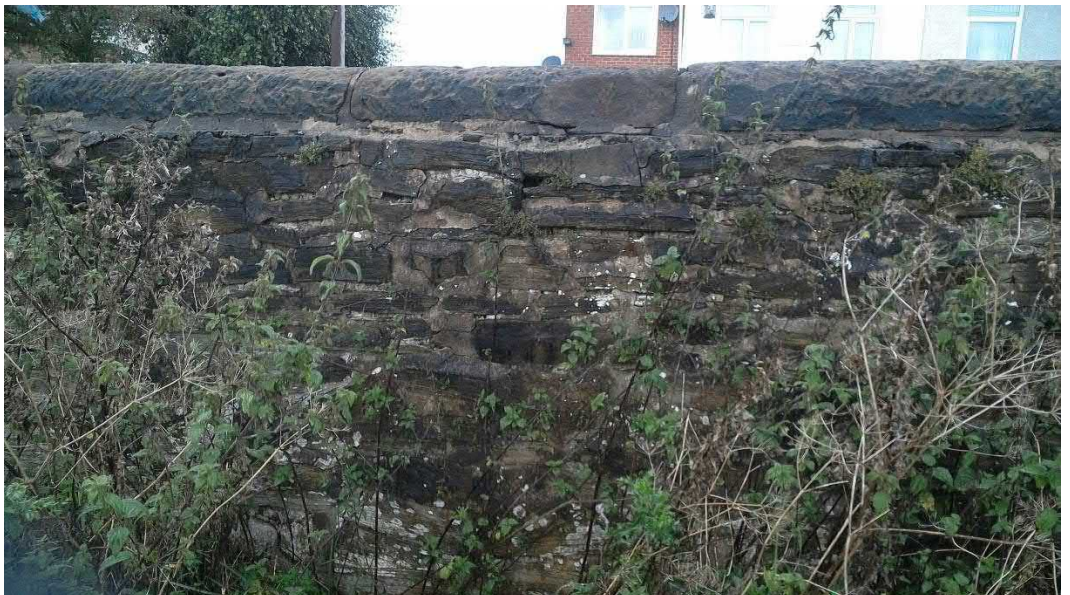
| Defect No: | 0062 | Elevation: | Parkside | Defect Chainage: | 228m |

| Defect Type: | Void | | Severity: | Low | |

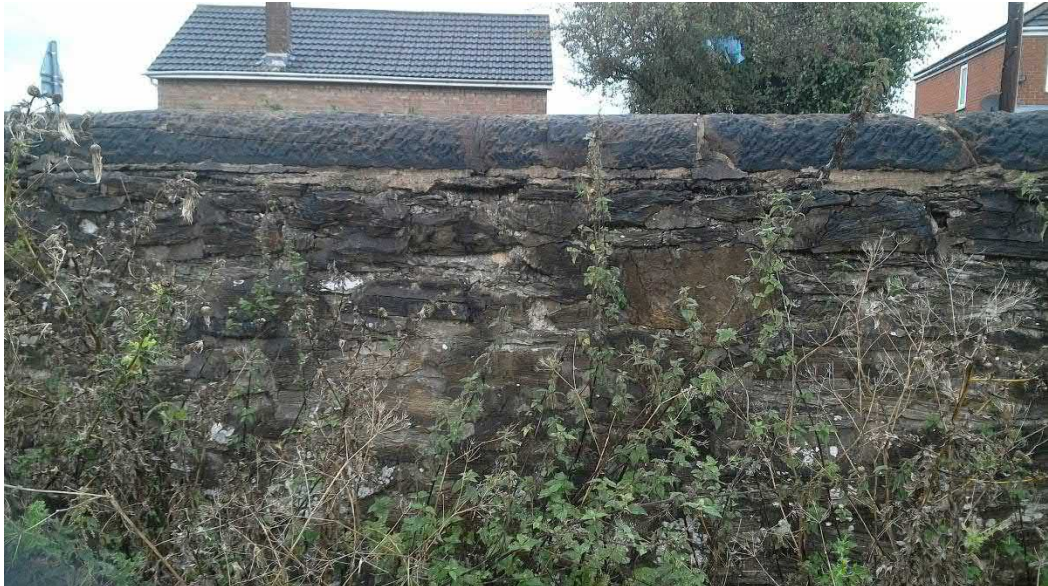
| Defect No: | 0063 | Elevation: | Parkside | Defect Chainage: | 240m |

| Defect Type: | Mortar Failure | | Severity: | Low | |

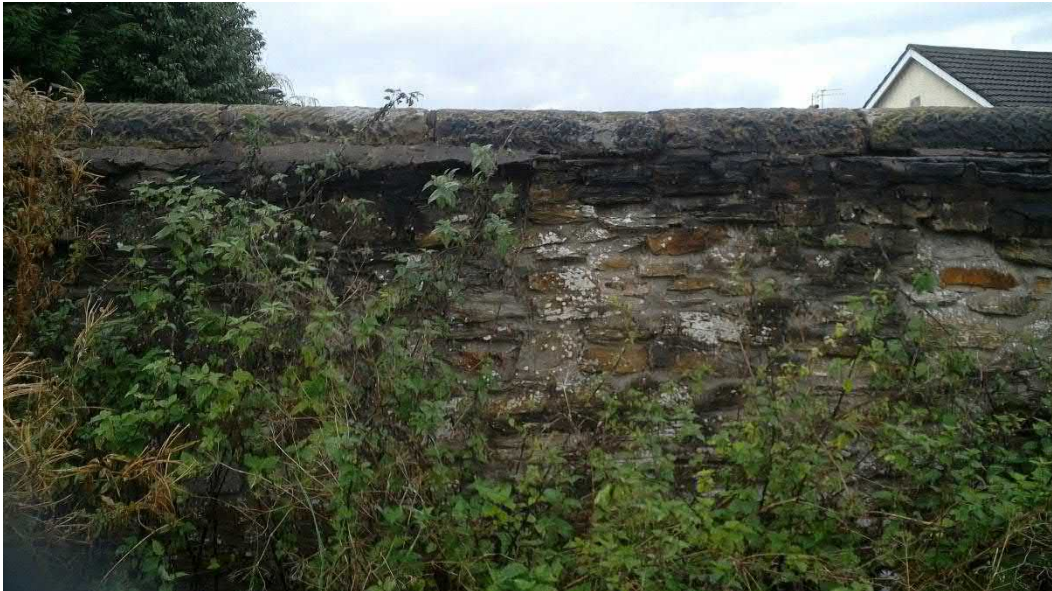
| Defect No: | 0064 | Elevation: | Parkside | Defect Chainage: | 249m |

| Defect Type: | Mortar Failure | | Severity: | Low | |

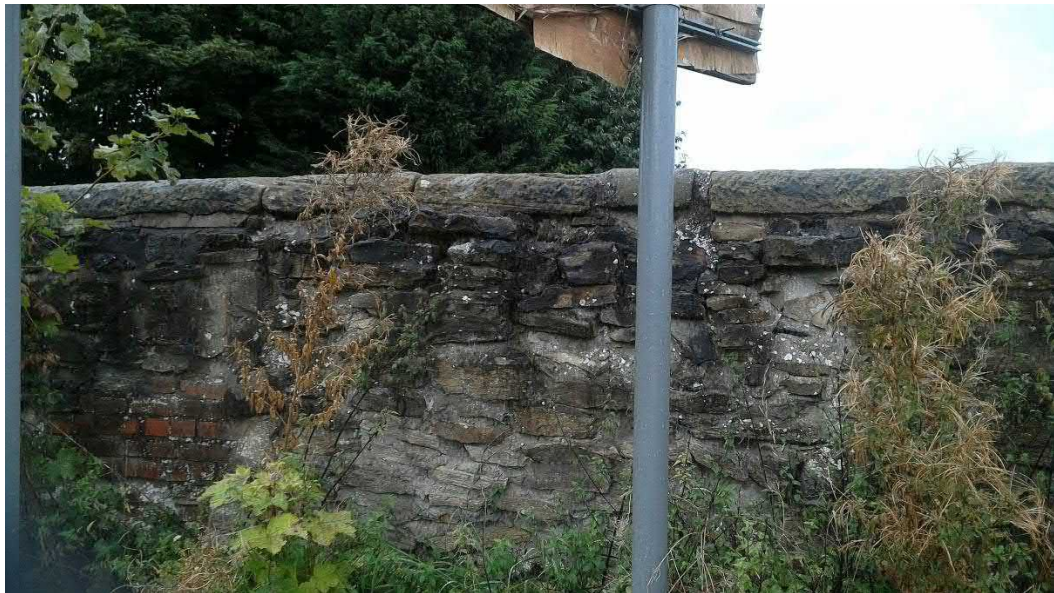
| Defect No: | 0065 | Elevation: | Parkside | Defect Chainage: | 260m |

| Defect Type: | Mortar Failure | | Severity: | Medium | |

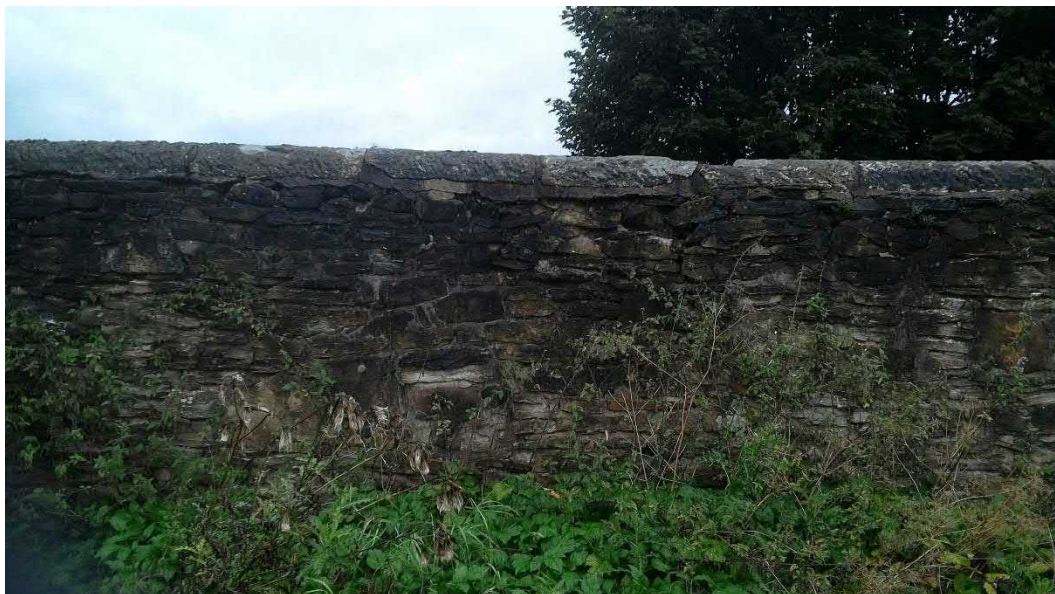
| Defect No: | 0066 | Elevation: | Parkside | Defect Chainage: | 270m |

| Defect Type: | Mortar Failure | | Severity: | Medium | |

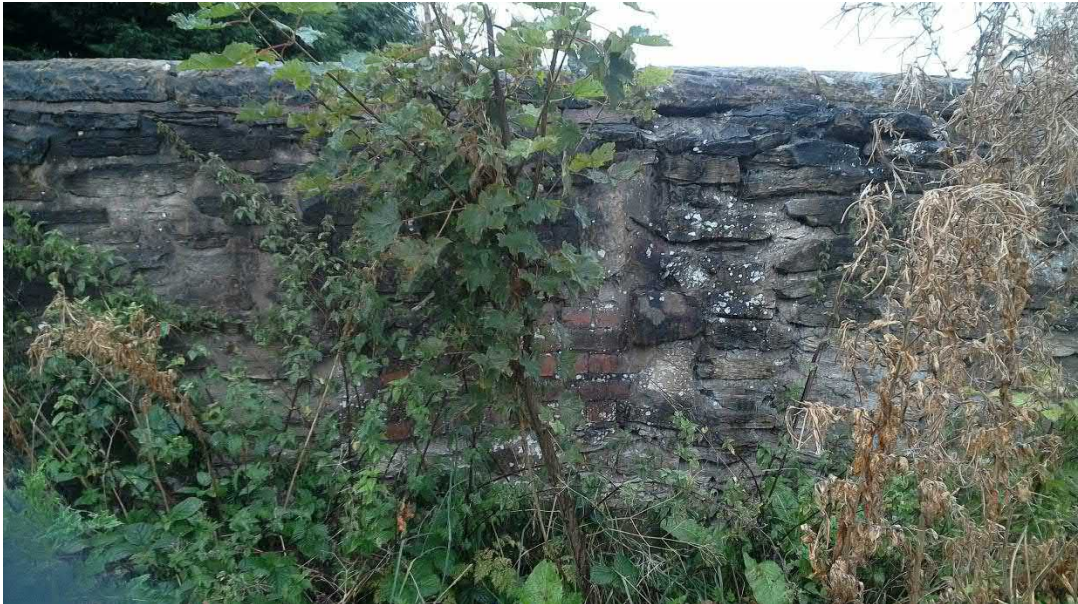
| Defect No: | 0067 | Elevation: | Parkside | Defect Chainage: | 273m |

| Defect Type: | Mortar Failure | | Severity: | Low | |

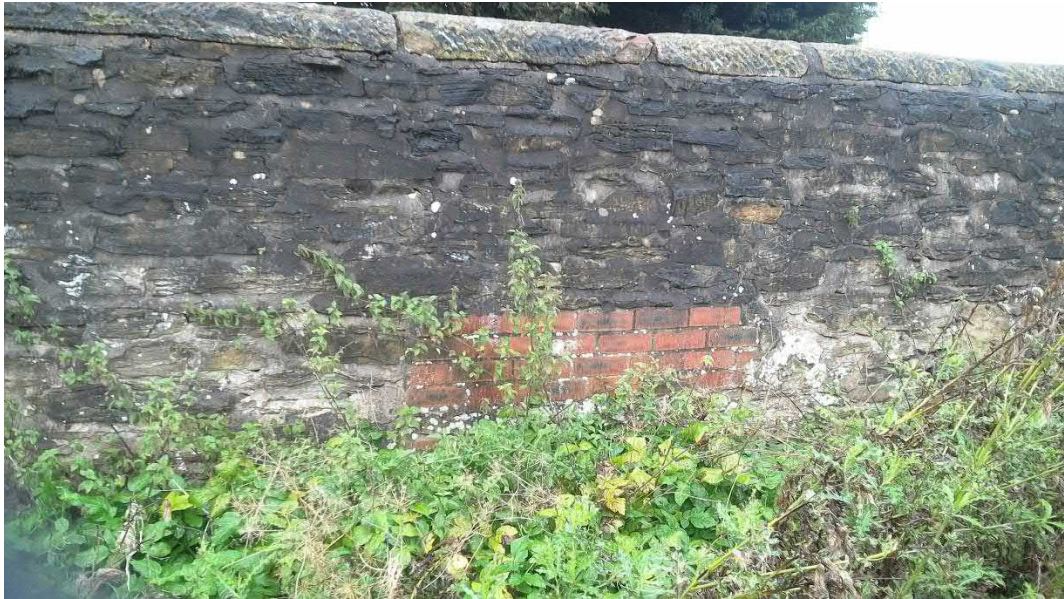
| Defect Type: | Brickwork Repair | | Severity: | Low | |

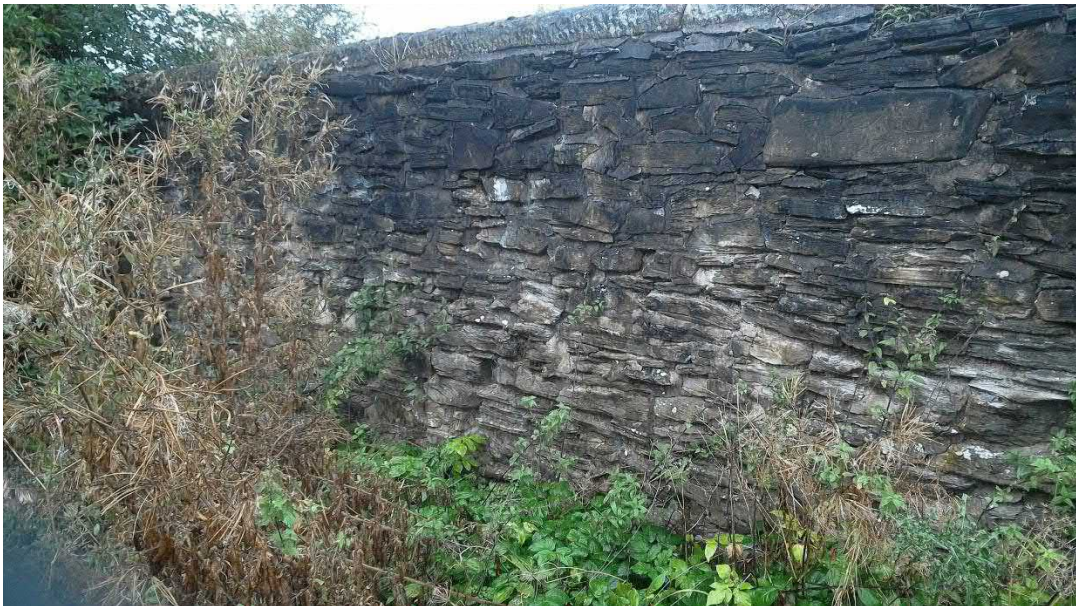
| Defect No: | 0069 | Elevation: | Parkside | Defect Chainage: | 283m |

| Defect Type: | Mortar Failure | | Severity: | Low | |
