## Phase IV Validation Completion Report

The Dales Bar  
Okell Drive  
Halewood  
L26 7XB

Reference: 34357-SUT-ZZ-00-RP-G-7401

Date: May 2026

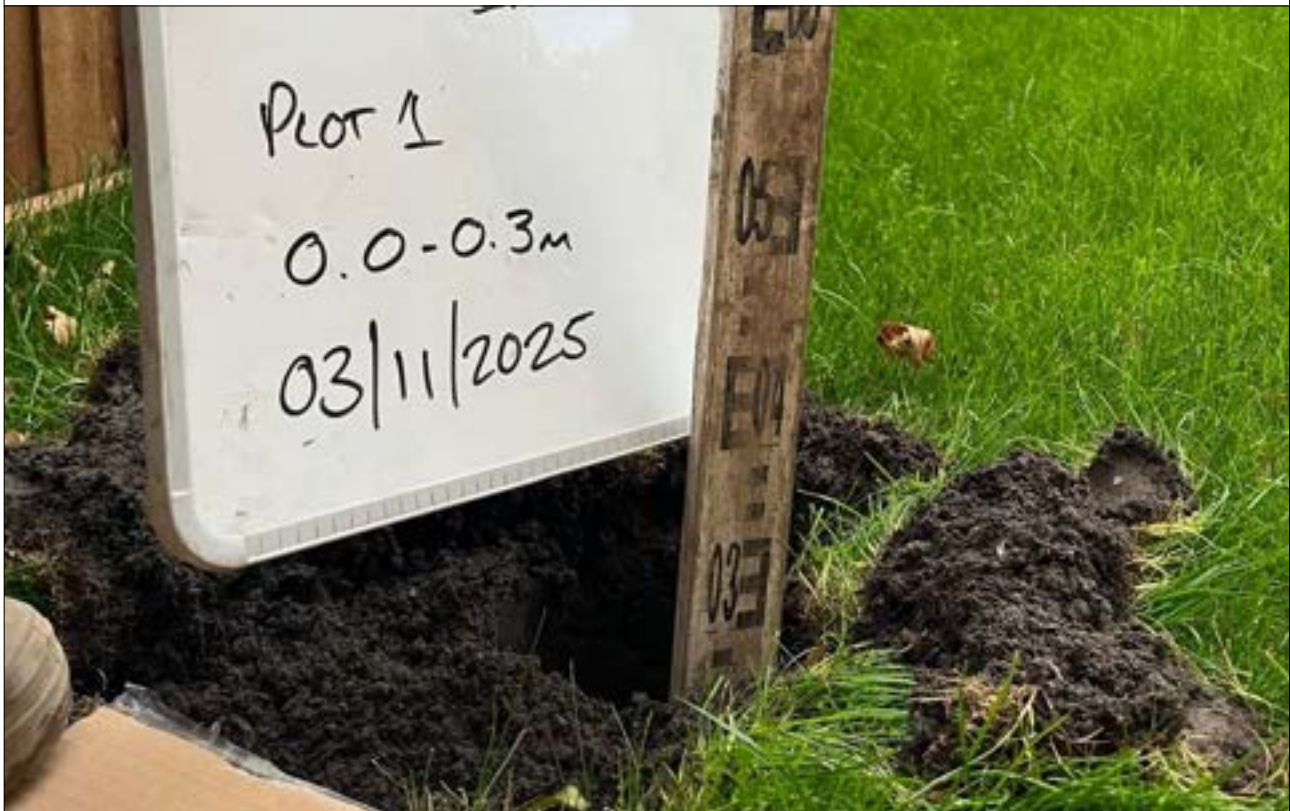
*Plate 1: Plot 1—General location*

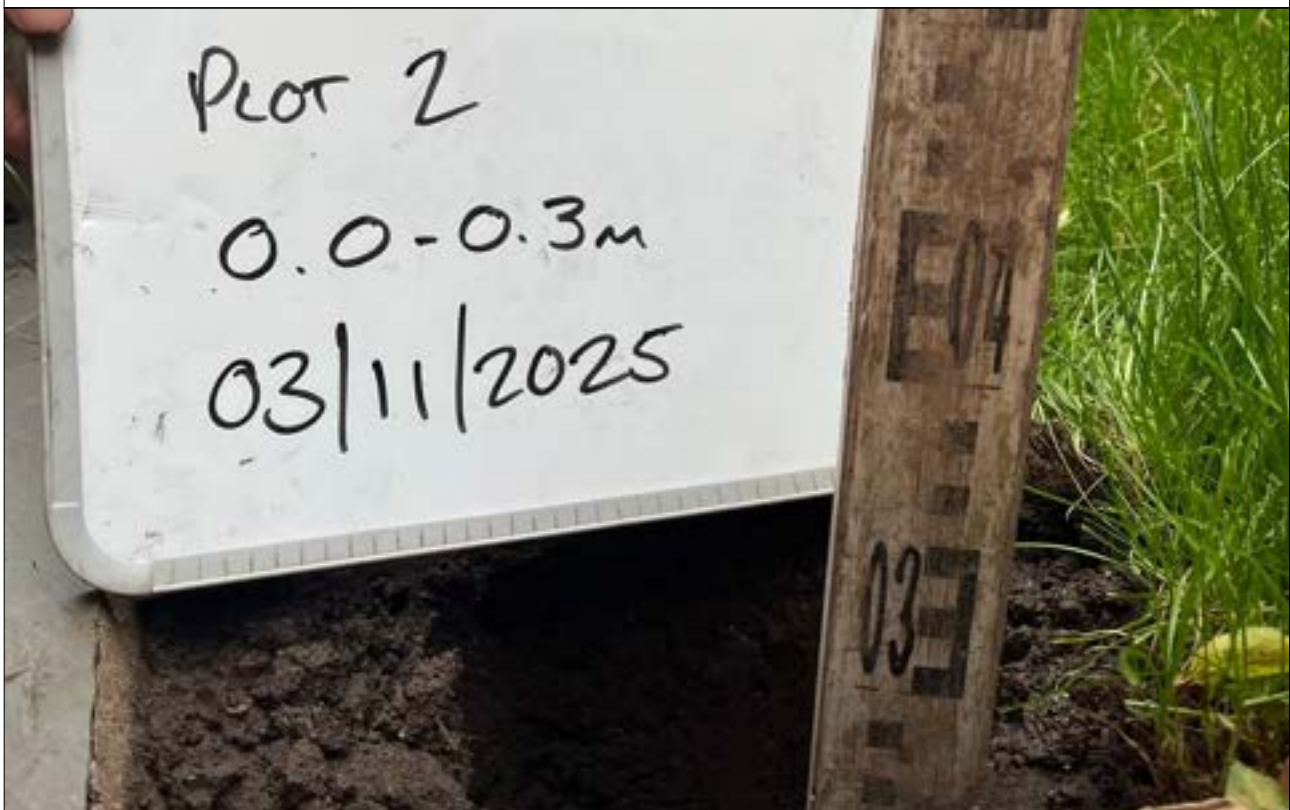
*Plate 2: Plot 2—General location*

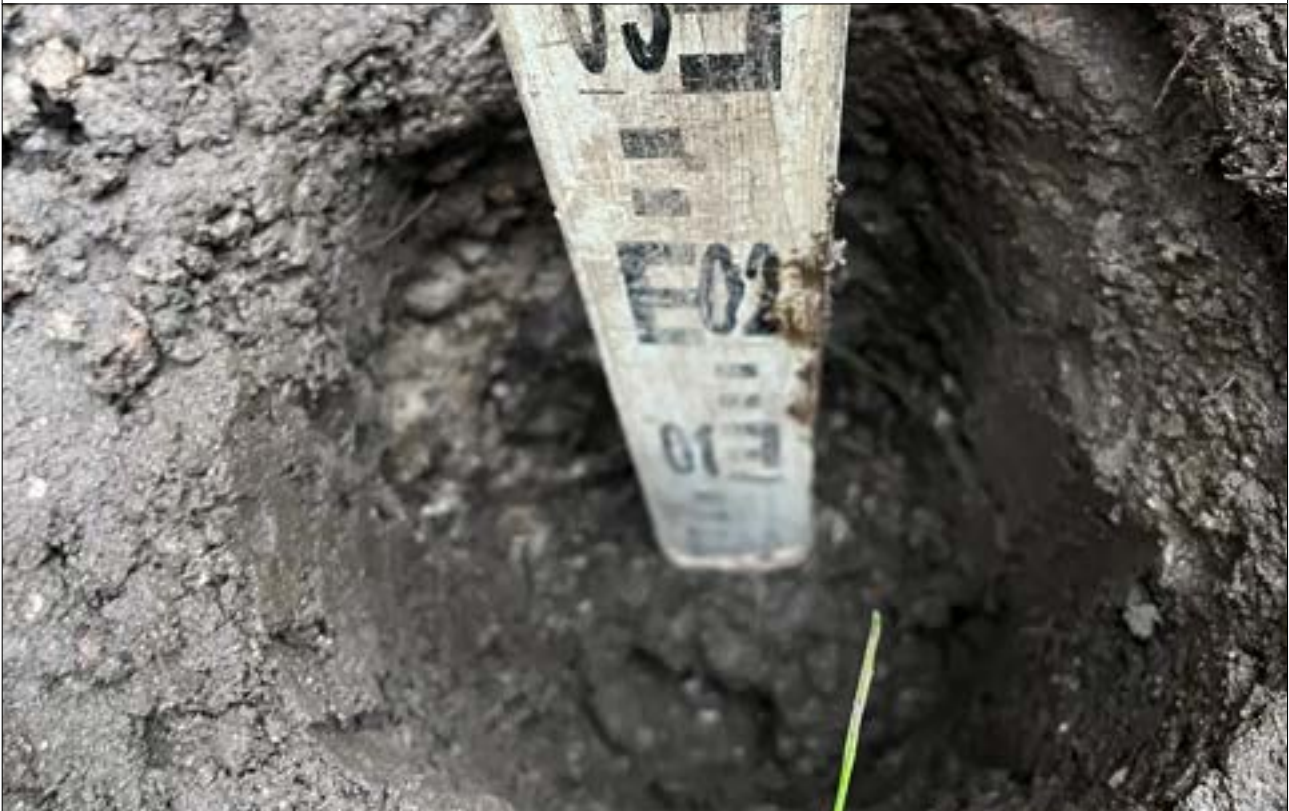
*Plate 3: Plot 2—Down Hole*

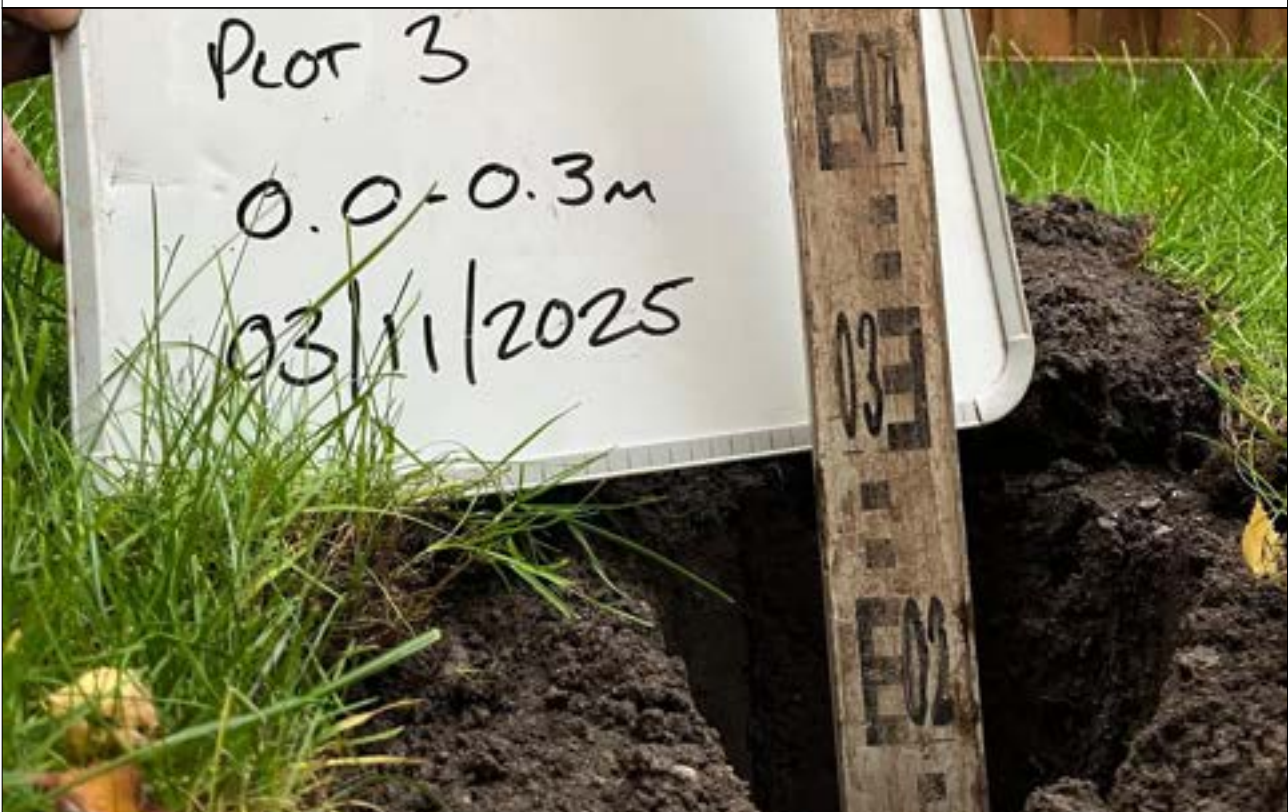
*Plate 4: Plot 3 —General location*

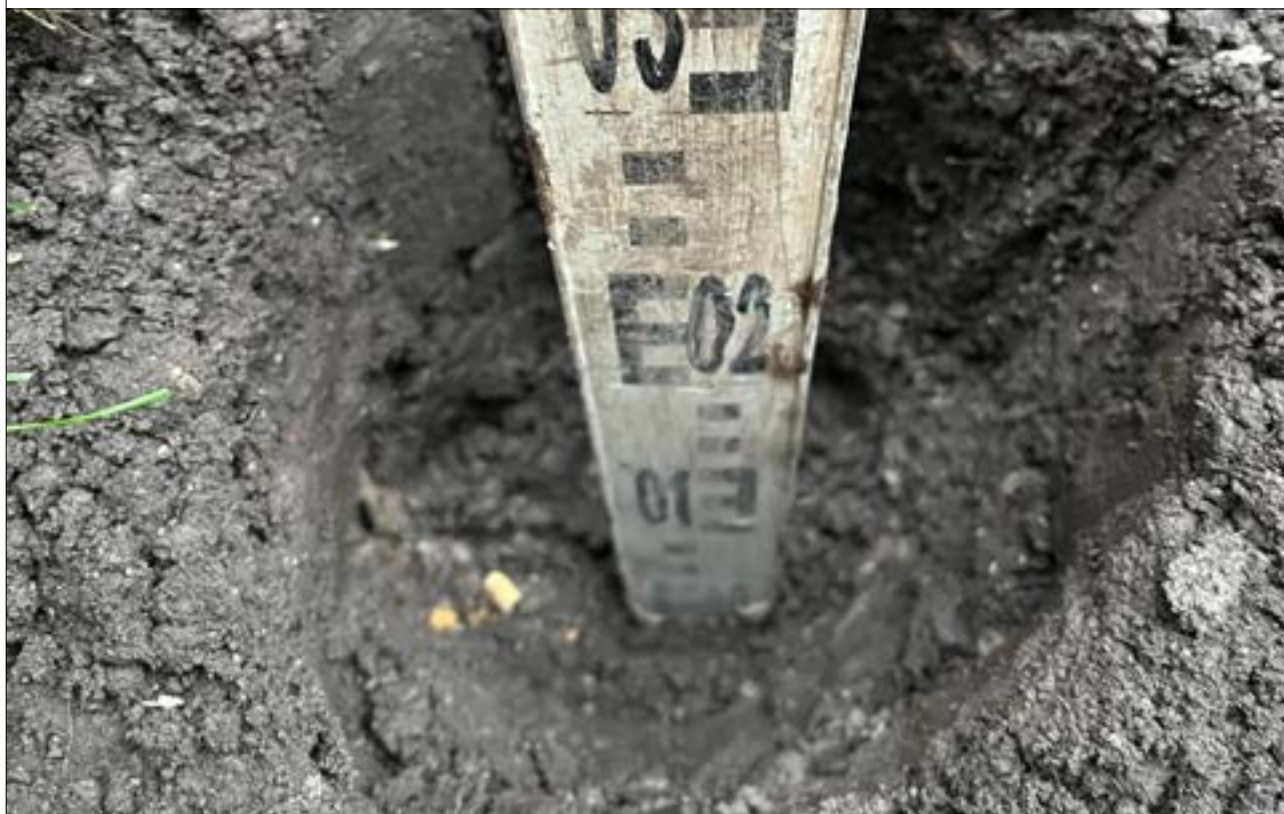
*Plate 5: Plot 3—Down Hole*

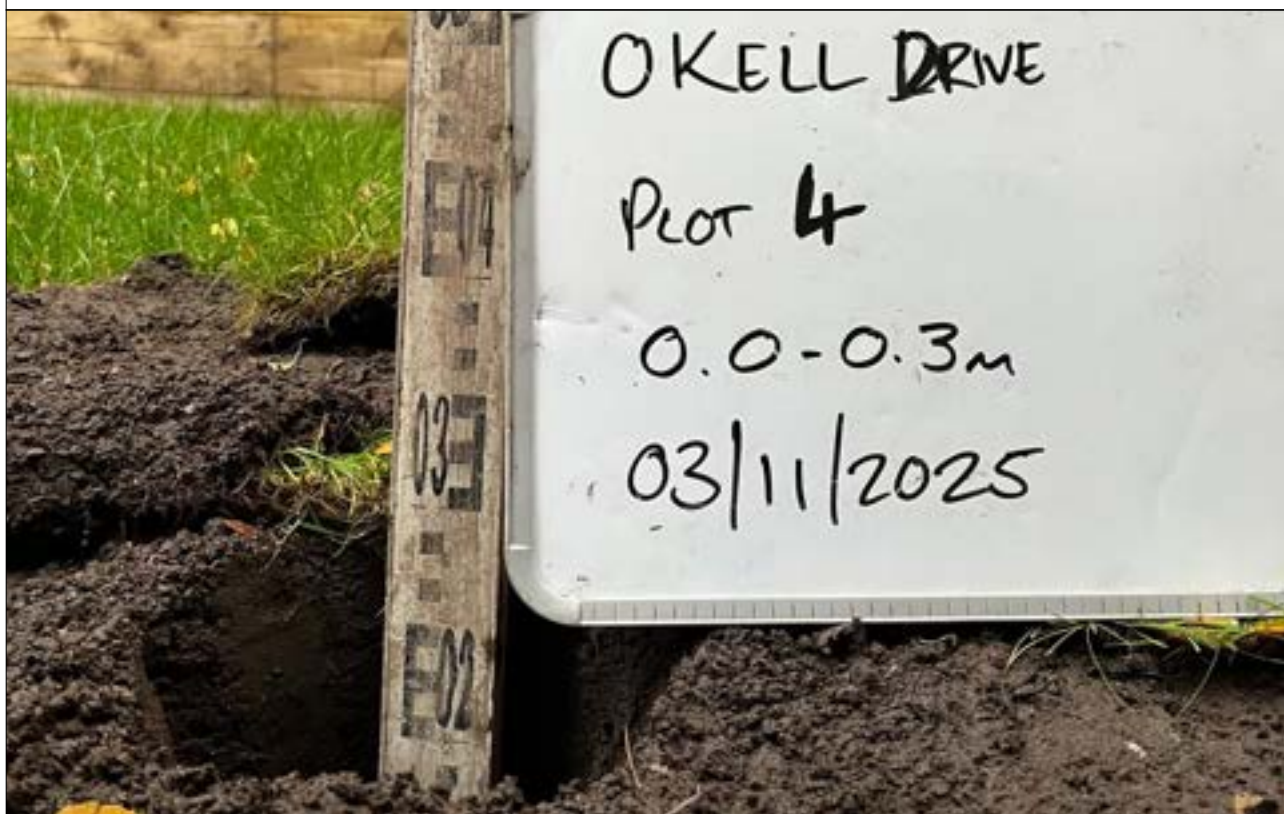
*Plate 6: Plot 4 —General location*

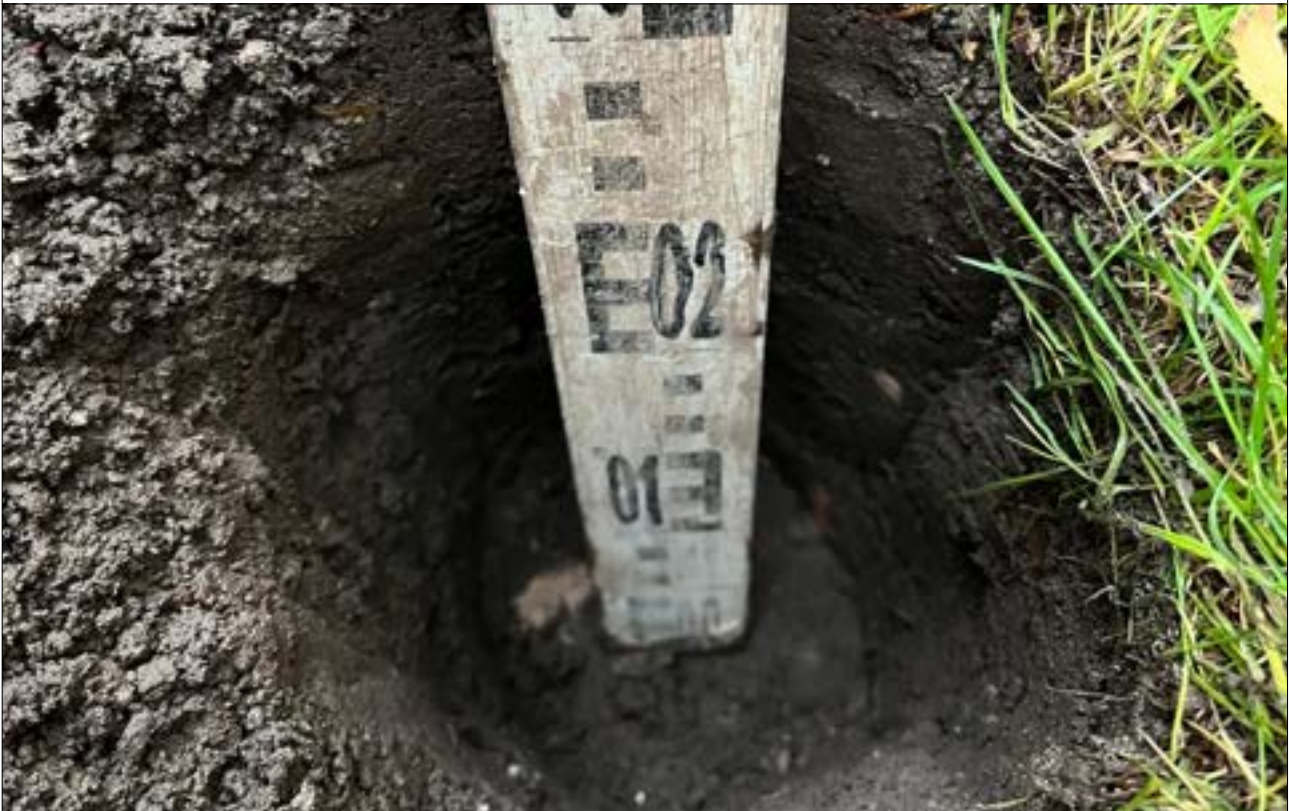
***Plate 7: Plot 4—Down Hole***

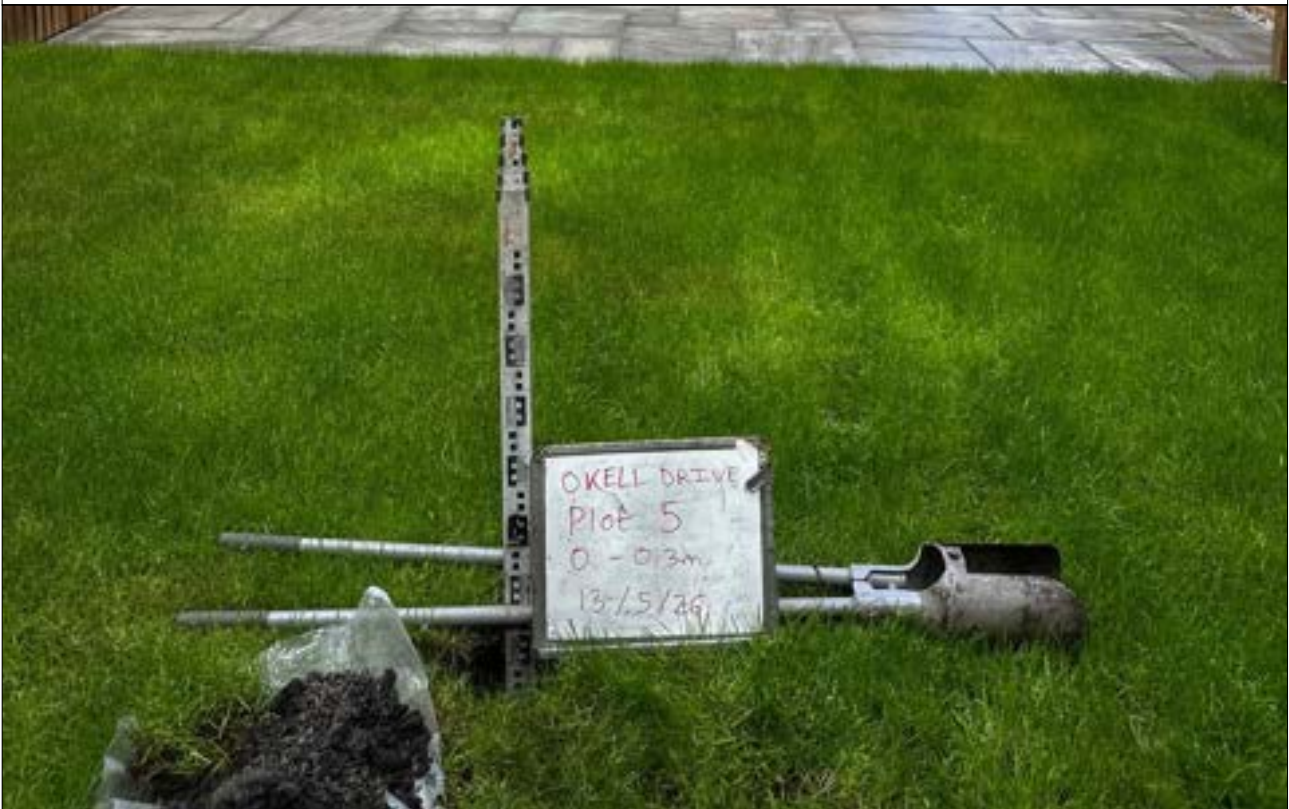
***Plate 8: Plot 5 —General location***

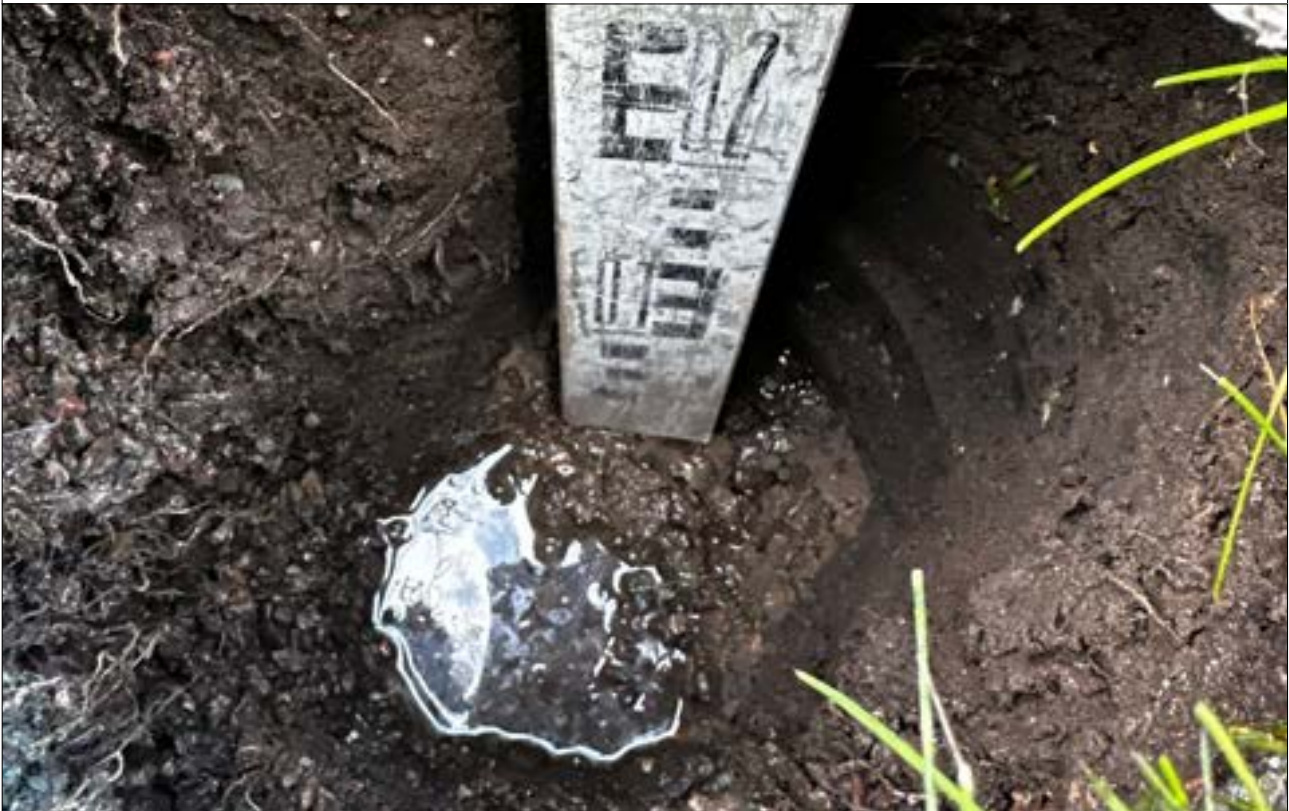
**Plate 9: Plot 5—Down Hole**

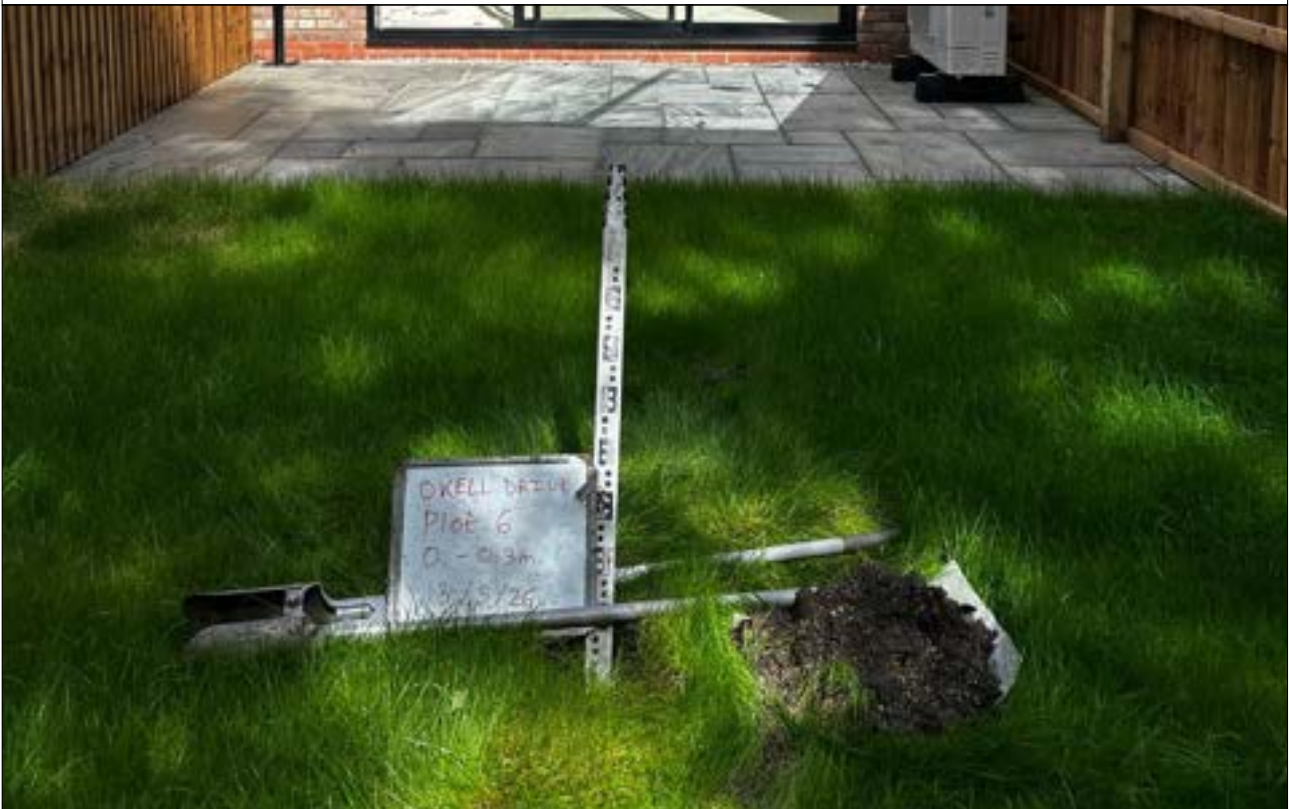
**Plate 10: Plot 6 —General location**

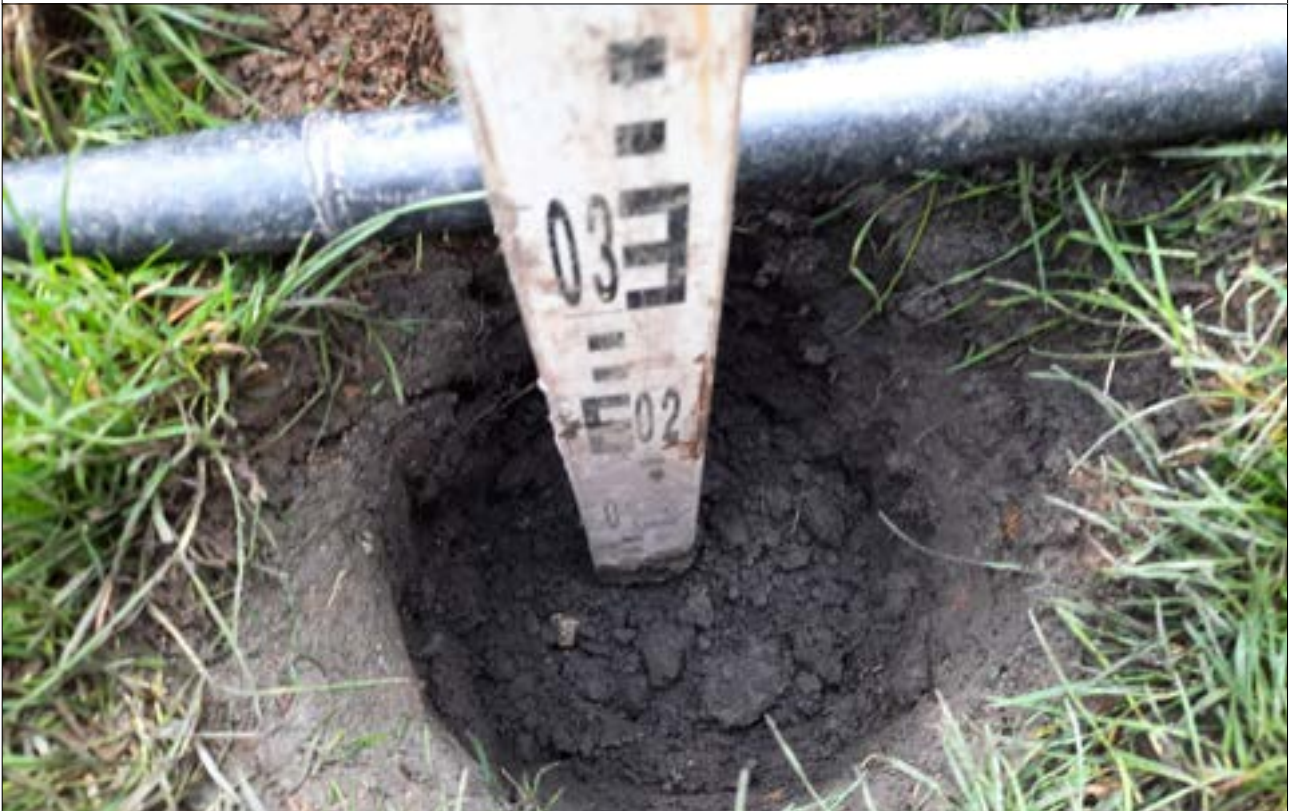
**Plate 11: Plot 6—Down Hole**

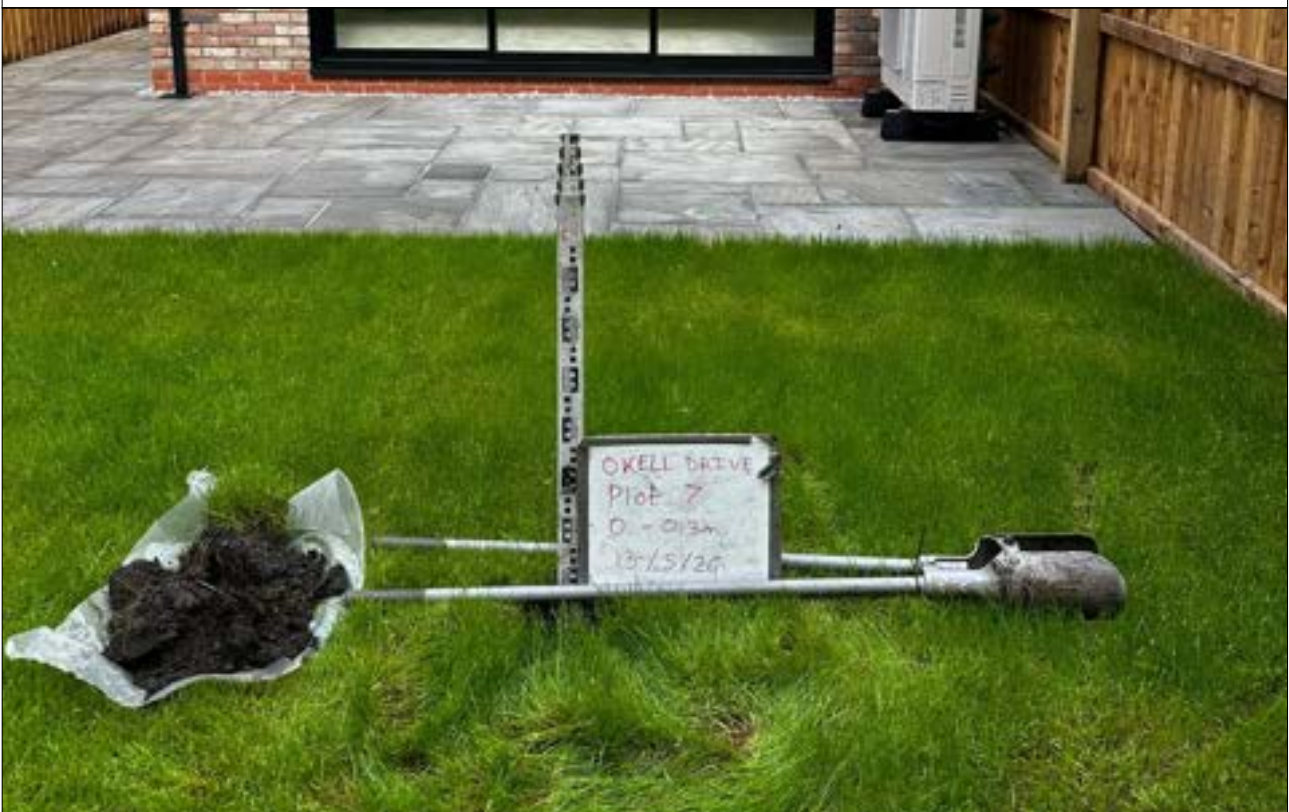
**Plate 12: Plot 7—General location**

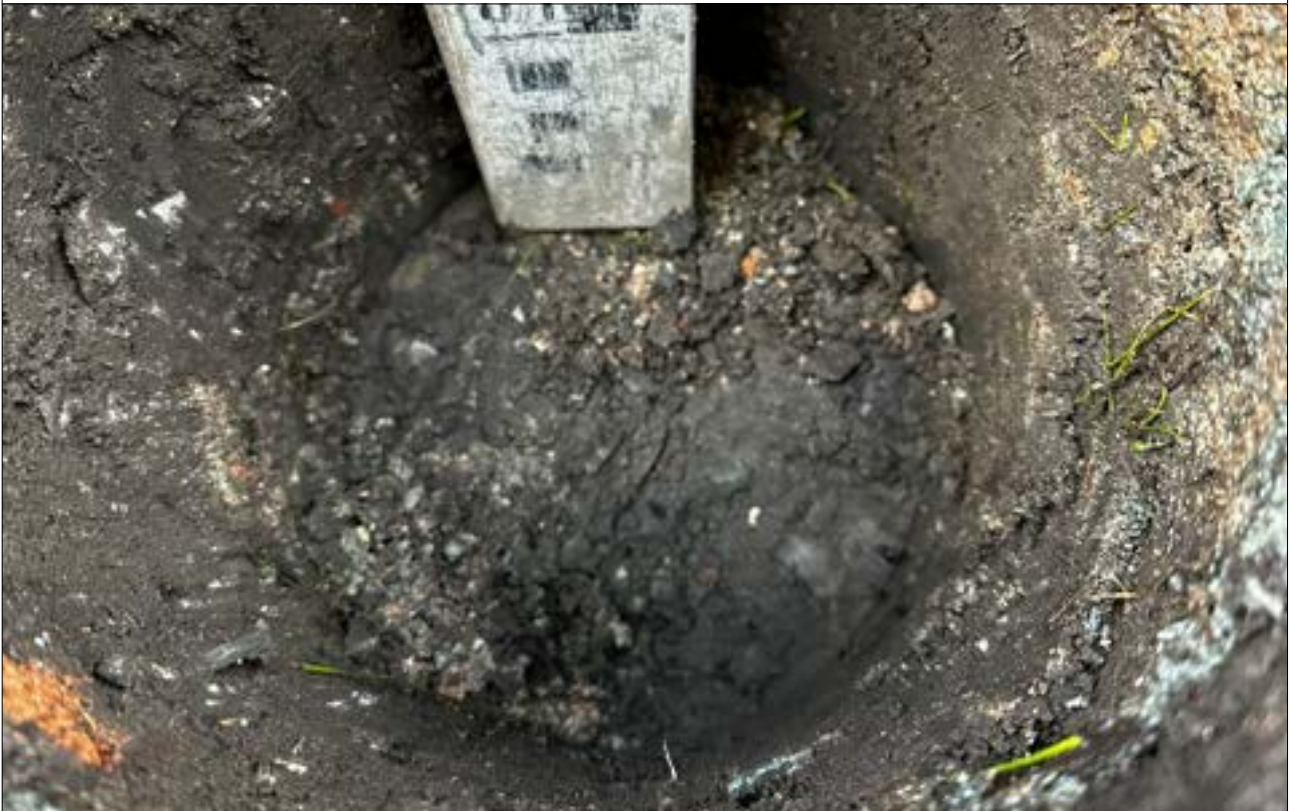
**Plate 13: Plot 7—Down Hole**

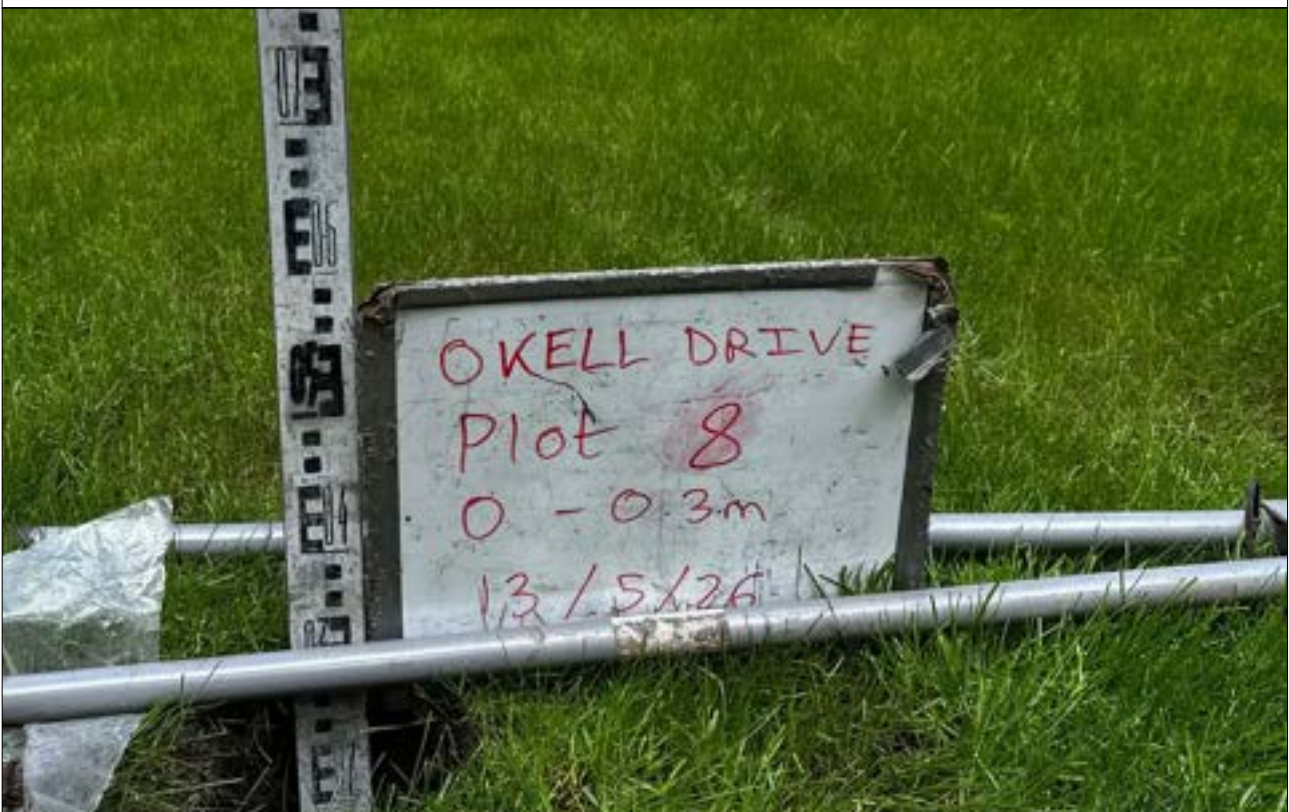
**Plate 14: Plot 8—General location**

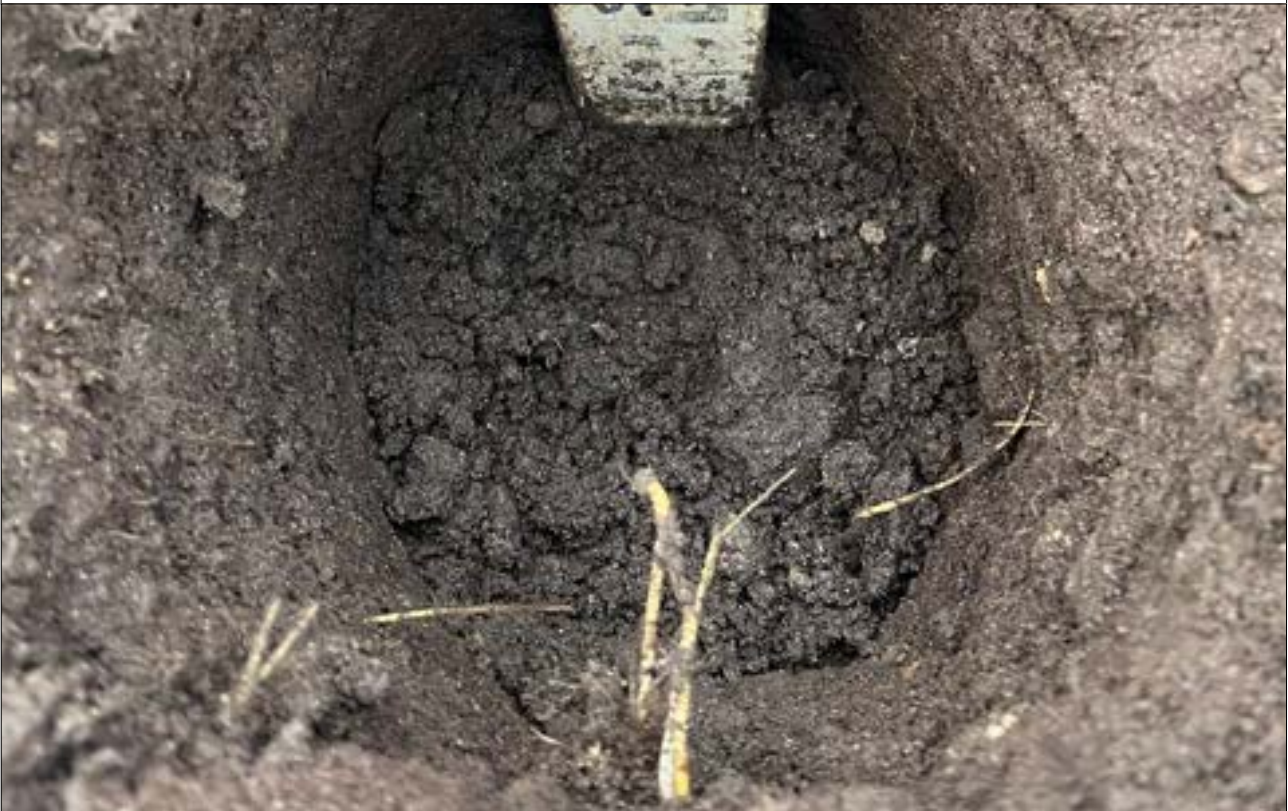
***Plate 15: Plot 8—Down Hole***

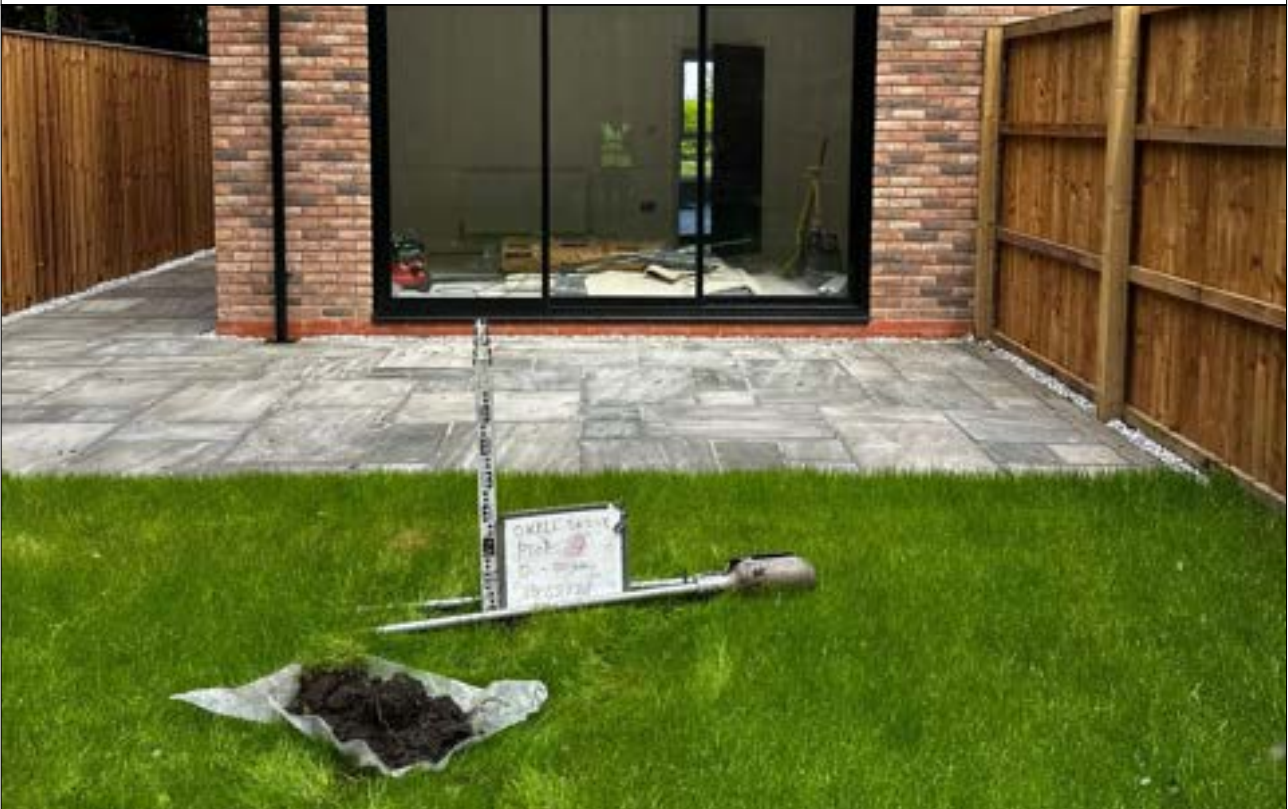
***Plate 16: Plot 9—General location***

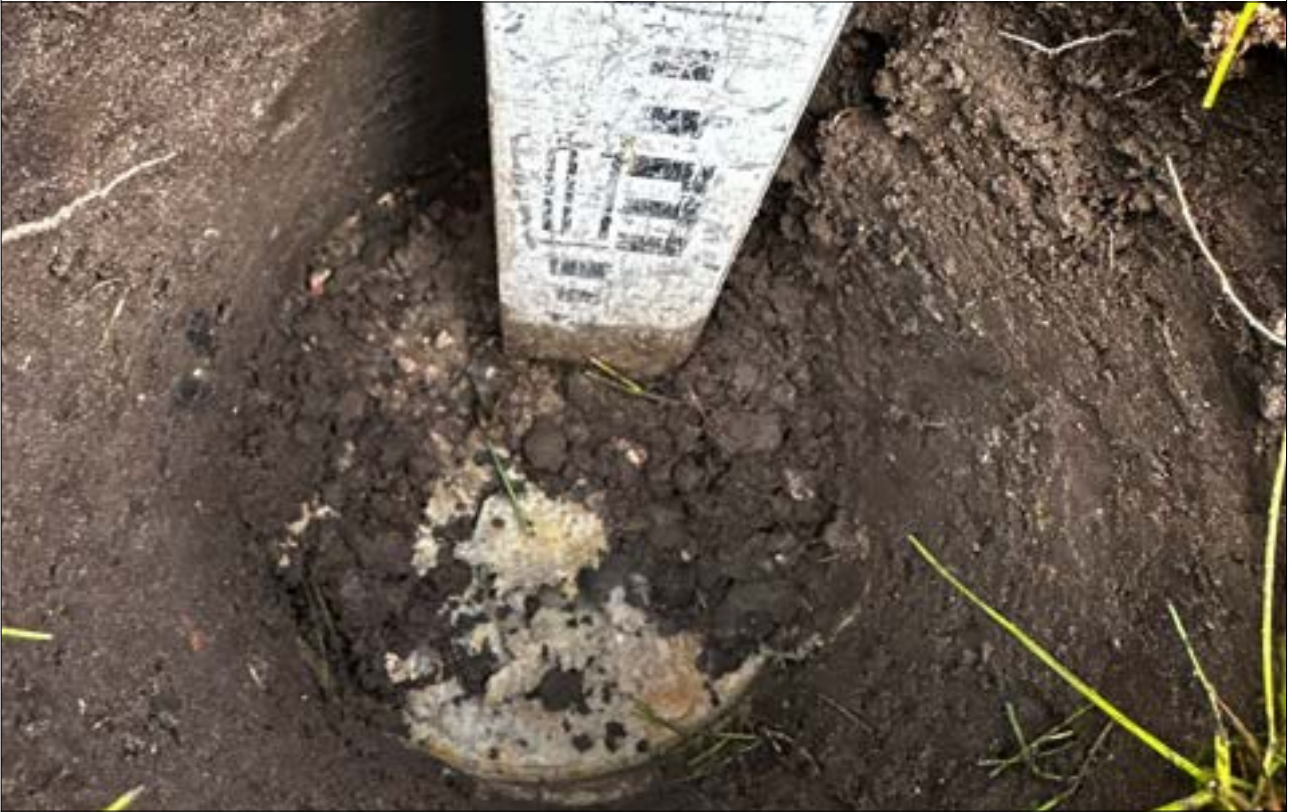
*Plate 17: Plot 9—Down Hole*
