## Phase IV Validation Completion Report

The Dales Bar  
Okell Drive  
Halewood  
L26 7XB

Reference: 34357-SUT-ZZ-00-RP-G-7401

Date: May 2026

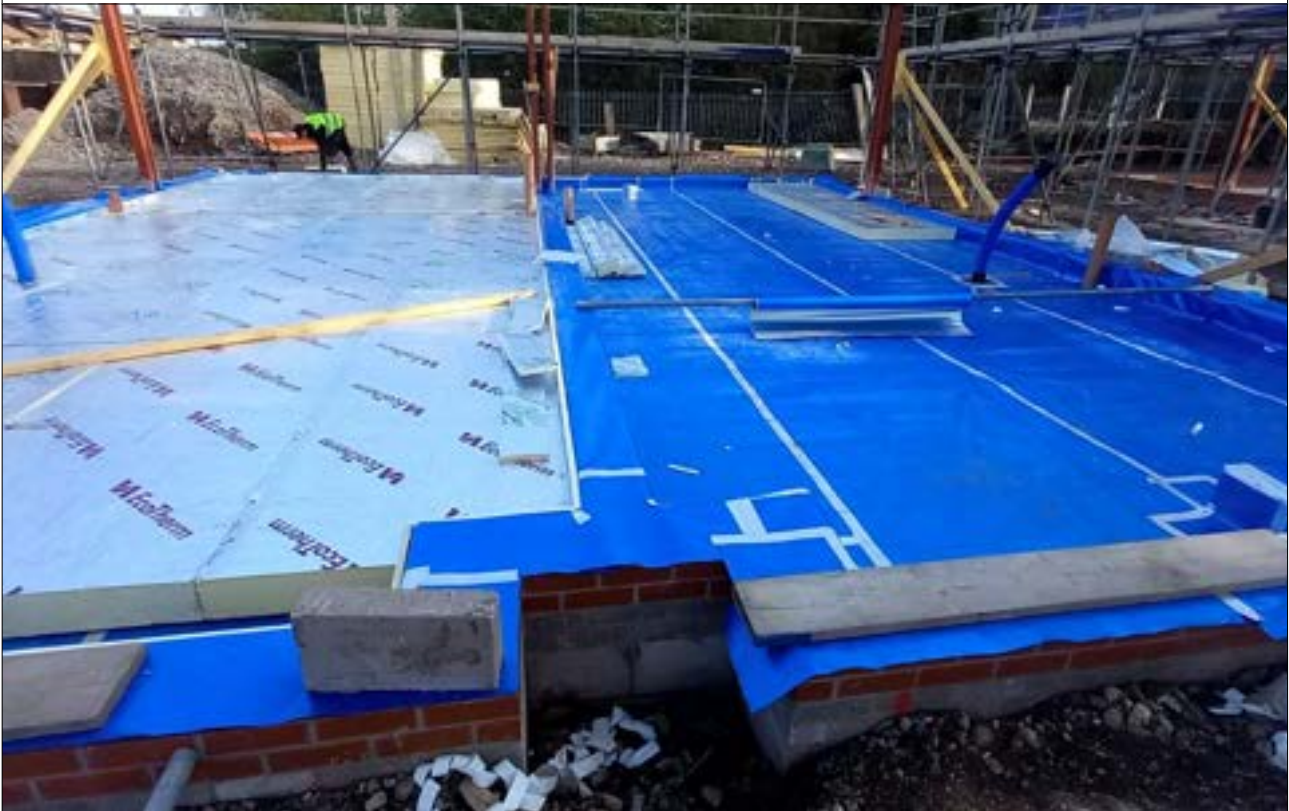
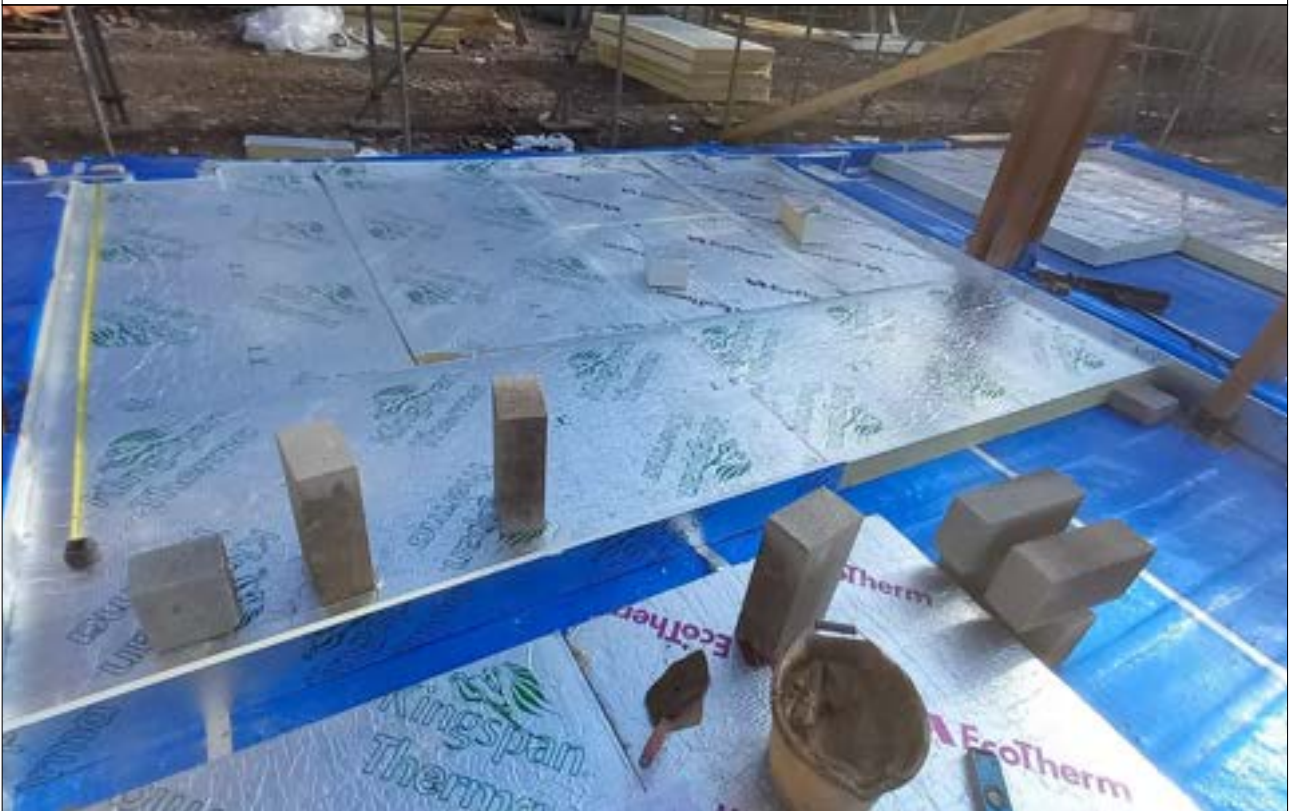
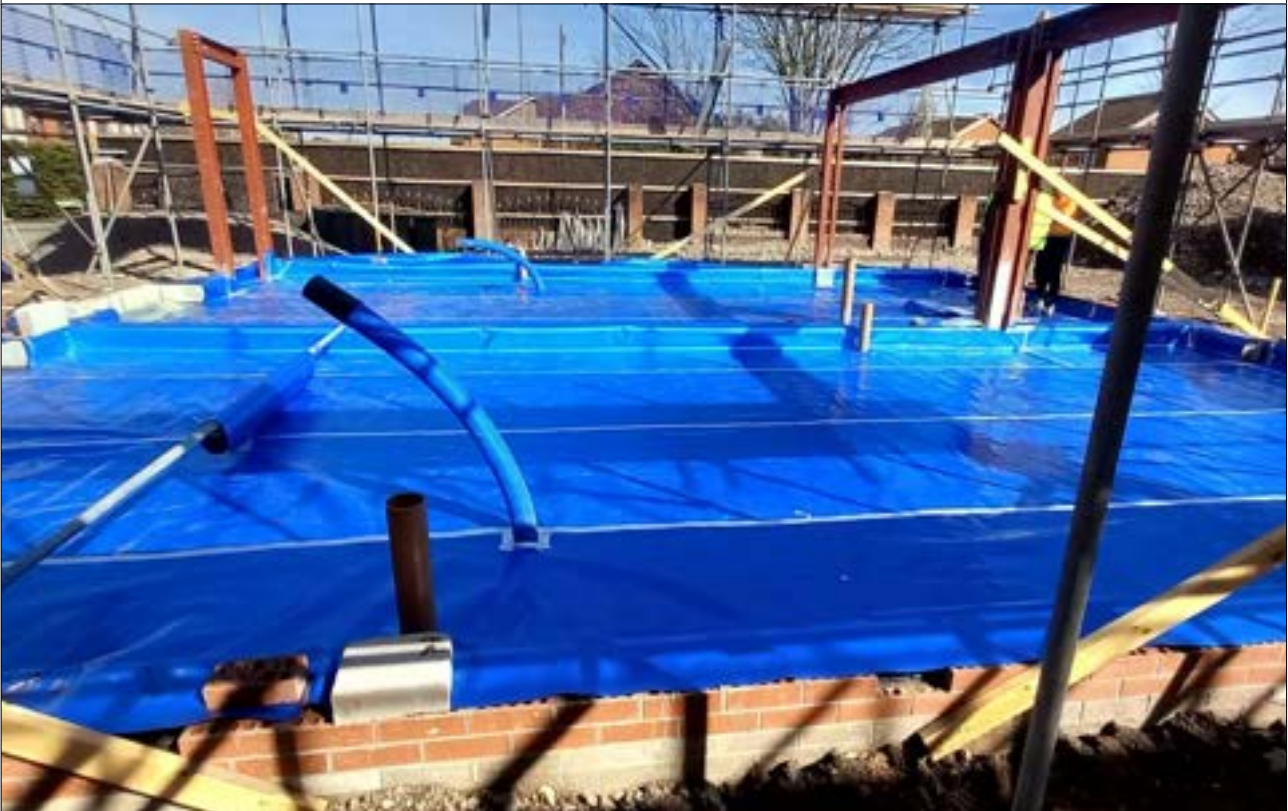
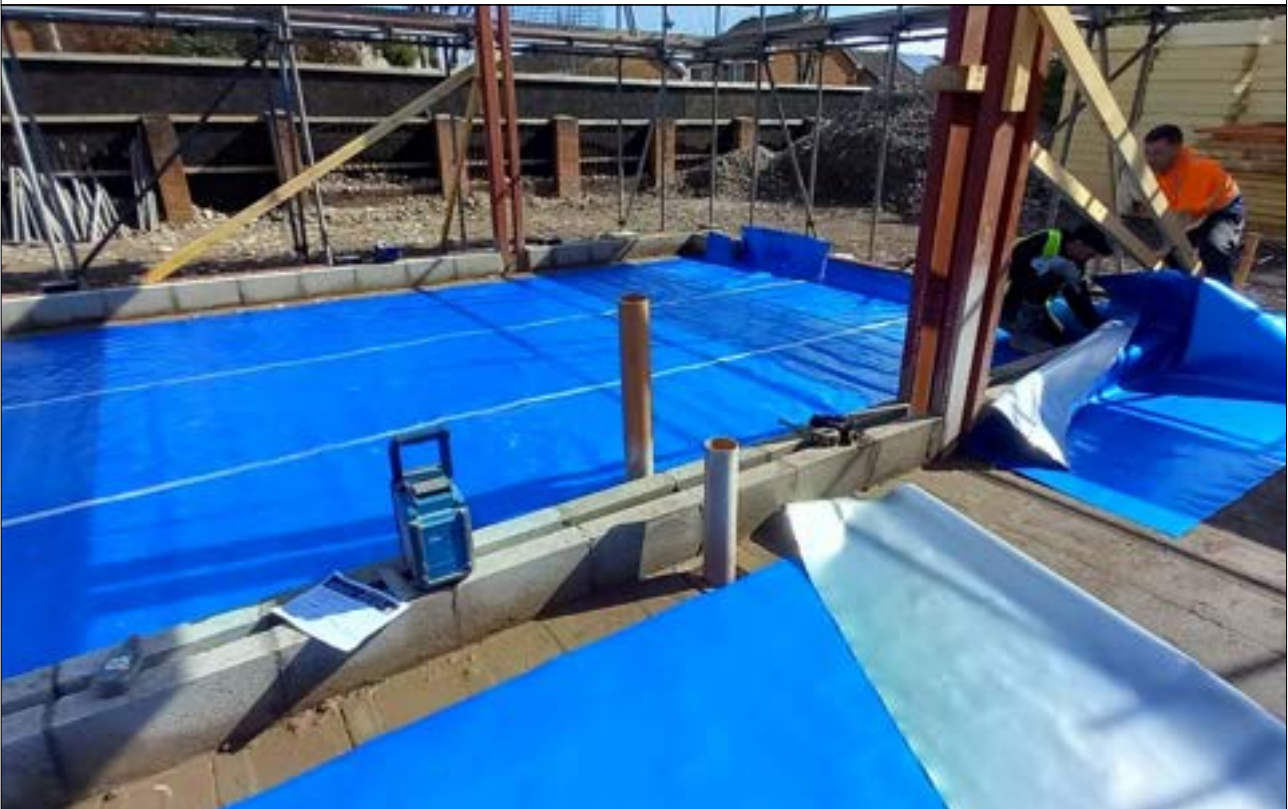
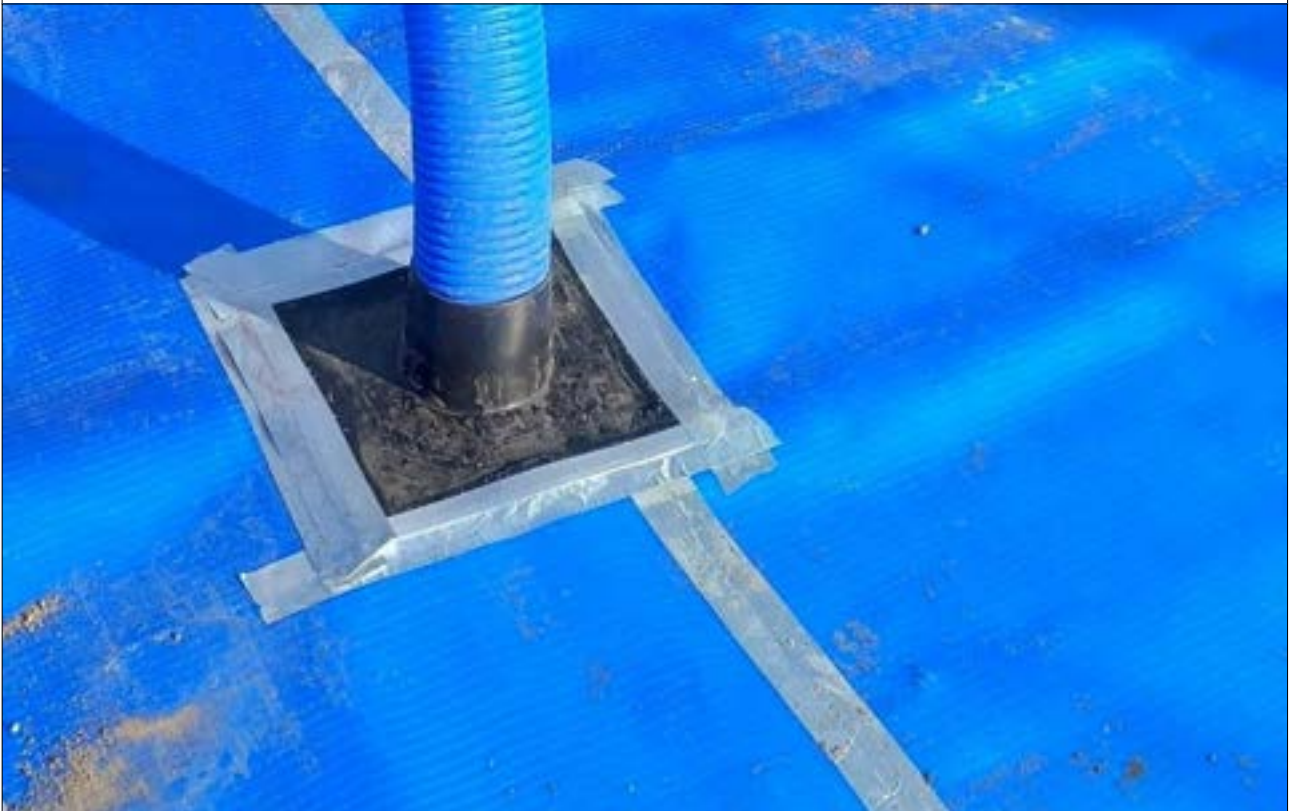
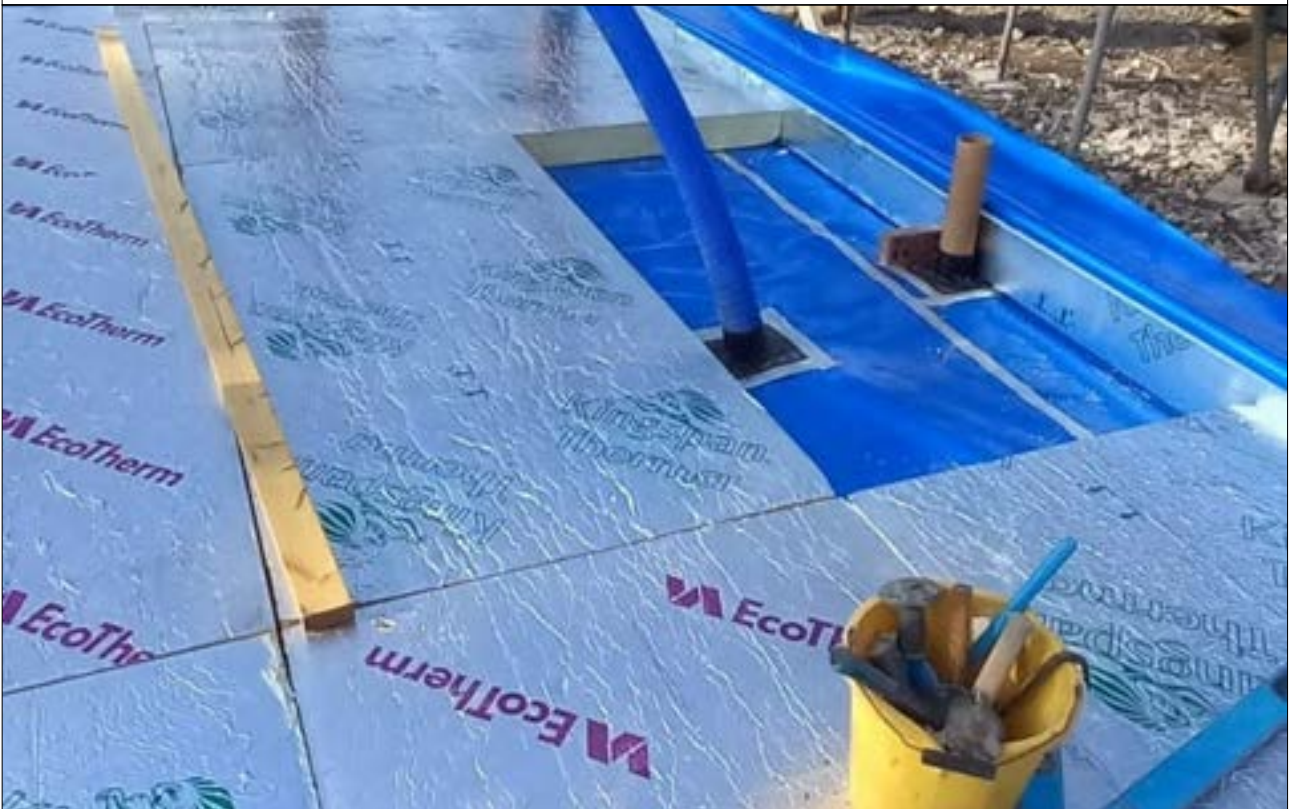
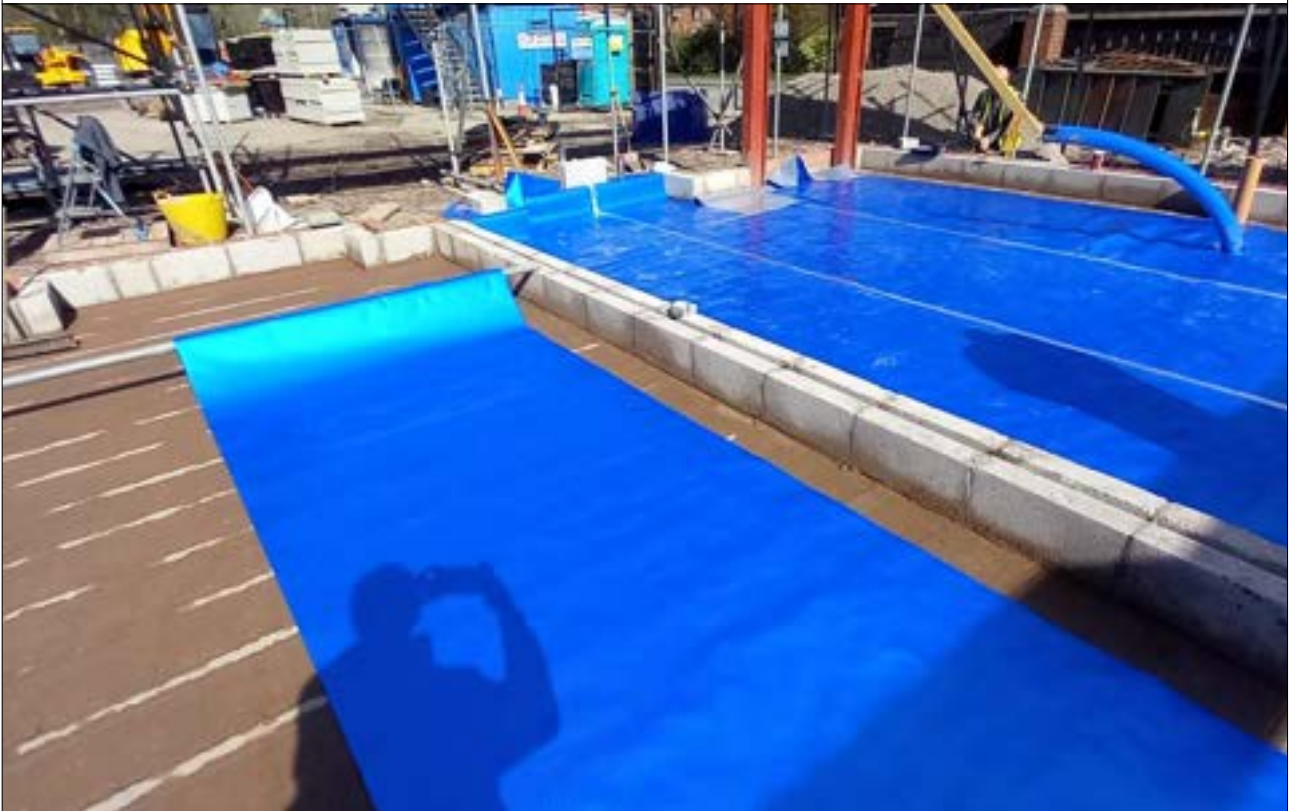
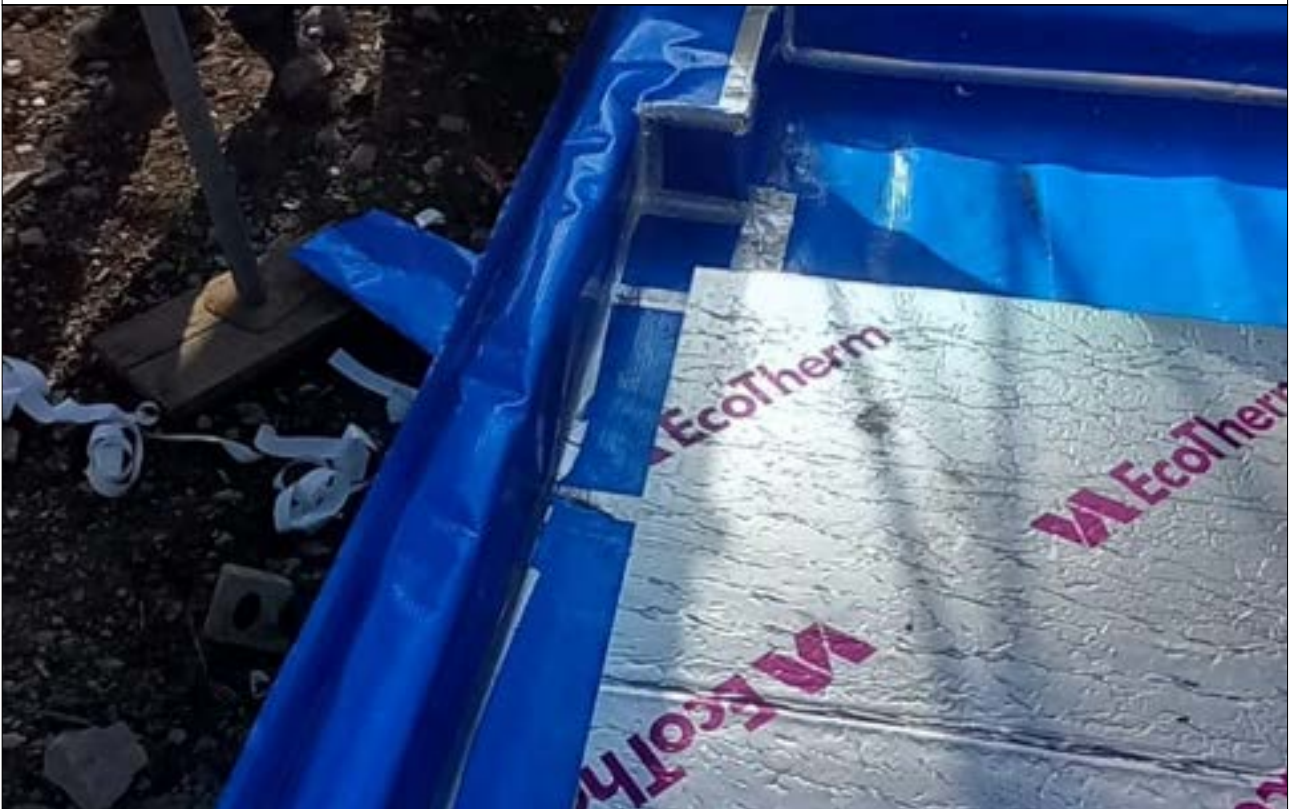
Plate 1: Plots 1 & 2 gas membrane general condition.

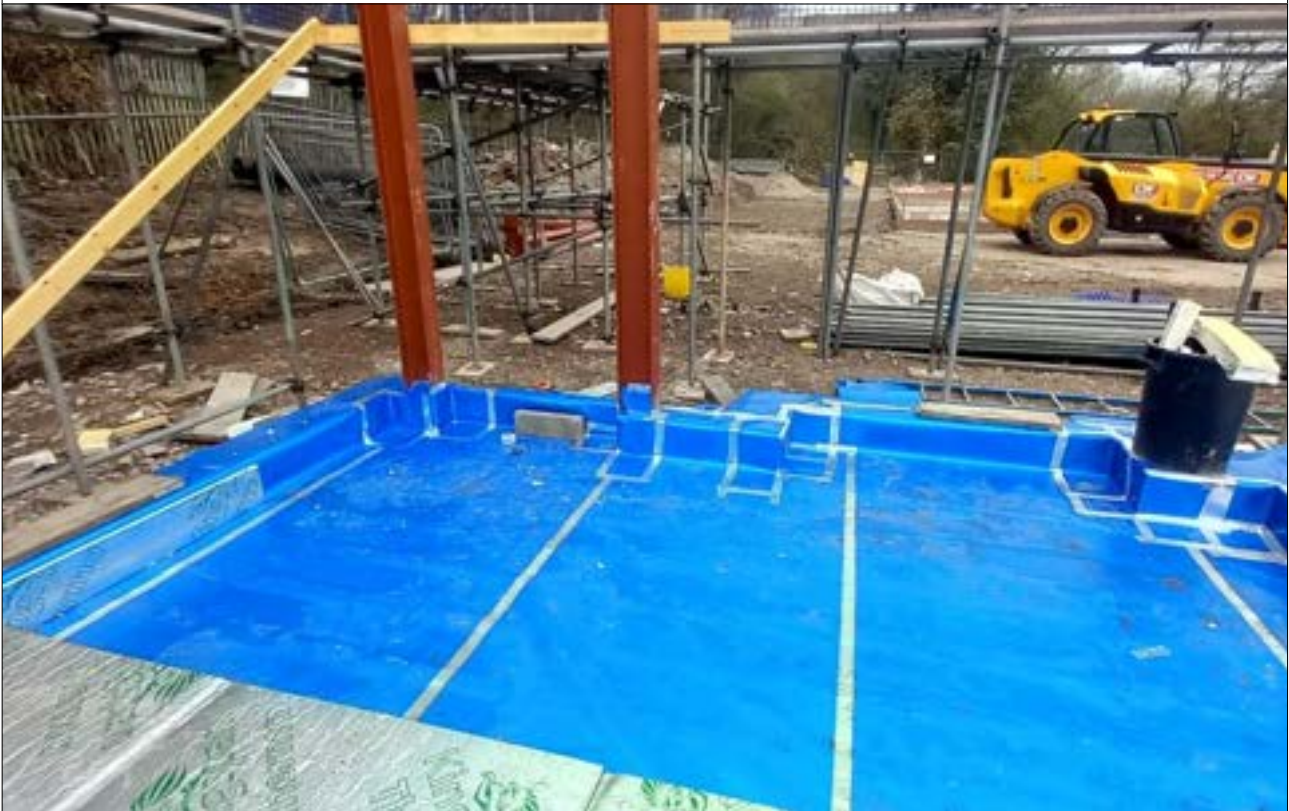
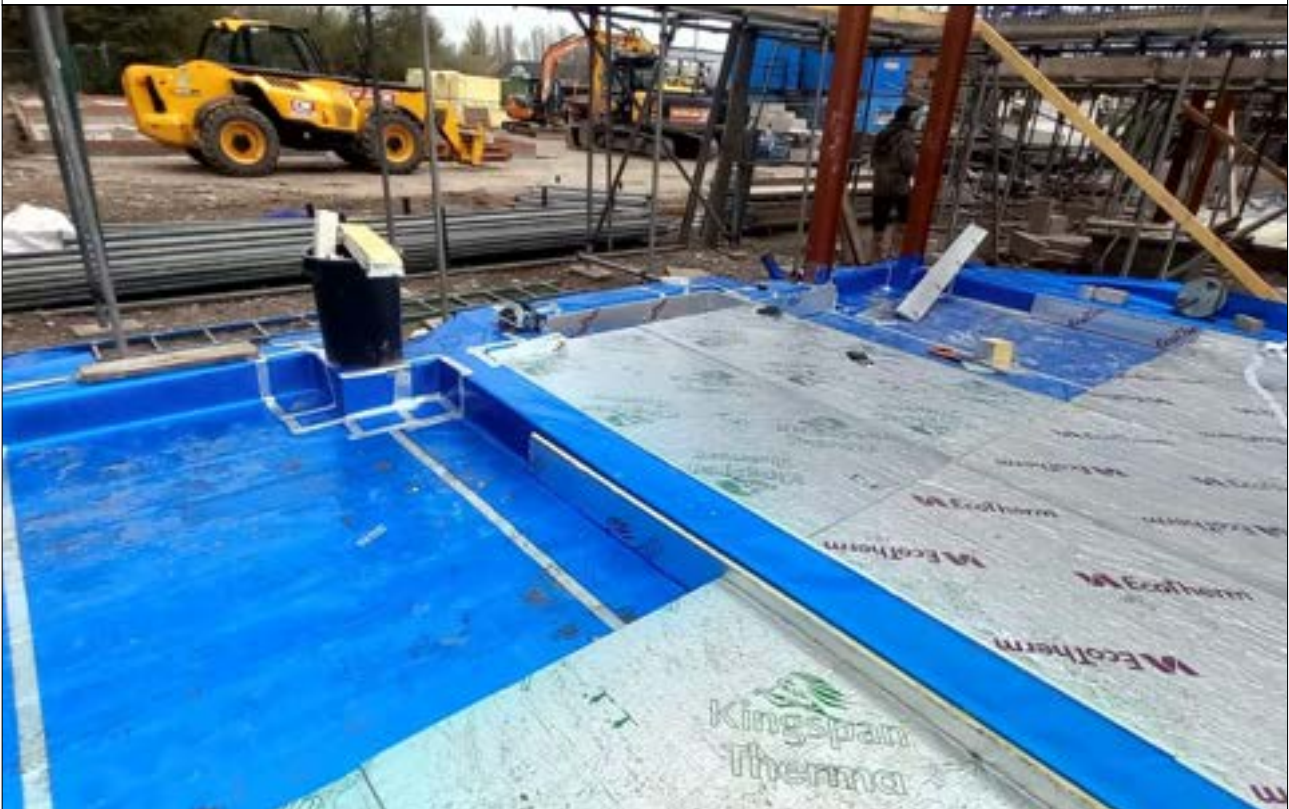
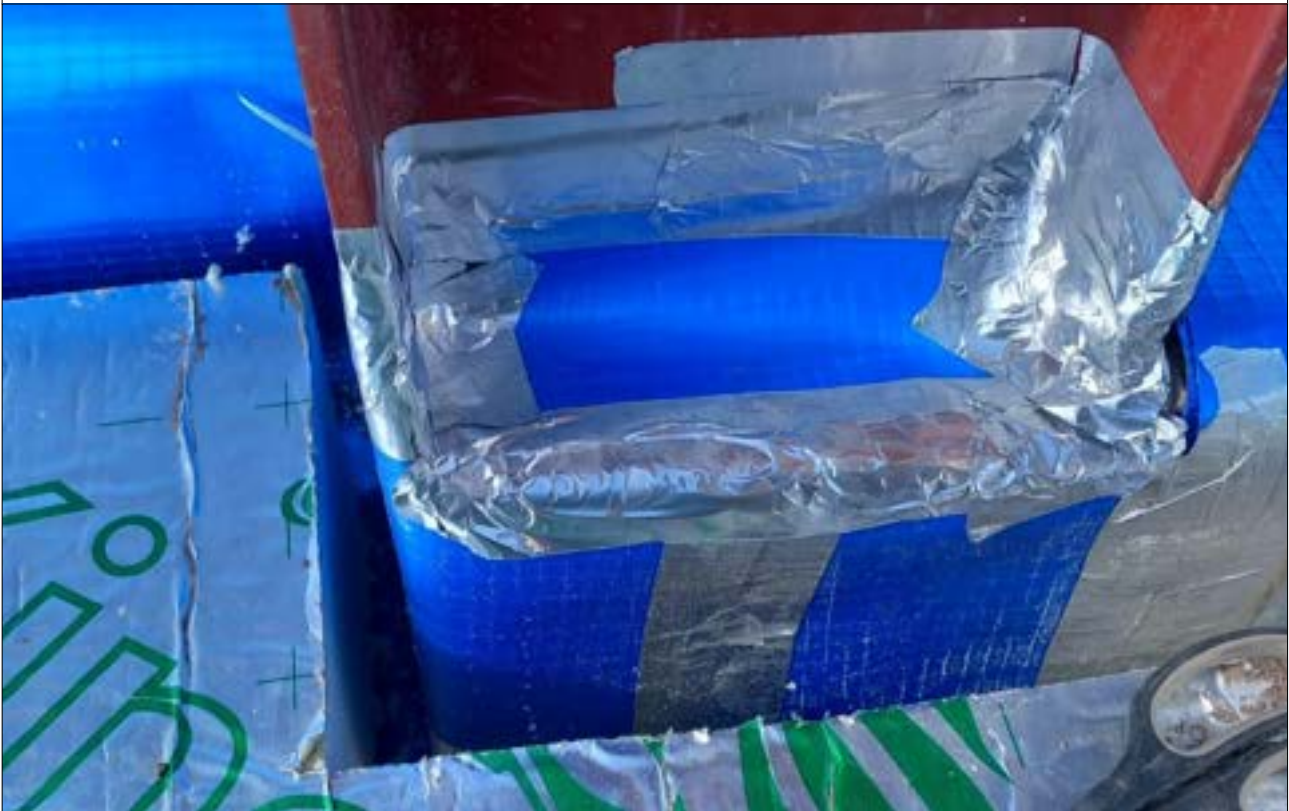
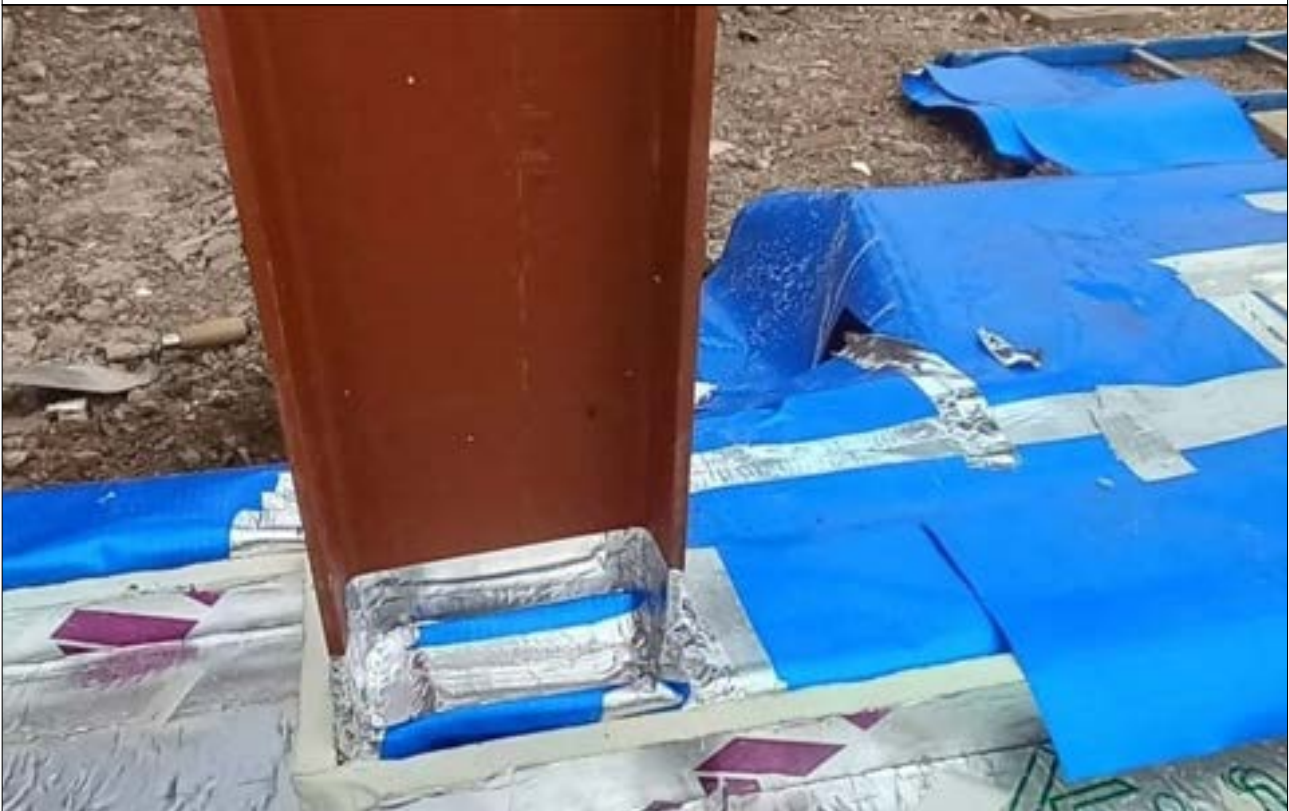
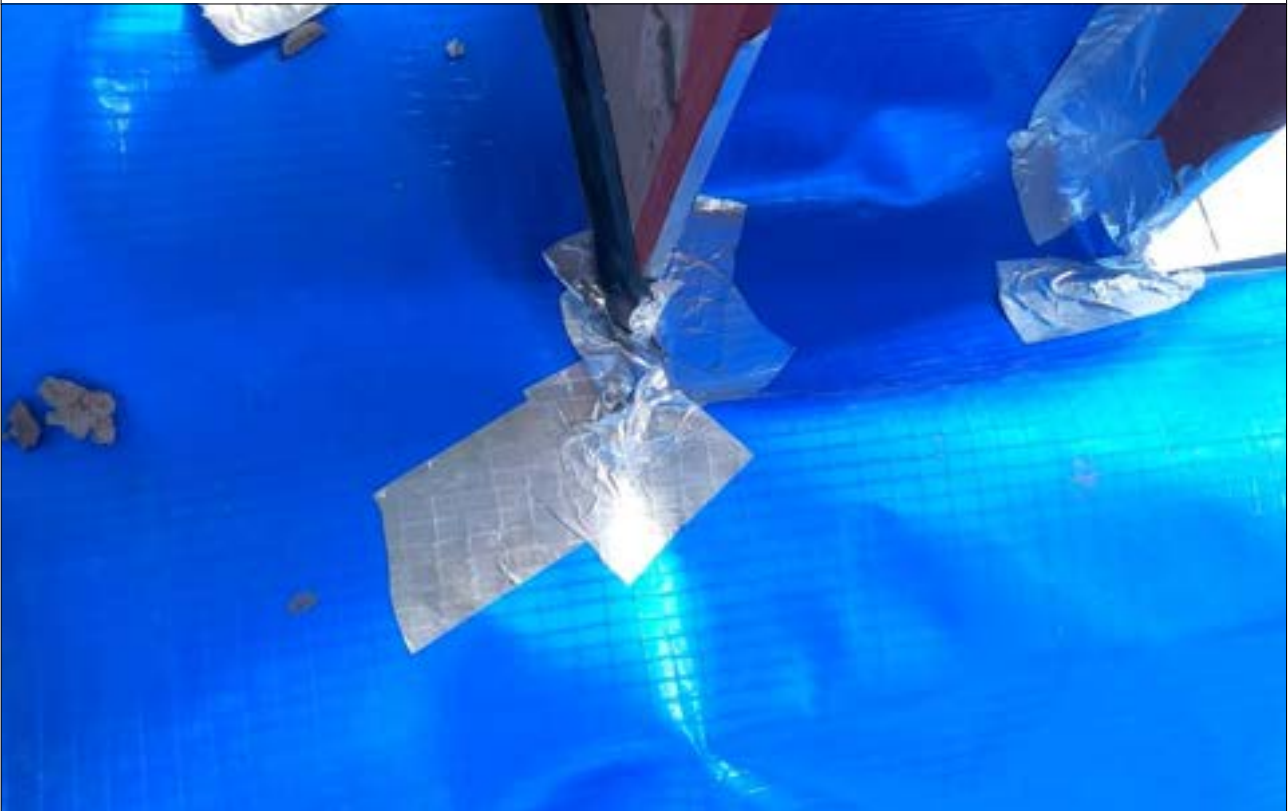
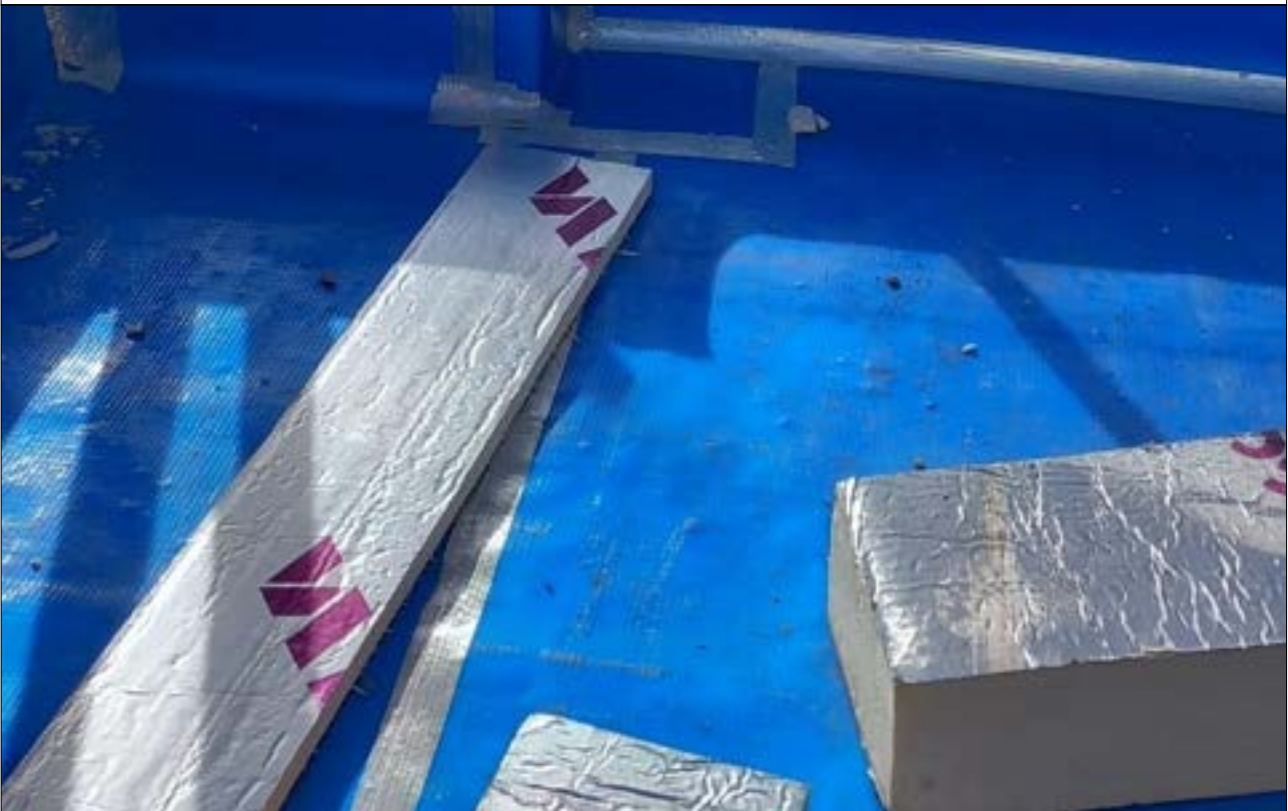
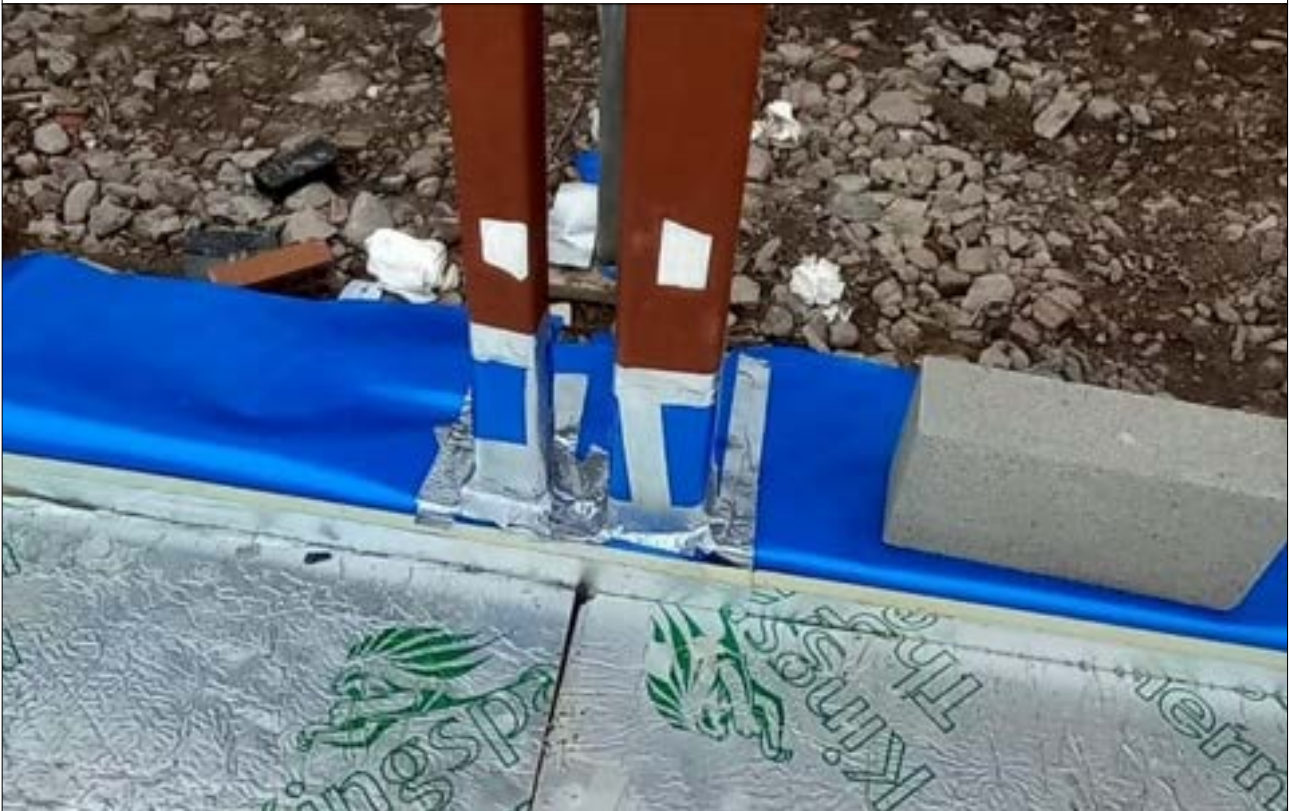
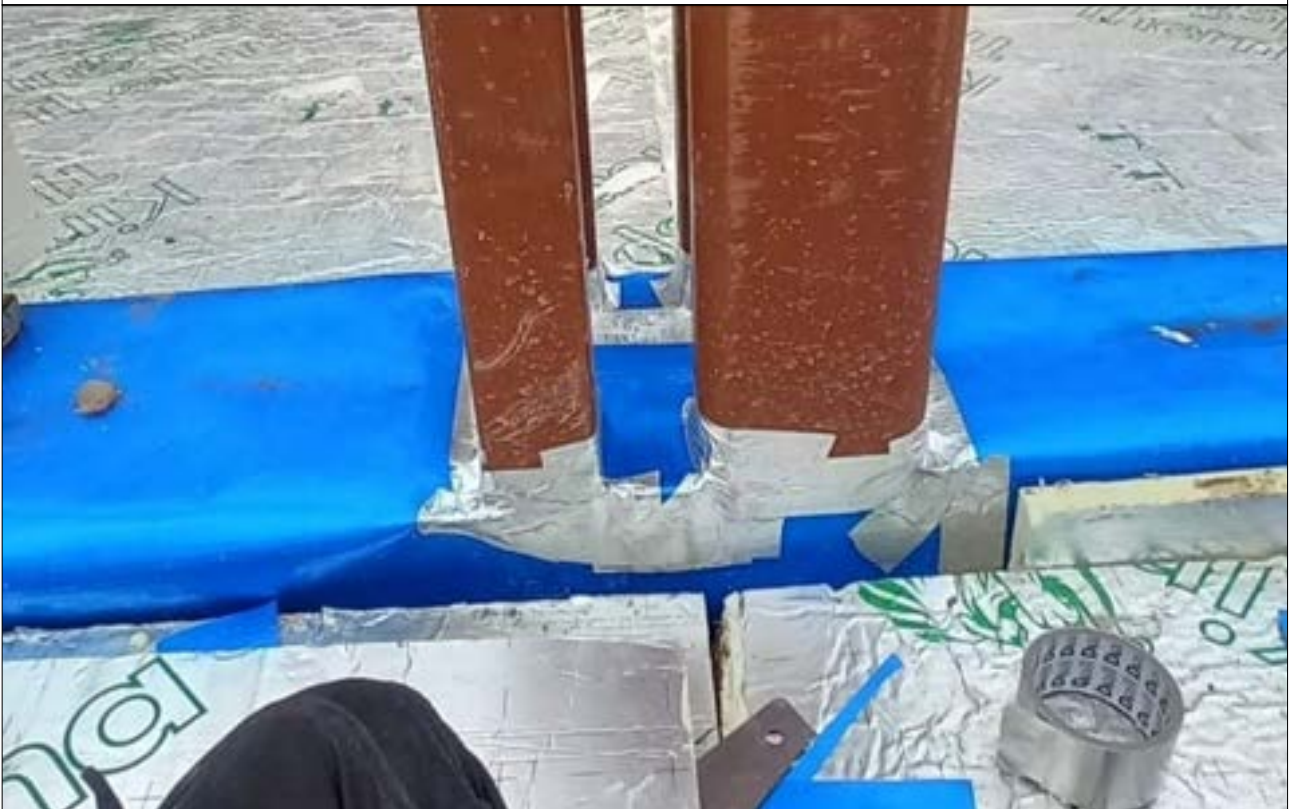
*Plate 9: Plots 3 & 4 gas membrane general condition.*
