## Phase IV Validation Completion Report

The Dales Bar  
Okell Drive  
Halewood  
L26 7XB

Reference: 34357-SUT-ZZ-00-RP-G-7401

Date: May 2026

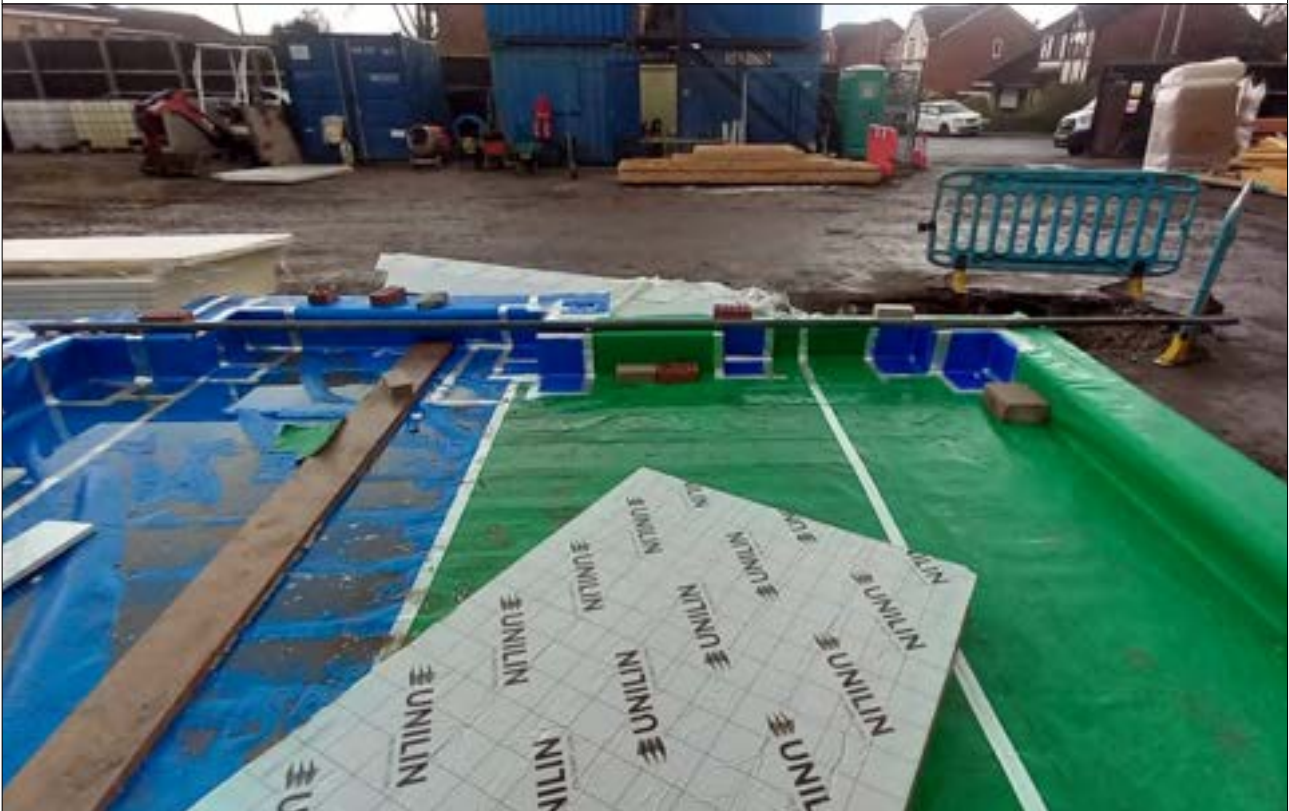
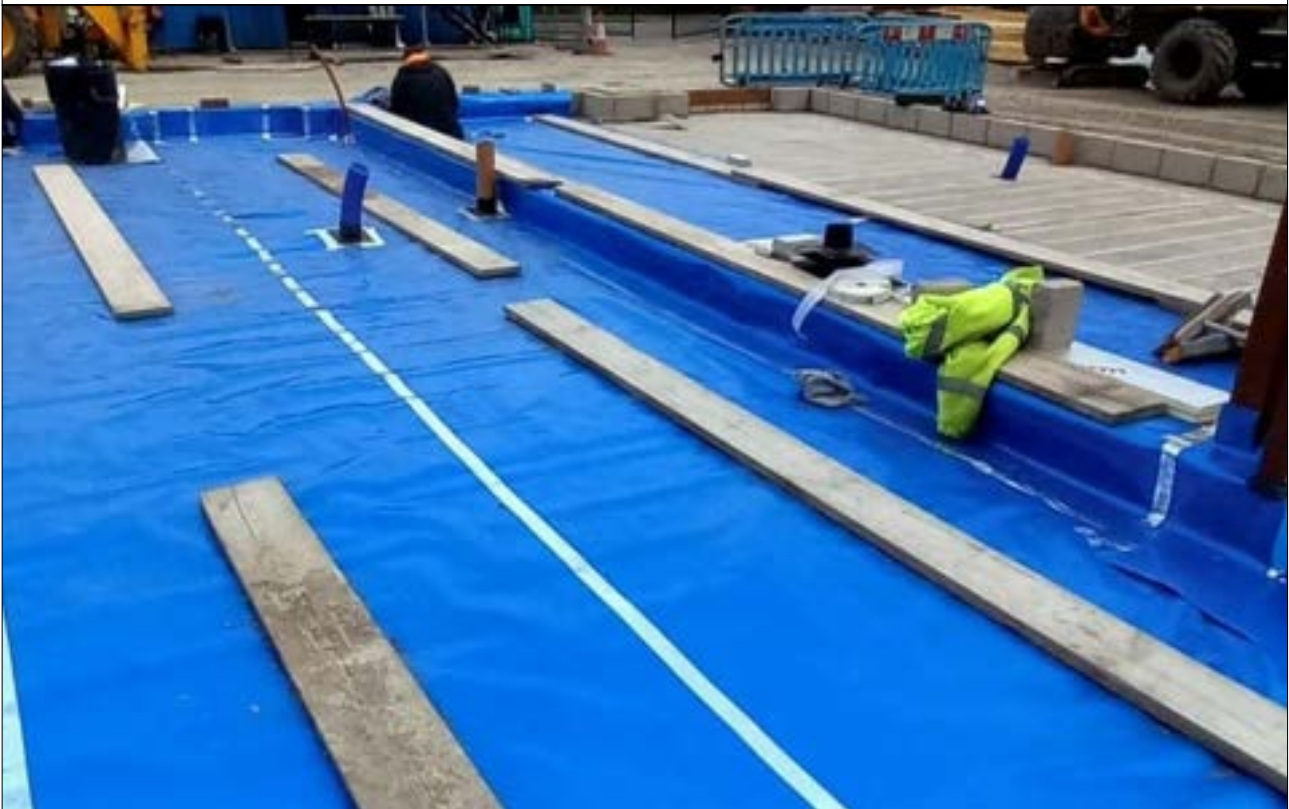
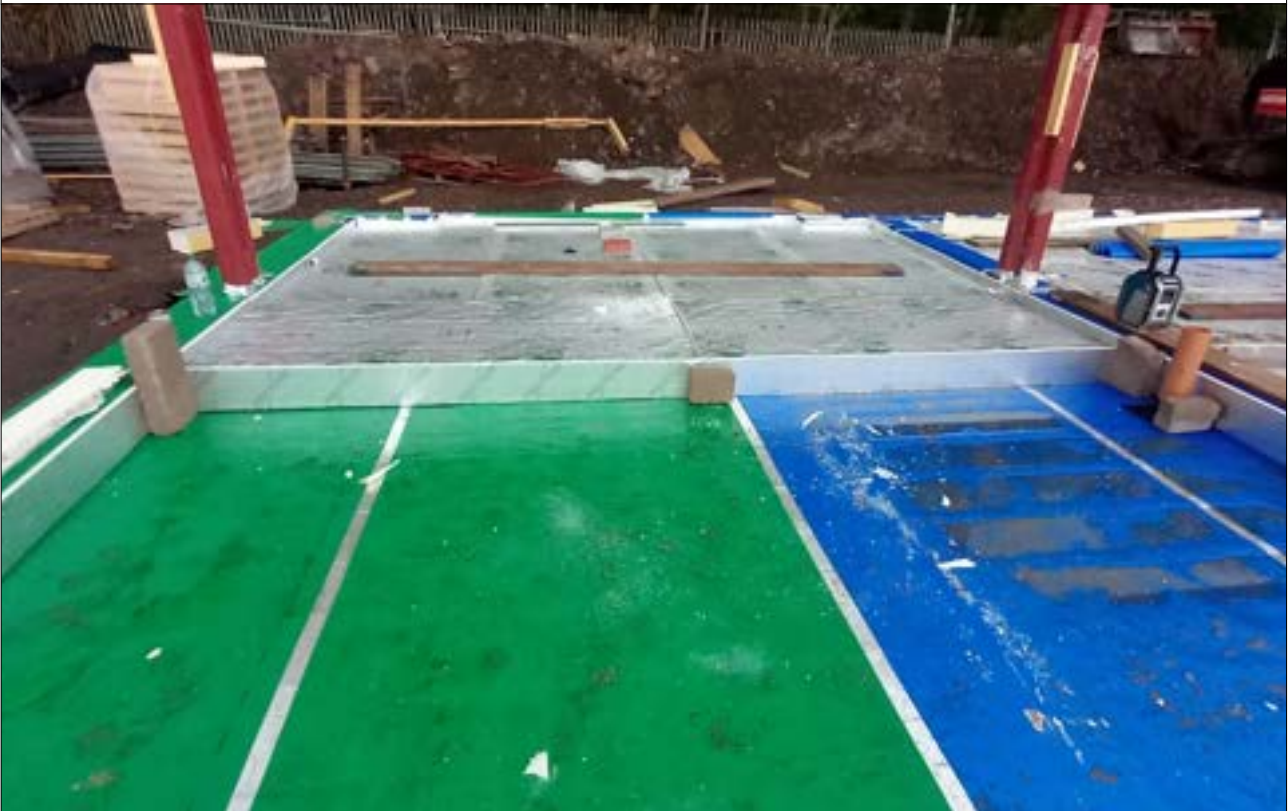
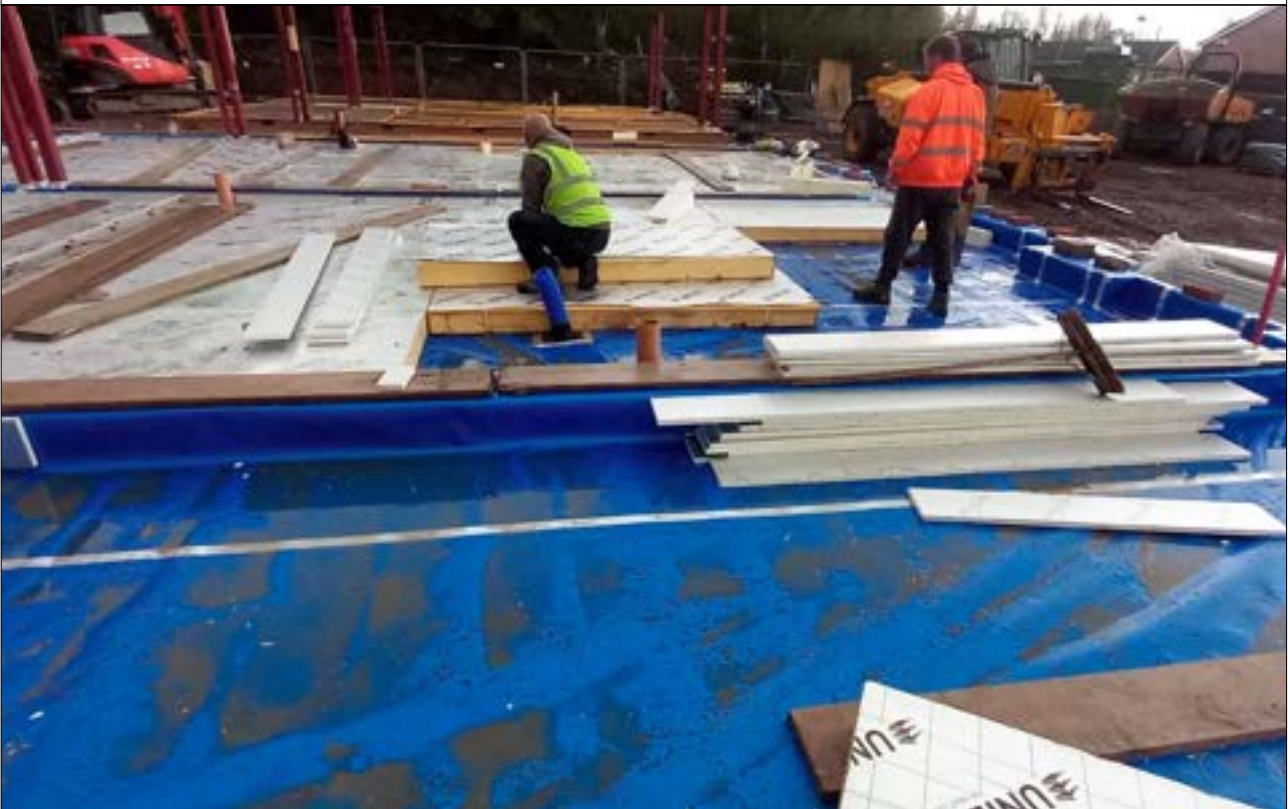
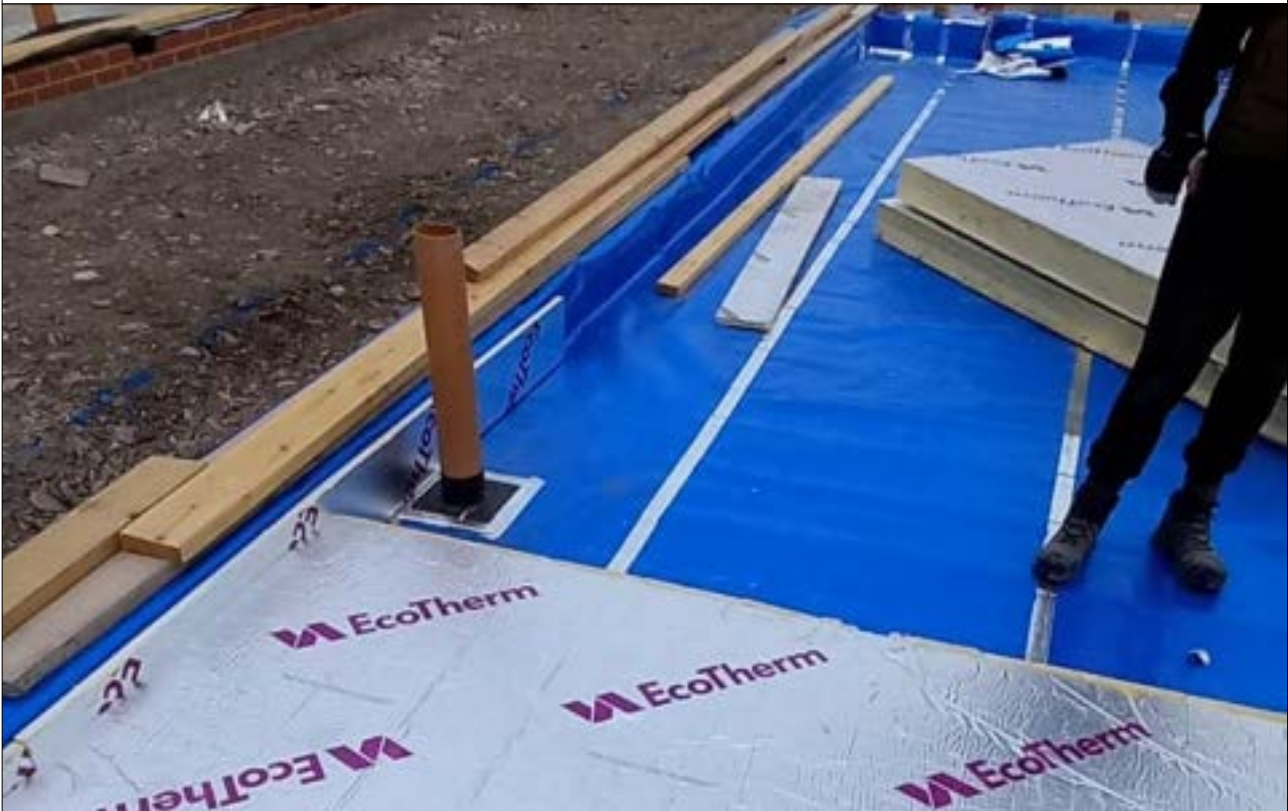
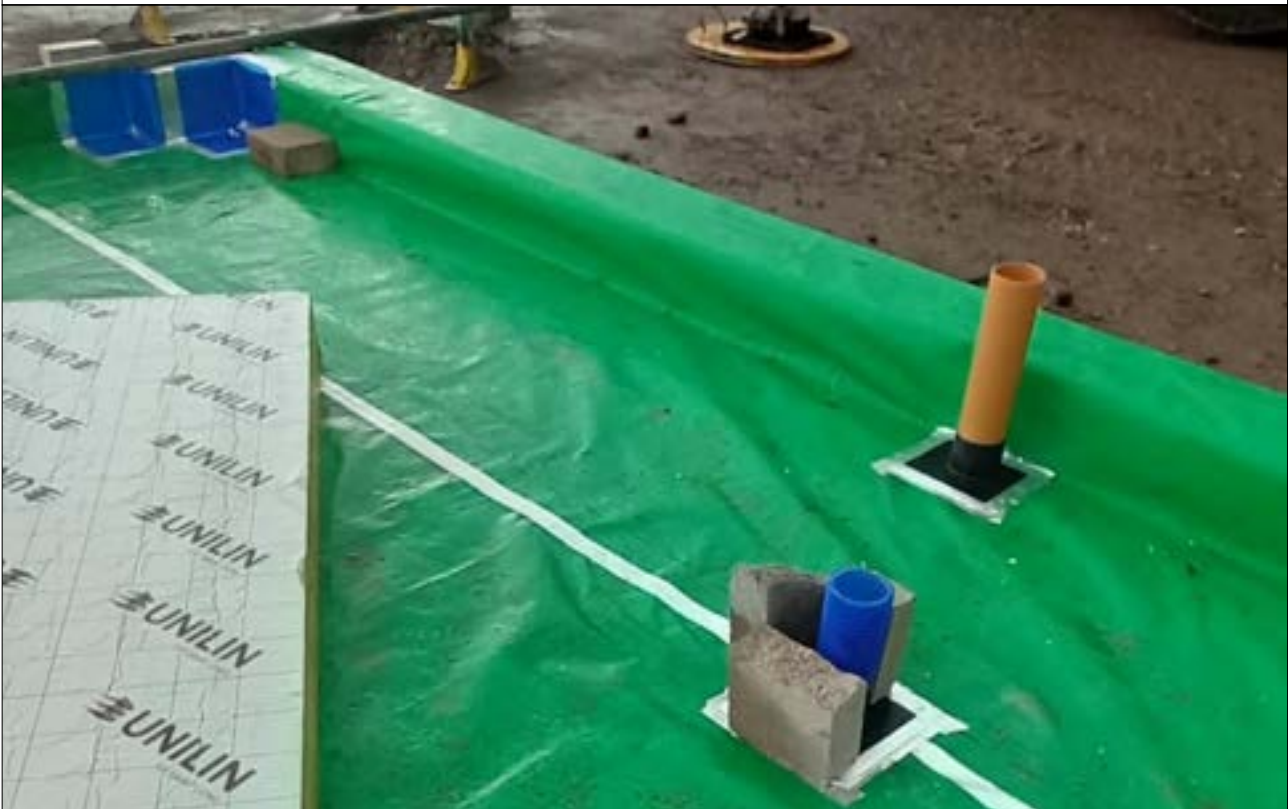
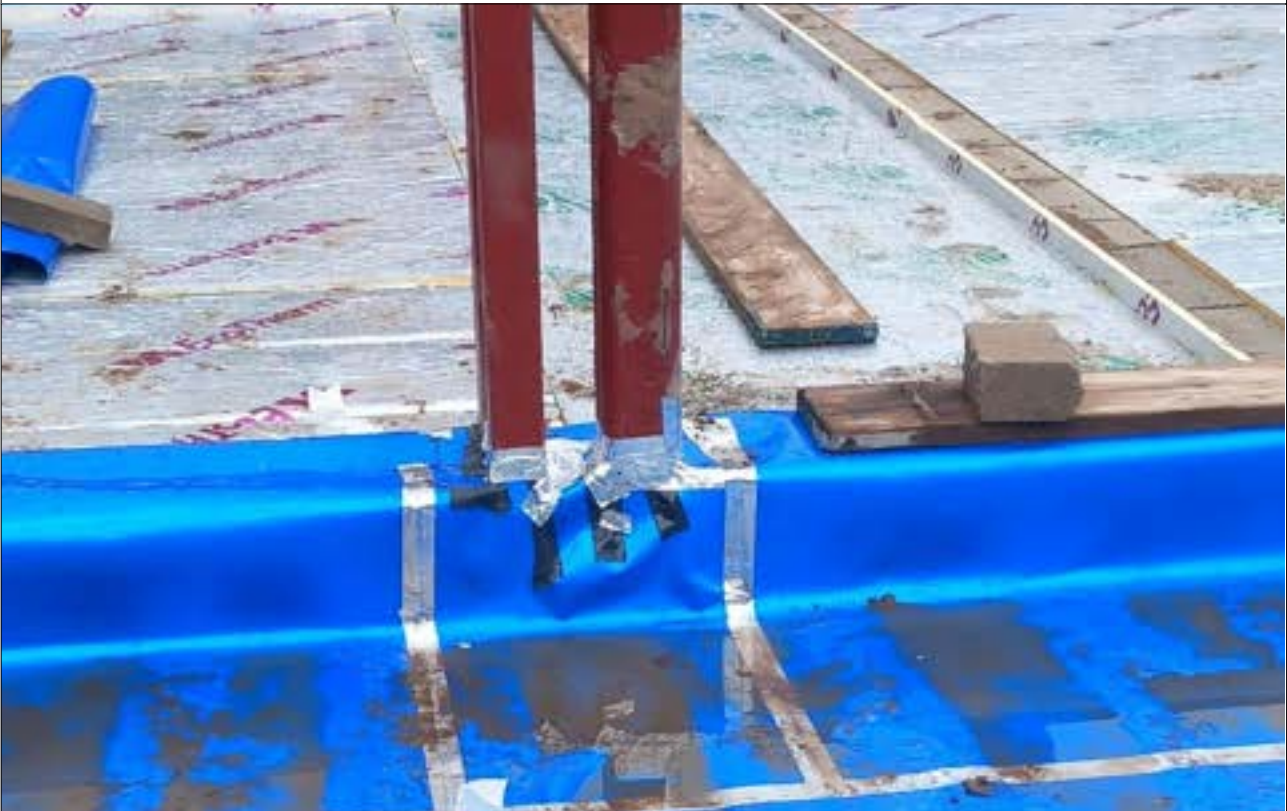
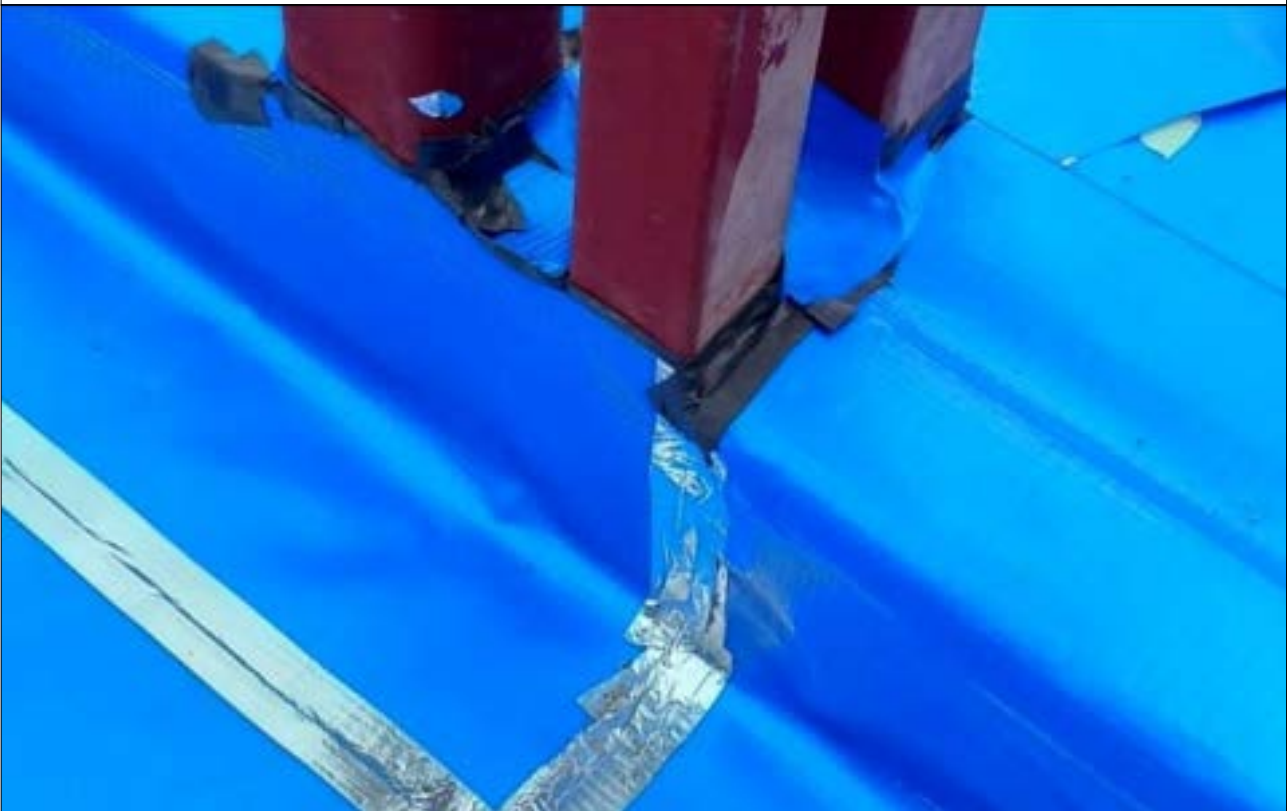
*Plate 17: Plots 5, 6 & 7 gas membrane general condition.*

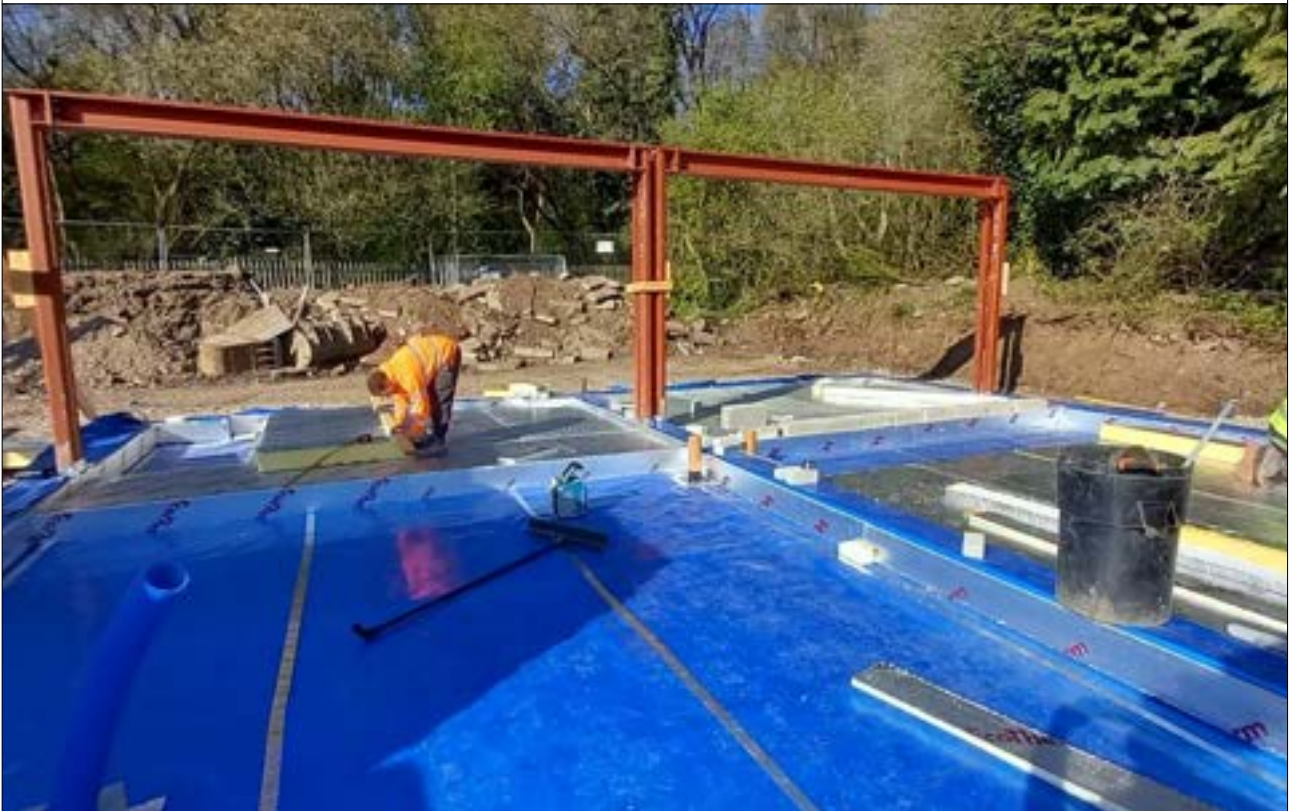
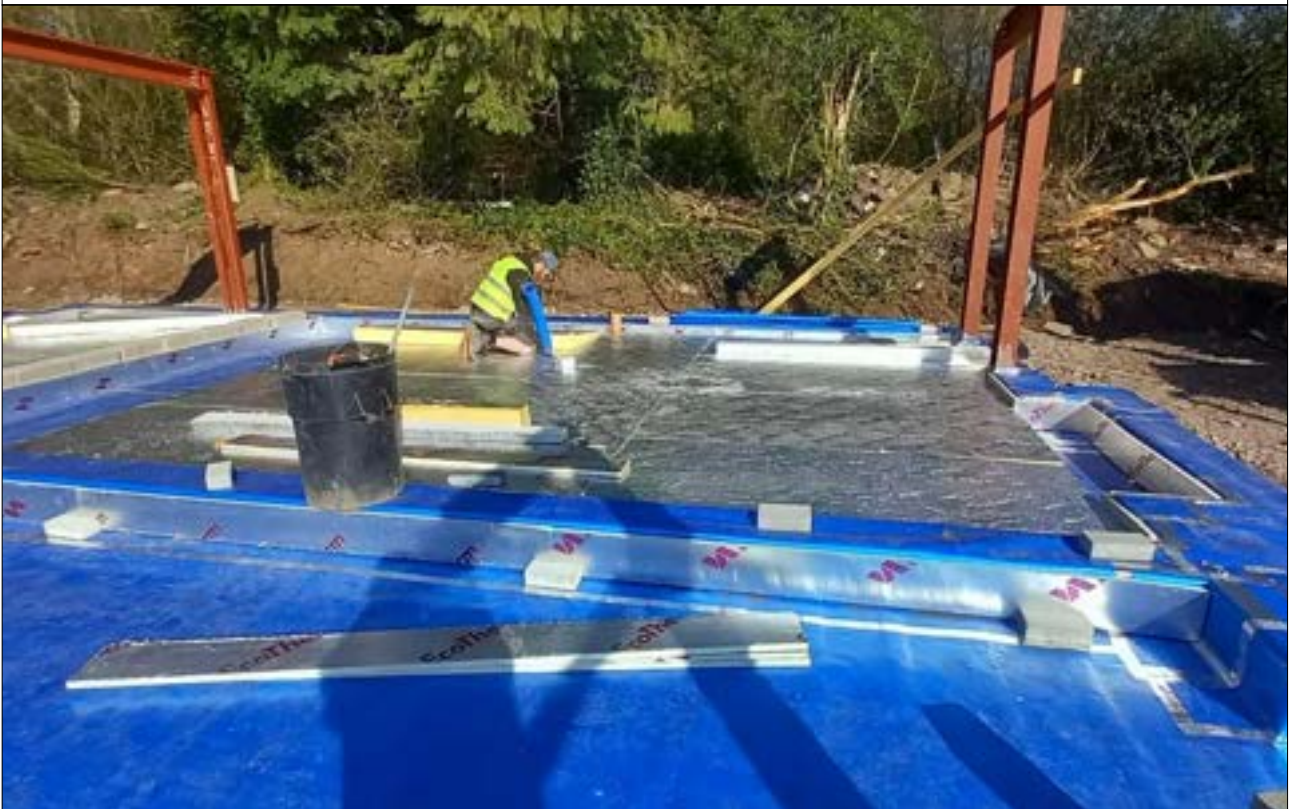
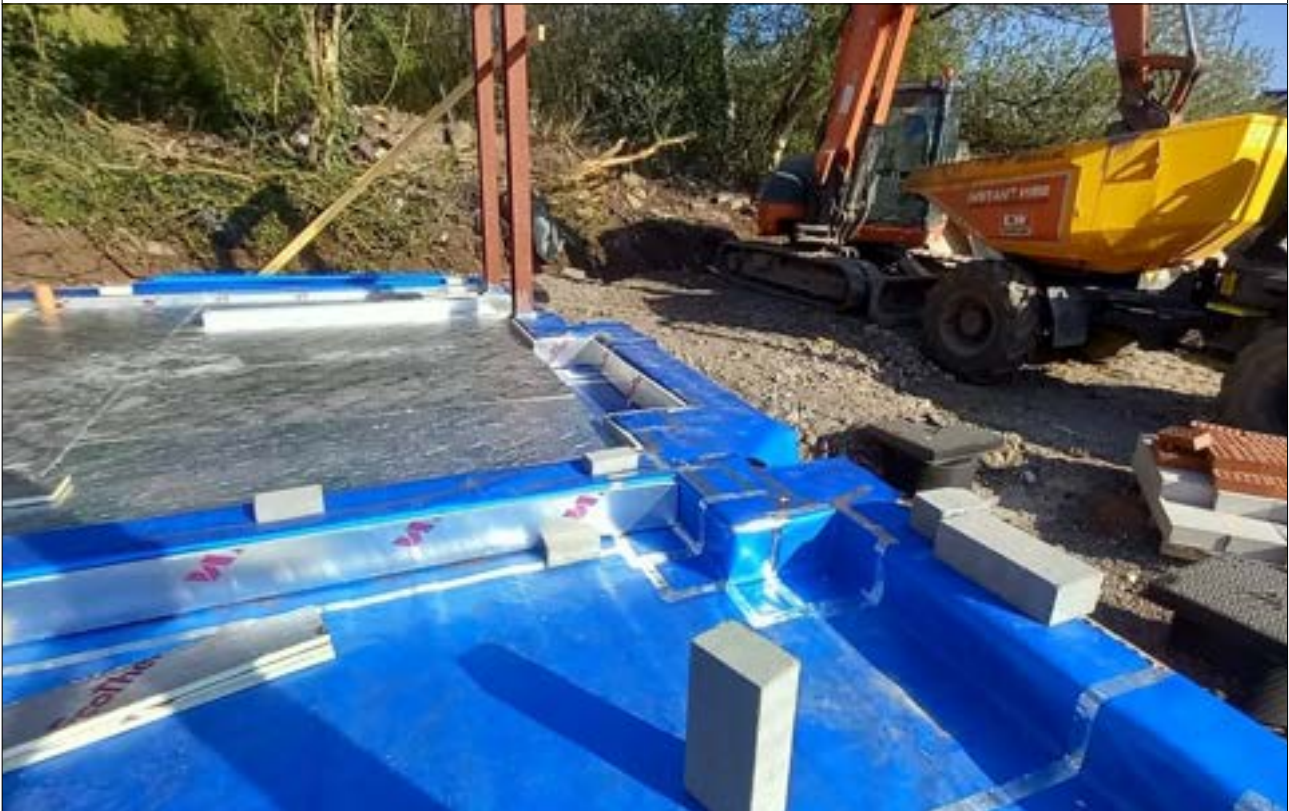
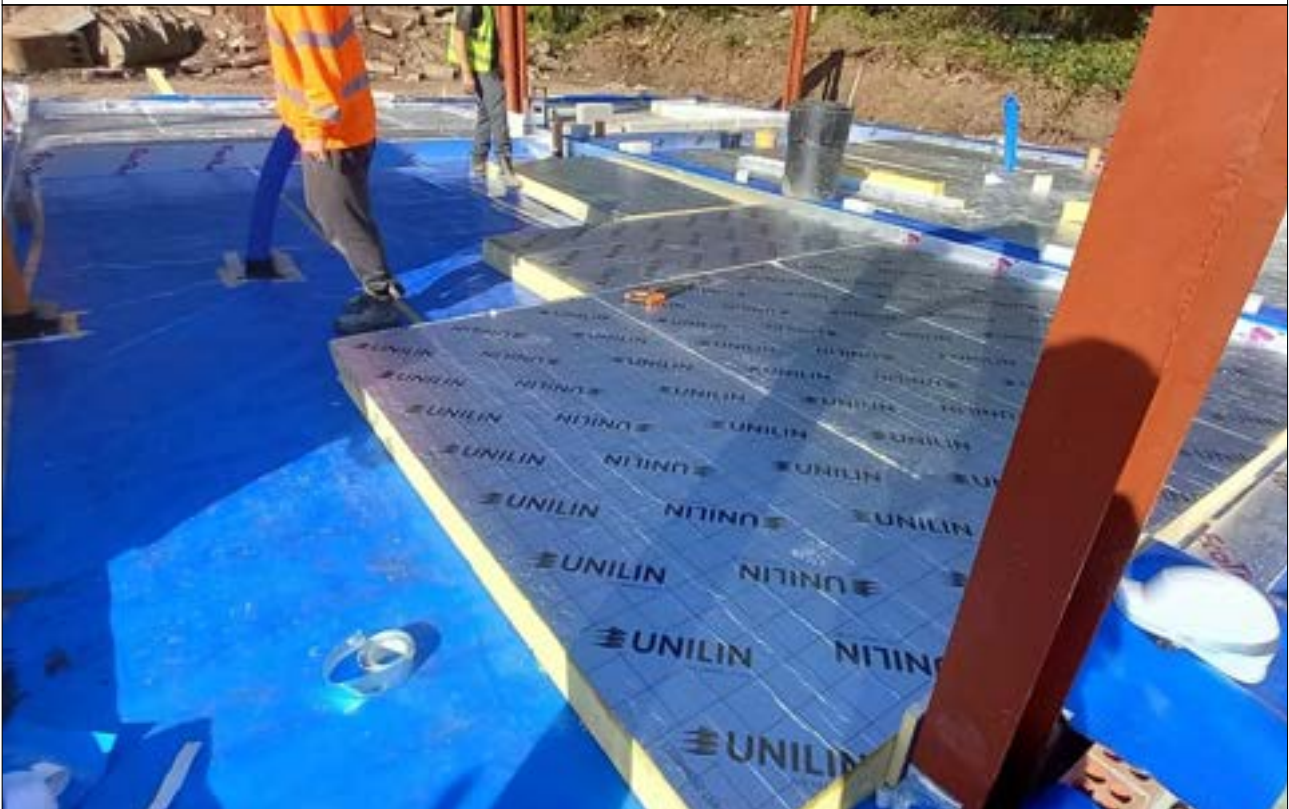
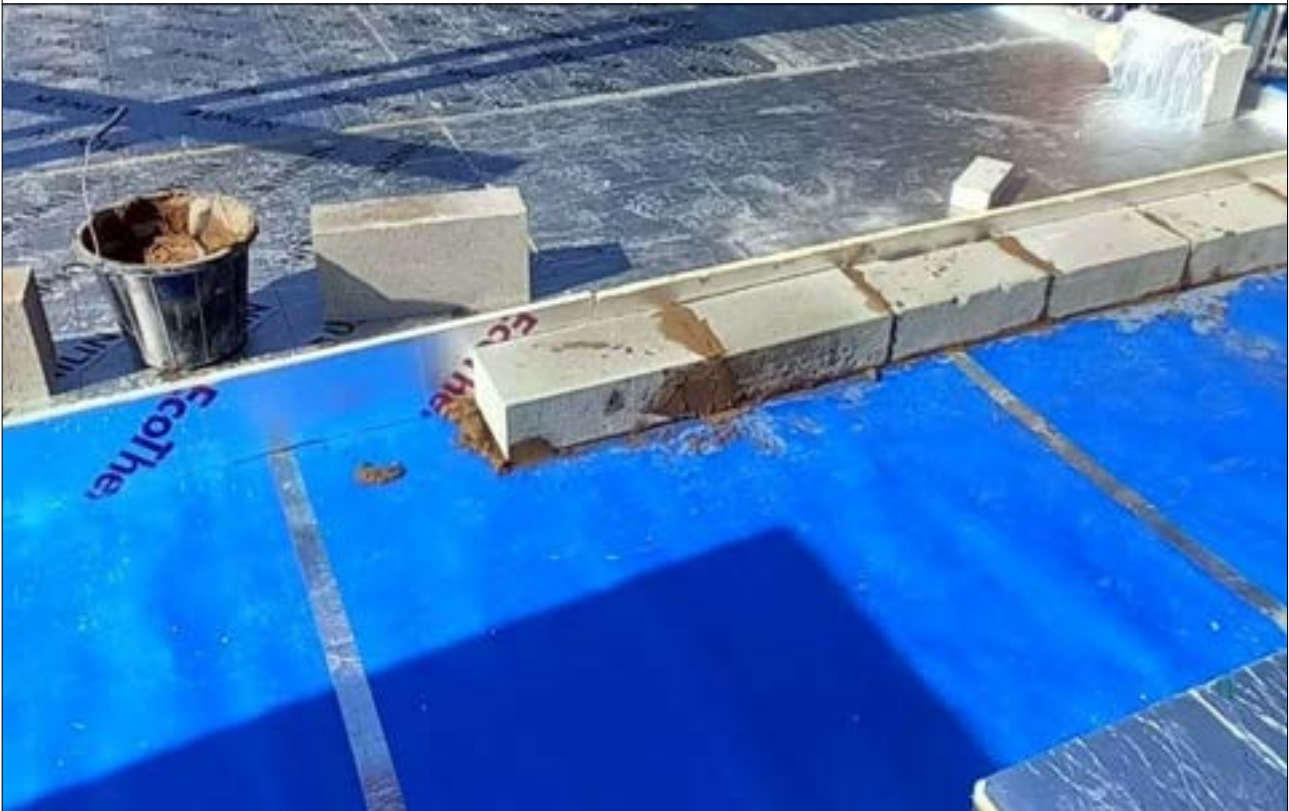
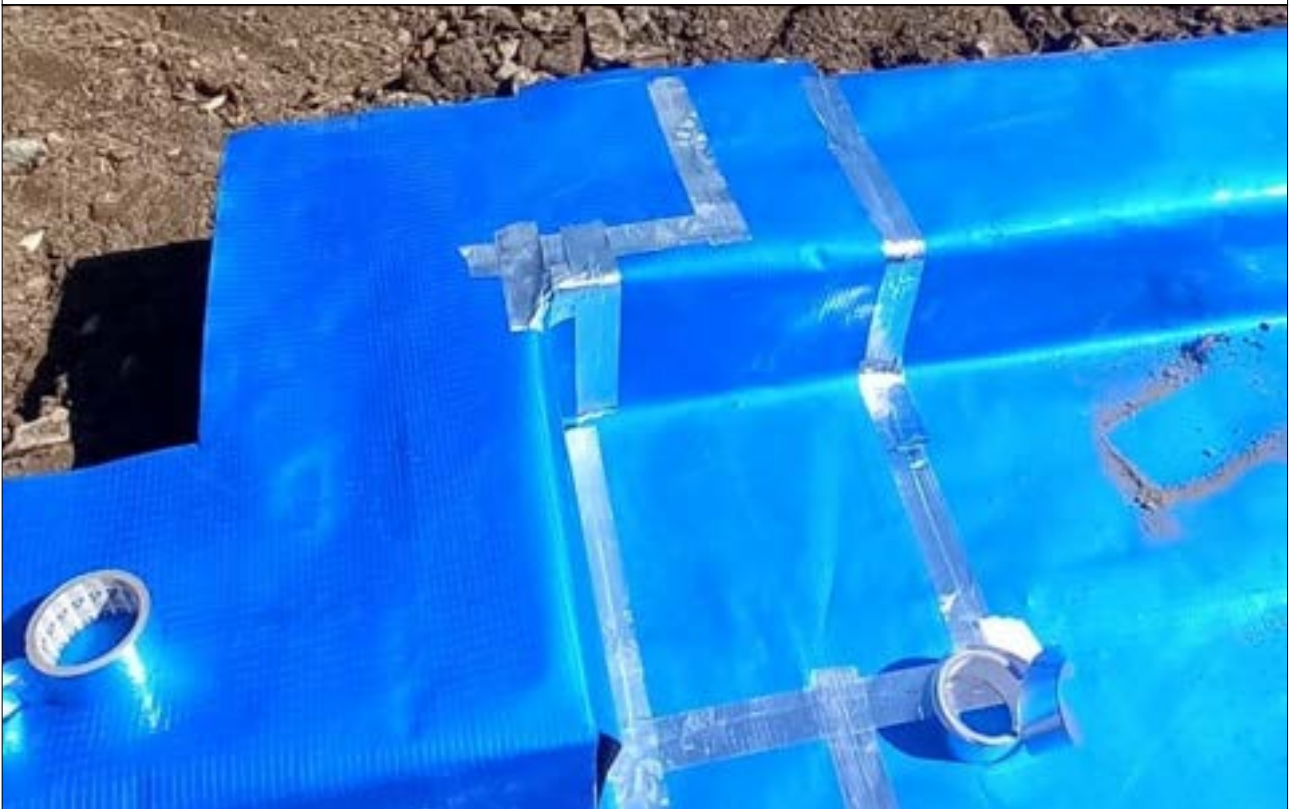
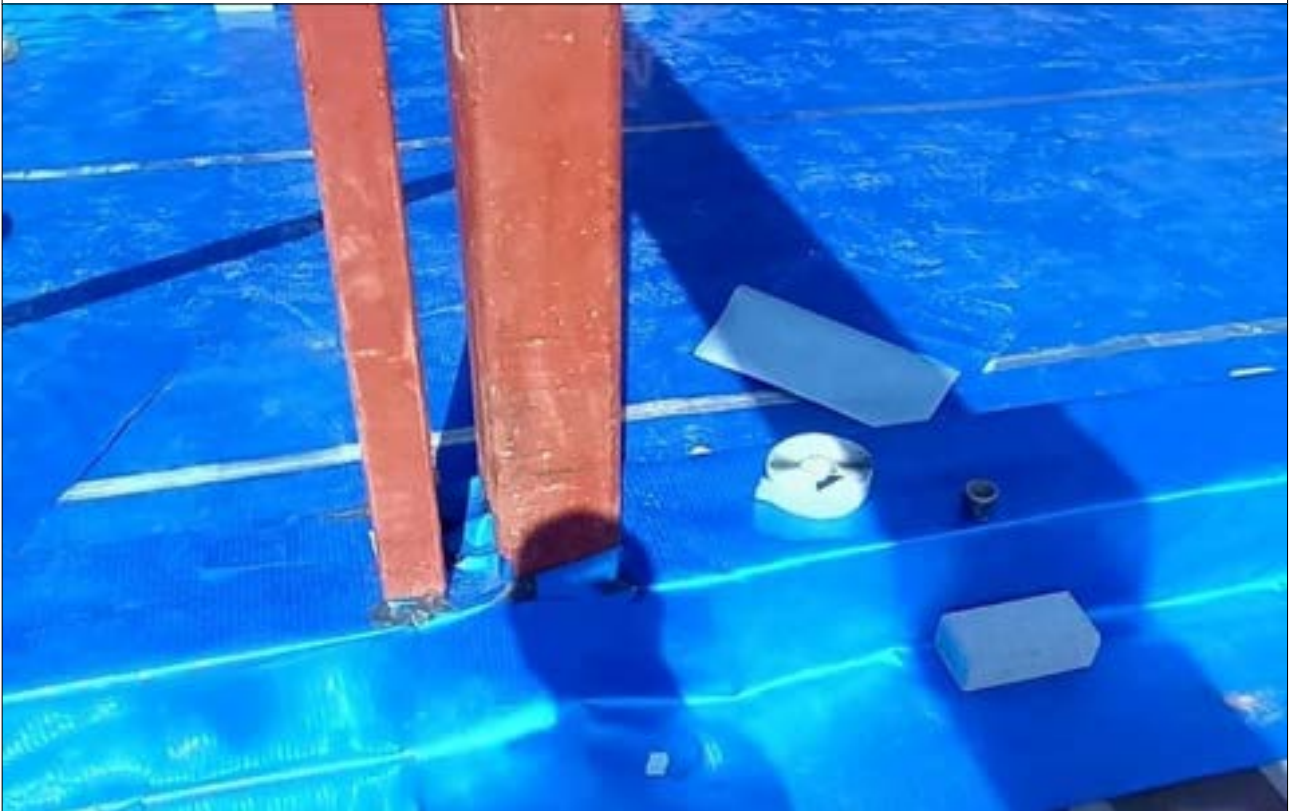
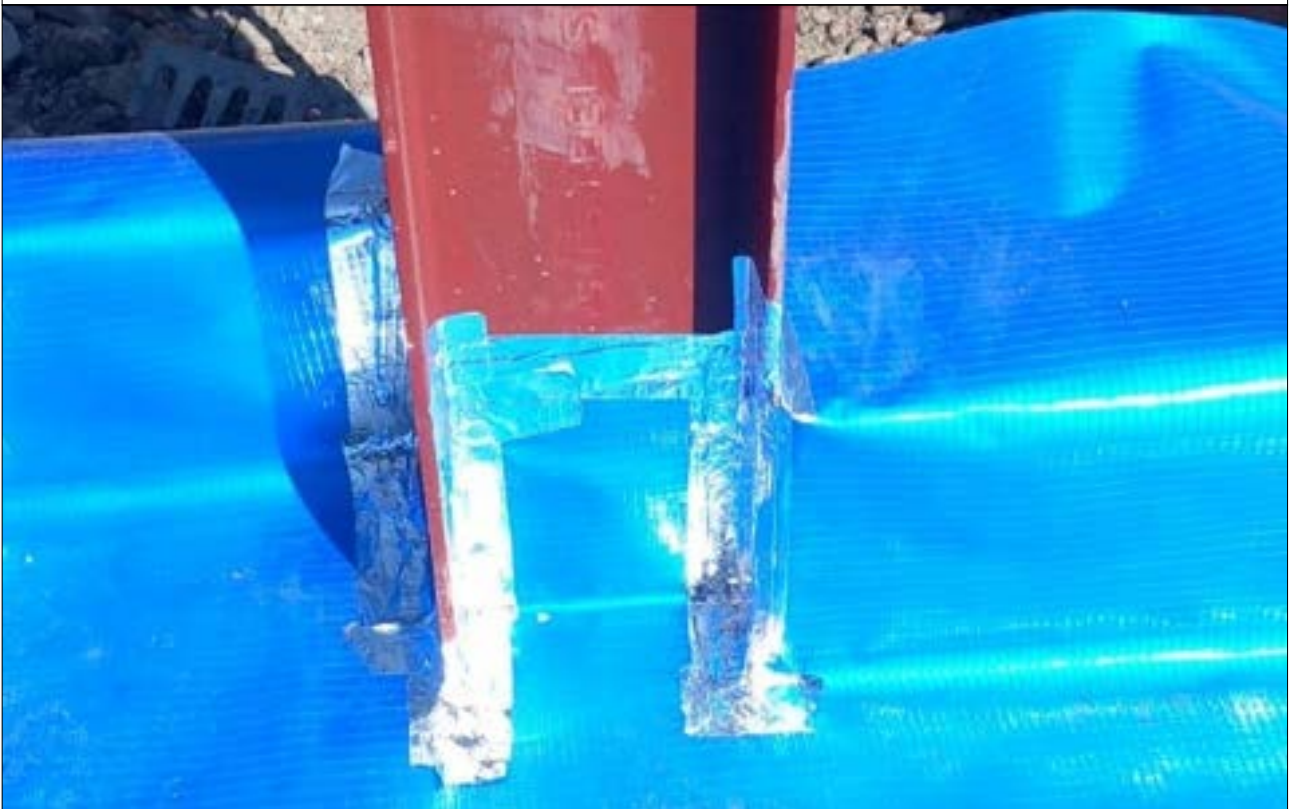
*Plate 25: Plots 8 & 9 gas membrane general condition.*
