# Photographic Schedule of Condition

Old Halsnead Hall, Fox's Bank Lane, Widnes, Prescot L35 3SU

April 2026

Doc Ref: 04C600152

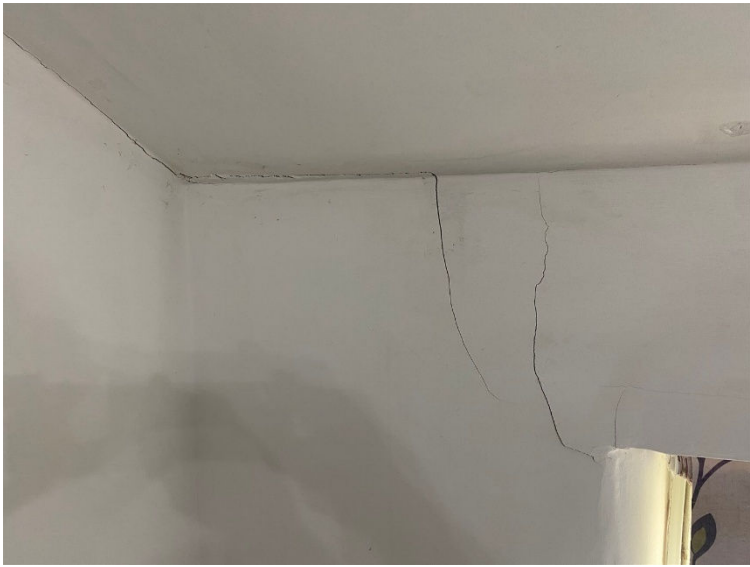
| Photo No | Photograph Description | Photograph |
|---|---|---|
| 3. | <b>Cinema Room</b><br>Cracking to left of window | |

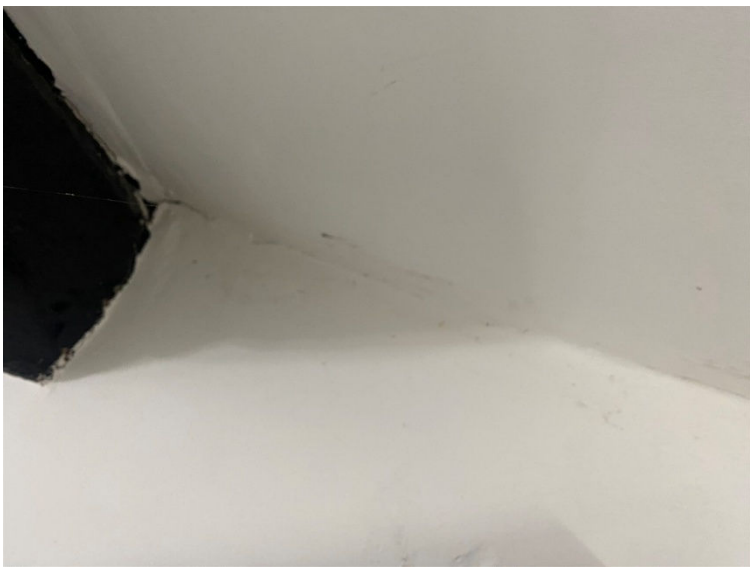
| Photo No | Photograph Description | Photograph |
|---|---|---|
| 5. | <b>Cinema Room</b><br>Crack adjacent to ceiling beam | |

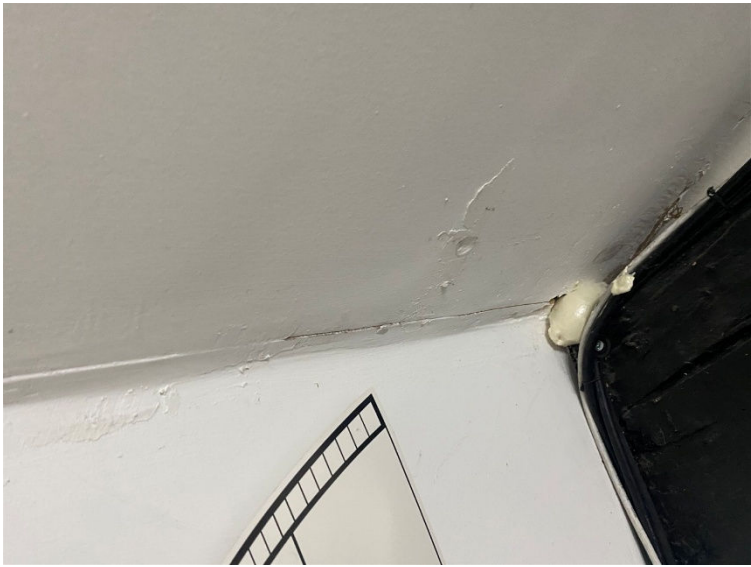
| Photo No | Photograph Description | Photograph |
|---|---|---|
| 9. | <b>Cinema Room</b><br>Crack and defective plaster at junction of ceiling and external wall | A photograph showing the corner of a room where a white ceiling meets a white external wall. A thin, dark crack runs along the junction. There is some peeling and crumbling of the white plaster at the corner. A black metal railing is visible in the lower left corner. |

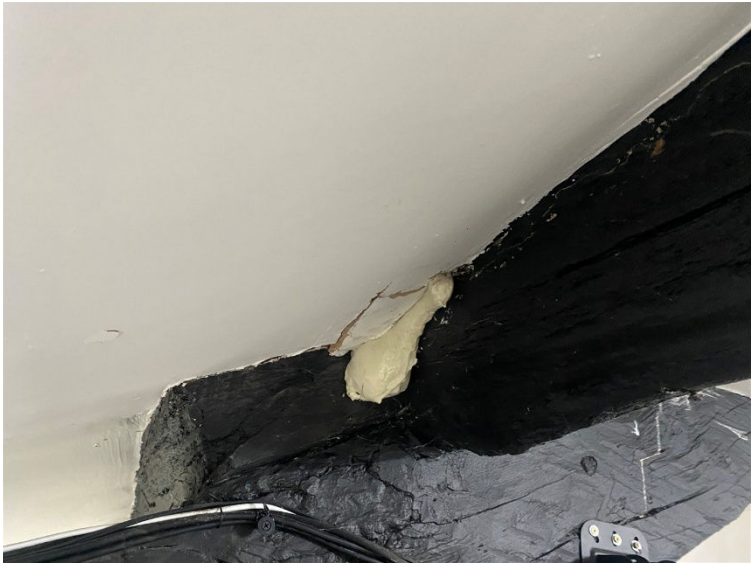
| Photo No | Photograph Description | Photograph |
|---|---|---|
| 10. | <b>Cinema Room</b><br>Defective plaster and expanded foam adjacent to the ceiling beam | A photograph showing a corner of a room. The ceiling is white, but the plaster is crumbling and peeling away from a dark, textured ceiling beam. A large, irregular mass of yellowish, expanded foam is visible where the plaster has detached. A black metal railing is visible in the lower left corner. |

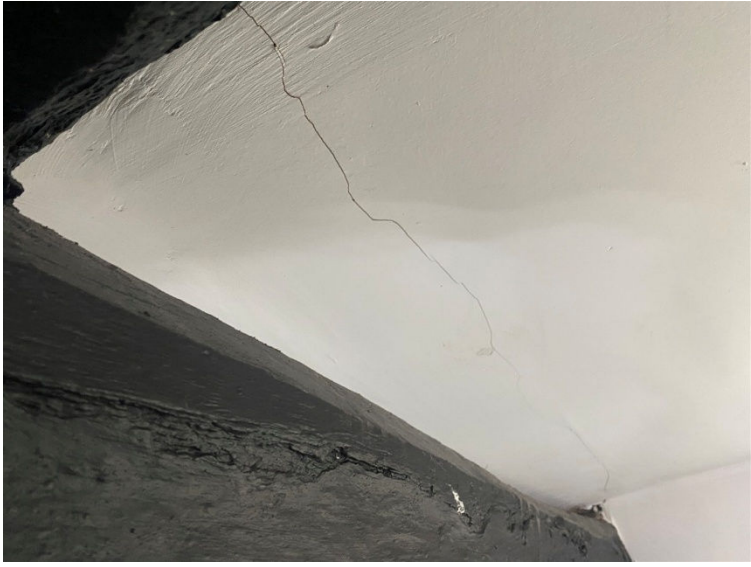
| Photo No | Photograph Description | Photograph |
|---|---|---|
| 11. | <b>Cinema Room</b><br>Crack running parallel to ceiling beam | A photograph showing a close-up of a white ceiling. A long, thin, dark crack runs diagonally across the ceiling surface, parallel to a dark, textured ceiling beam. The plaster appears slightly uneven and aged. |

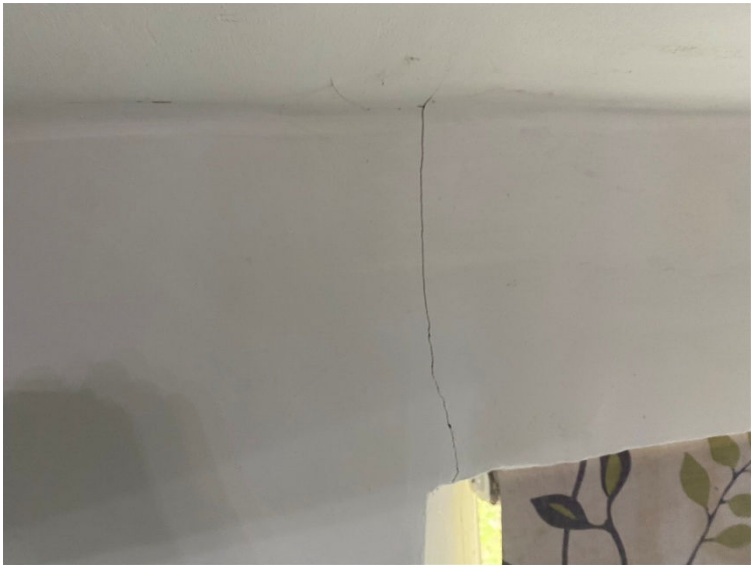
| Photo No | Photograph Description | Photograph |
|---|---|---|
| 12. | <b>Cinema Room</b><br>Crack to left of window | A photograph showing a vertical crack in a white wall. To the right, a portion of a window is visible, featuring a patterned curtain with green leaves and a yellow light source. |

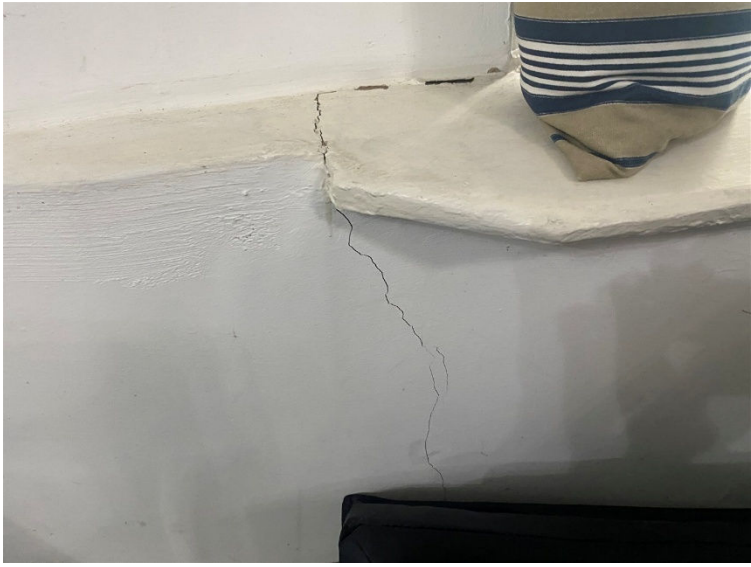
| Photo No | Photograph Description | Photograph |
|---|---|---|
| 13. | <b>Cinema Room</b><br>Crack below windowsill | A photograph of a crack in a white wall, located directly below a stone windowsill. A blue and white striped cushion is resting on the windowsill. |

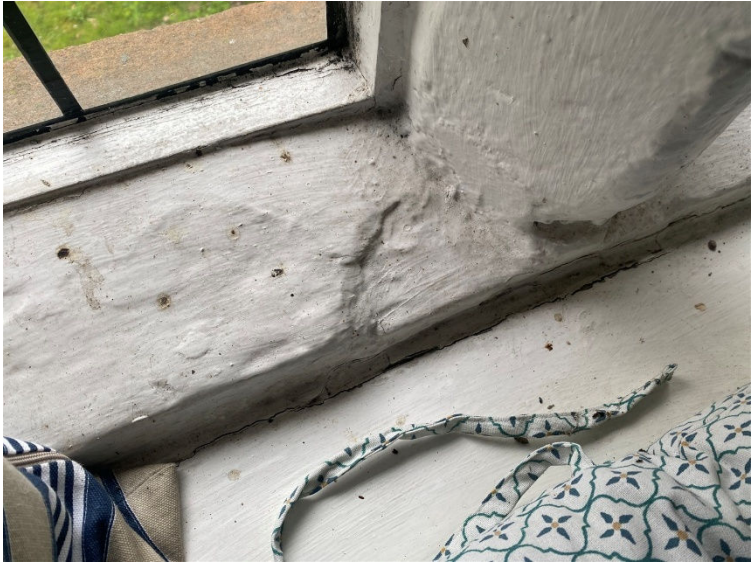
| Photo No | Photograph Description | Photograph |
|---|---|---|
| 14. | <b>Cinema Room</b><br>Crack between window seat and stone window surround | A close-up photograph showing a crack in the white wall between a window seat and a stone window surround. A patterned fabric is visible in the foreground. |

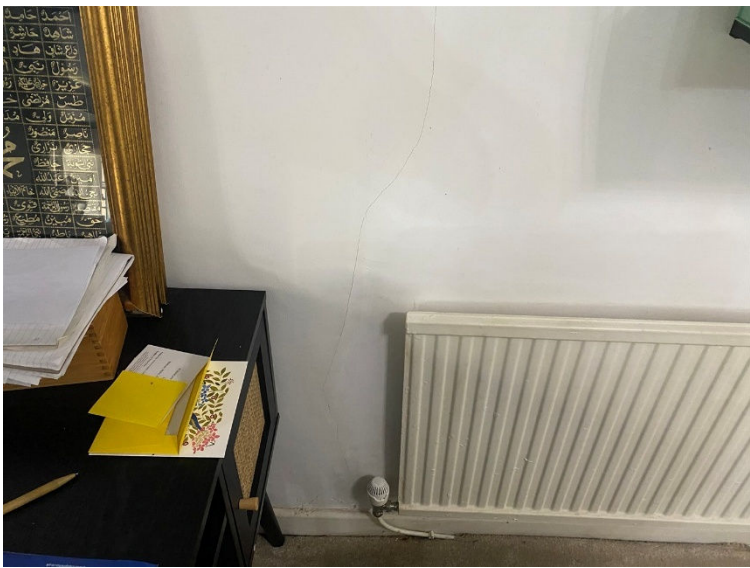
| Photo No | Photograph Description | Photograph |
|---|---|---|
| 17. | <b>Cinema Room</b><br>Hairline crack to external wall running from radiator to approximately 200mm short of purlin. | |

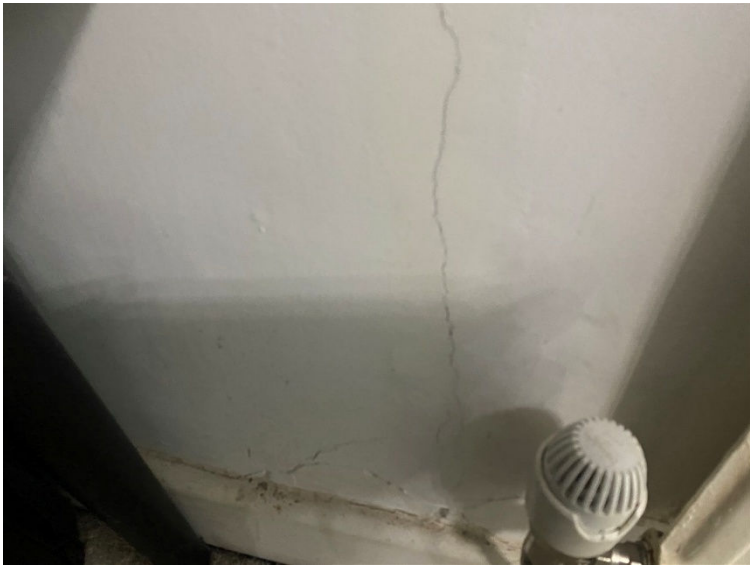
| Photo No | Photograph Description | Photograph |
|---|---|---|
| 18. | <b>Cinema Room</b><br>Close up of crack to left of radiator | |

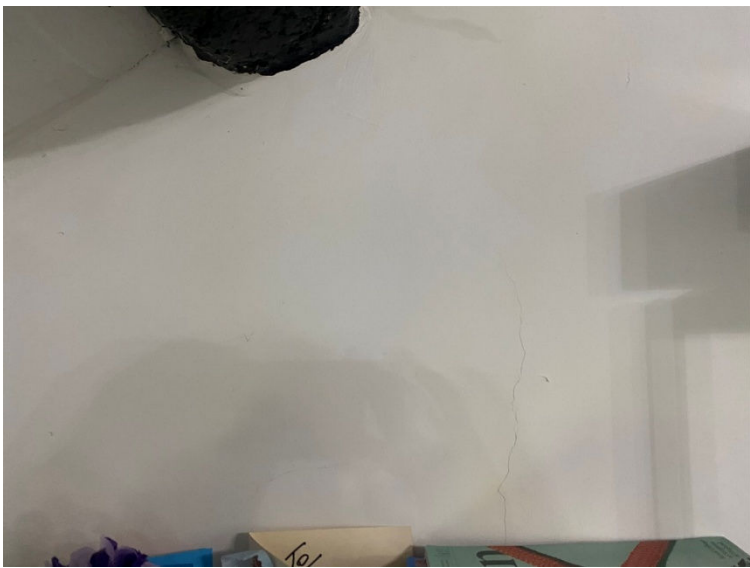
| Photo No | Photograph Description | Photograph |
|---|---|---|
| 20. | <b>Cinema Room</b><br>Close up of crack to left of radiator | |

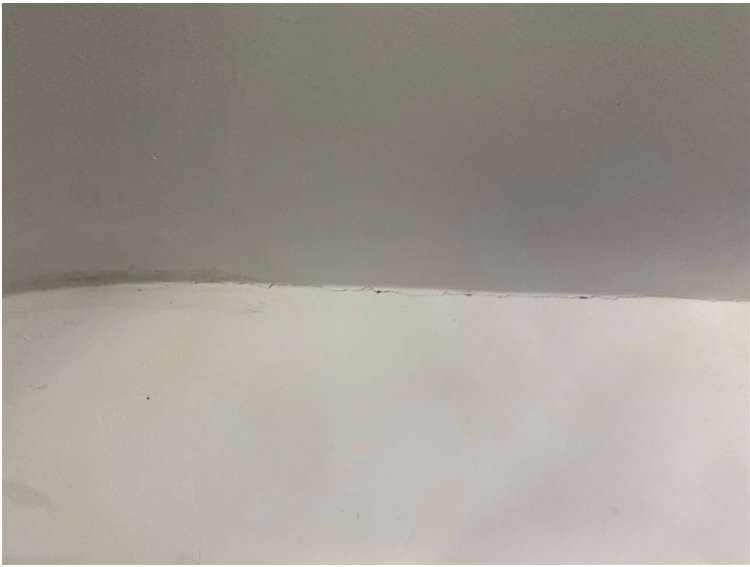
| Photo No | Photograph Description | Photograph |
|---|---|---|
| 21. | <b>Cinema Room</b><br>Hairline crack between wall and ceiling | |

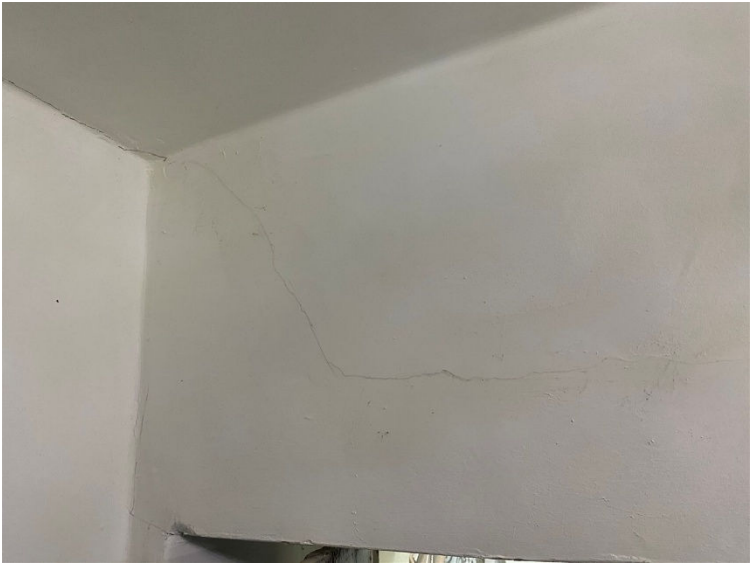
| Photo No | Photograph Description | Photograph |
|---|---|---|
| 22. | <b>Cinema Room</b><br>Hairline crack above door | |

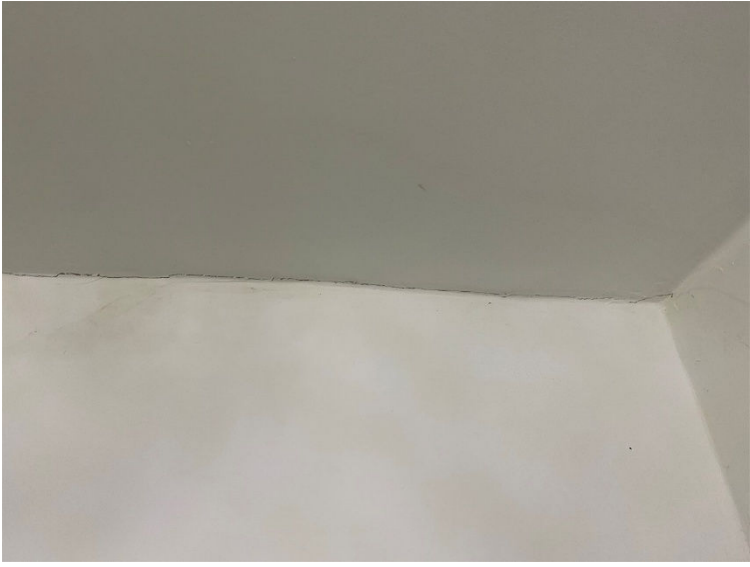
| Photo No | Photograph Description | Photograph |
|---|---|---|
| 23. | <b>Cinema Room</b><br>Hairline crack between wall and ceiling | |

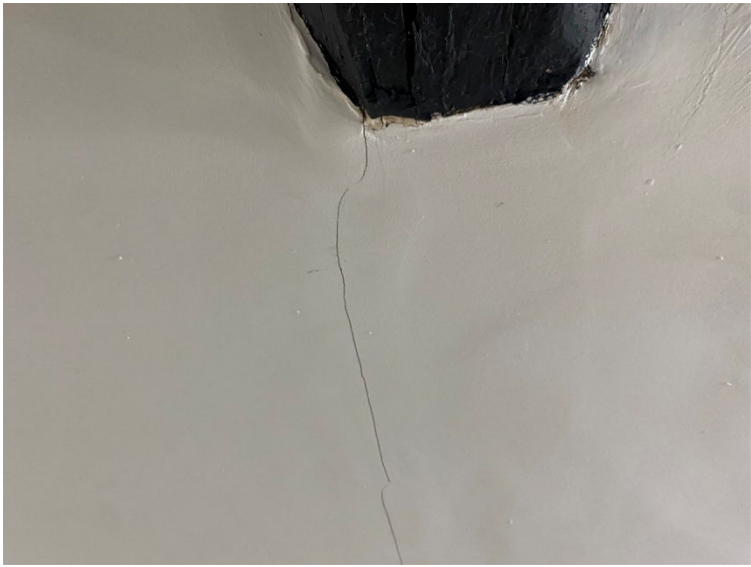
| Photo No | Photograph Description | Photograph |
|---|---|---|
| 27. | <b>Cinema Room</b><br>Crack adjacent to ceiling beam | |

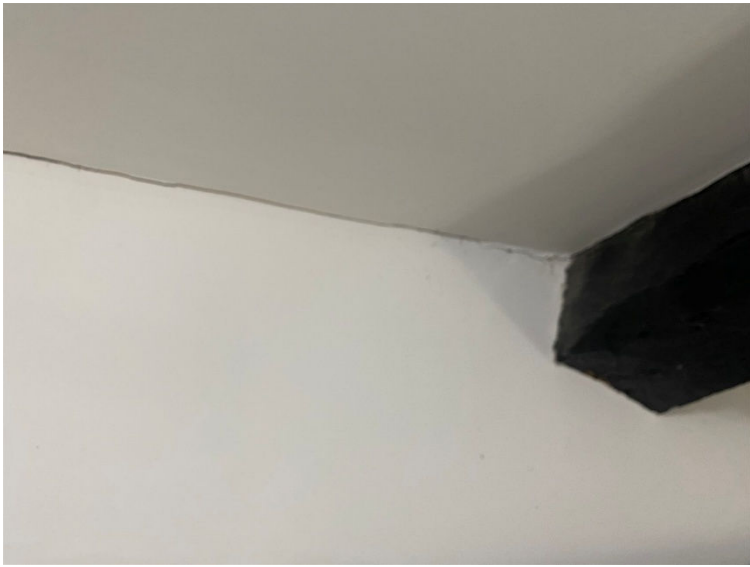
| Photo No | Photograph Description | Photograph |
|---|---|---|
| 30. | <b>Cinema Room</b><br>Crack between wall and ceiling | |

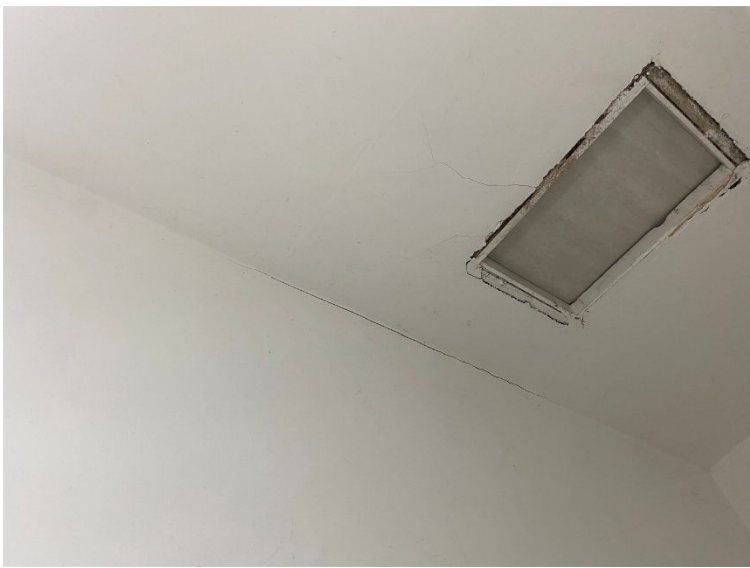
| Photo No | Photograph Description | Photograph |
|---|---|---|
| 32. | <b>East stairs</b><br>Hairline cracks approximately 300mm in length adjacent loft access hatch | |

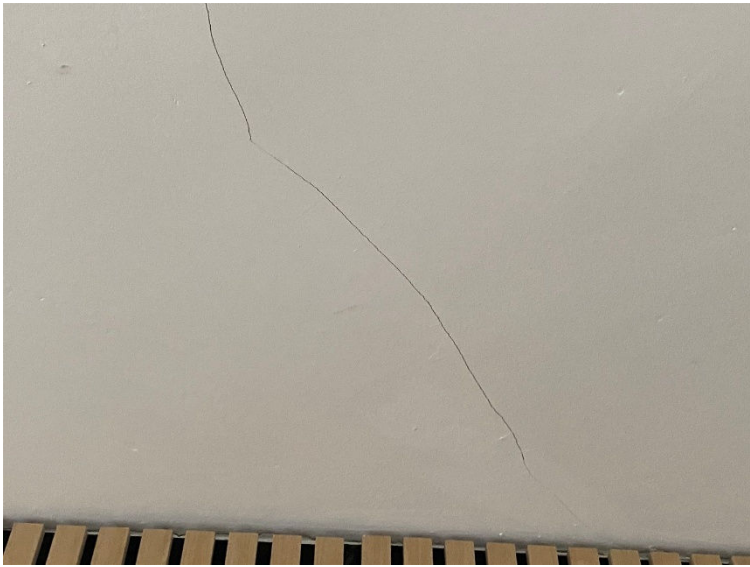
| Photo No | Photograph Description | Photograph |
|---|---|---|
| 42. | <b>East bedroom</b><br>Hairline crack approximately 2.5m long running from timber panelling to the centre of the ceiling | |

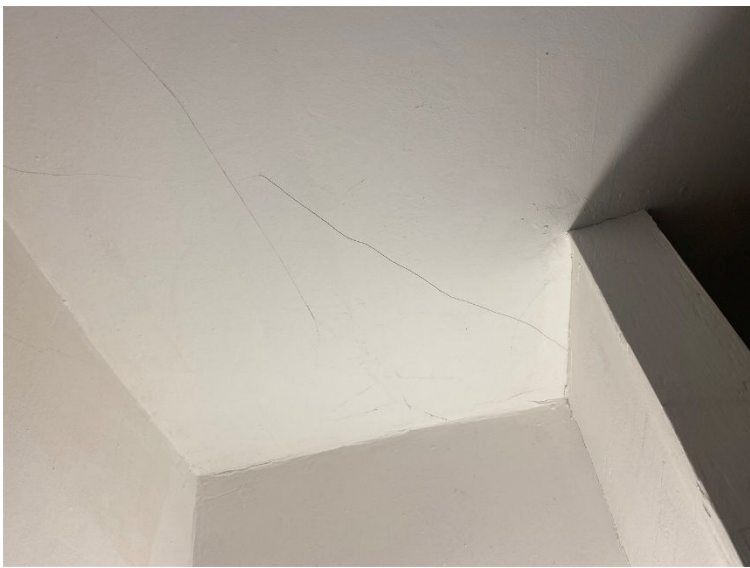
| Photo No | Photograph Description | Photograph |
|---|---|---|
| 44. | <b>East bedroom - walk-in wardrobe</b><br>Crack to ceiling | |

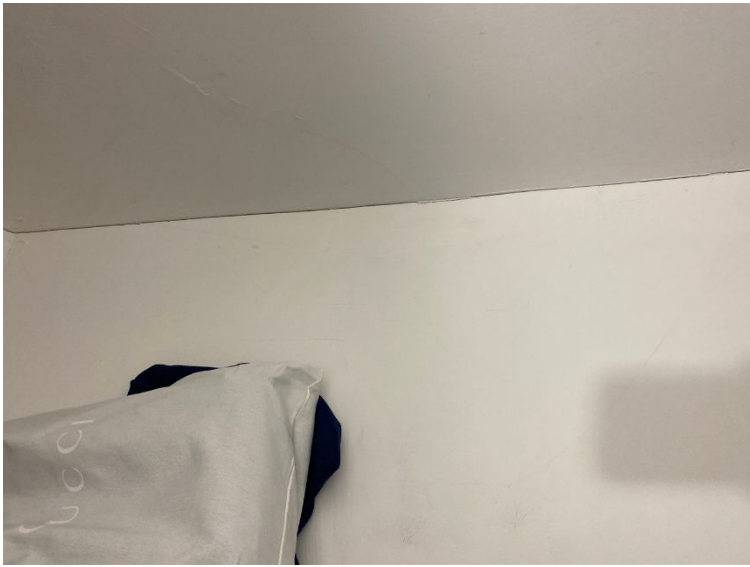
| Photo No | Photograph Description | Photograph |
|---|---|---|
| 48. | <b>East bedroom - walk-in wardrobe</b><br>Crack at junction between wall and ceiling | |

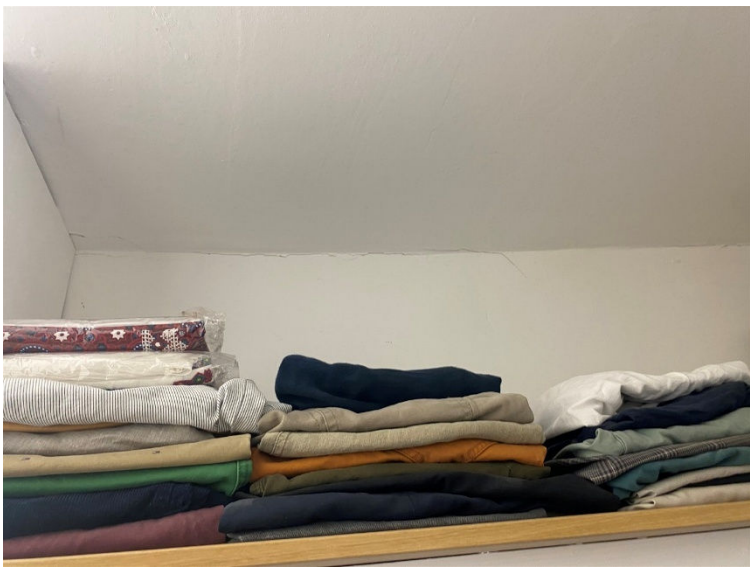
| Photo No | Photograph Description | Photograph |
|---|---|---|
| 50. | <b>East bedroom - walk-in wardrobe</b><br>Crack at junction between wall and ceiling | |

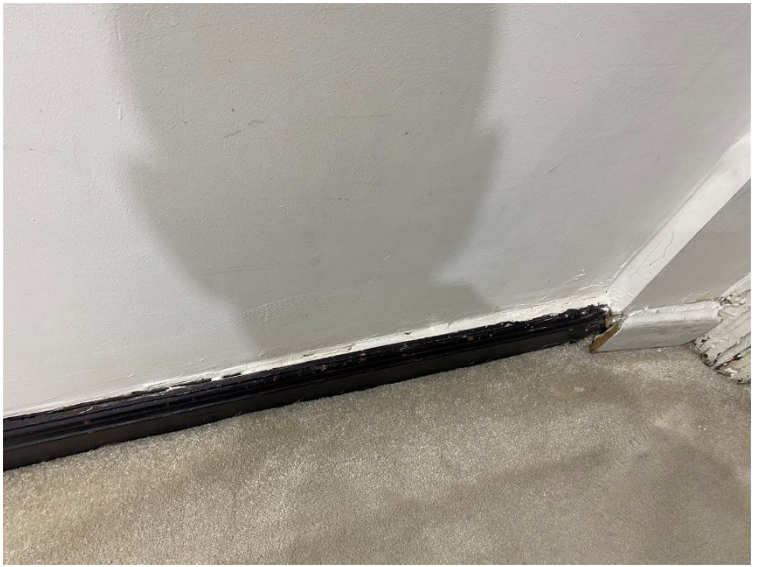
| Photo No | Photograph Description | Photograph |
|---|---|---|
| 69. | <b>Landing</b><br>Open joint between skirting and wall | |

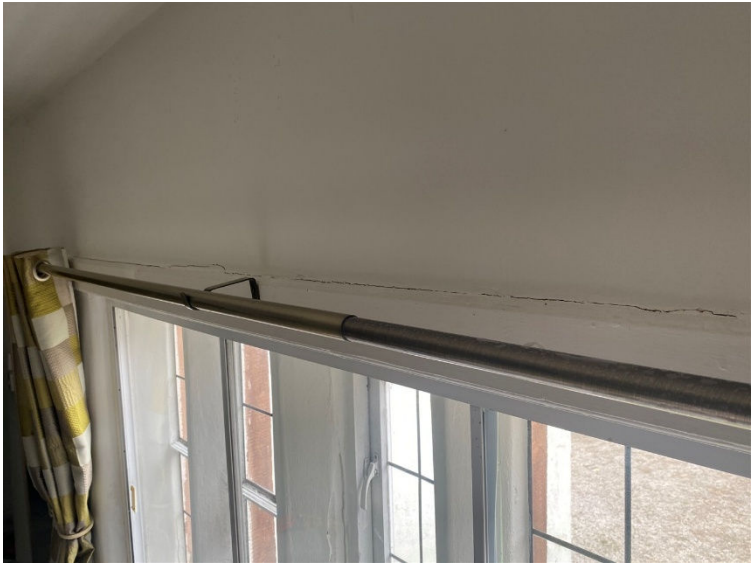
| Photo No | Photograph Description | Photograph |
|---|---|---|
| 76. | <b>Middle bedroom</b><br>Crack between window surround and wall above | |

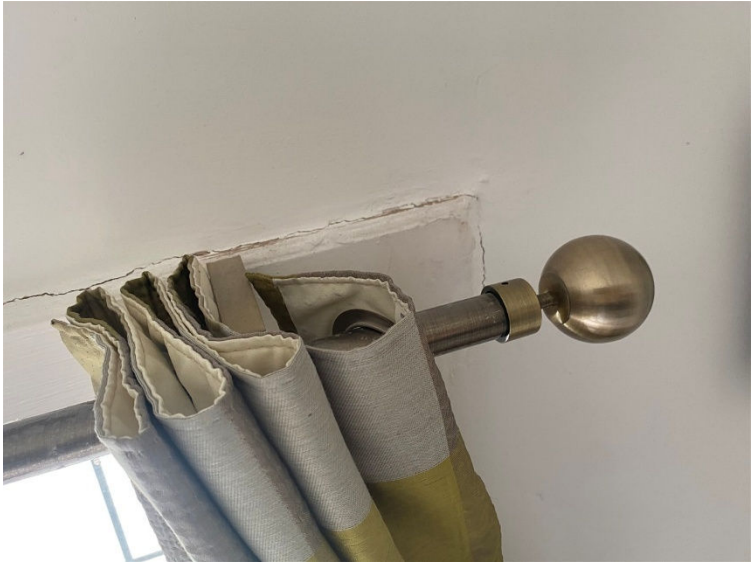
| Photo No | Photograph Description | Photograph |
|---|---|---|
| 77. | <b>Middle bedroom</b><br>Crack between window surround and the wall | |

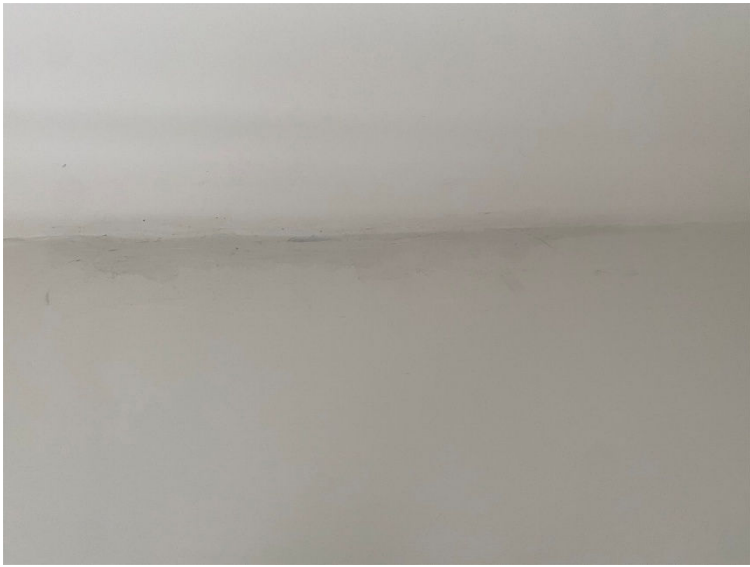
| Photo No | Photograph Description | Photograph |
|---|---|---|
| 78. | <b>Middle bedroom</b><br>Filled crack at junction between ceiling and external wall | |

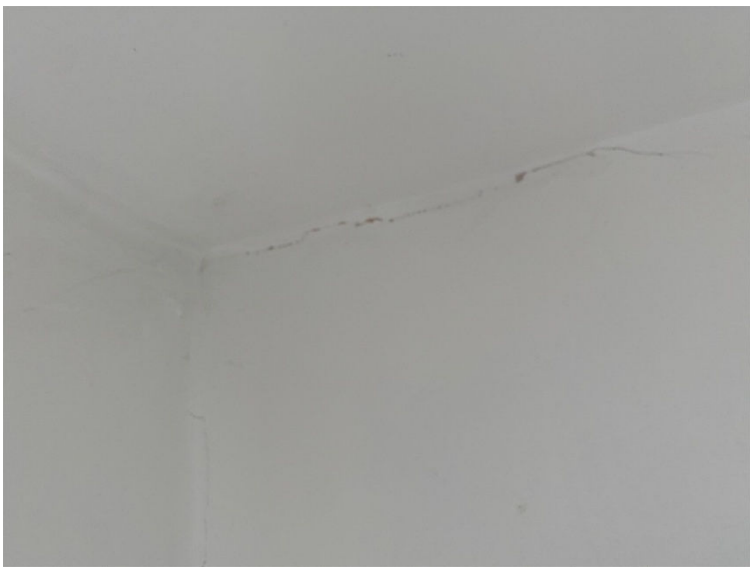
| Photo No | Photograph Description | Photograph |
|---|---|---|
| 80. | <b>Middle bedroom</b><br>Hairline cracks on junction between wall and ceiling on west side | |

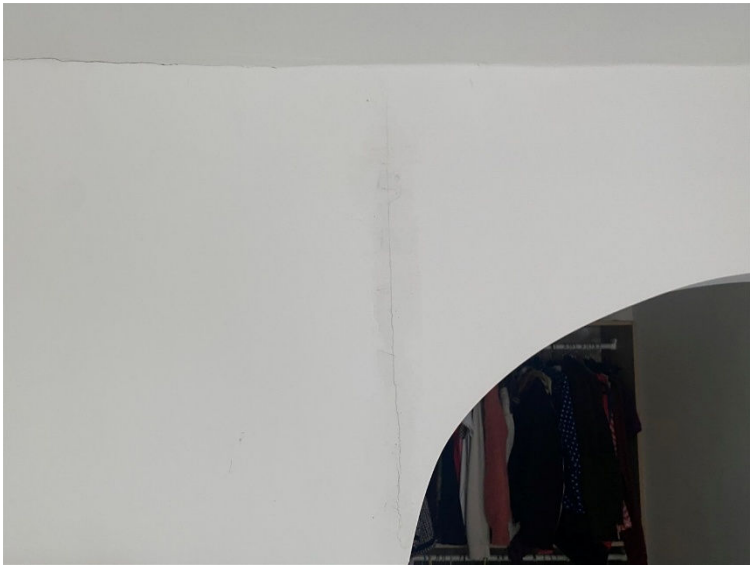
| Photo No | Photograph Description | Photograph |
|---|---|---|
| 81. | <b>Middle bedroom</b><br>One of two filled vertical cracks to either side of arched door opening | A photograph showing a vertical crack in a white wall. The crack runs from the ceiling down towards the floor. To the right of the crack, there is an arched doorway leading into a room where clothes are hanging on a rack. |

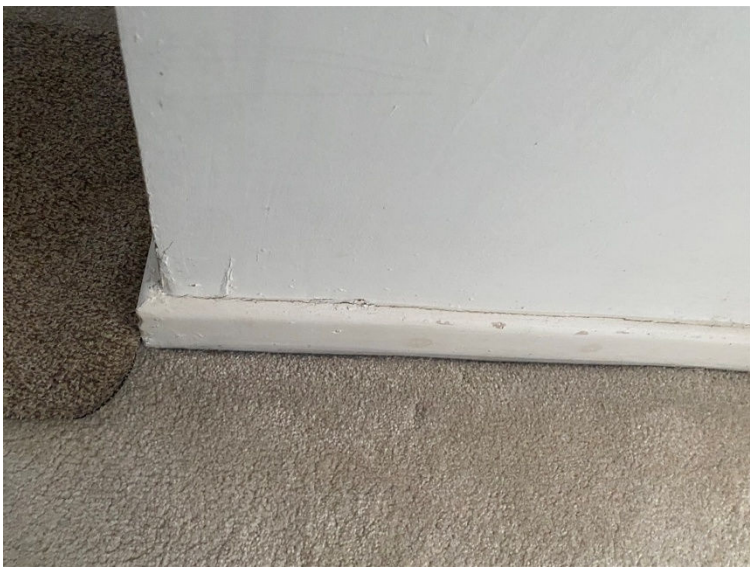
| Photo No | Photograph Description | Photograph |
|---|---|---|
| 83. | <b>Middle bedroom</b><br>Crack between skirting and wall | A photograph showing a crack between a white skirting board and a white wall. The crack is visible along the length of the skirting board. The floor is covered with a grey carpet. |

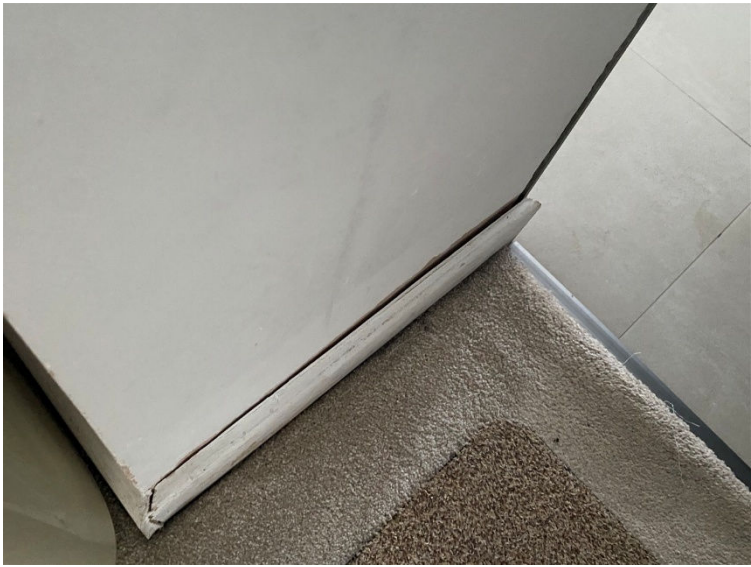
| Photo No | Photograph Description | Photograph |
|---|---|---|
| 84. | <b>Middle bedroom</b><br>Open joint between skirting and wall | |

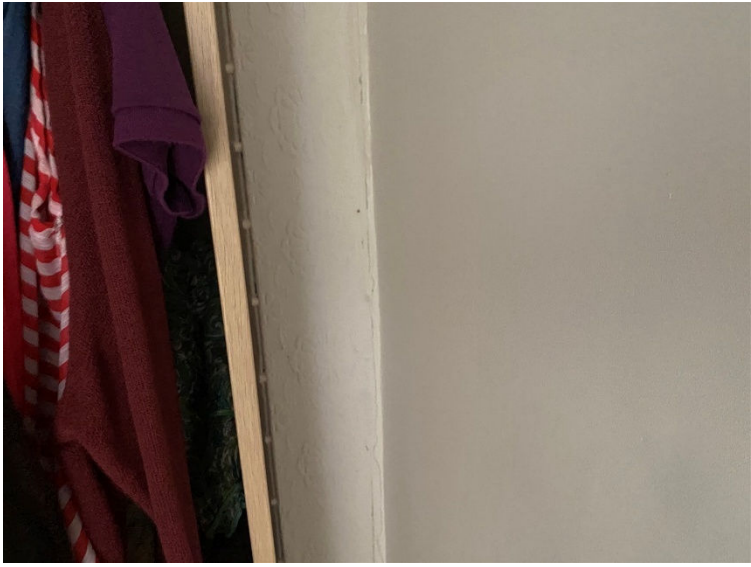
| Photo No | Photograph Description | Photograph |
|---|---|---|
| 85. | <b>Middle bedroom walk-in wardrobe</b><br>Vertical hairline crack | |

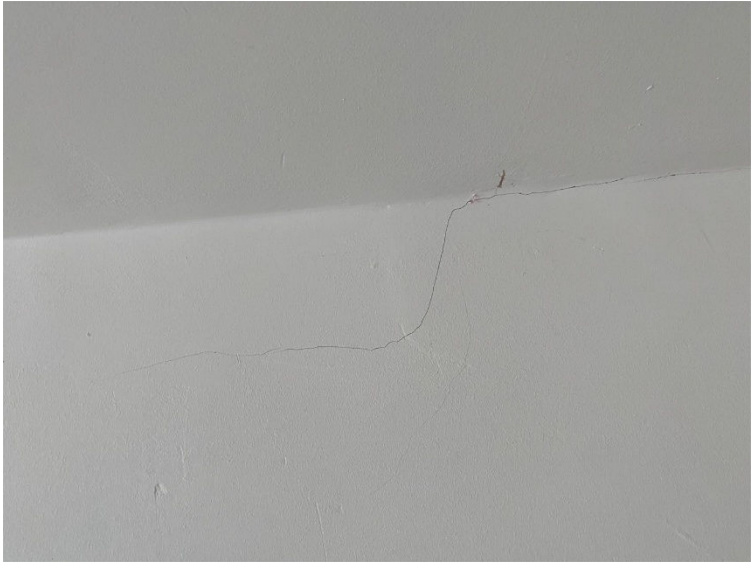
| Photo No | Photograph Description | Photograph |
|---|---|---|
| 86. | <b>Middle bedroom walk-in wardrobe</b><br>Hairline crack at junction between wall and ceiling running down the wall | |

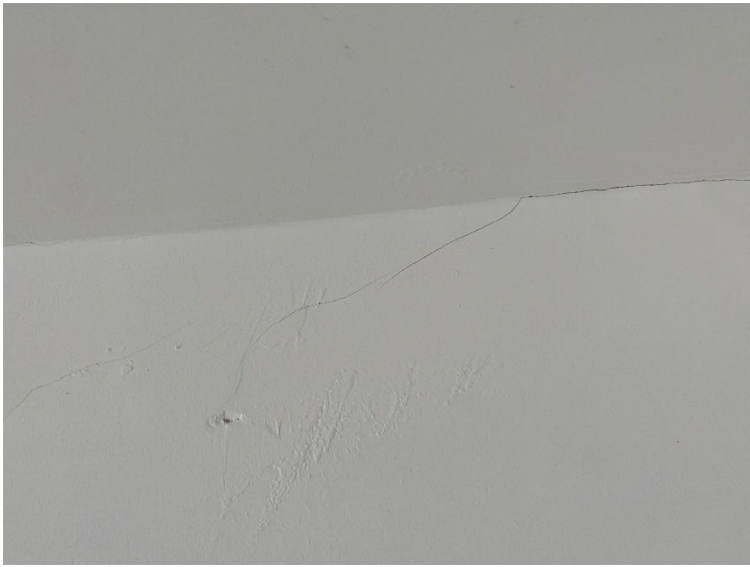
| Photo No | Photograph Description | Photograph |
|---|---|---|
| 87. | <b>Middle bedroom walk-in wardrobe</b><br><br>Hairline crack at junction between wall and ceiling extending down the wall | |

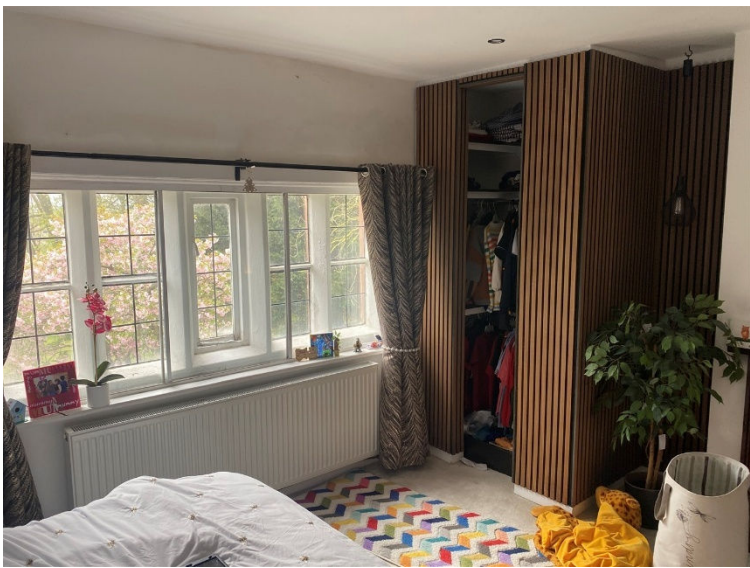
| Photo No | Photograph Description | Photograph |
|---|---|---|
| 89. | <b>Southwest bedroom</b><br><br>2 vertical hairline cracks and discolouration above window | |

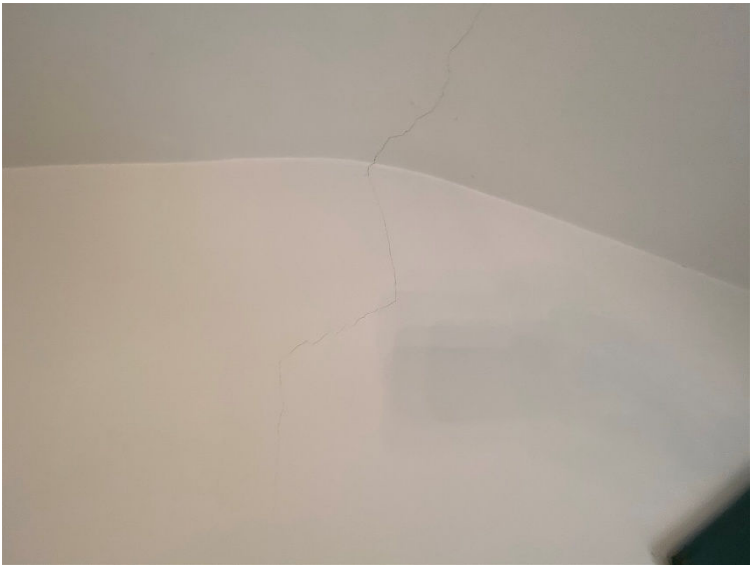
| Photo No | Photograph Description | Photograph |
|---|---|---|
| 102. | <b>Northwest bedroom</b><br>Hairline crack to external wall running into ceiling | |

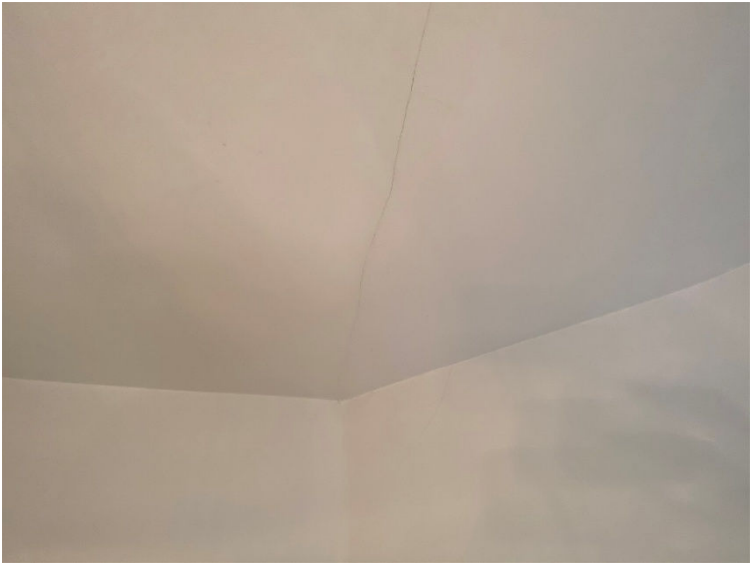
| Photo No | Photograph Description | Photograph |
|---|---|---|
| 103. | <b>Northwest bedroom</b><br>Hairline crack to ceiling | |

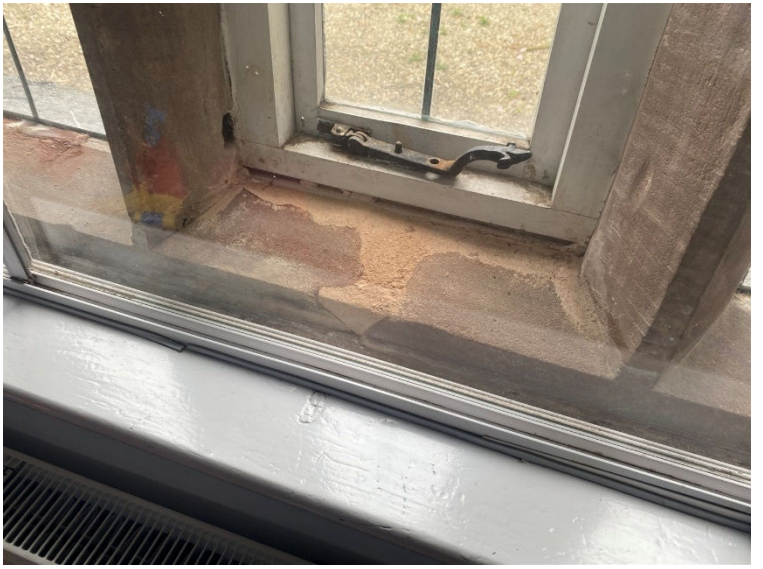
| Photo No | Photograph Description | Photograph |
|---|---|---|
| 135. | <b>TV room</b><br>Repaired stone window surround | |

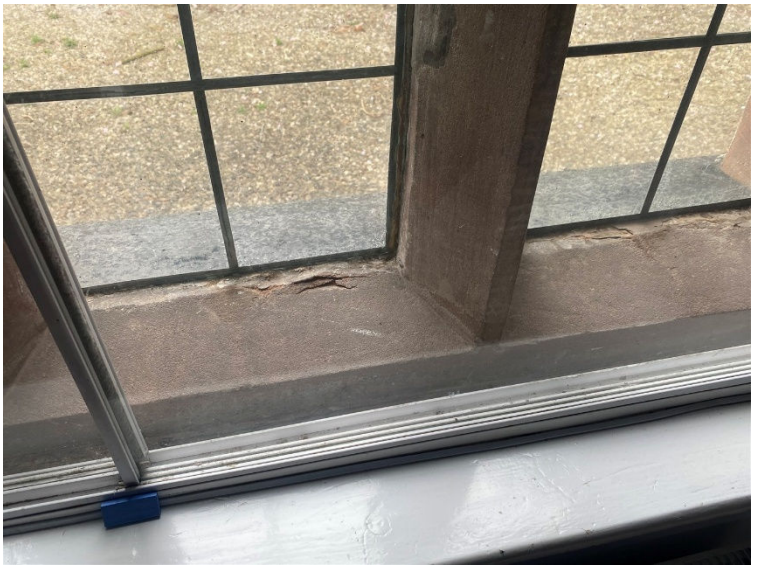
| Photo No | Photograph Description | Photograph |
|---|---|---|
| 136. | <b>TV room</b><br>Crack to stone window surround | |

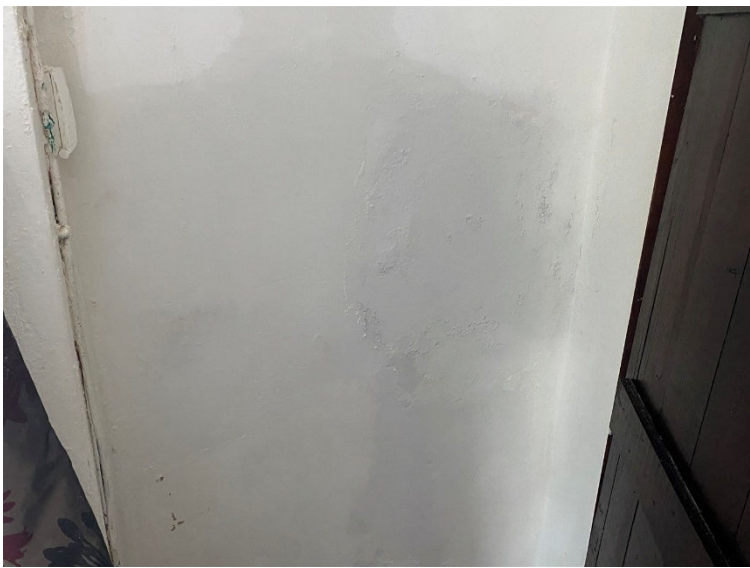
| Photo No | Photograph Description | Photograph |
|---|---|---|
| 161. | <b>Dining room</b><br>Plaster in poor condition adjacent external door | |

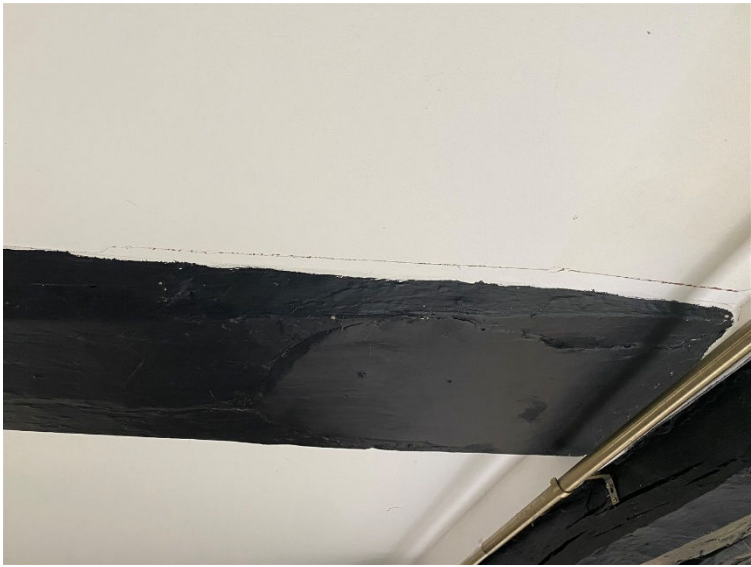
| Photo No | Photograph Description | Photograph |
|---|---|---|
| 162. | <b>Dining room</b><br>Crack adjacent ceiling beam | |

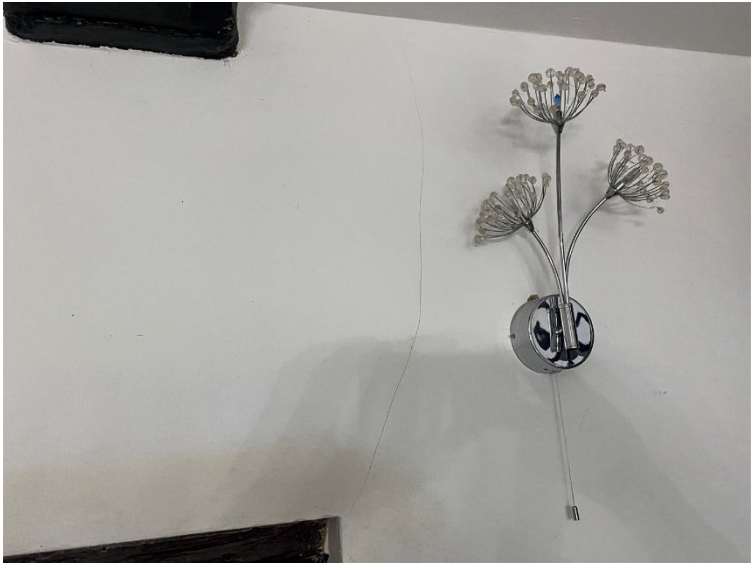
| Photo No | Photograph Description | Photograph |
|---|---|---|
| 163. | <b>Dining room</b><br>Hairline crack to right top corner of door | |

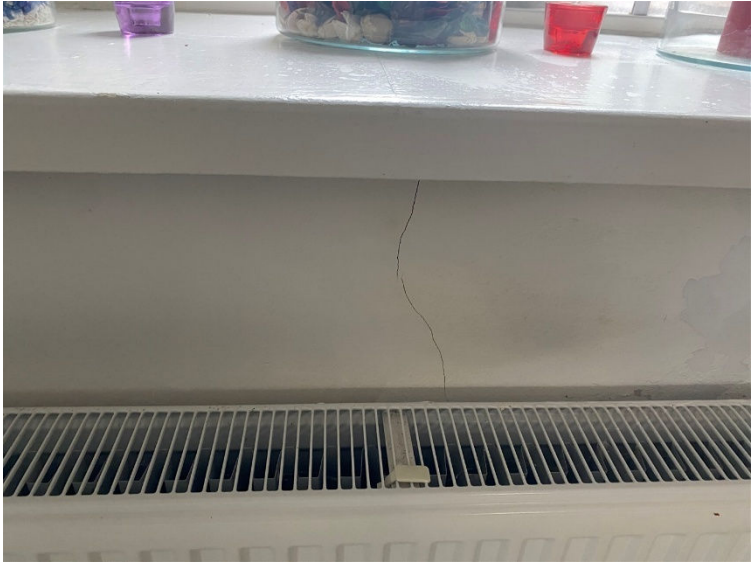
| Photo No | Photograph Description | Photograph |
|---|---|---|
| 164. | <b>Dining room</b><br>Crack below window | |

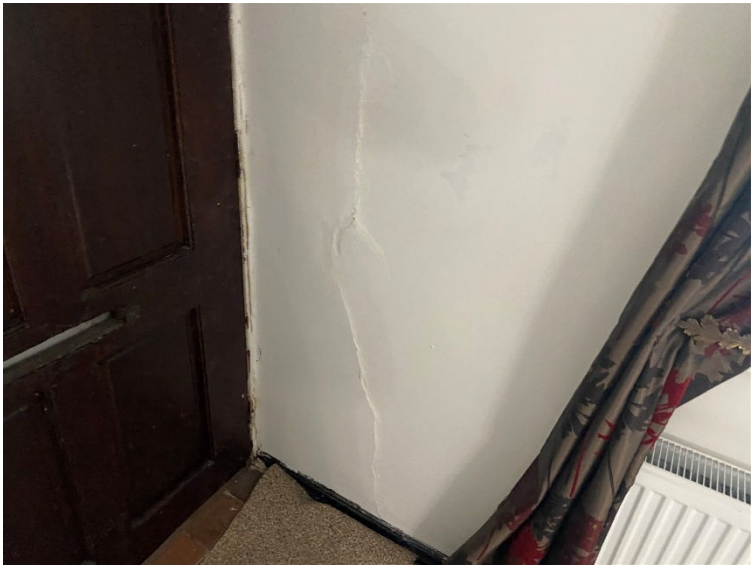
| Photo No | Photograph Description | Photograph |
|---|---|---|
| 165. | <b>Dining room</b><br>Cracked and uneven plaster adjacent to external door | A photograph showing a dark wooden door on the left. To the right of the door, the white plaster on the wall is cracked and uneven. A patterned curtain is visible on the right side of the frame. |

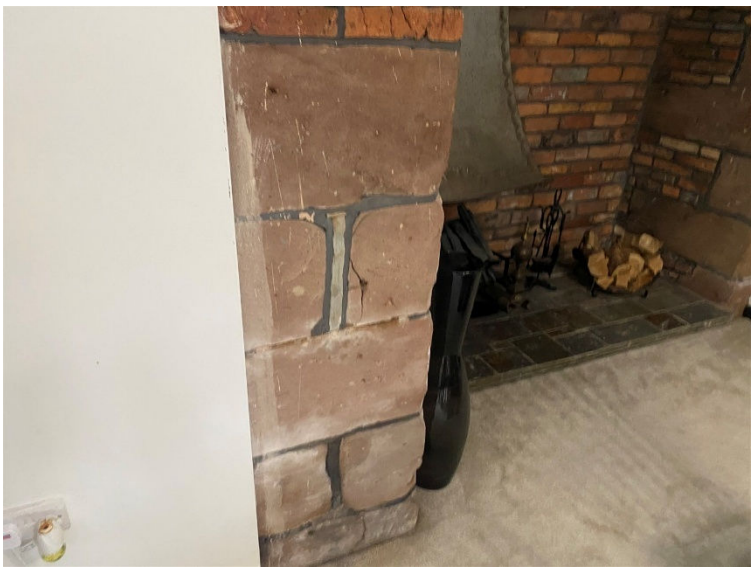
| Photo No | Photograph Description | Photograph |
|---|---|---|
| 167. | <b>Dining room</b><br>Crack in stonework around fireplace | A photograph showing a fireplace with a brick and stone surround. A crack is visible in the stonework above the fireplace. A black bag is hanging on the wall to the left of the fireplace. |

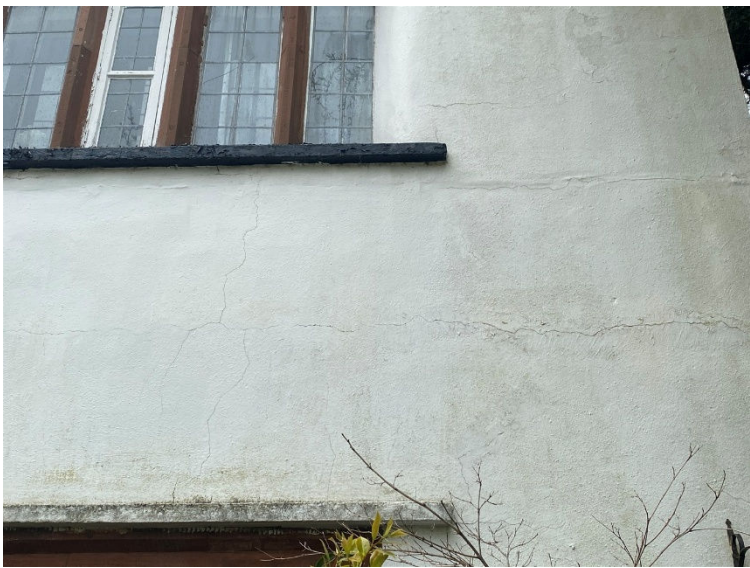
| Photo No | Photograph Description | Photograph |
|---|---|---|
| 194. | <b>Front elevation</b><br>Vertical and horizontal cracking between ground and first floor windows | |

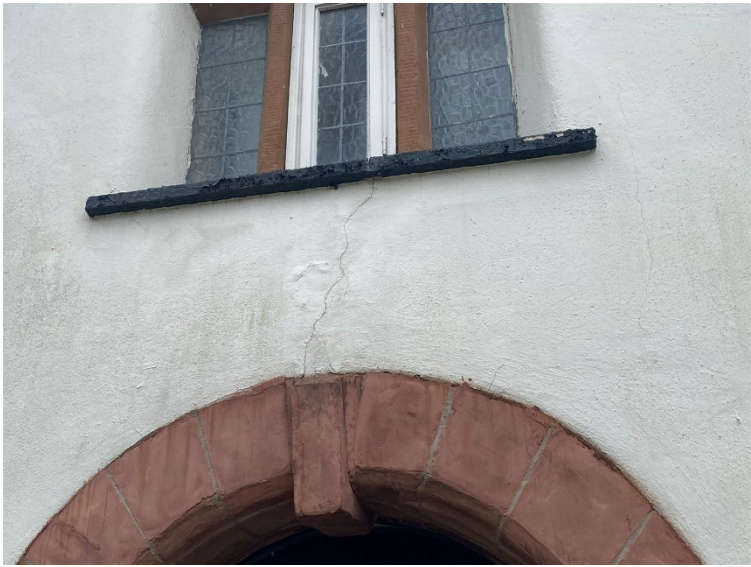
| Photo No | Photograph Description | Photograph |
|---|---|---|
| 198. | <b>Front elevation</b><br>Crack between main entrance arch and window above | |

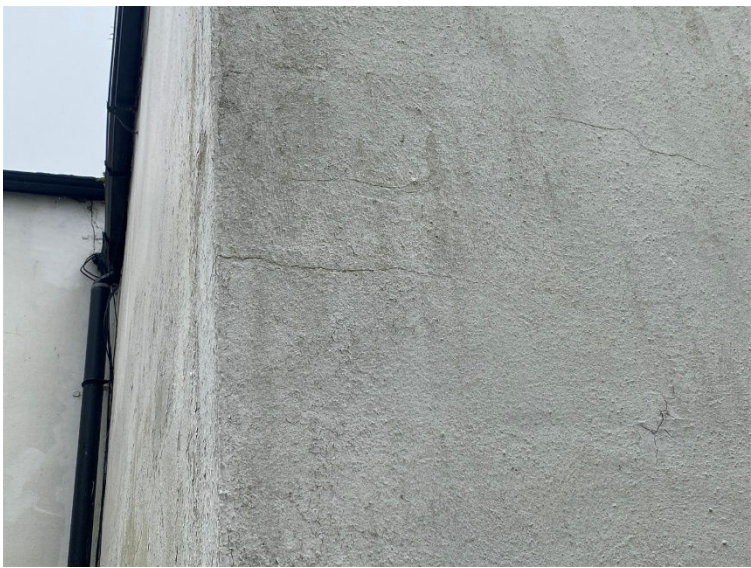
| Photo No | Photograph Description | Photograph |
|---|---|---|
| 200. | <b>Front elevation</b><br>Crack to left side of porch | |

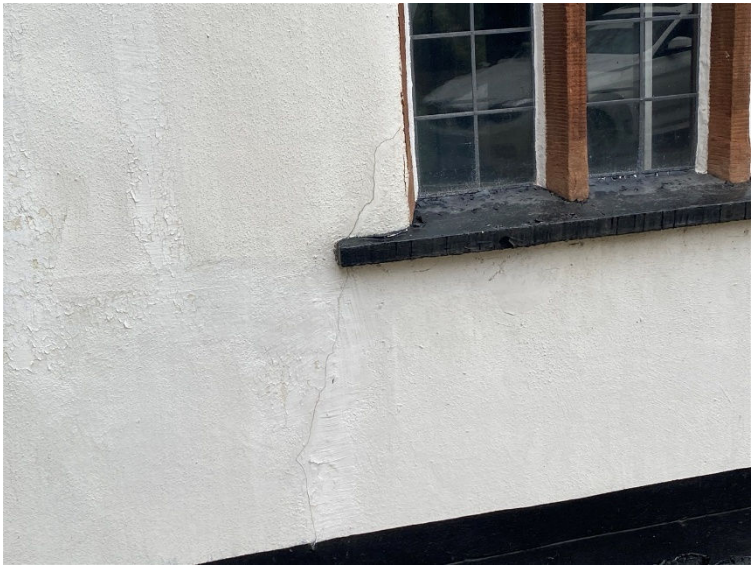
| Photo No | Photograph Description | Photograph |
|---|---|---|
| 210. | <b>Front elevation</b><br>Cracking at low level between sill and black band | |

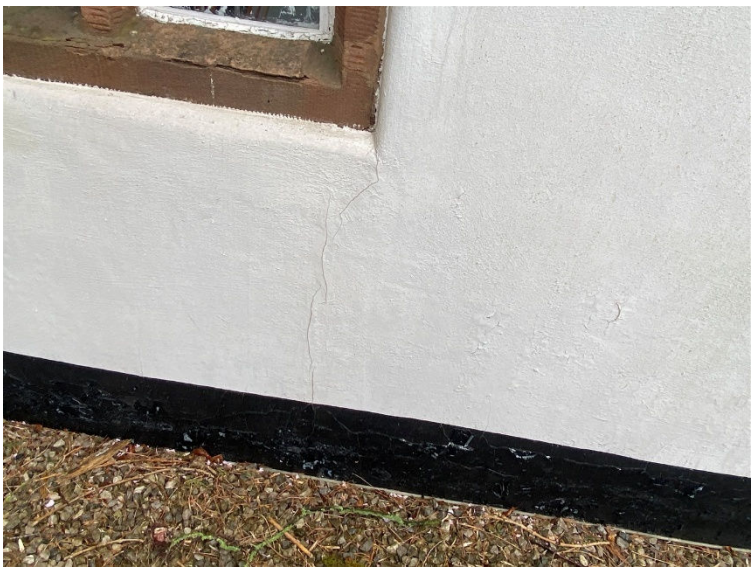
| Photo No | Photograph Description | Photograph |
|---|---|---|
| 212. | <b>Front elevation</b><br>Cracking between ground floor window and black band | |
