# Photographic Schedule of Condition

Old Halsnead Hall, Fox's Bank Lane, Widnes, Prescot L35 3SU

April 2026

Doc Ref: 04C600152

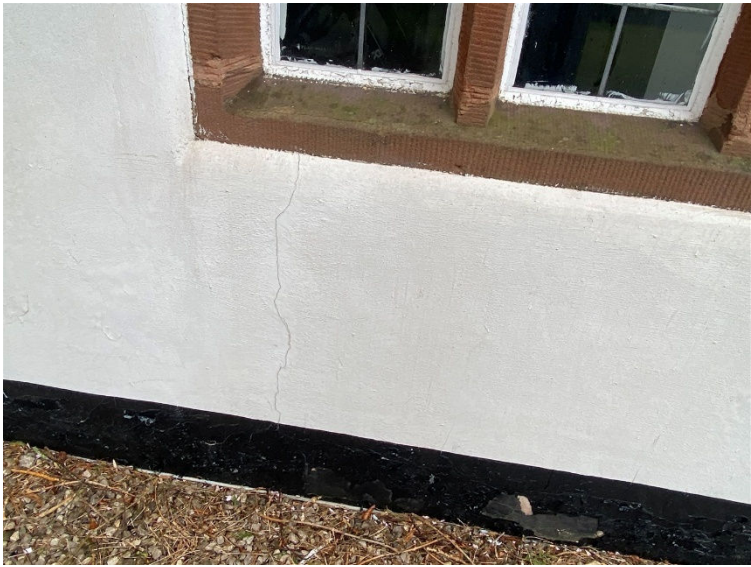
| Photo No | Photograph Description | Photograph |
|---|---|---|
| 213. | <b>Front elevation</b><br>Cracking between ground floor window and black band | |

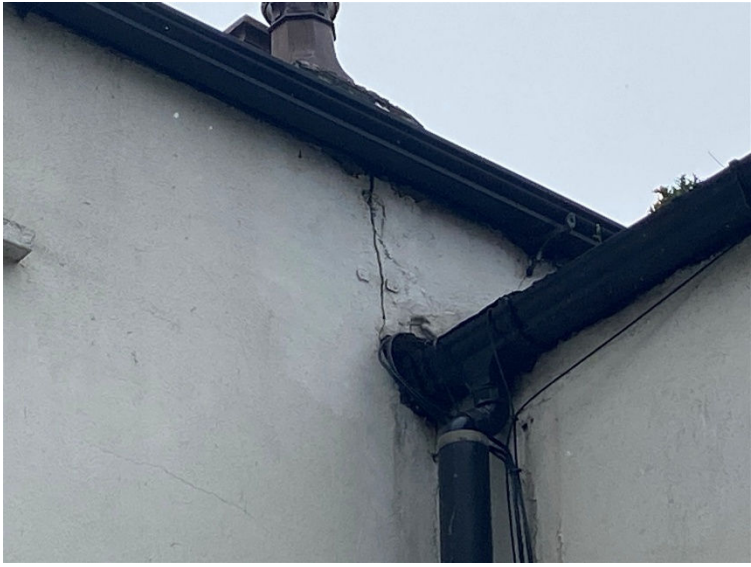
| Photo No | Photograph Description | Photograph |
|---|---|---|
| 214. | <b>Front elevation</b><br>Cracking between two storey eaves and porch on left hand side | |

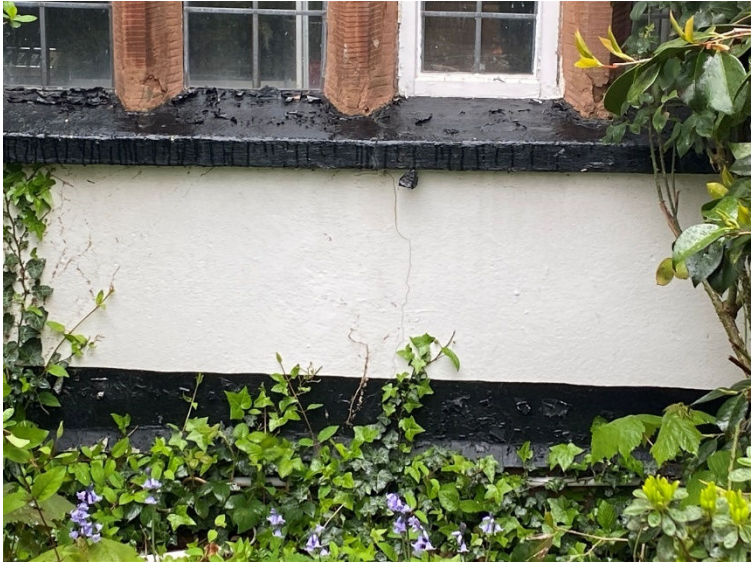
| Photo No | Photograph Description | Photograph |
|---|---|---|
| 215. | <b>Front elevation</b><br>Cracking between ground floor window and black band to right hand side | |

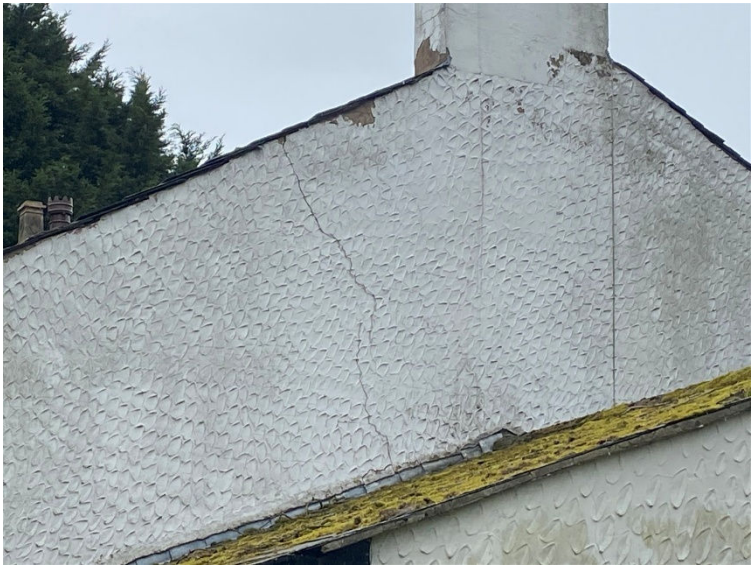
| Photo No | Photograph Description | Photograph |
|---|---|---|
| 219. | <b>West elevation</b><br>Cracking to left side of gable at high level | A photograph of the upper part of a white building with a textured, pebble-dash finish. A vertical crack runs down the left side of the gable. The roofline is visible at the top, and some greenery is in the background. |

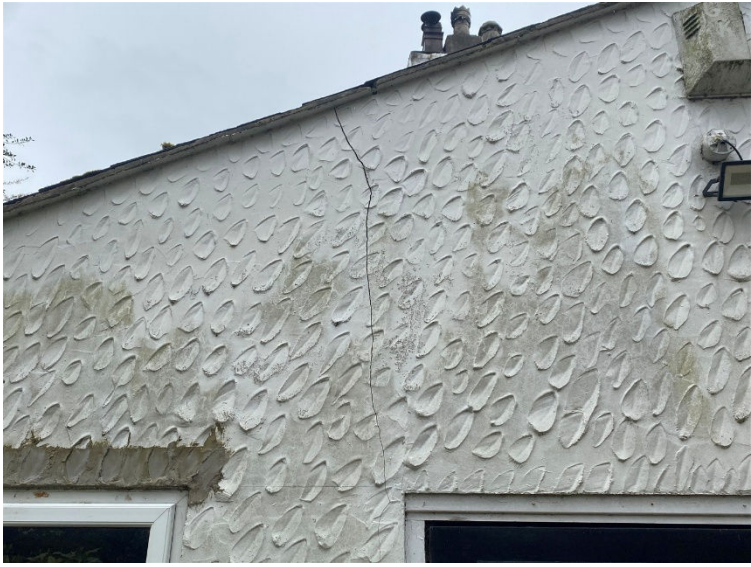
| Photo No | Photograph Description | Photograph |
|---|---|---|
| 220. | <b>West elevation</b><br>Cracking to left side of single storey section | A photograph of the side of a white building with a textured, pebble-dash finish. A vertical crack runs down the left side of the single storey section. The roofline is visible at the top, and some greenery is in the background. |

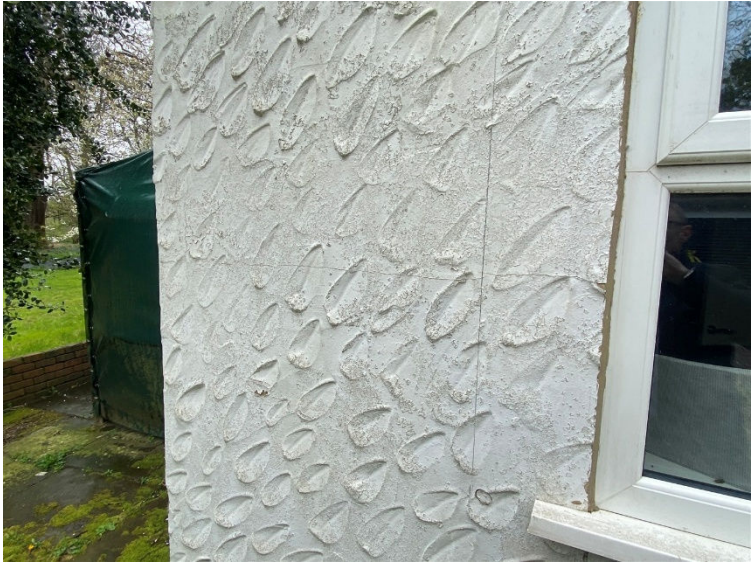
| Photo No | Photograph Description | Photograph |
|---|---|---|
| 221. | <b>West elevation</b><br>Vertical crack to left of window | A close-up photograph of the side of a white building with a textured, pebble-dash finish. A vertical crack runs down the wall to the left of a window. The window frame is visible on the right side of the image. |

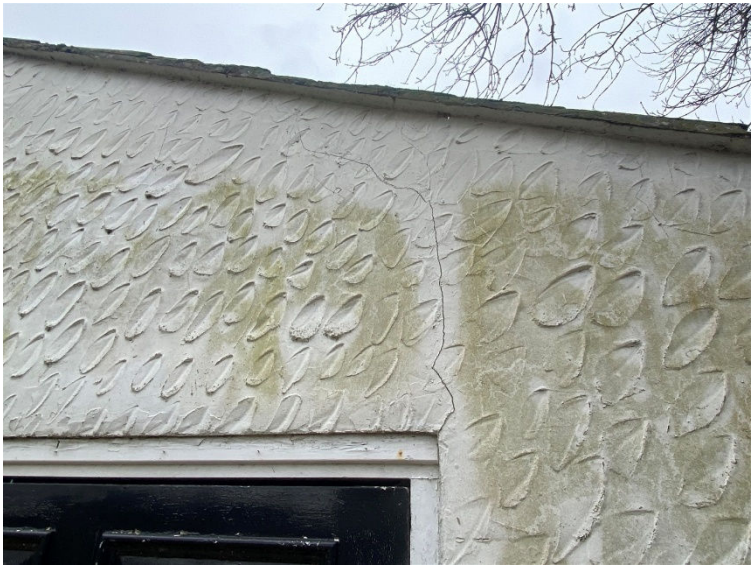
| Photo No | Photograph Description | Photograph |
|---|---|---|
| 222. | <b>West elevation</b><br>Crack to top right of window | |

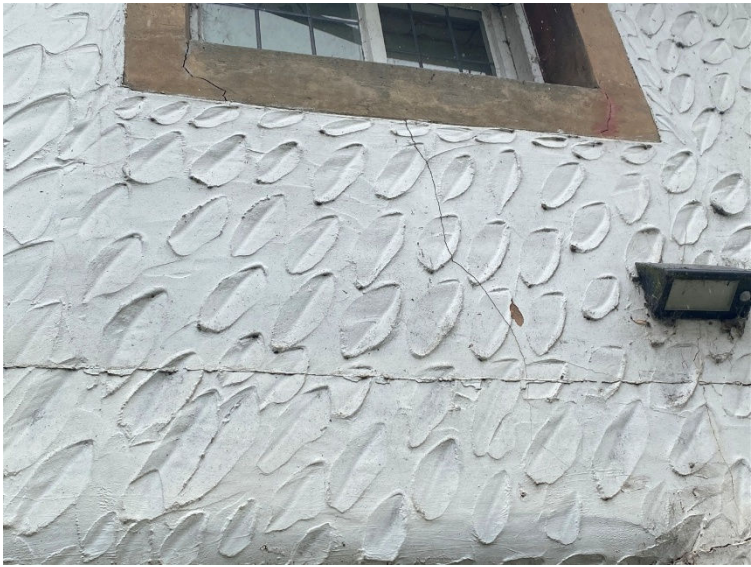
| Photo No | Photograph Description | Photograph |
|---|---|---|
| 234. | <b>North elevation</b><br>Hairline crack below window | |

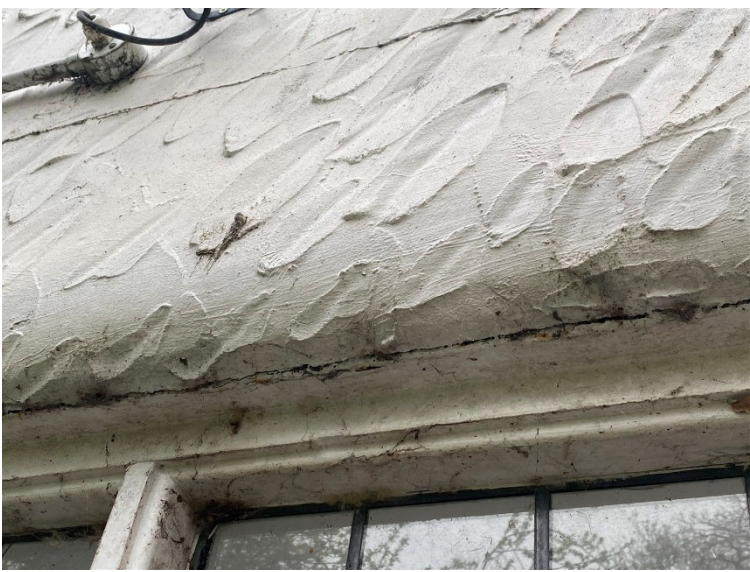
| Photo No | Photograph Description | Photograph |
|---|---|---|
| 237. | <b>North elevation</b><br>Cracking around window reveal | |

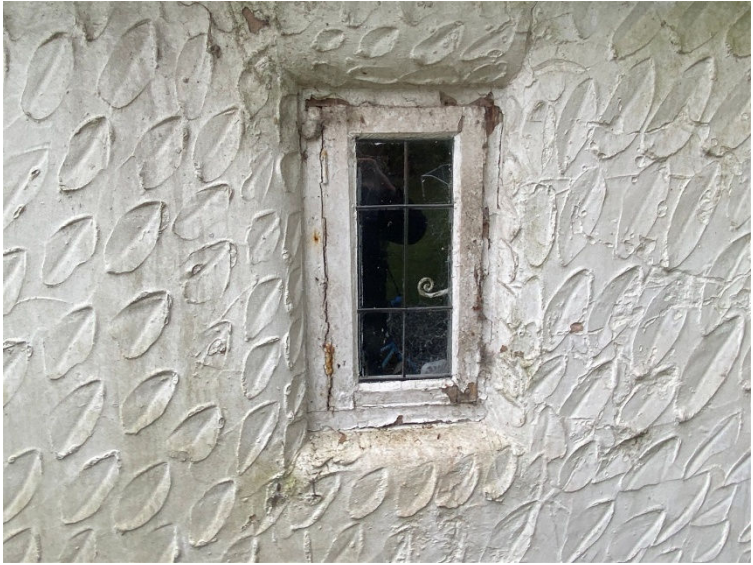
| Photo No | Photograph Description | Photograph |
|---|---|---|
| 240. | <b>North elevation</b><br>Cracking around window | |

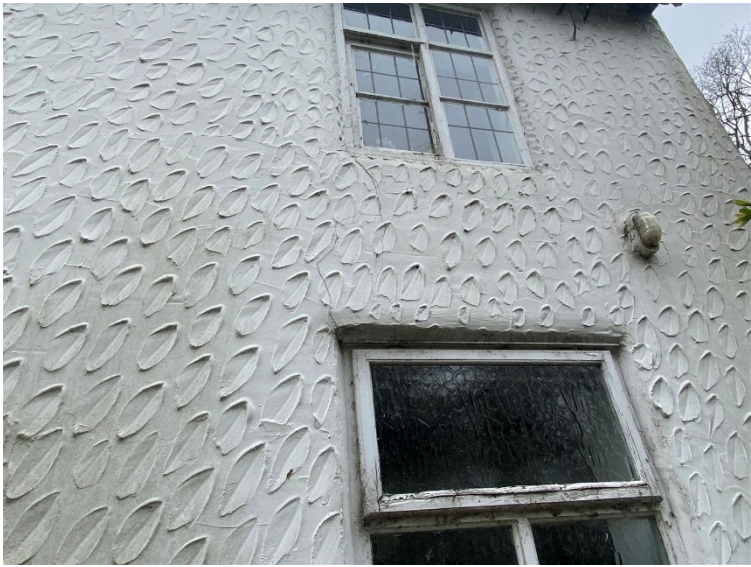
| Photo No | Photograph Description | Photograph |
|---|---|---|
| 243. | <b>North elevation</b><br>Cracking between ground and first floor windows | |

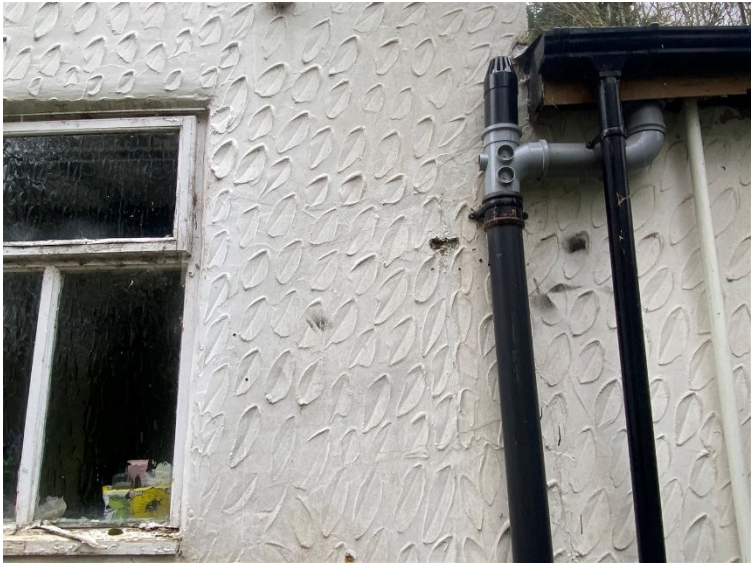
| Photo No | Photograph Description | Photograph |
|---|---|---|
| 244. | <b>North elevation</b><br>Cracking to right of window | |

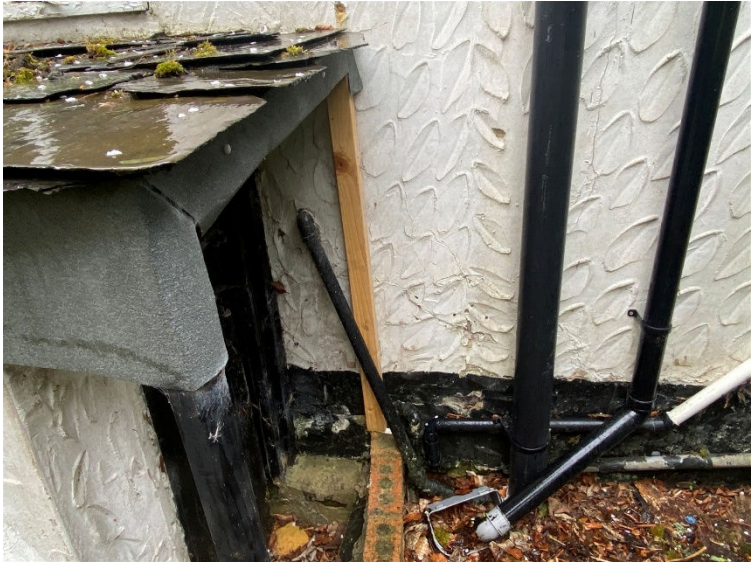
| Photo No | Photograph Description | Photograph |
|---|---|---|
| 245. | <b>North elevation</b><br>Cracking behind pipe work | |
