## GAS MEMBRANE VALIDATION – DRAW WELL ROAD

| <b>Project Name:</b> | Draw Well Road, Knowsley |
| <b>Project Number:</b> | 12-969 |
| <b>Plots:</b> | Unit 1 |

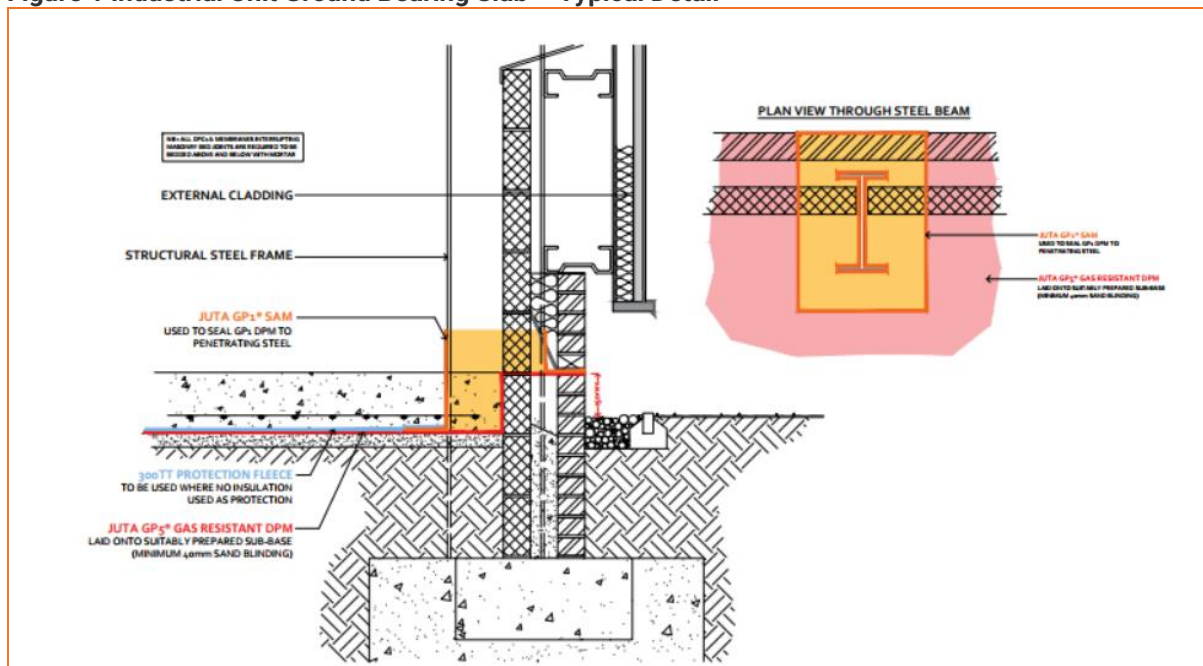
Figure 1 Industrial Unit Ground Bearing Slab – Typical Detail

It has been confirmed as part of the validation that the membrane utilised in the units (office areas) discussed herein matches that of **Figure 1-2**.

The E3P Technician has inspected the installation of this membrane in line with the specifications in terms of placement and position (**Figure 1-2**), and the manufacturer's detail in terms of the workmanship. **Figure 3** illustrates the ground floor layout for the unit numbers validated within this letter.

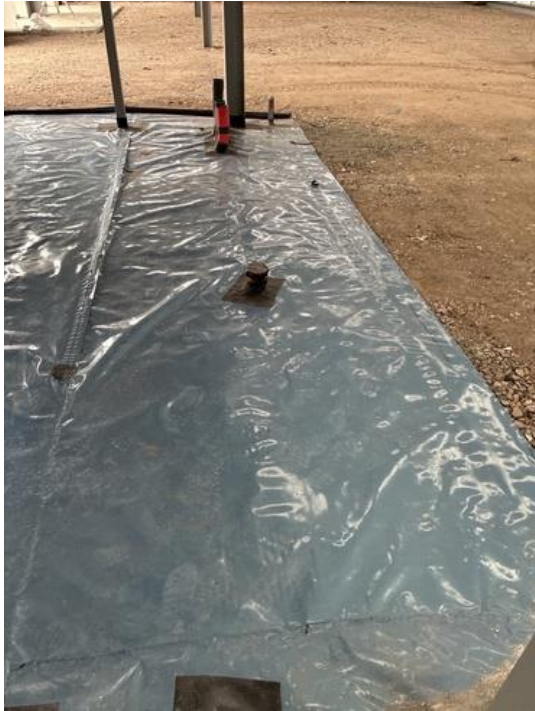
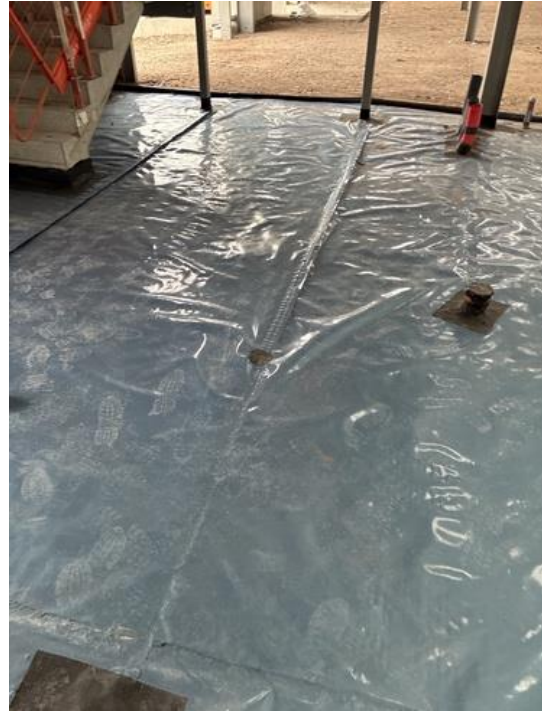
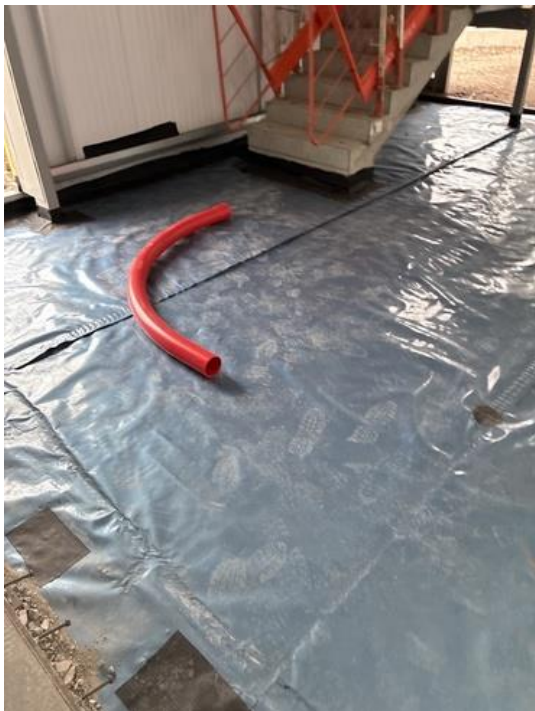
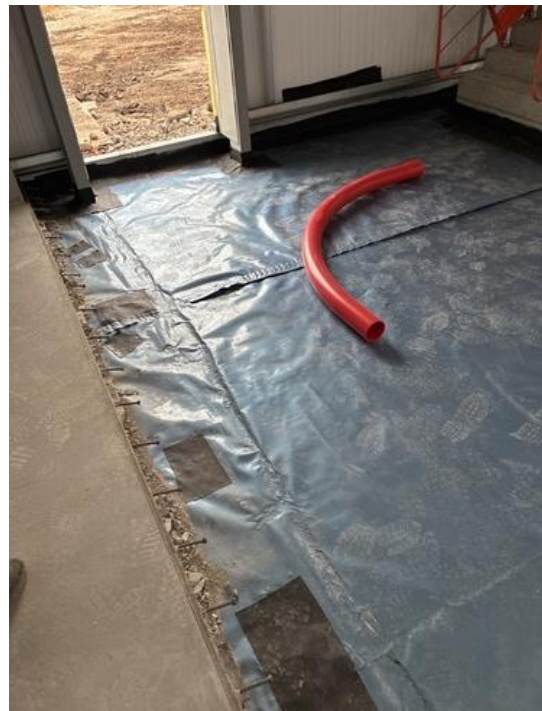
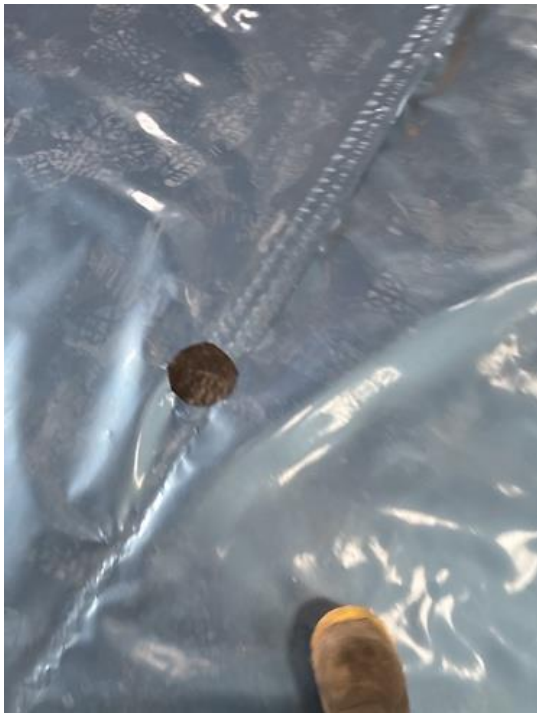
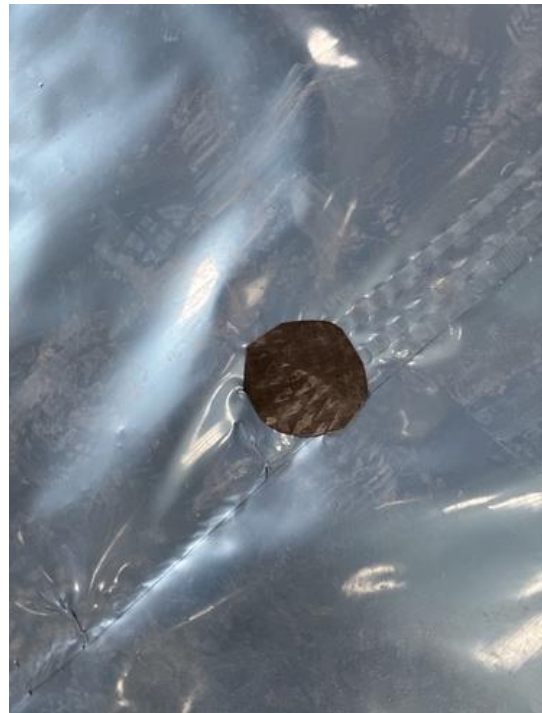
| <b>Gas Membrane Condition: Open punctures, tears, rips, stretching, Presence of debris, Repairs, Signs of weakness such as raised or sunken indentations, Protection plan in place to restrict access to gas membrane? IF FAIL DESCRIPTION IN ACTIONS AND PHOTOS REQUIRED</b> | <div>Pass</div> |

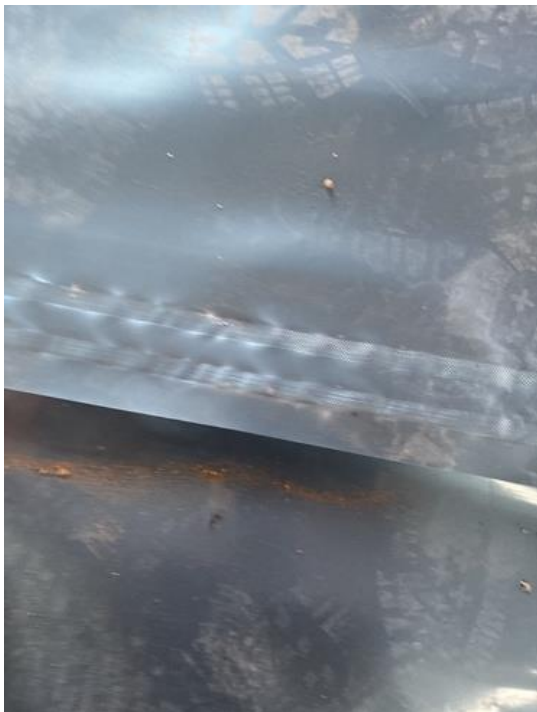
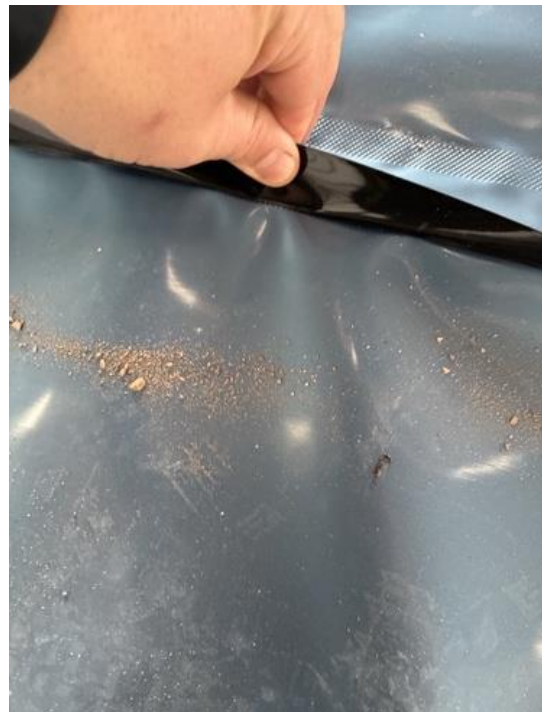
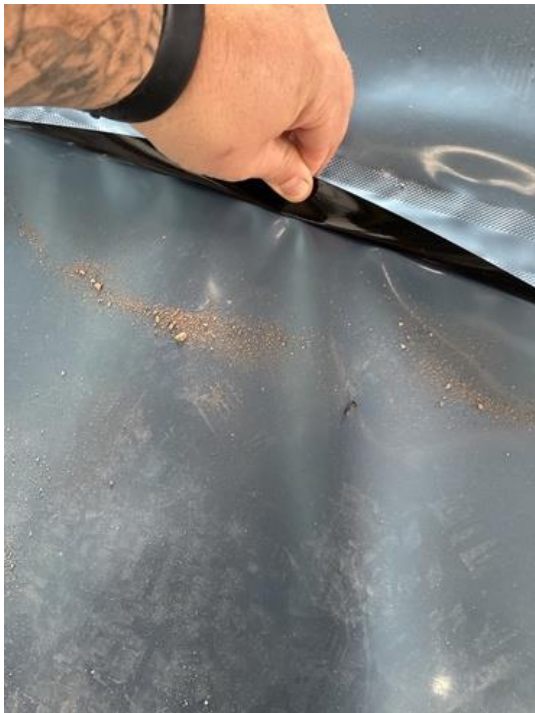
| <b>Are welds complete?</b> | Yes |

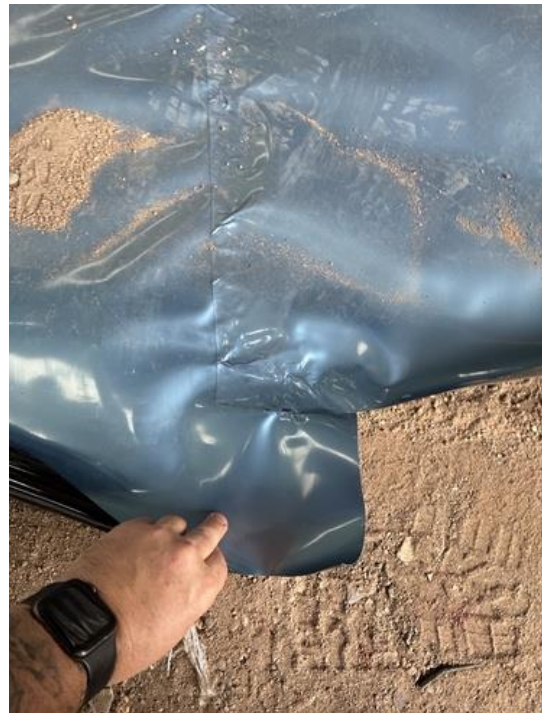
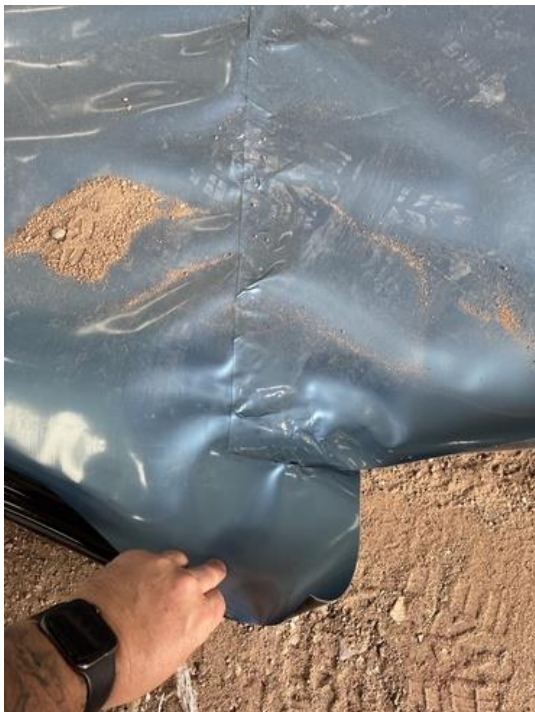
| <b>Are Joints lapped and sealed in accordance with manufacturer's requirements/ specification?</b> | Yes |

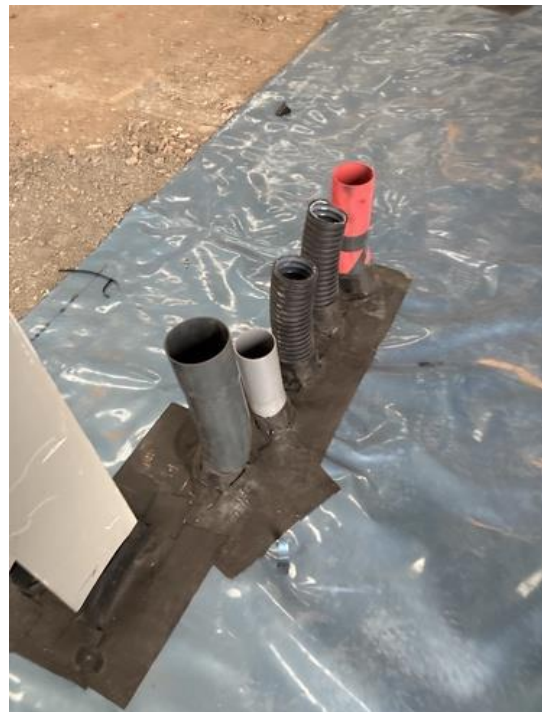
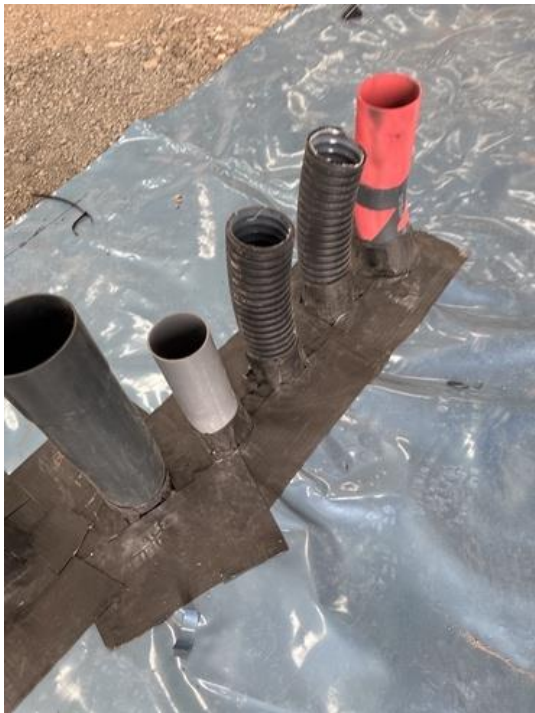
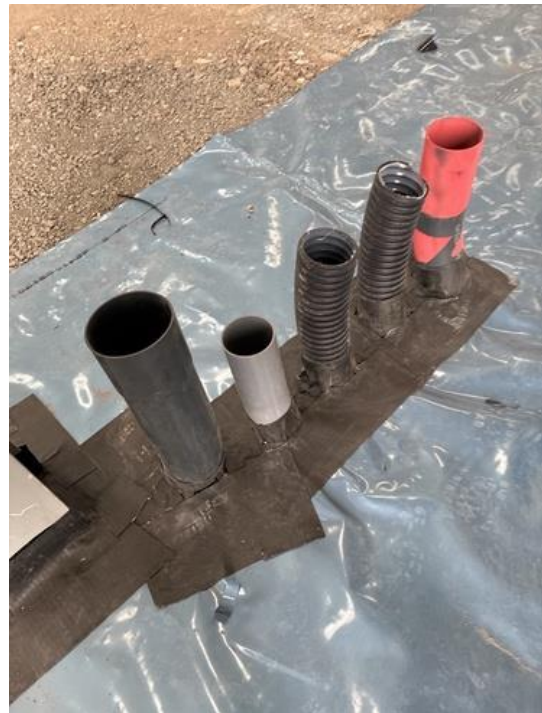
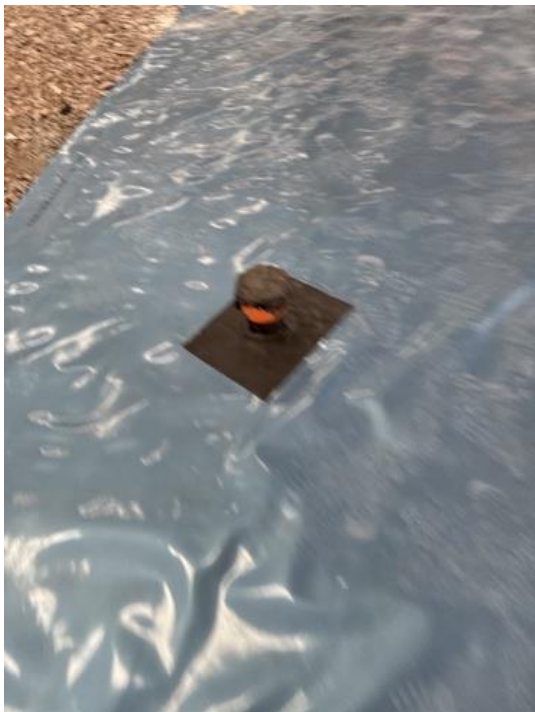
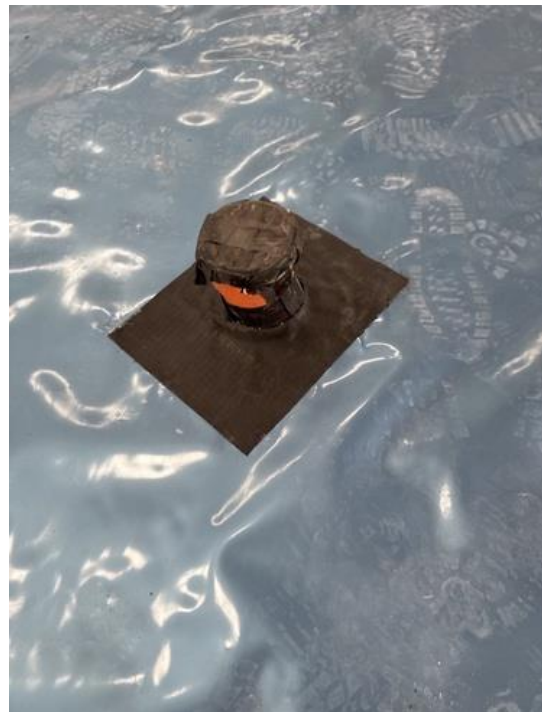
Where any penetration or service duct is present within the floor area E3P inspected each one in turn and can confirm that rigid black polyethylene top hat units have been adequately sealed against the membrane with double-sided jointing tape at both the base and the protruding pipe as well as being secured against the pipe with a metal jubilee clip.

**Service entries seals: Top hats seal arrangements fixed around service entries? Use of Jubilee clips or Bitumastic Sealant**

Pass

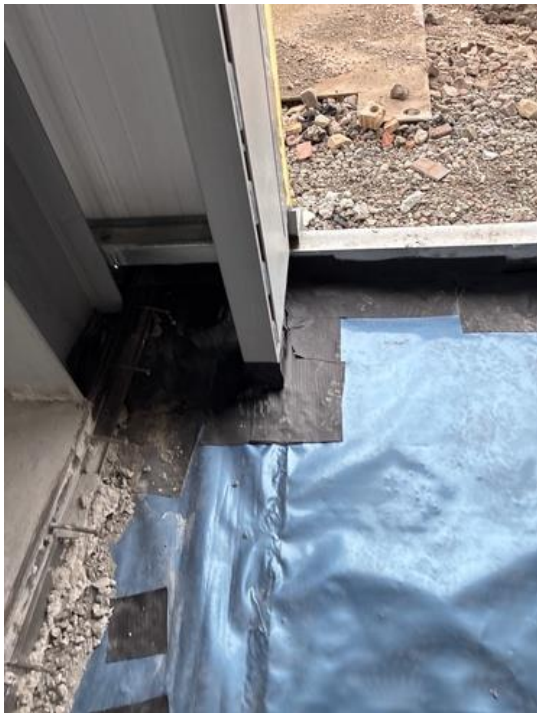
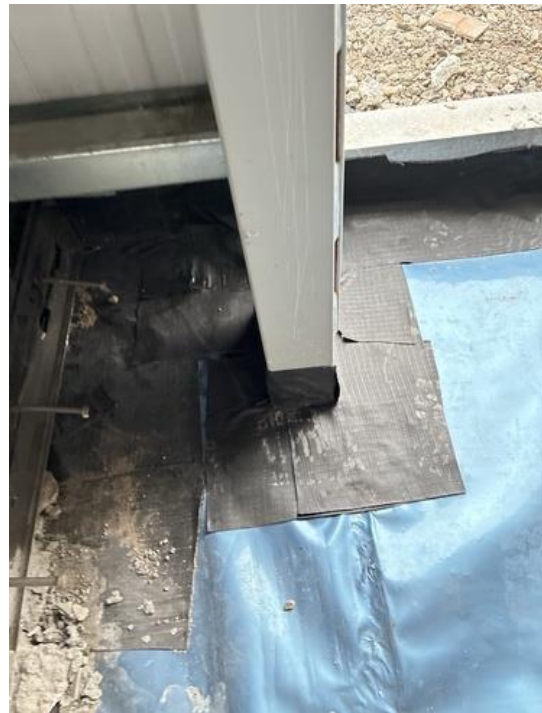
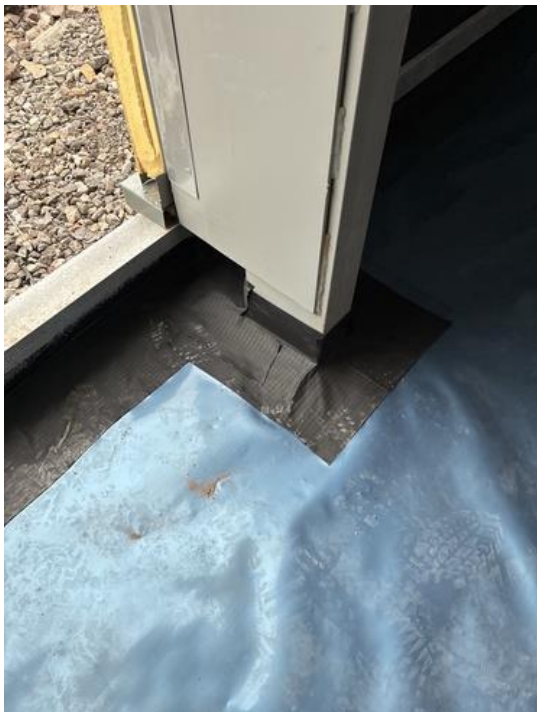
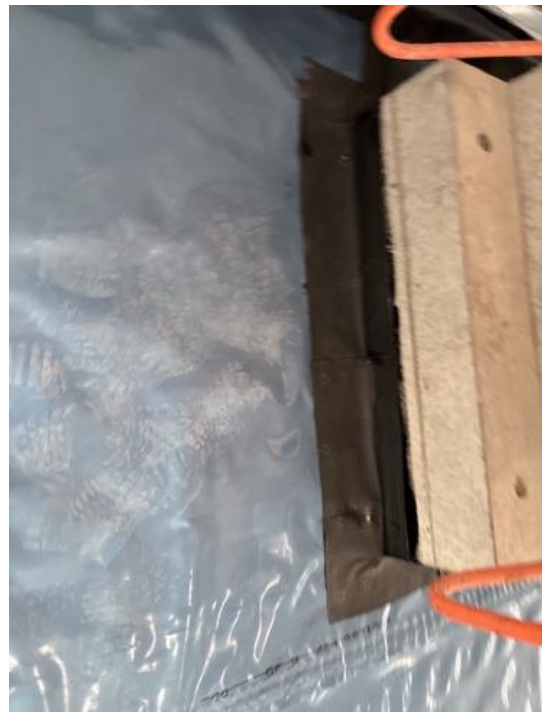
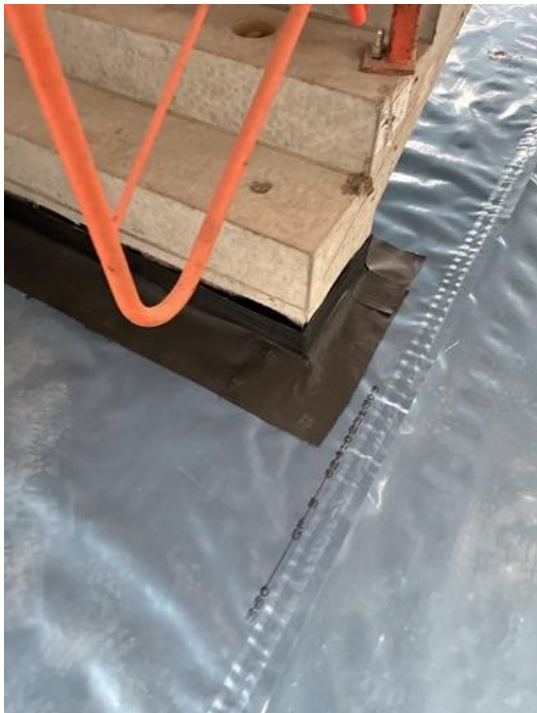
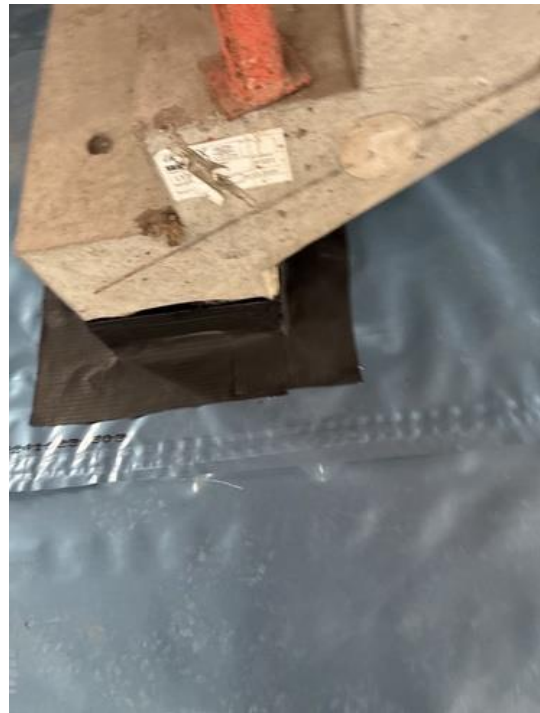
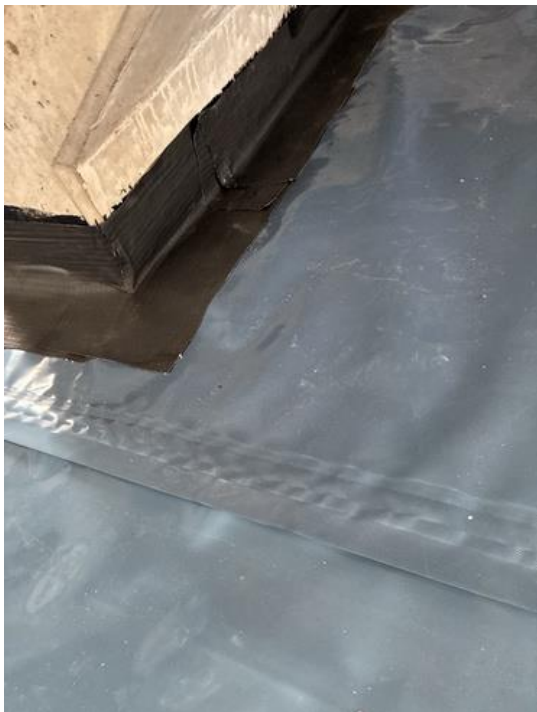
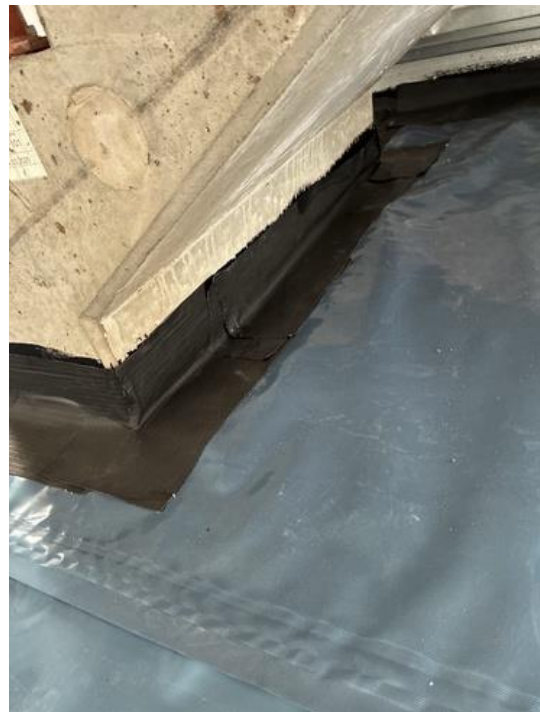
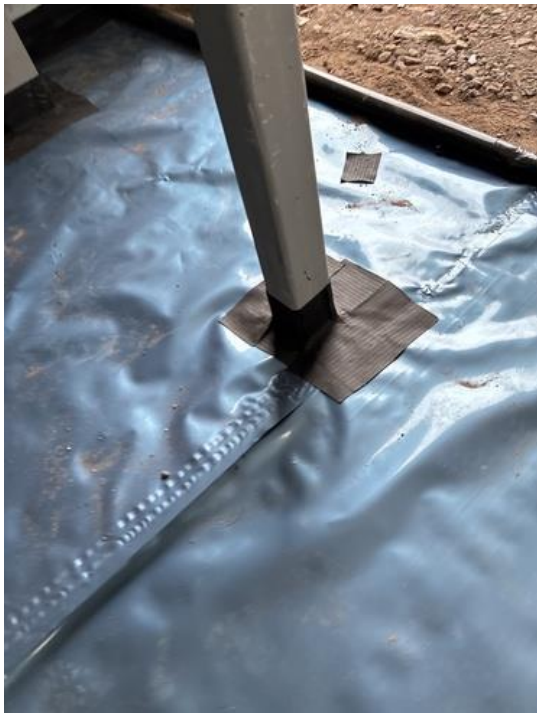
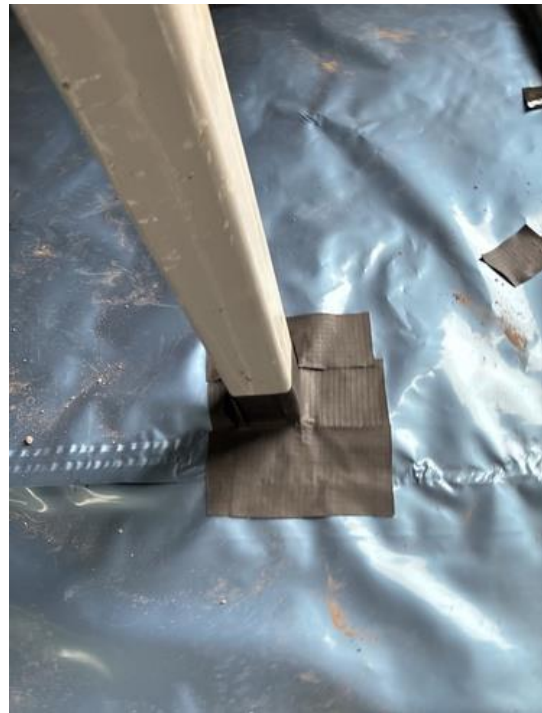
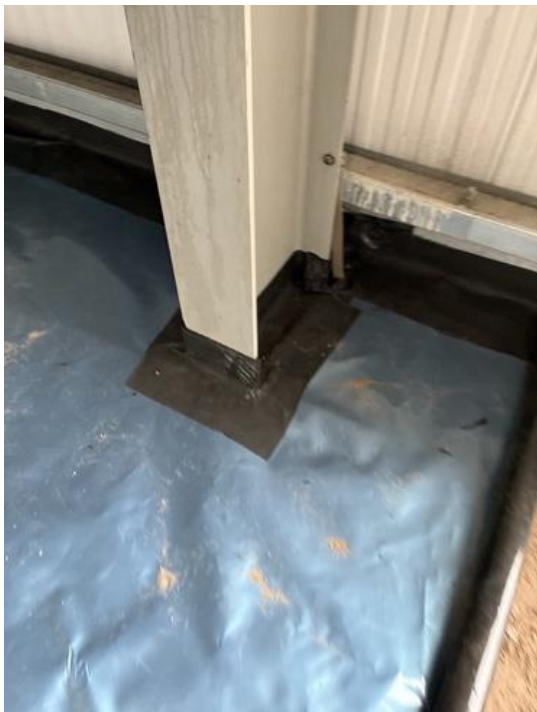
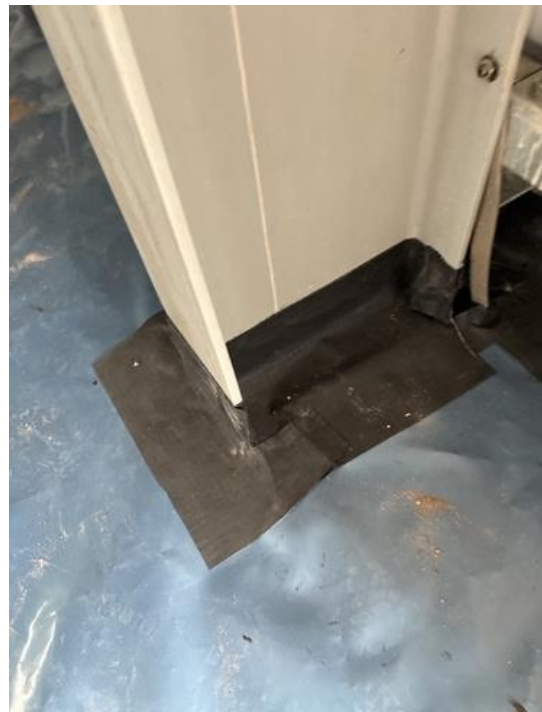
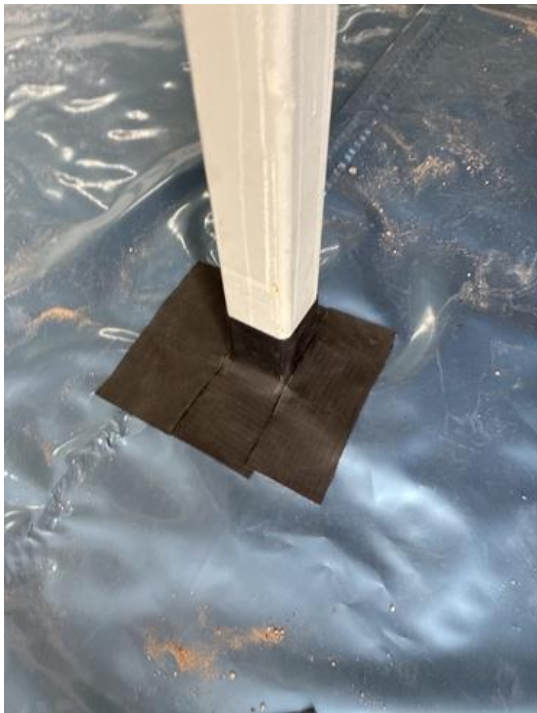
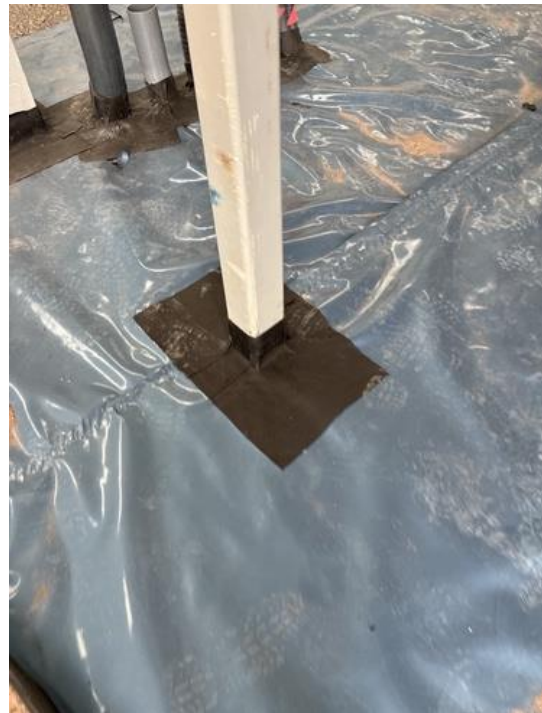
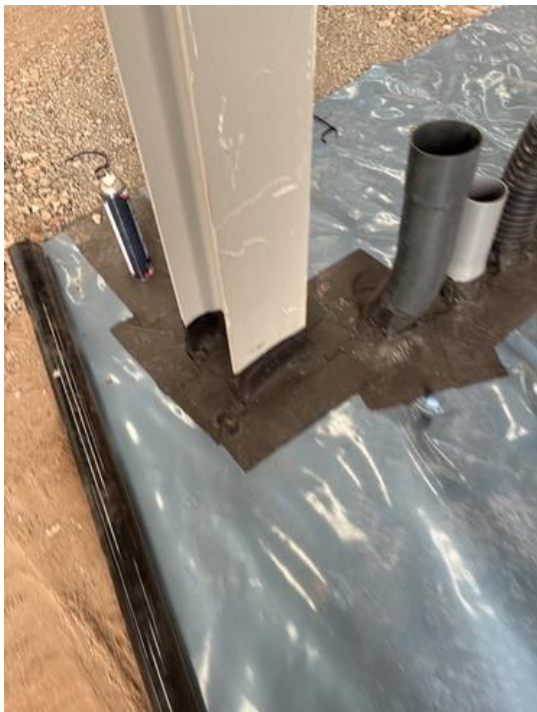
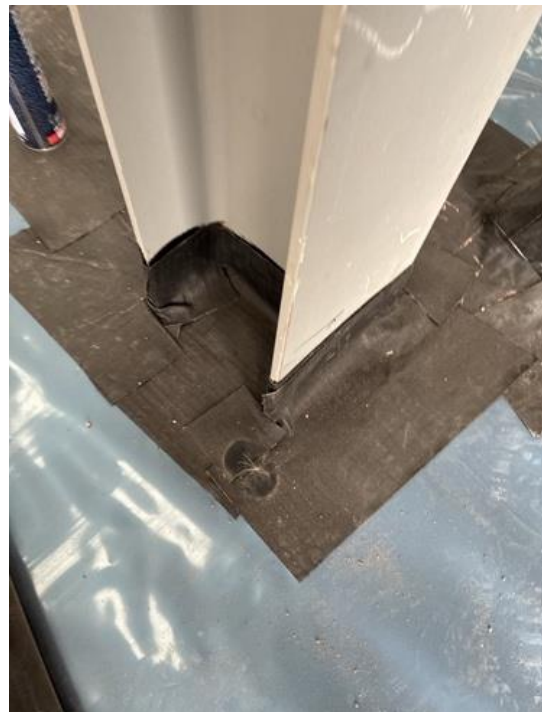
**Corners / Internal joints: Check all corners are correctly formed or contractor has used preformed corners.**

Pass

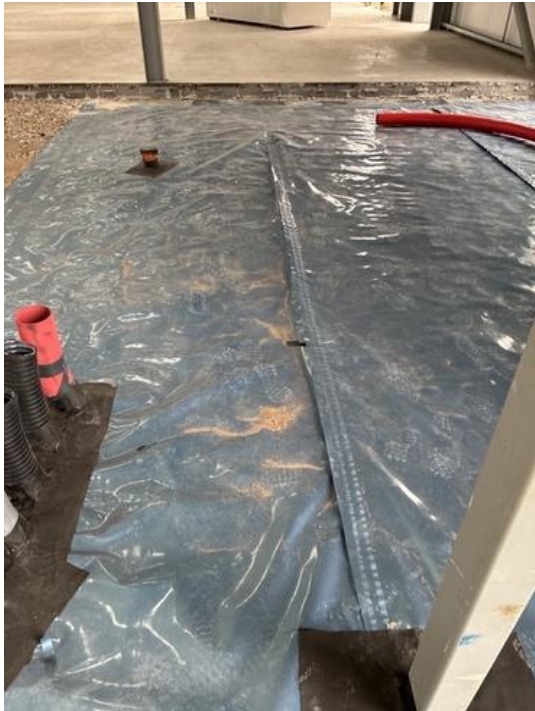
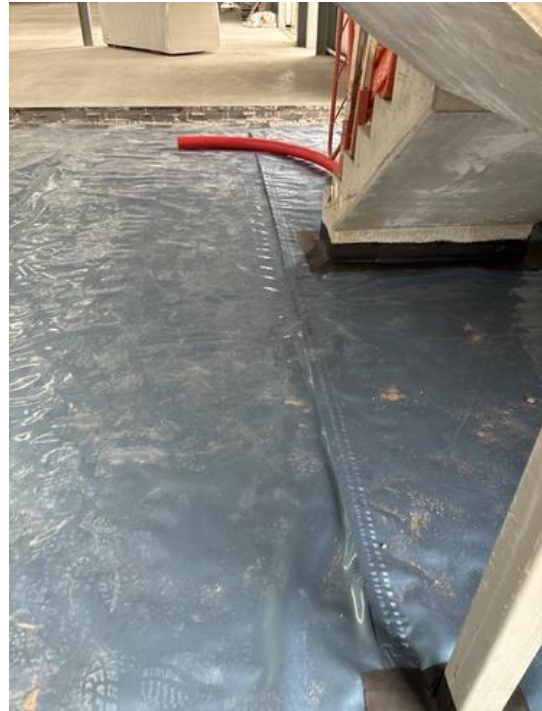
**Are folds running in line with joints? (no joints cutting across folds)**

Pass

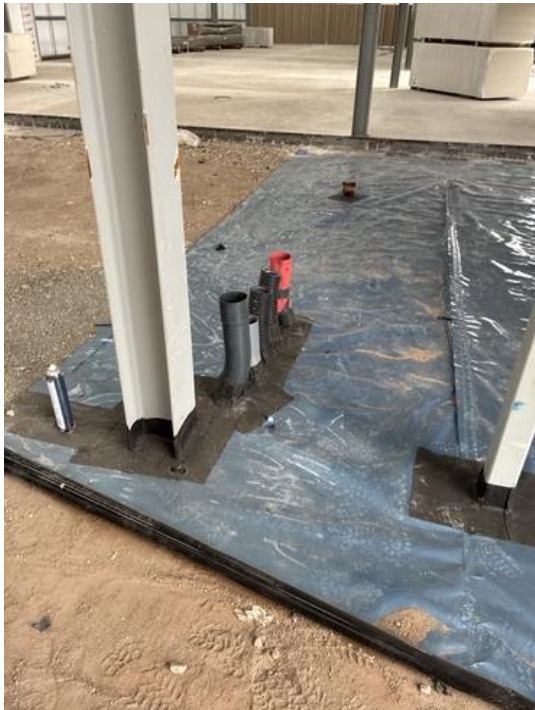
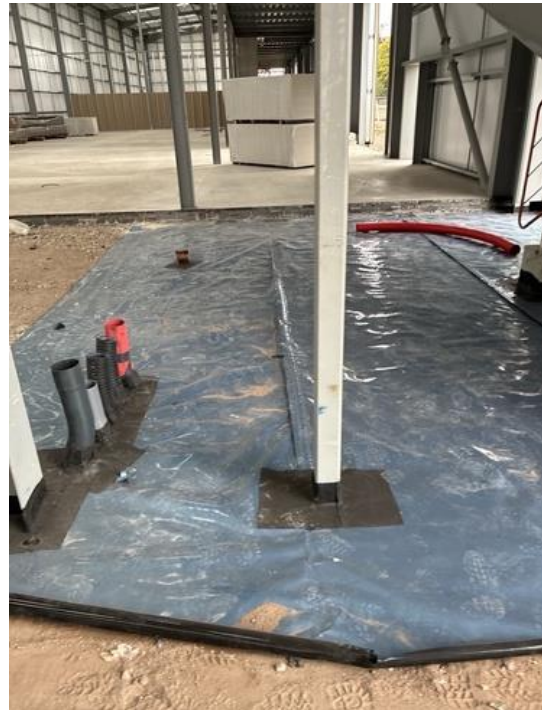
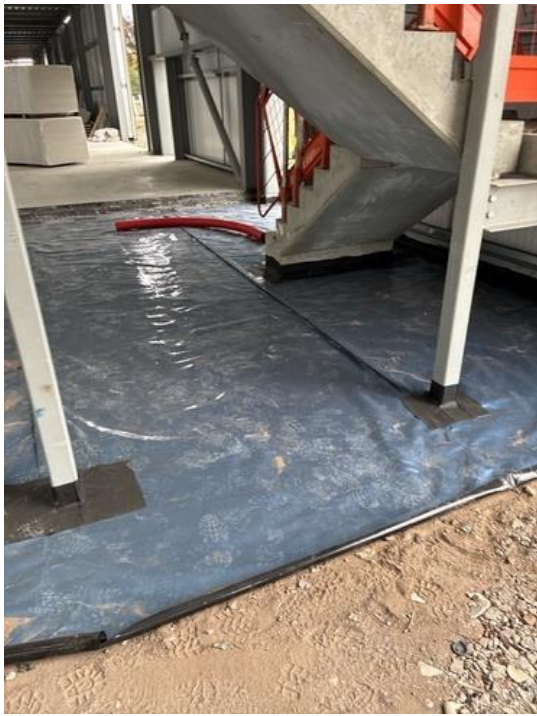
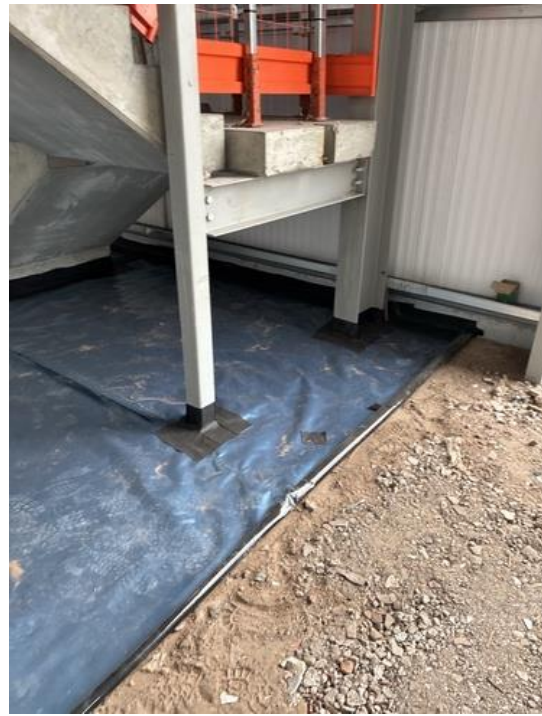
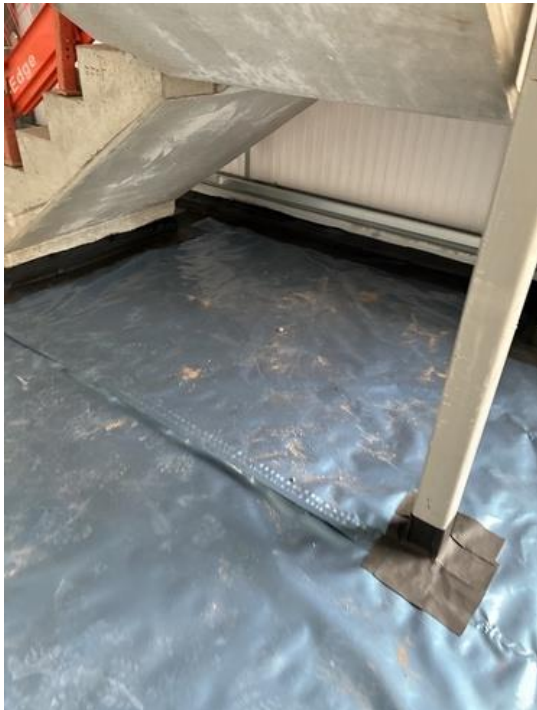
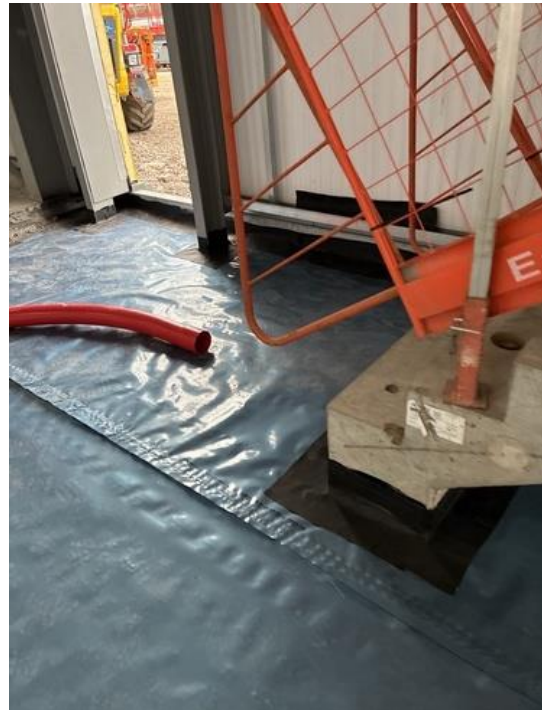
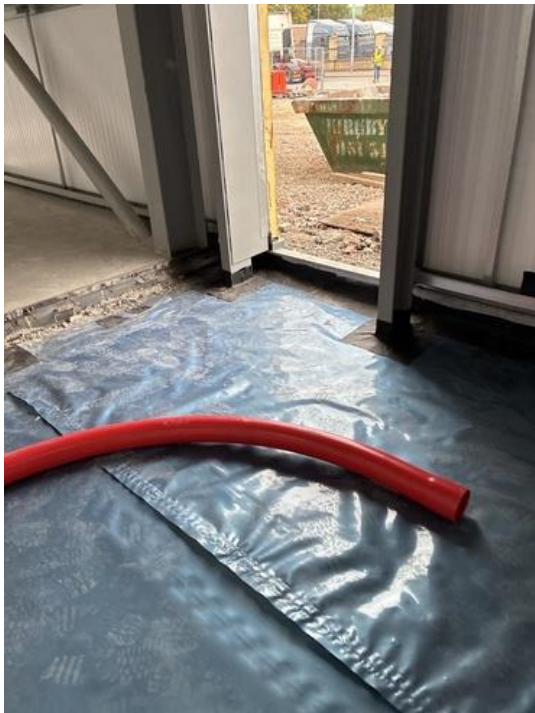
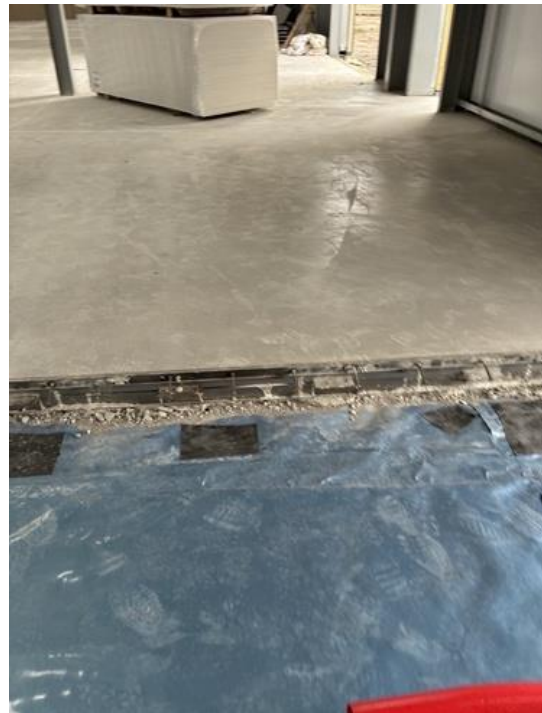
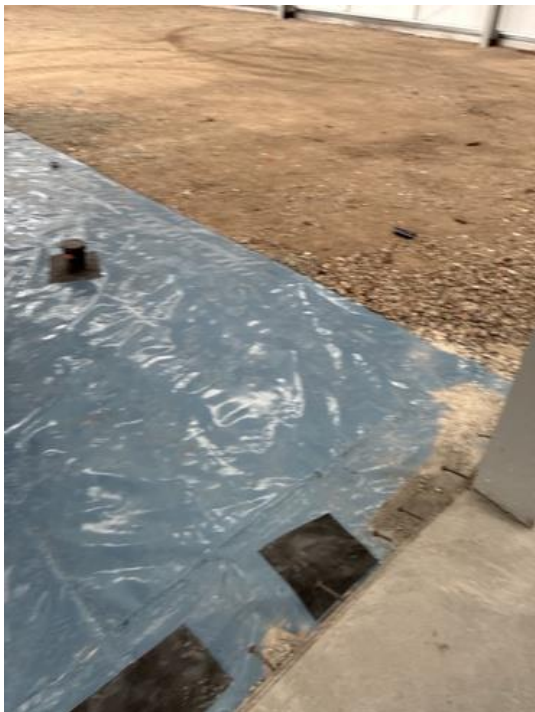
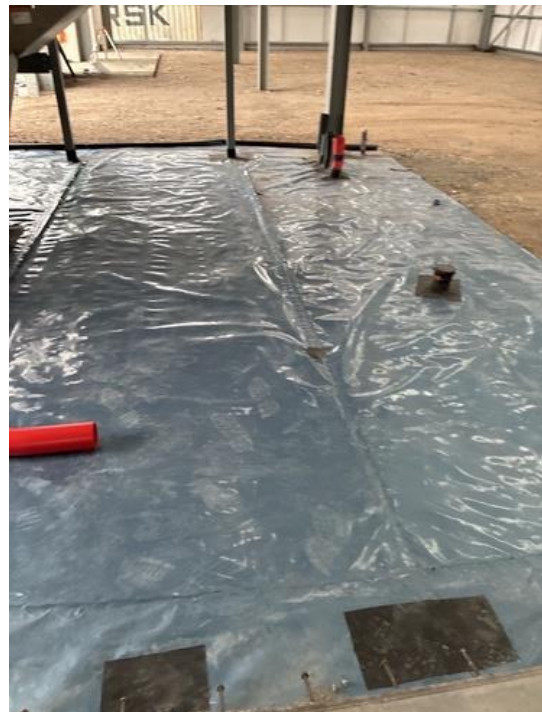
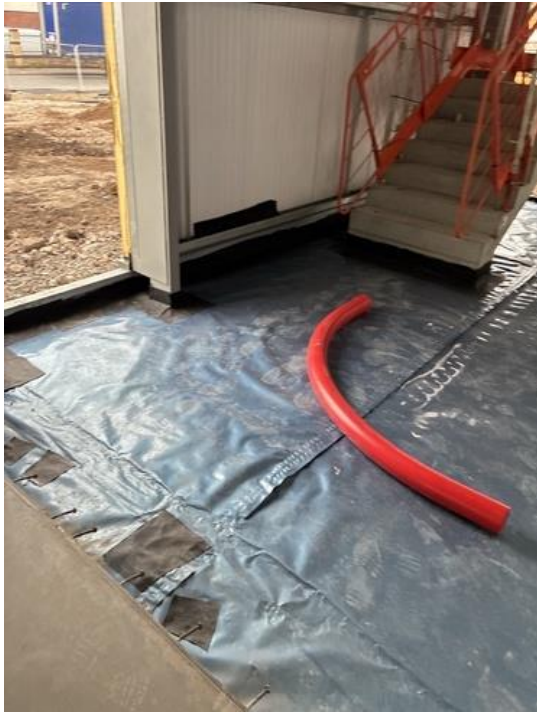
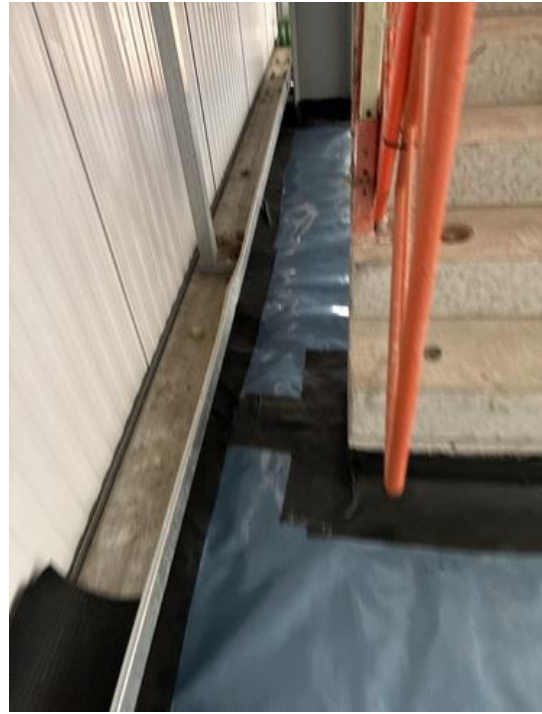
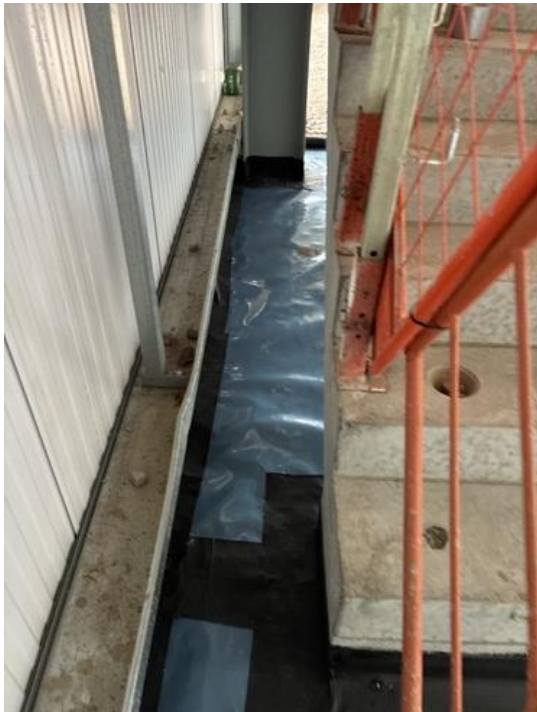
**Extent of Coverage: Is the membrane covering the entire plot? Does membrane span over outside walls?**

Yes
