Date: 15<sup>th</sup> August 2025  
Reference: 12-969-V1

## GAS MEMBRANE VALIDATION – DRAW WELL ROAD

| <b>Project Name:</b> | Draw Well Road, Knowsley |
| <b>Project Number:</b> | 12-969 |

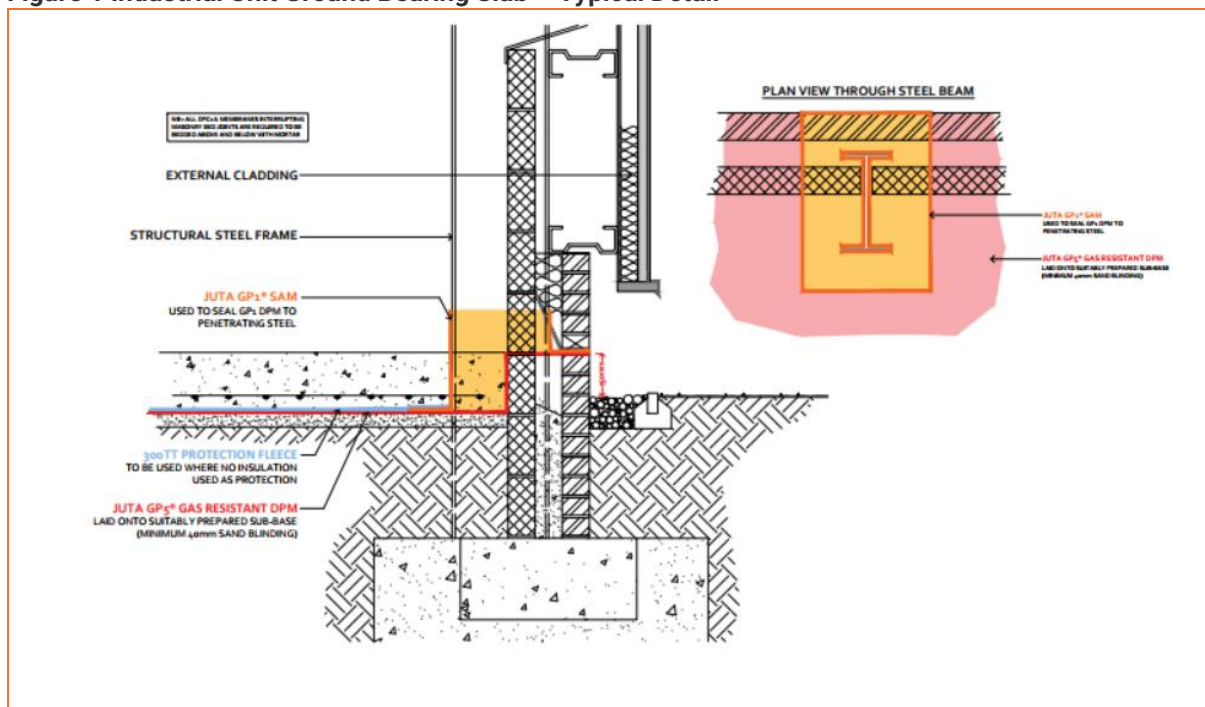
Figure 1 Industrial Unit Ground Bearing Slab – Typical Detail

It has been confirmed as part of the validation that the membrane utilised in the units (office areas) discussed herein matches that of **Figure 1-2**.

The E3P Technician has inspected the installation of this membrane in line with the specifications in terms of placement and position (**Figure 1-2**), and the manufacturer's detail in terms of the workmanship. **Figure 3** illustrates the ground floor layout for the unit numbers validated within this letter.
